Lockheed

SERVICE NEWS

VOL. 10, NO. 1, JANUARY—MARCH 1983

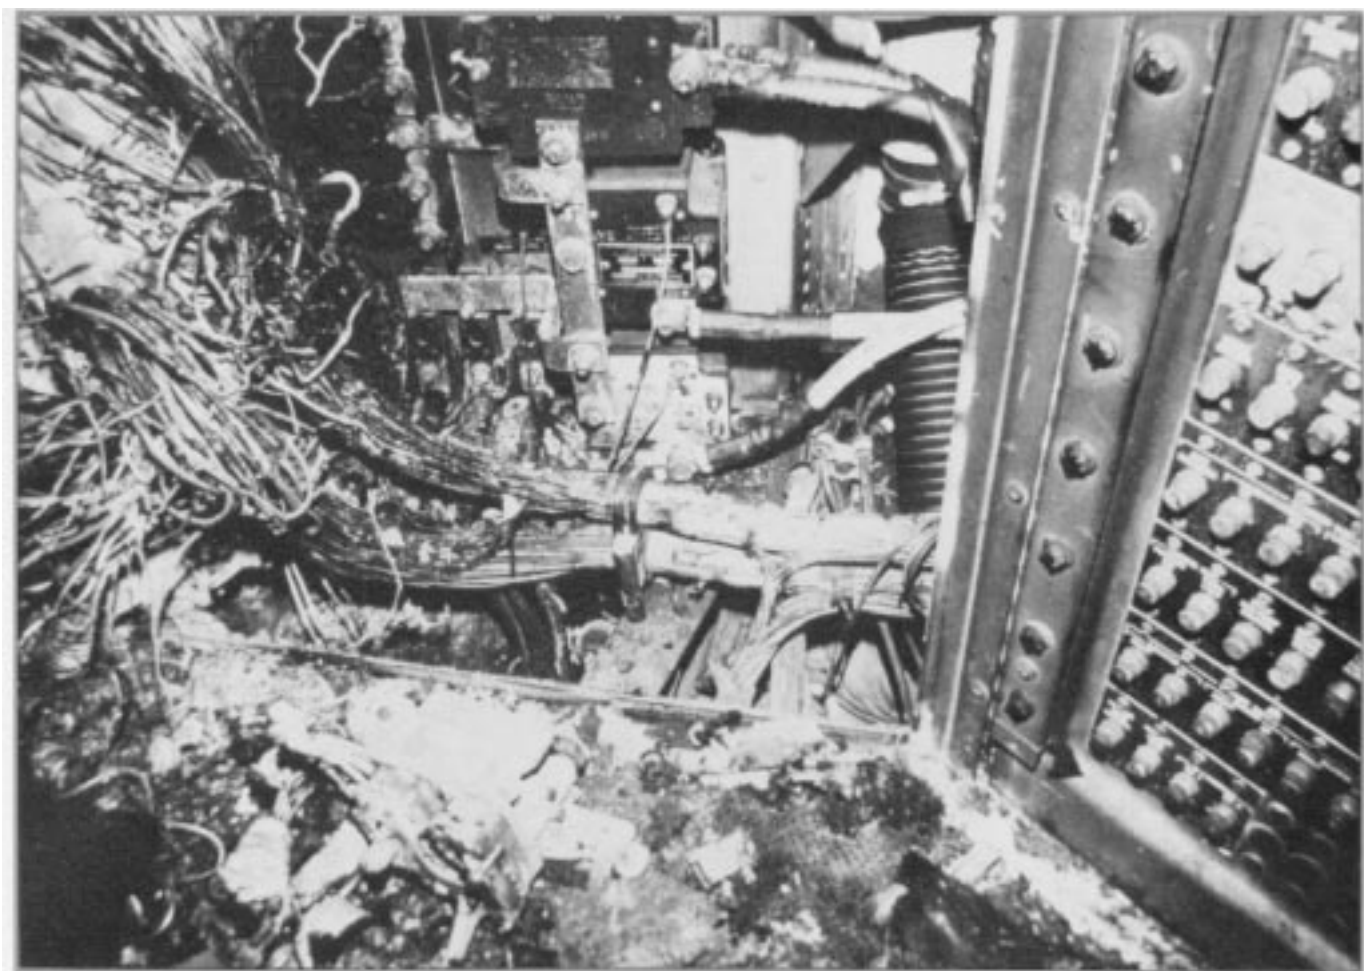
Figure 1. The aftermath. A well-intended effort to solve a minor problem ultimately yielded this scene of destruction.

creased in intensity as the aircraft was stopped and crew members made an emergency evacuation. Fire and crash equipment operators on the scene were able to save the airplane, but the flight station area sustained heavy damage (Figure 1).

Engineering review is currently in process to block unwanted access to Hercules aircraft power distribution areas, but hardware alone cannot provide total protection against the consequences of innovative "solutions" to transient problems that fail to take all possible risk factors into account.

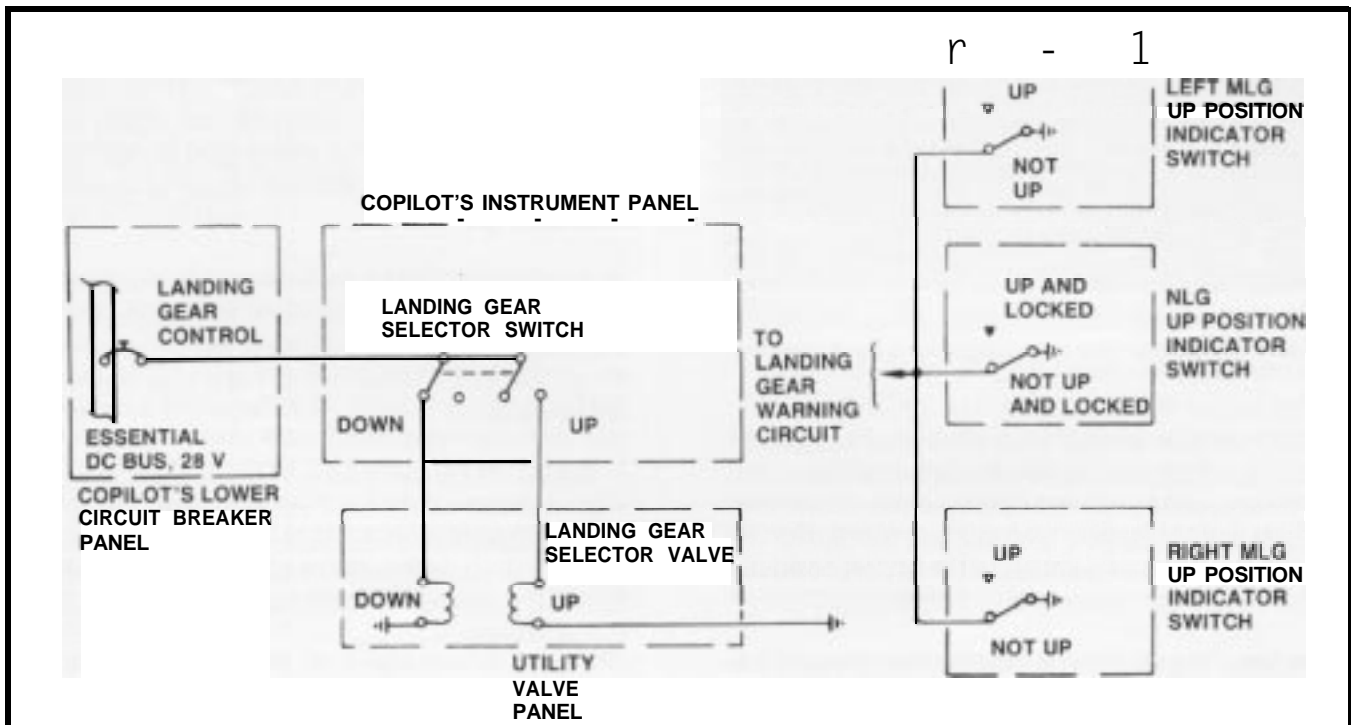
A change was made to Hercules aircraft wiring starting with Lockheed serial number LAC 4637 which keeps the “up” solenoid of the landing gear selector valve energized anytime the landing gear control handle is in the up position (Figure 1). Previously, the up solenoid deenergized as soon as all three landing gear up position indicator switches were actuated (Figure 2). At about the same time that the wiring change was made on new production aircraft, Lockheed issued Service Bulletins 82-380

Figure 1. Landing gear control wiring diagram for Hercules aircraft LAC 4637 and up, and earlier Hercules aircraft incorporating Service Bulletins 82-380 or 382-064, or TCTO 1 C-130-1065.

and 382-064 to allow commercial and foreign military customers to modify their Hercules aircraft to the new wiring configuration. Subsequently, Warner Robins Air Logistics Center issued TCTO 1 C-130-1065 to retrofit all United States Air Force C-130s (except A-models, which were not affected). Like most changes, there were advantages and disadvantages associated with changing the wiring. Let us examine Lockheed engineering’s analysis of the wiring change, and why it was concluded that there

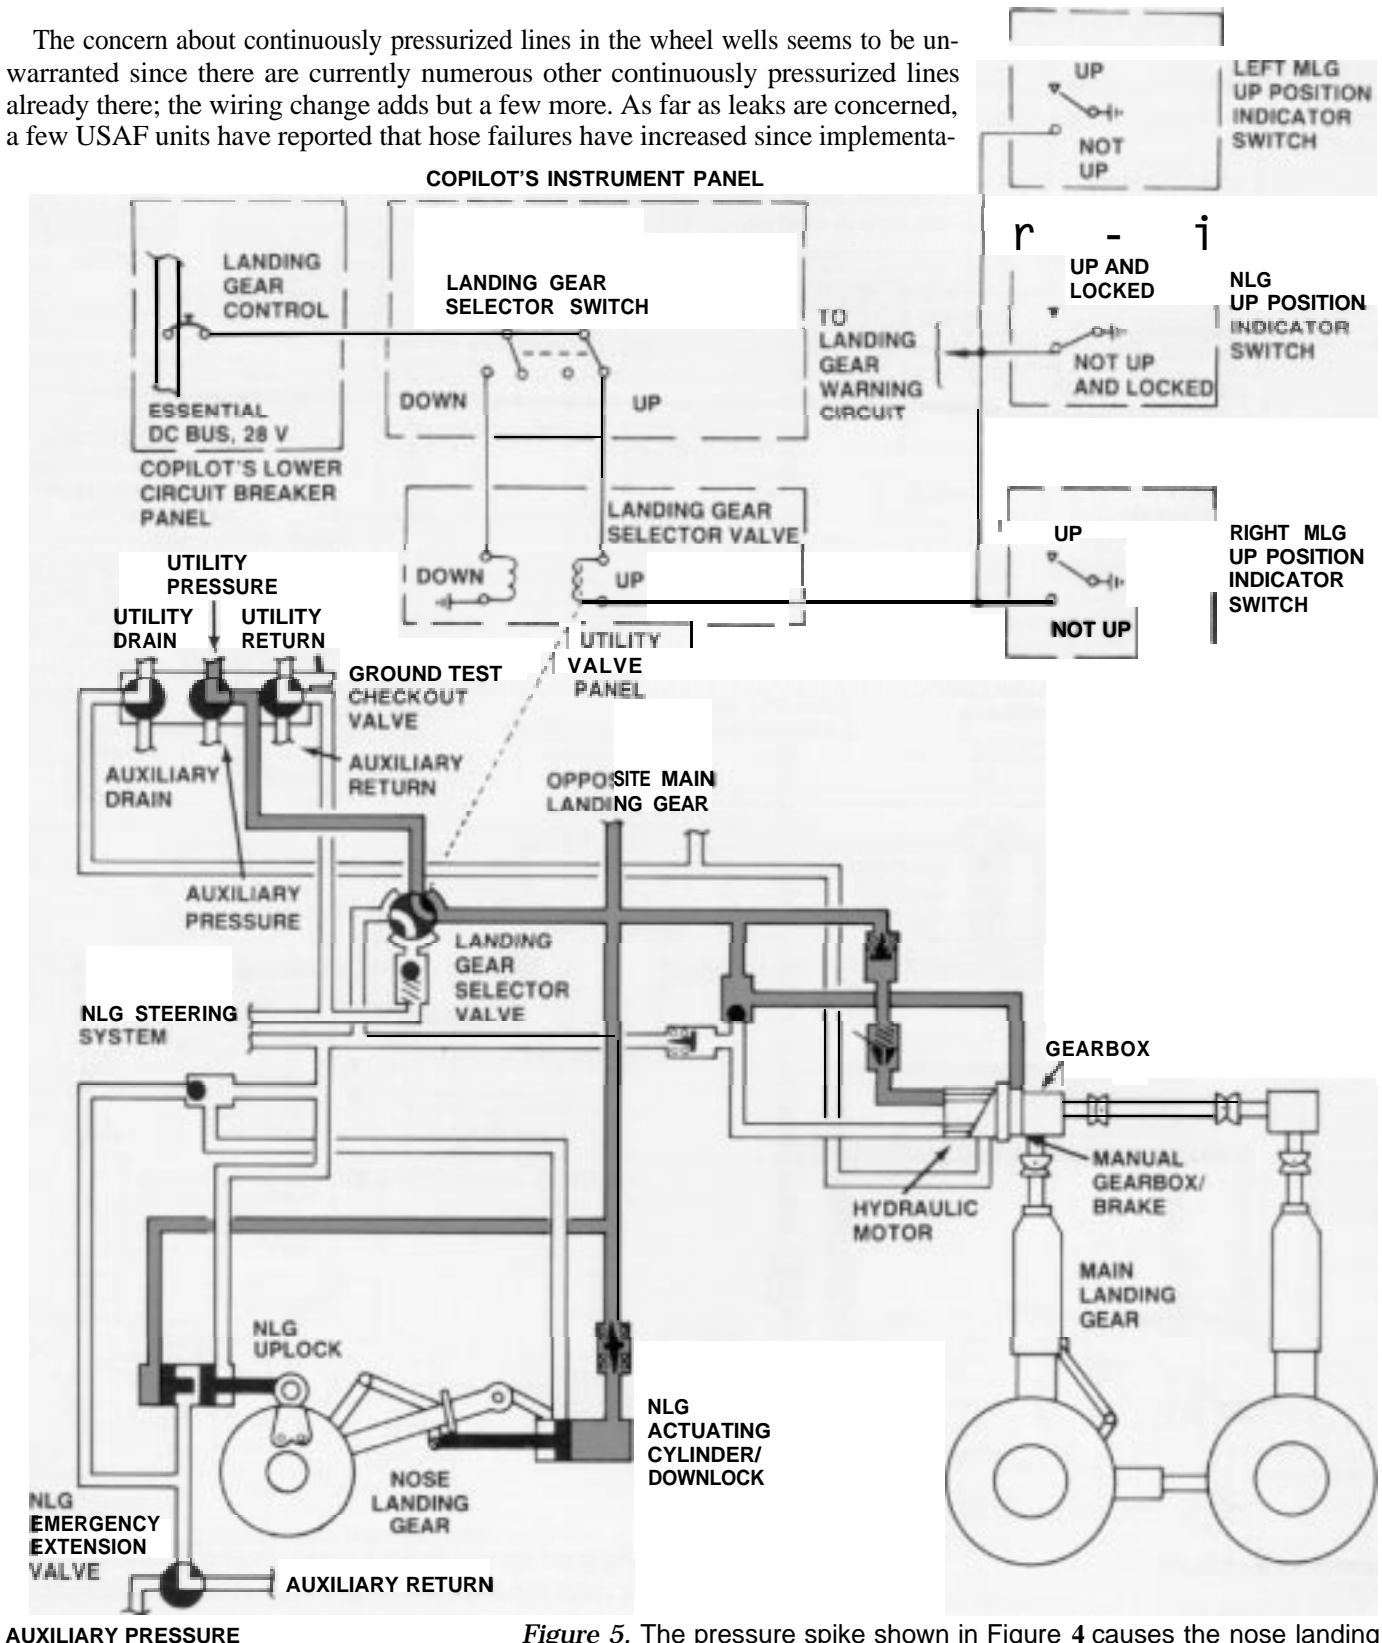
to unlock momentarily (Figure 5). As soon as the uplock is unlocked, the nose gear up position indicator switch provides a ground to reenergize the selector valve up solenoid and relock the nose gear uplock. This momentary unlocking of the nose landing gear uplock is the blip that shows up on the nose landing gear indicator as a momentary in-transit indication.

Figure 5. The pressure spike shown in Figure 4 causes the nose landing gear to unlock momentarily.

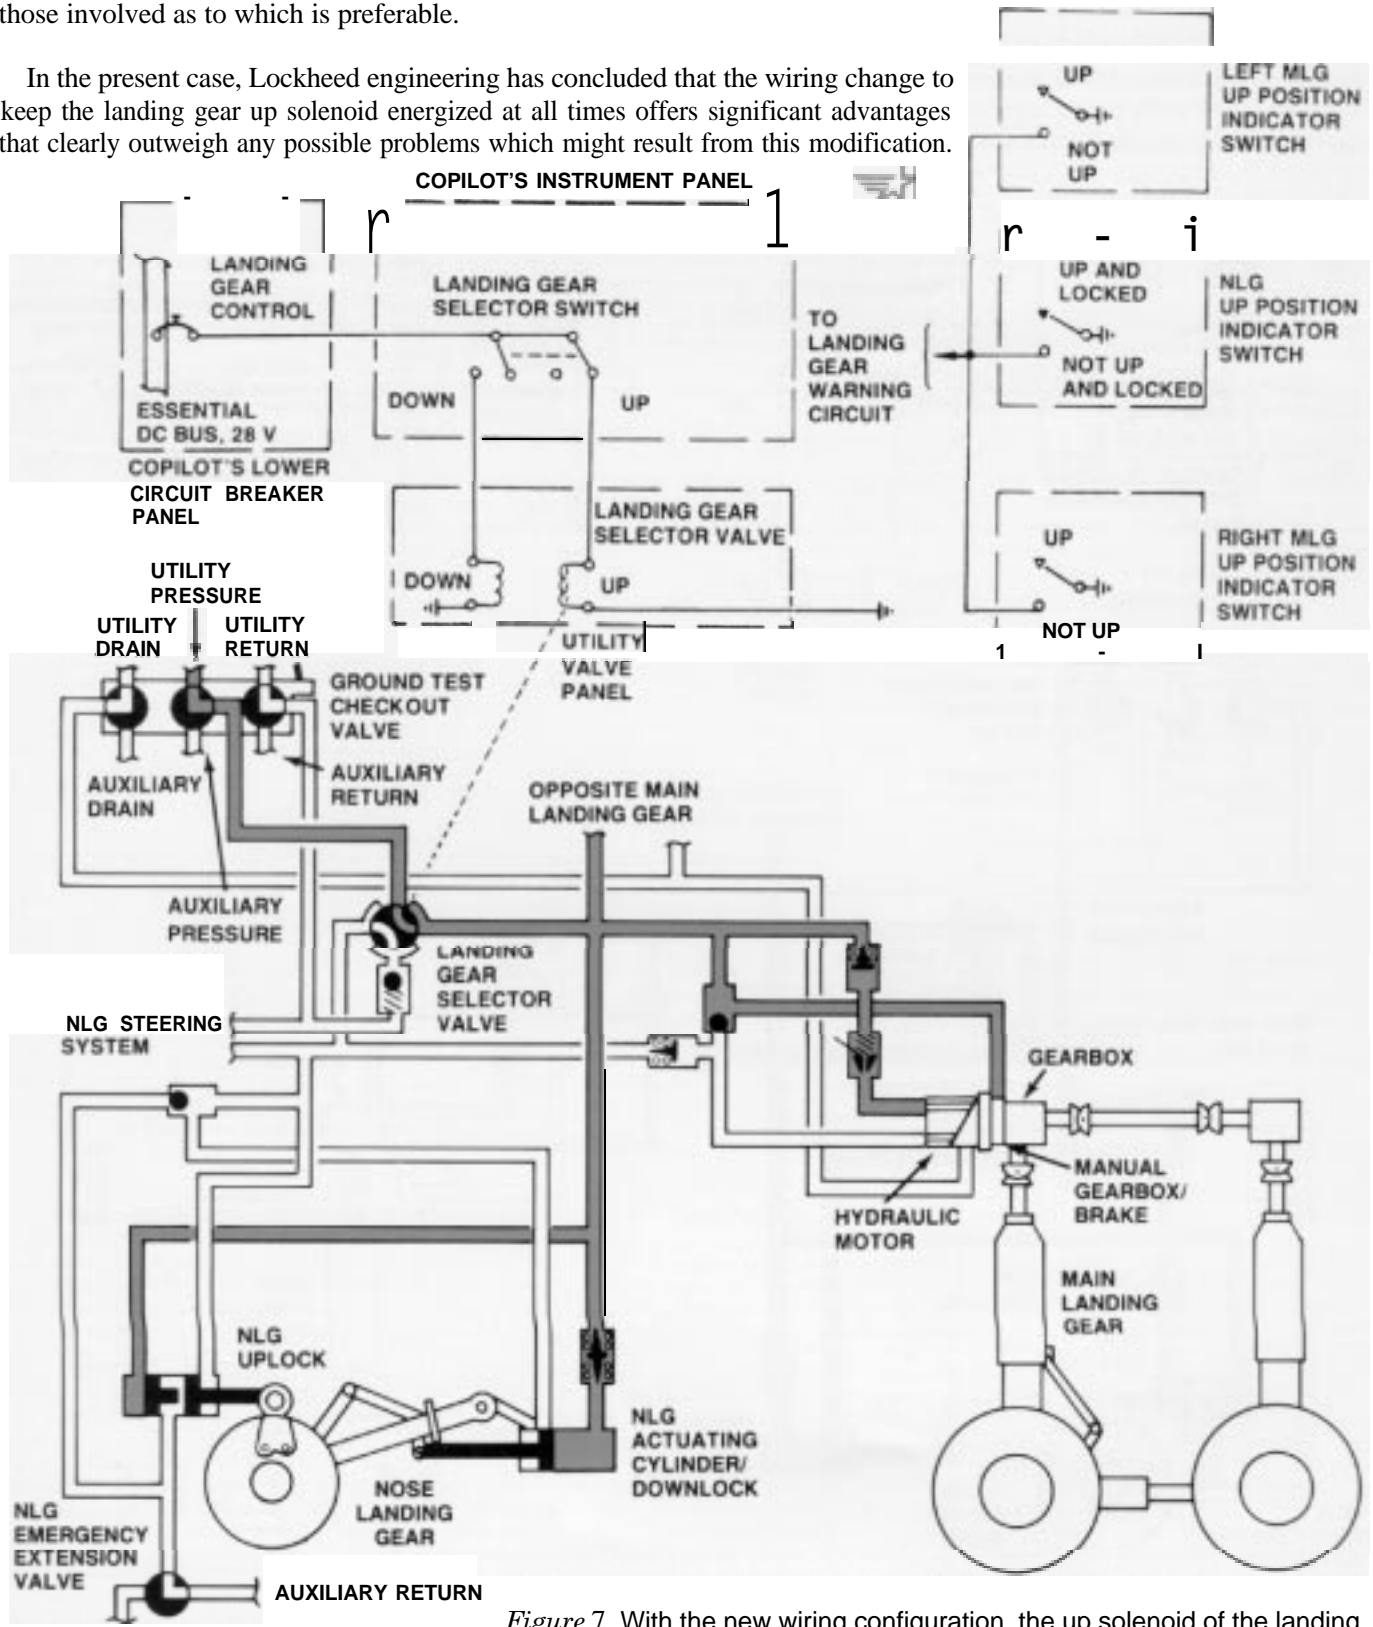
Some operators have asked whether the constant application of hydraulic pressure when the gear is up (Figure 7) does not result in a disadvantage by exposing the wheel wells to continuously pressurized lines and increasing the likelihood of leaks.

The concern about continuously pressurized lines in the wheel wells seems to be unwarranted since there are currently numerous other continuously pressurized lines already there; the wiring change adds but a few more. As far as leaks are concerned, a few USAF units have reported that hose failures have increased since implementa-

tion of the wiring change; however, the available evidence does not support the contention that hose failures are caused by the application of a steady 3000 psi pressure on the lines. Tests have indicated that flexing of the hoses with each application of pressure will result in a greater fatigue rate and cause hose failure sooner than continuously applied pressure.

The most likely explanation of the reported hose failures is simply that the hoses are getting old. Currently, USAF manuals do not specify a periodic change of hydraulic hoses; they are visually inspected and changed only if they appear bad. Unfortunately, visual inspections usually cannot detect weakened hoses that are about to fail internally.

Figure 7. With the new wiring configuration, the up solenoid of the landing gear selector valve remains energized anytime the landing gear control handle is up; the hydraulic lines remain pressurized.

In the present case, Lockheed engineering has concluded that the wiring change to keep the landing gear up solenoid energized at all times offers significant advantages that clearly outweigh any possible problems which might result from this modification.
