SERVICE NEWS

VOL. 10, NO. 2, APRIL—JUNE 1983

Engine-Driven Hydraulic Pumps

Vol. 10, No. 2, April-June 1983

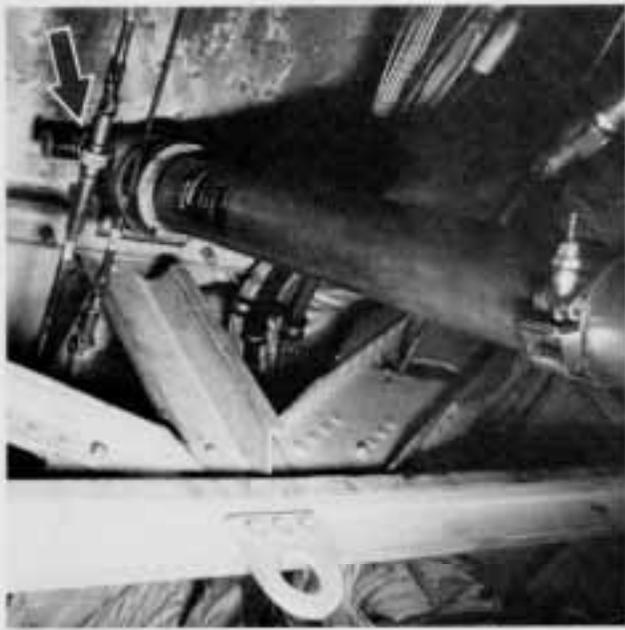
After a paratroop, the aft cargo door switch was left in the neutral position and the emergency manual release cable was used to close the cargo door. Unfortunately, air had become trapped in the associated hydraulic lines and the heavy door dropped suddenly and with considerable force. This applied excessive stress to the structure supporting the upper end of the cargo door actuating cylinder at FS 968, causing it to fracture.

In itself, this would not have resulted in anything more serious than an inoperable door system. But the bleed valve on the actuating cylinder snagged one of the elevator control cables that run beneath it as it dropped, causing the aircraft to assume a nose-down attitude. The aircraft did not prove uncontrollable, however, and landed safely.

Aft cargo door actuator. Note the protruding bleed valve.

To avoid any possible repetition of this type of problem, Lockheed engineering recommends that two actions be taken by Hercules aircraft operators. First, if there is a bleed valve on the aft cargo door actuating cylinder of any of your aircraft, it should be replaced with a bleed plug. Lockheed engineering will soon

issue Service Bulletins SB 82-532 and 382-29-6, "Bleed Plugs - Aft Cargo Door - Bleed Valve Replacement," which describes replacement of the bleed valve. The bleed plug, which is used in place of the bleed valve on all current production Hercules, is too short to foul the elevator cables should the aft cargo door actuating cylinder become loose for any reason.

The second recommendation is that Hercules aircraft operators who have not accomplished Service Bulletins SB 82-299 or 382-093, "Doors - Installation of Snubber and Attaching Structure on the Aft Cargo Door," do so as soon as possible. These service bulletins install a snubber on the aft cargo door which will prevent the door from dropping too rapidly when it is allowed to close of its own weight.

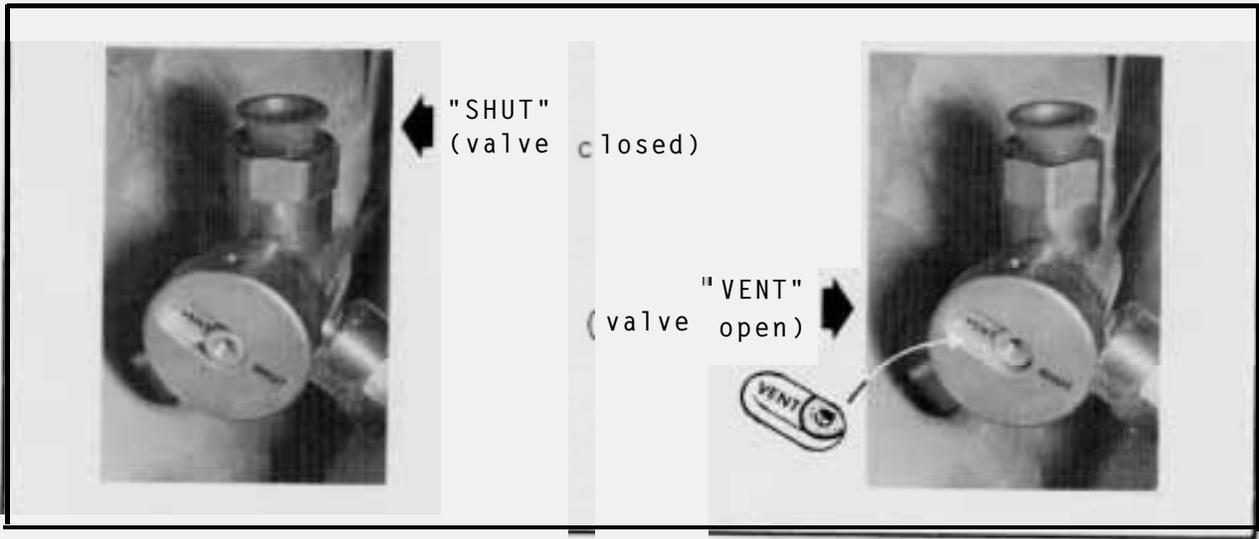
Figure 1. Vent valve positions.

this partial inflation occurs. Lockheed engineering has long suspected that the majority of these unscheduled life raft deployments occur either because the raft was incompletely evacuated prior to installation, or because the P/N 9153 vent valve on rafts so equipped has been left in the closed position. Figure 1 illustrates the appearance of the vent valve in both the closed (SHUT) and open (VENT) positions.

It is very important that the vent valve be left in the open (VENT) position once the life rafts are installed in their compartments. The porosity of the life raft material will not permit the raft to remain evacuated indefinitely, and venting of the raft is therefore required to avoid expansion at altitude. Also, if the vent is left closed, any leakage from the CO2 cylinders used to inflate the rafts for use cannot escape to the atmosphere and will enter the raft itself.

position. The raft appeared to have been properly evacuated and installed, except for the valve position, but the access door clearly showed signs of damage. Each time the aircraft went to altitude, the air trapped in the raft expanded, pushing on the door latches. How long the raft had been installed could not be determined, but loss of the life raft appeared imminent because of bending of the door latches.

In an effort to reduce the chance that a vent valve will be left in the closed position after installation of the rafts in their compartments, Lockheed has added a decal (Figure 2) to the life raft access doors on new production airplanes which shows the proper positioning of the vent valve. The Lockheed part number of the decal is 3319712-1, and it is installed in a space on the access doors next to the existing decals which describe how to fold the life raft.

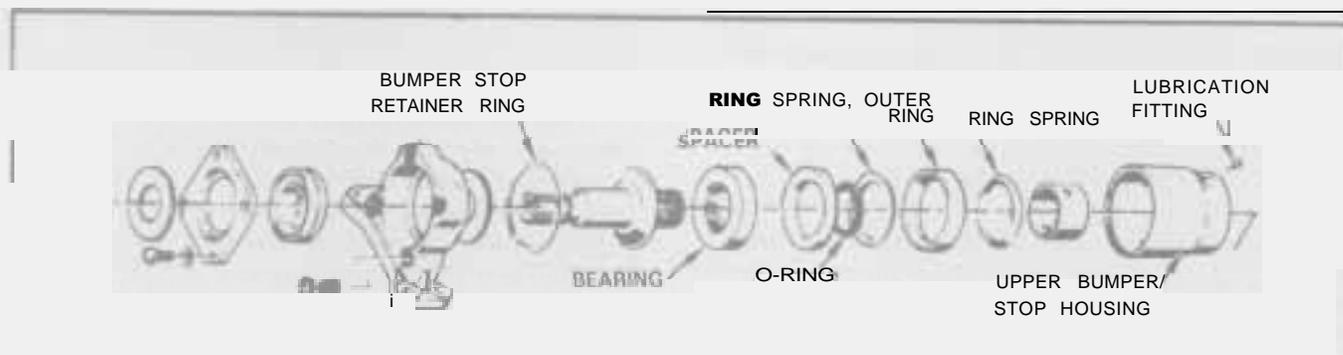
Figure 2. Exploded view of the Western Gear upper bumper stop.

Investigation determined that in each of the cases the ring spring assembly had jammed, which accounted for the excessive axial clearance. The exact cause of the condition was more difficult to pinpoint, but it appears that heavy loads, harsh climatic condi-

When the ring spring assembly is exposed, check to see if the spring elements are still stuck together. If they are, you should be able to separate them by lightly tapping on the outer ring with a mallet. Once the elements are freed, examine them for corrosion, scored surfaces, nicks, chipped mating surfaces, and broken parts. Serious damage will require that the ring spring assembly be replaced, which should be done in the shop after removal of the ballscrew assembly from the airplane.

Minor damage can be much easier to correct. If corrosion is only minor and there are no signs of permanent physical damage, the only repair that will be necessary is to clean all grease from the mating surfaces of the ring spring elements and remove any corrosion with emery cloth. Avoid “polishing” the

Before reinstalling the ring spring assembly, lubricate the elements of the ring spring assembly liberally with MIL-G-81322 grease. Insert the ring spring elements, the spacer, and the bearing into the upper bumper stop housing. Press the upper bumper stop housing upward on the ballscrew with a standard gear puller and install the bumper stop retainer ring. Rotate the ring in its groove on the bumper stop housing to ensure positive seating.

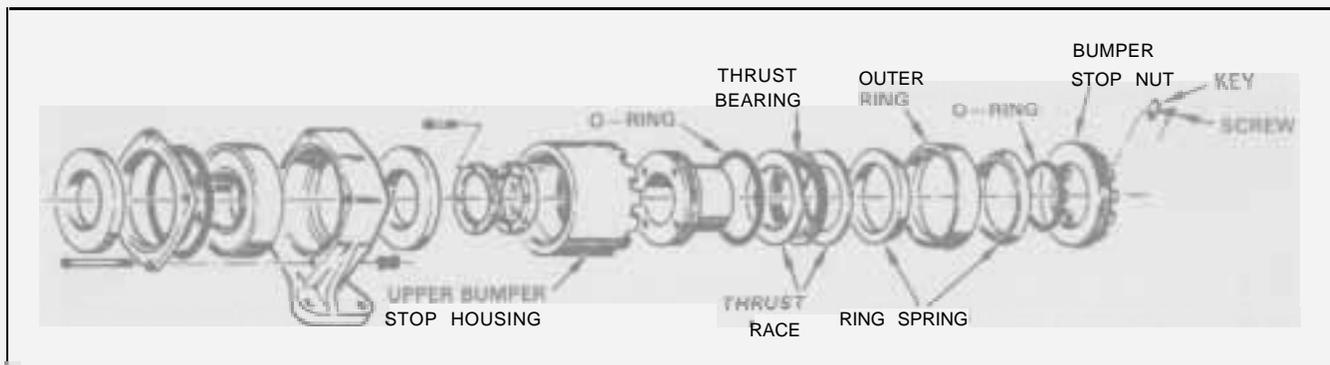
Figure 3. Exploded view of the Calco upper bumper stop.

Inspect the ring spring assembly to determine if the spring elements are still jammed. If they are, tap the outer ring lightly with a mallet to free them. After the elements are separated, check them for corrosion, scored surfaces, nicks, chipped mating surfaces, and broken parts. If any significant damage is present, the

ring spring assembly must be replaced, which should be done in the shop after removal of the ballscrew from the airplane.

In cases where only minor corrosion is found, the only repair required will be to clean the mating surfaces of the ring spring elements carefully and remove any corrosion with emery cloth. Don't "polish" the elements, and protect the other parts of the ballscrew assembly from any foreign particles that may become loosened while you work.

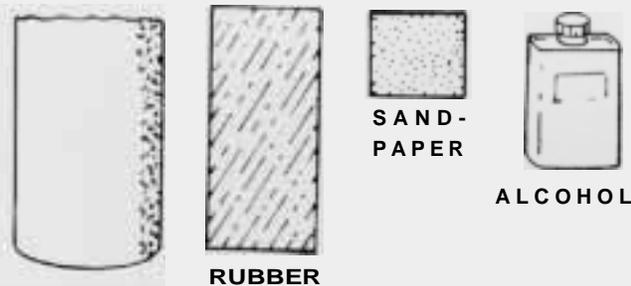
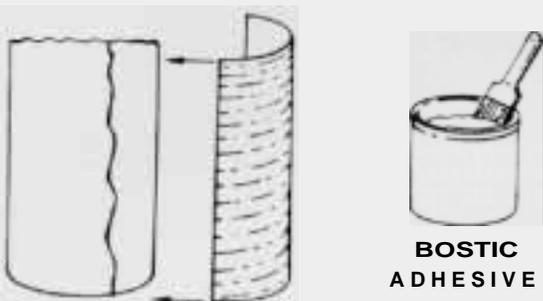
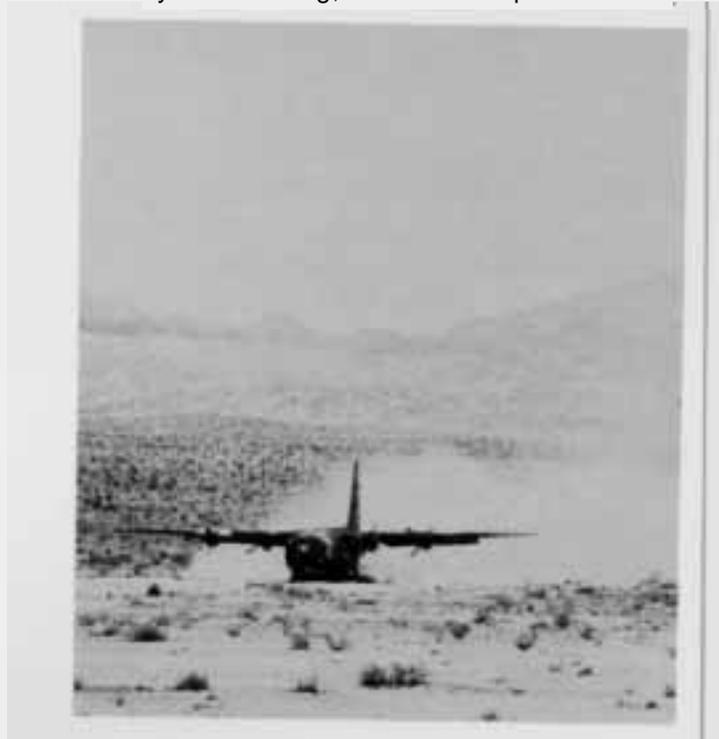
The leading edges of the blade-type UHF and VHF antennas located on the lower part of the Hercules aircraft fuselage are often gradually eroded by sand, gravel, and other solid particles tossed up by the propellers and nose wheels during landings and ground operations. Ice crystals and hail encountered in flight can also cause significant wear and tear on these surfaces.

A simple but effective approach to protecting the leading edge of an antenna of this type is to glue on a strip of rubber cut from an old inner tube. The rubber strip should be large enough to overlap 3/4 inch to 1 inch on each side of the antenna leading edge, and it should be long enough to run the full length of the antenna. Both the antenna and the rubber strip need to be prepared for adhesion by roughening the surfaces that will be in contact. Use medium-grade sandpaper for this purpose, and then clean the surfaces with solvent. Alcohol is a good choice because it leaves no residue.

Any strong adhesive can be used to cement the rubber strip to the antenna leading edge. One recommended brand is Bostic No. 1096, used with Boscodur No. 9 accelerator. Be sure to follow the manufacturer's instructions carefully to ensure maximum adhesion and durability.
