SERVICE NEWS

VOL. 10, NO. 3, JULY—SEPTEMBER 1983

***RUDDER
THRUST
BEARING
SERVICING***

Controlling Rudder Thrust Bearing Wear

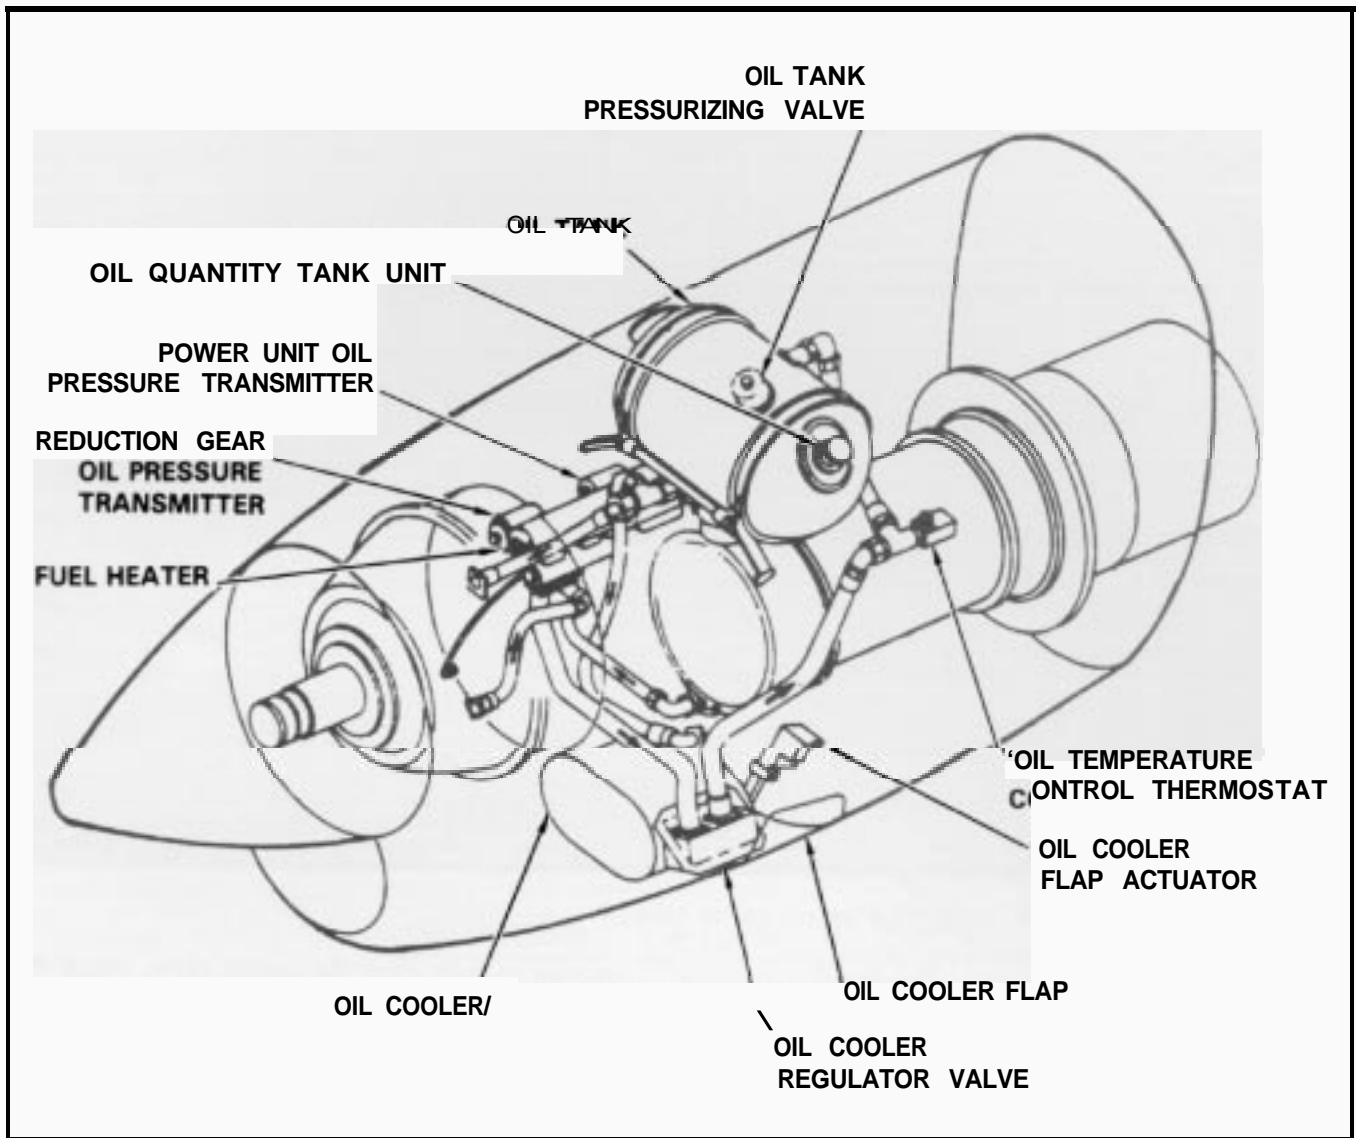
Figure 1. Engine oil supply system.

One such occurrence involved a Hercules aircraft equipped with three glass-mercury thermostats and one solid-state thermostat. On the ground, with all oil cooler flap switches in automatic, the cooler flaps were full open (Figure 2). As power was applied for takeoff, the oil cooler flaps that were controlled by the glass-mercury thermostats moved toward the closed position and the oil temperatures stabilized at 85°C. The cooler flap controlled by the solid-state thermostat remained open until the oil cooler flap switch was placed to CLOSE. When the flap reached 40%, the switch was placed back to AUTOMATIC, at which time the flap continued to close to about 5% open. With this oil cooler flap at 5%, the oil temperature stabilized at 76°C.

controlled oil cooler flap did not automatically close in this case can be traced to the interaction of the oil temperature control thermostat and the thermostatic bypass and relief valve assembly in the oil cooler regulator valve.

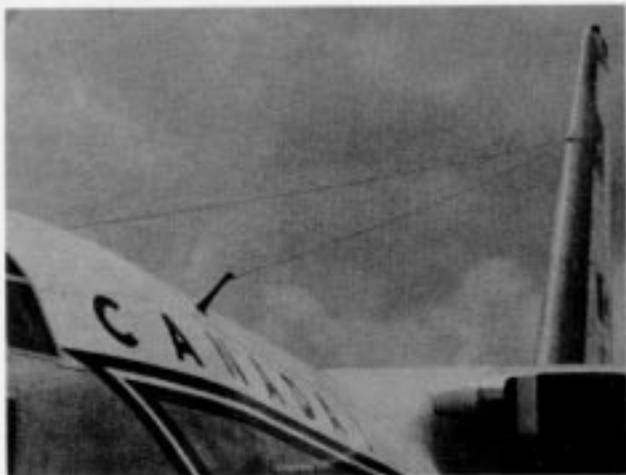
Figure 1. The forward end of each HF antenna wire is anchored to an AML-61 antenna mast.

The most common cause of wire failure has been shown to be corrosion. Laboratory examination of the chuck assemblies in a number of cases where the antenna wire had failed indicated that the principal corrosion product was iron oxide (rust) from the copper-coated steel antenna wire and copper-coated steel chuck spring. The stainless steel chuck assembly body and spring locating screw and the brass chuck jaws are apparently not corroding. An exploded view of the wire chuck assembly and its installation is shown in Figure 2.

Evidently, the problem begins when the copper coating of the antenna wire is broken during preparation for installation. If the wire is nicked at all, it exposes the steel core of the wire, which subsequently rusts. The copper coating on the spring is probably rubbed off during normal service use, which causes the exposed steel to rust when moisture enters the antenna mast.

Lockheed engineering recommends three steps to be taken to prevent corrosion within the antenna mast: proper assembly of the antenna mast and wire, proper preparation of the antenna wire, and the addition of a corrosion preventive compound to the chuck assembly.
