SERVICE NEWS

CONSERVING TURBINE LIFE

Vol. 14, No. 1, January-March 1987

- 2 Focal Point
Glenn M. Gray
Director
Flying Operations
- 3 Conserving Turbine Life
A practical approach to extending the service life of 501/T56 engine turbines.

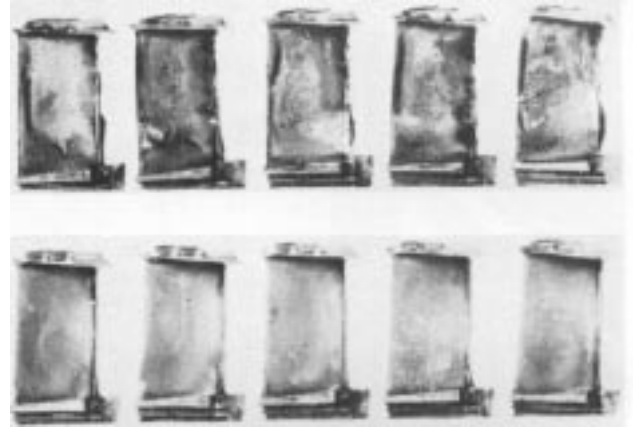
First stage turbine blades after service test.

Top row: uncoated alloy.

Bottom row: the same alloy protected with Alpak.

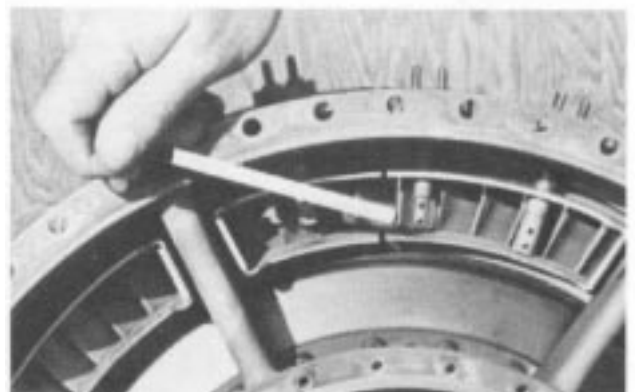
This turbine vane burn-through was caused by the use of thermocouples of the incorrect type.
