# ***SERVICE NEWS***

## **C-130 Ramp Hook Retainers**

Vol. 20, No. 4, October-December 1993

# C-130 RAMP HOOK RETAINER MISLOCATION

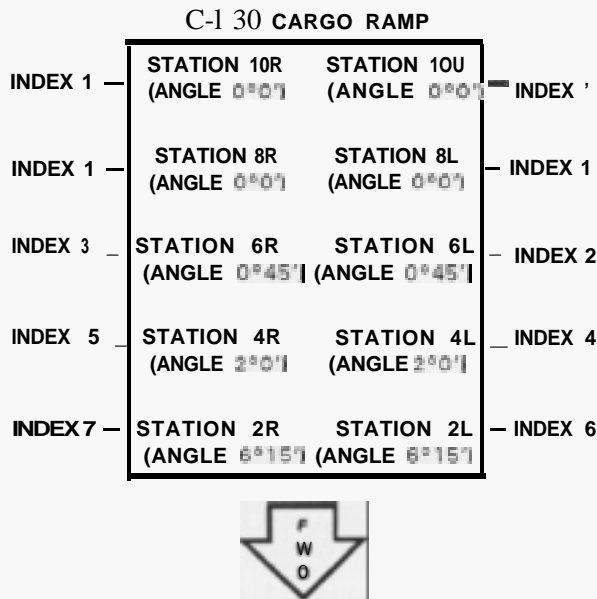
The cargo ramp hook retainers are bolted to the sloping longerons on both sides of the ramp opening at the aft end of the cargo compartment (Figure 1). They serve as strike plates for ramp latches to engage when the ramp is closed and locked.

figure 1. Cargo ramp hook retainer layout. The index numbers correspond to the part numbers shown in Fig. 3.

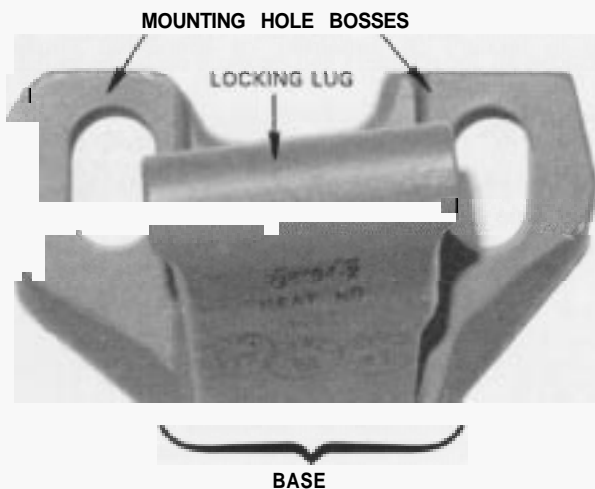
Figure 2. A current-production PN 3338394-2 hook retainer (index 7). It is used at ramp station 2R.

retainer designed for the 2R position. The locking lug in this case is angled 6°15' with respect to the mounting hole bosses to accommodate the curve of the longeron at its intended mounting location. As we have already seen, in the last two retainers on each side towards the aft end of the aircraft, the locking lug is parallel with the base of the retainer and the tops of the mounting hole bosses. These retainers have “no” angle and all are identified by the same part number.

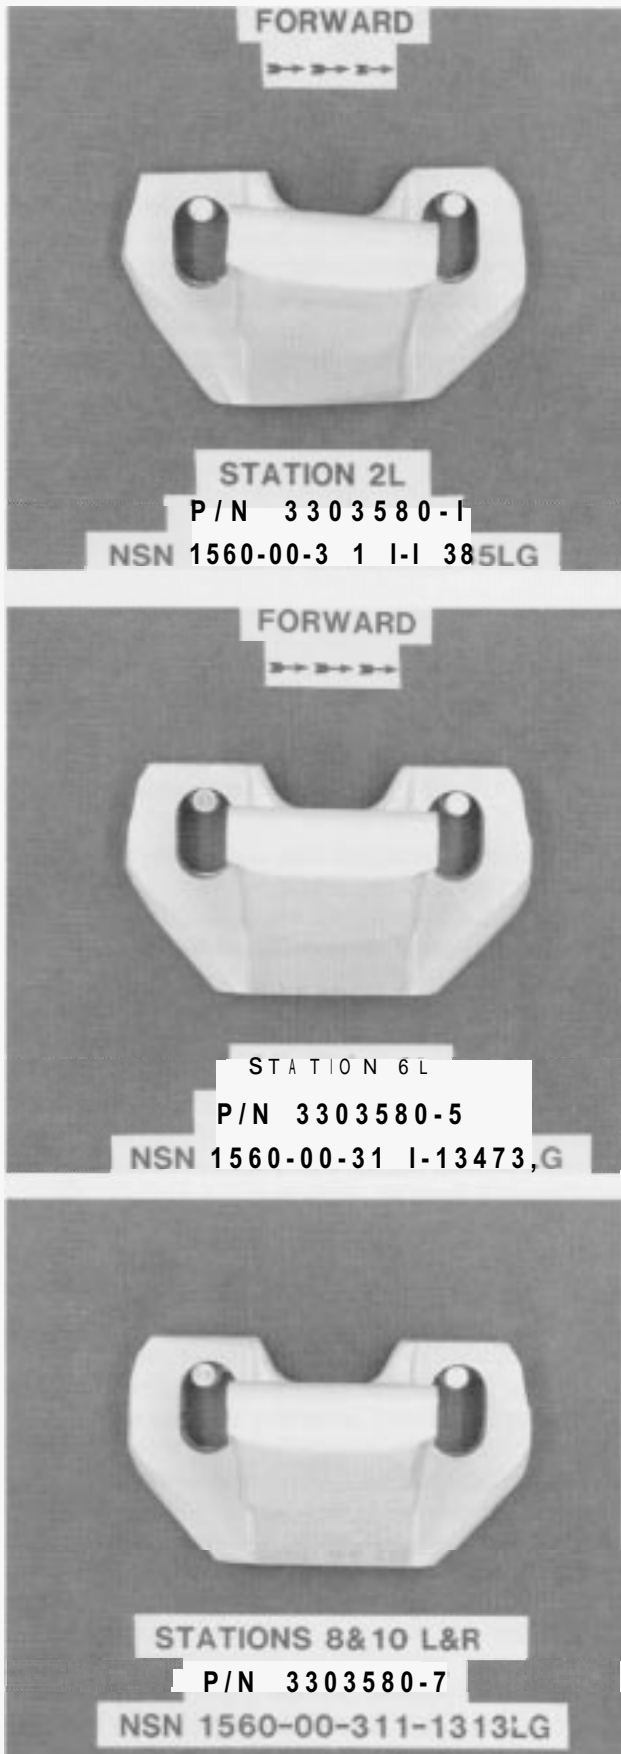
Ramp hook retainers that are not located in their intended positions but randomly intermingled can become hidden obstructions to successful ramp rigging. The reason “hidden” is the operative word here is that it is virtually impossible to identify any of the hook retainers simply by looking at them, or connect the appearance of a retainer with its intended location on the longeron. Put another way, all of the ramp hook retainers look pretty much alike, and even experienced technicians will be hard-pressed to distinguish one from the other without finding a part number or making some careful measurements (Figure 4).

Figure 4. Locking lug angles range from small to zero. "Eyeball" identification is next to impossible.

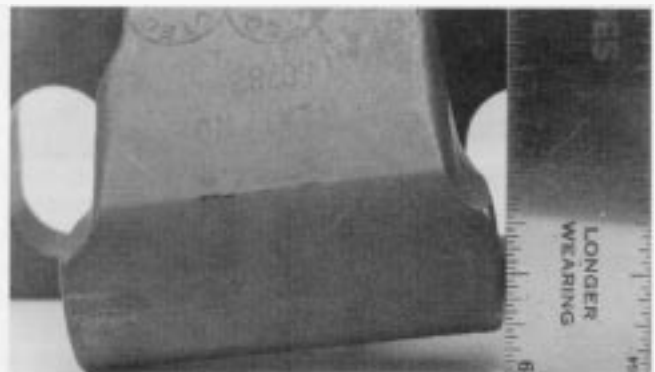
The key measurement that must be established to determine the identity of individual retainers is the angle of the locking lug relative to the top of the mounting hole bosses. A simple, although not necessarily ideal, local procedure that will accomplish this consists of inverting the hook retainer being checked on a smooth, flat table top so that it touches the three points described by the two mounting hole bosses and the locking lug (Figure 5).

Figure 5. Manual measurement is useful, but tedious. This 2R retainer shows a 7/32-inch (0.219") gap.

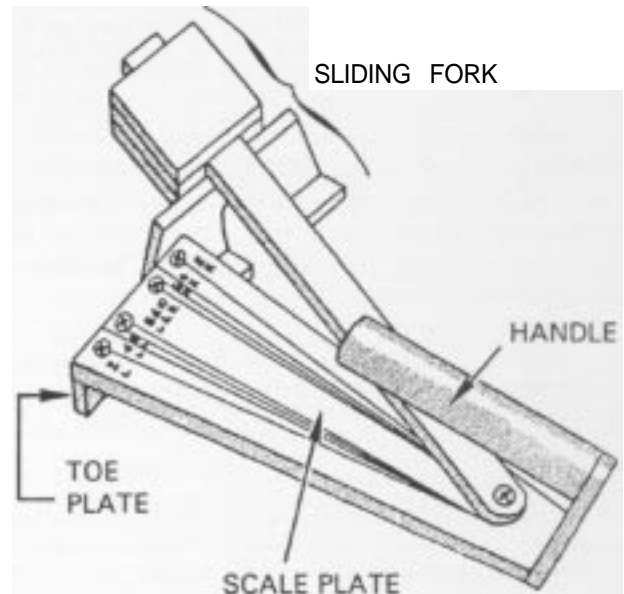
Figure 7. The design of the identification tool's scale plate makes it easy to distinguish between R and L retainers.

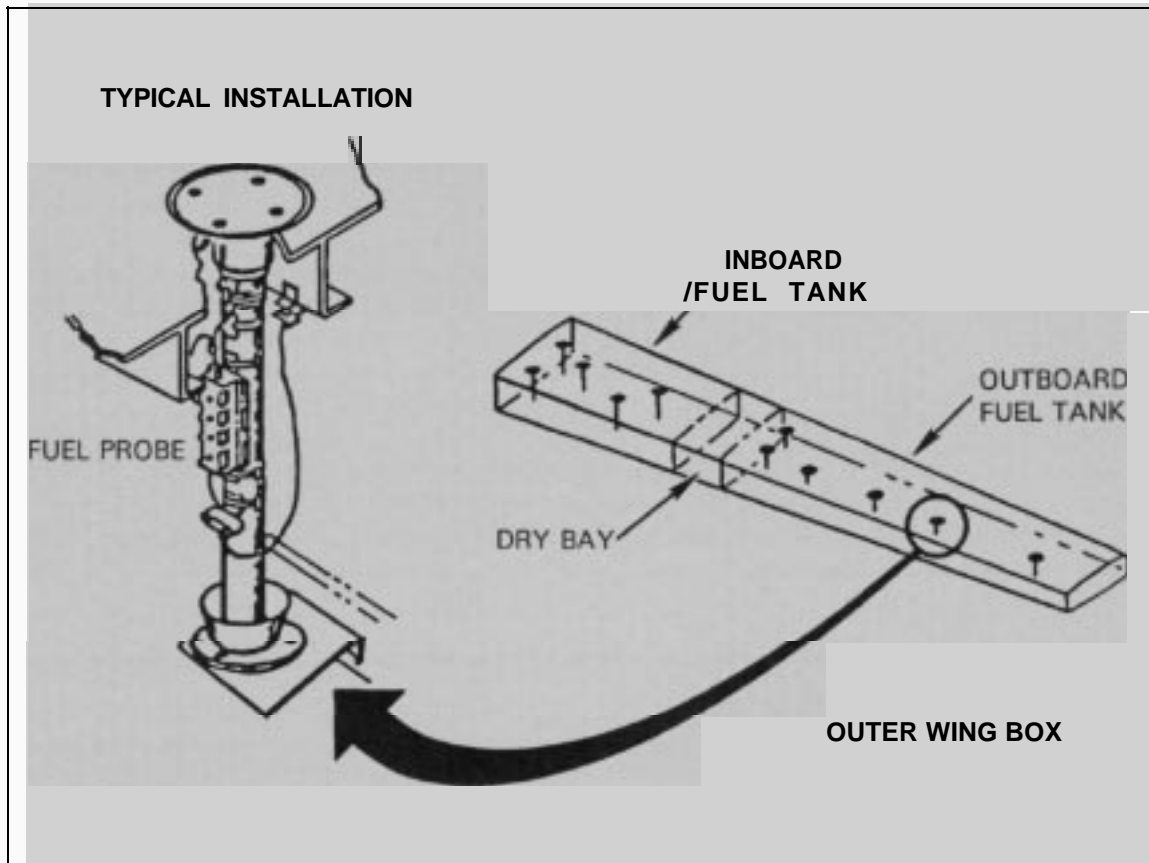
Figure 1. Mounting fuel quantity probes externally reduces the need for personnel to enter the tanks, reducing both downtime and maintenance costs.

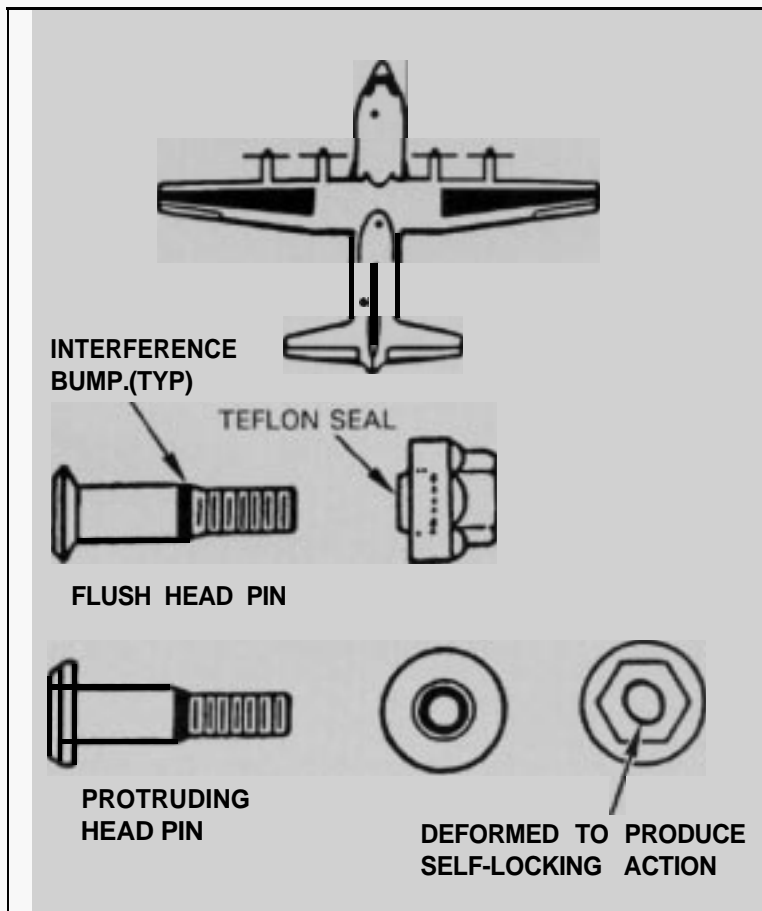
figure 2. Improved interference-fit fasteners are used in the outer wings for better fuel sealing and enhanced fatigue resistance.

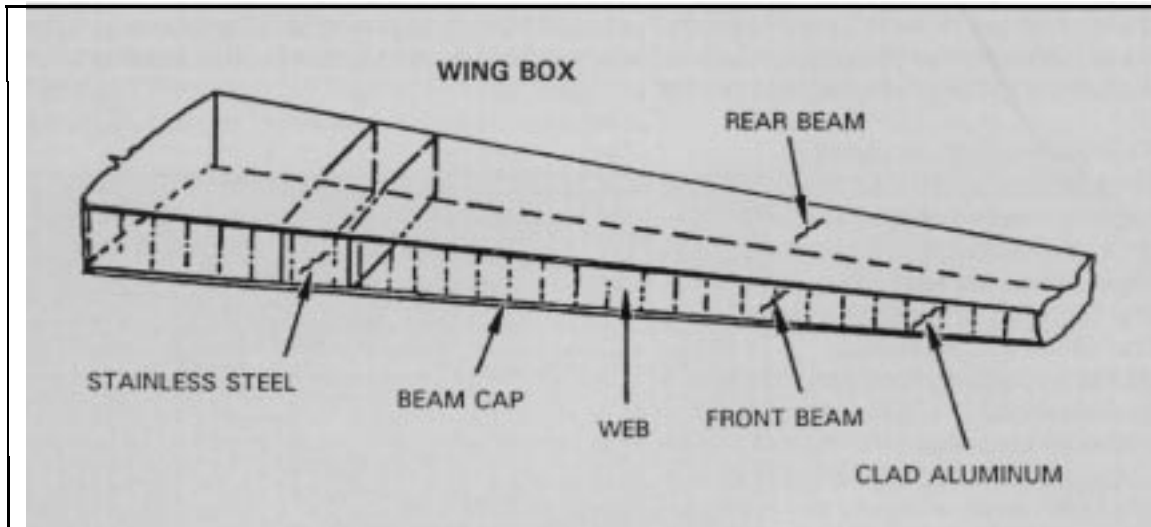
Wash rack personnel generally agree that few areas on the airplane are harder to clean than the soot-covered surfaces of the wing beams. Soot tends to embed in the paint, often making removal of this carbon residue laborious and difficult. If not removed, however, the carbon will, in time, penetrate the protective coating on the webs and establish a galvanic cell with the high-strength aluminum alloy. The result is pitting and exfoliation corrosion.

Figure 3. Using clad 7075-T6 aluminum on the wing beam webs helps provide increased corrosion resistance.

To afford an extra measure of protection to the wing beam webs, Lockheed now uses clad 7075-T6 aluminum alloy sheet for webs instead of nonclad sheet (Figure 3). Cladding is recognized as paramount protection for high-strength aluminum alloys because of its sacrificial nature. This change from nonclad to clad went into effect at LAC 4827.

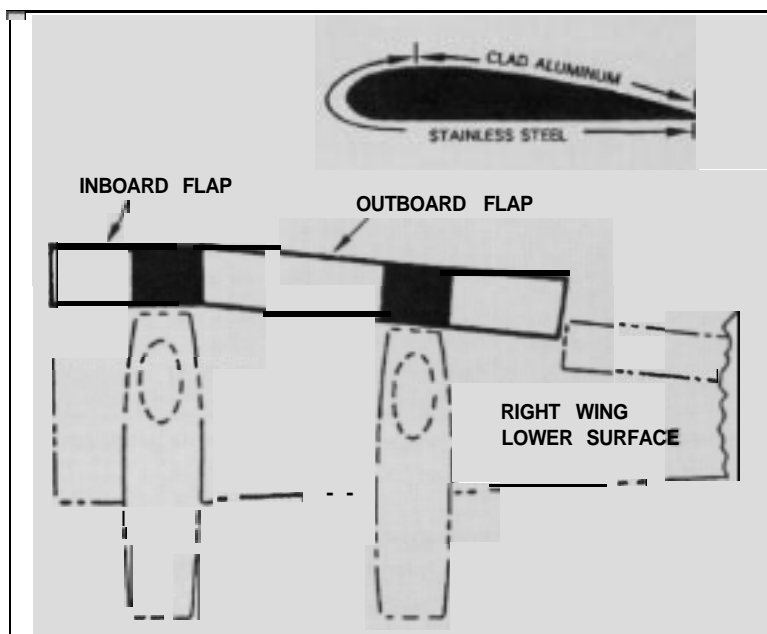
One of the most corrosion-prone areas on any aircraft is in the engine exhaust path where the carbon and sulfuric acids collect on the structure. A section of each C-130H wing flap is in the impingement path of engine exhaust emissions. To resist the heat and corrosive products of engine exhaust gases, the exposed section of the flap skins on the C-130H prior to LAC 4992 was made of commercially pure titanium sheet 0.025-inch thick.

Figure 4. Wing flap skins of stainless steel sheet of 301 alloy are more resistant to fatigue cracking and corrosion than either aluminum or titanium.

Stainless steel sheet of 301 alloy proved successful in both resisting corrosion and fatigue cracking during the service evaluations. It proved better than either titanium or aluminum alloy 2219-T81. Effective on Lockheed aircraft serial number LAC 5091 and up, the affected skins are 0.025-inch stainless steel (Figure 4).

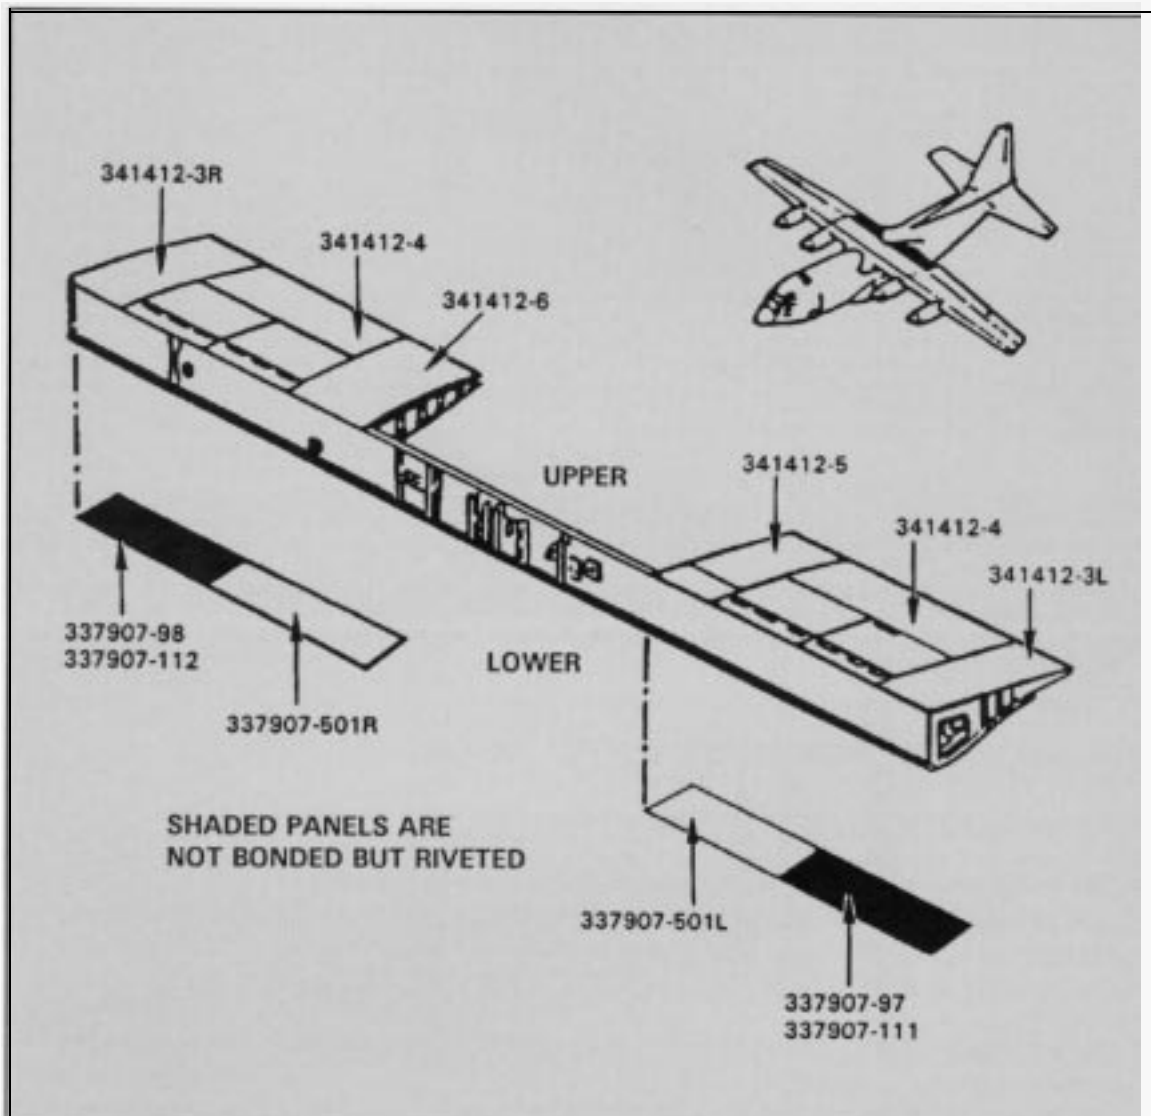
Figure 5. Riveted wing panels made of 2014-T3 aluminum alloy used at specific locations along the center wing trailing edge resist corrosion, disbandment.

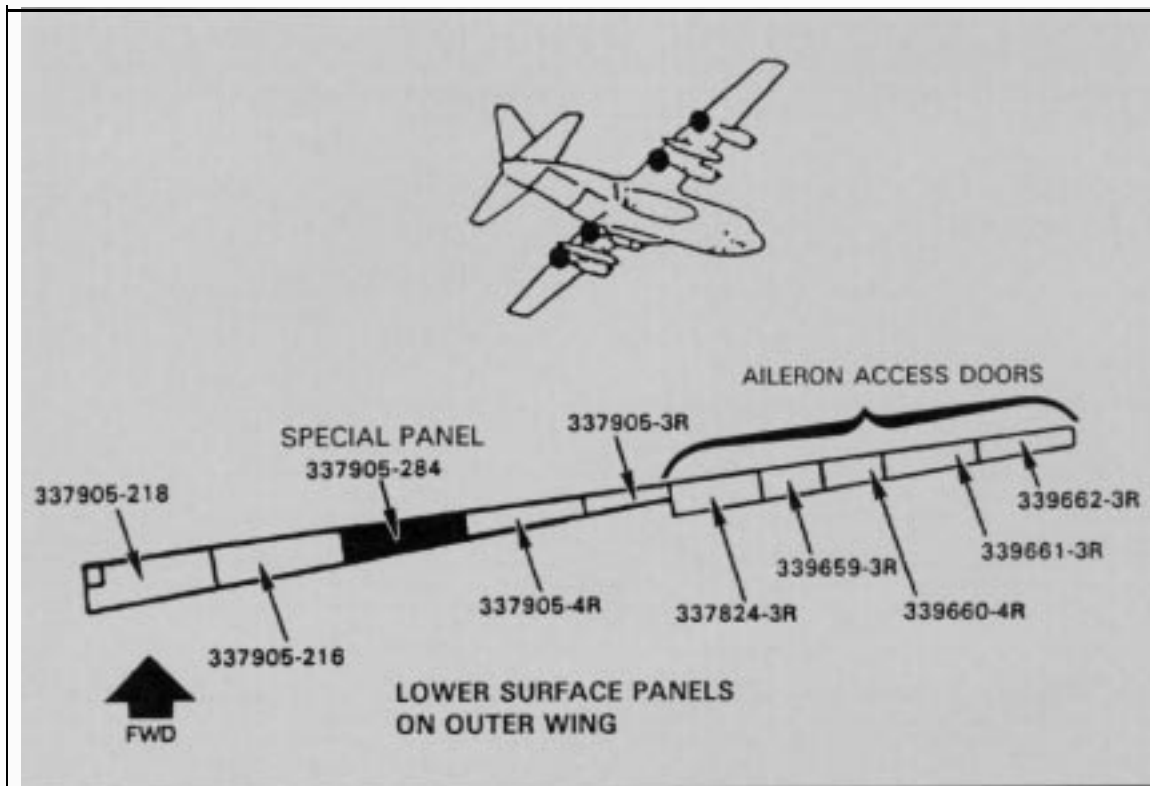
Service history has shown there is a susceptibility for the panel to disbond. To avoid disbondment, Lockheed has redesigned the assembly, using corrosion inhibitive sealant in the interface and rivets for attachment strength. This change was effected at LAC 5071 (Figure 6).

Figure 6. Similar riveted panels of corrosion-resistant 2219-T81 aluminum alloy are also used at critical locations in the outer wing.
