Lockheed Martin  
Maritime Systems & Sensors  
1210 Massillon Road Akron, OH 44315  
Telephone 330.796.2800

Re: Lockheed Martin Corporation Akron  
Airdock Exterior Remediation Program,  
Akron, Ohio

### **Haley's Ditch Investigation – November 2006 Sampling Results**

## **Airdock - Haley's Ditch Voluntary Site Monitoring**

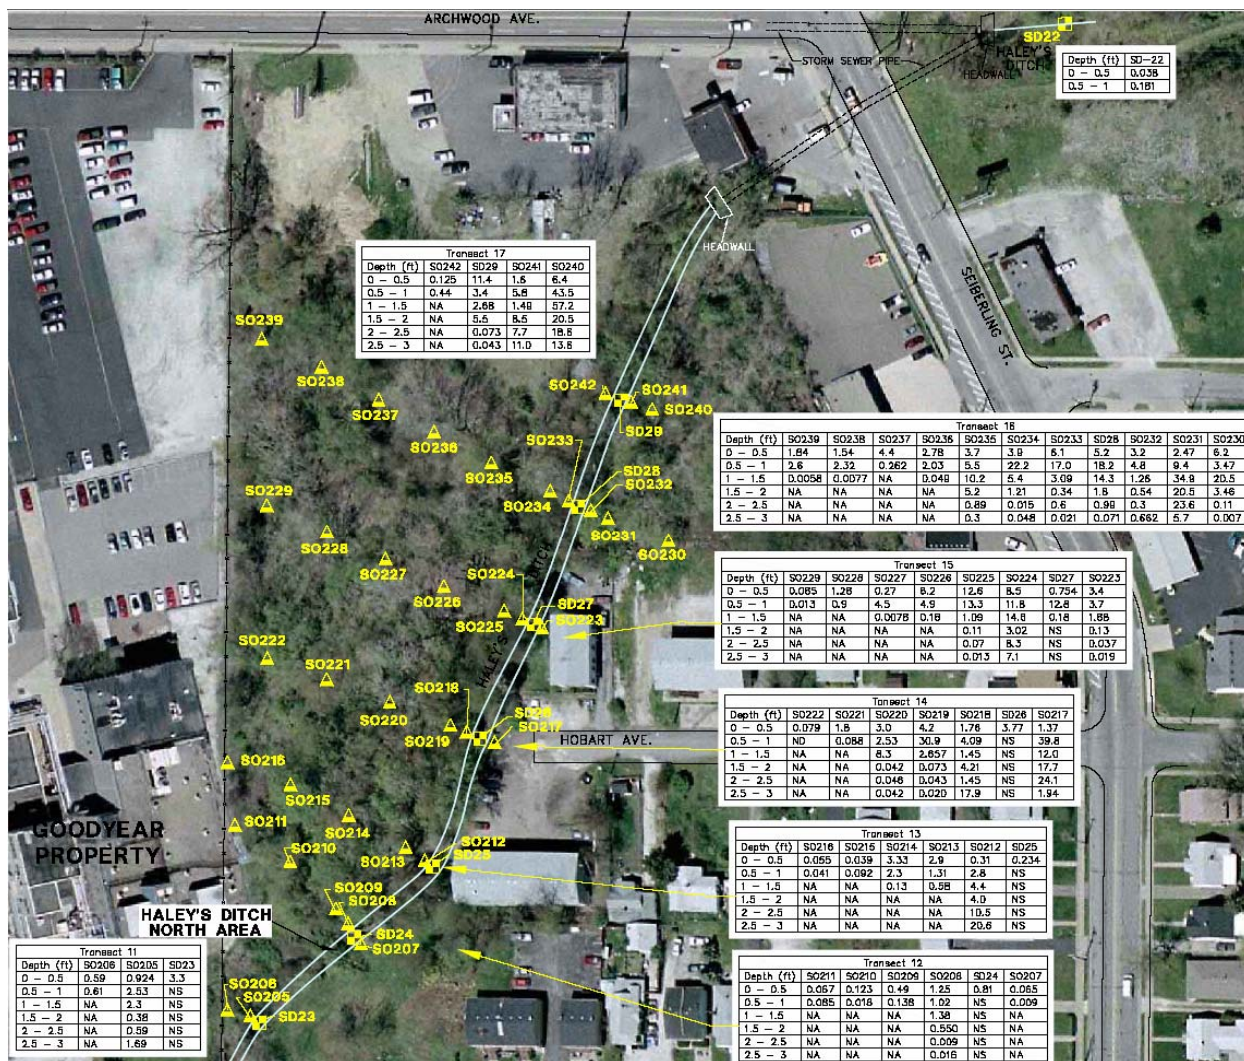
Figure 2. Haley's Ditch November 2006 Sample Location Map

Soil samples locations were generally sited along transects aligned perpendicular to the ditch at approximately 100 foot spacing across the study area which extends from the Goodyear property westward towards Seiberling Street. At a minimum, two soil sample locations were sited on each side of the creek, one at the approximate top of bank, and one sediment sample location was sited in the center of the ditch. In areas which appeared prone to flooding, additional soil samples were sited at approximately 50 foot intervals from the ditch to the limits of the flood prone area as shown on Figure 2.
