Akron Airdock PCB Exterior Remediation Strategy

June 22, 2007

Lockheed Martin Corporation
1210 Massillon Road
Akron, Ohio 44315

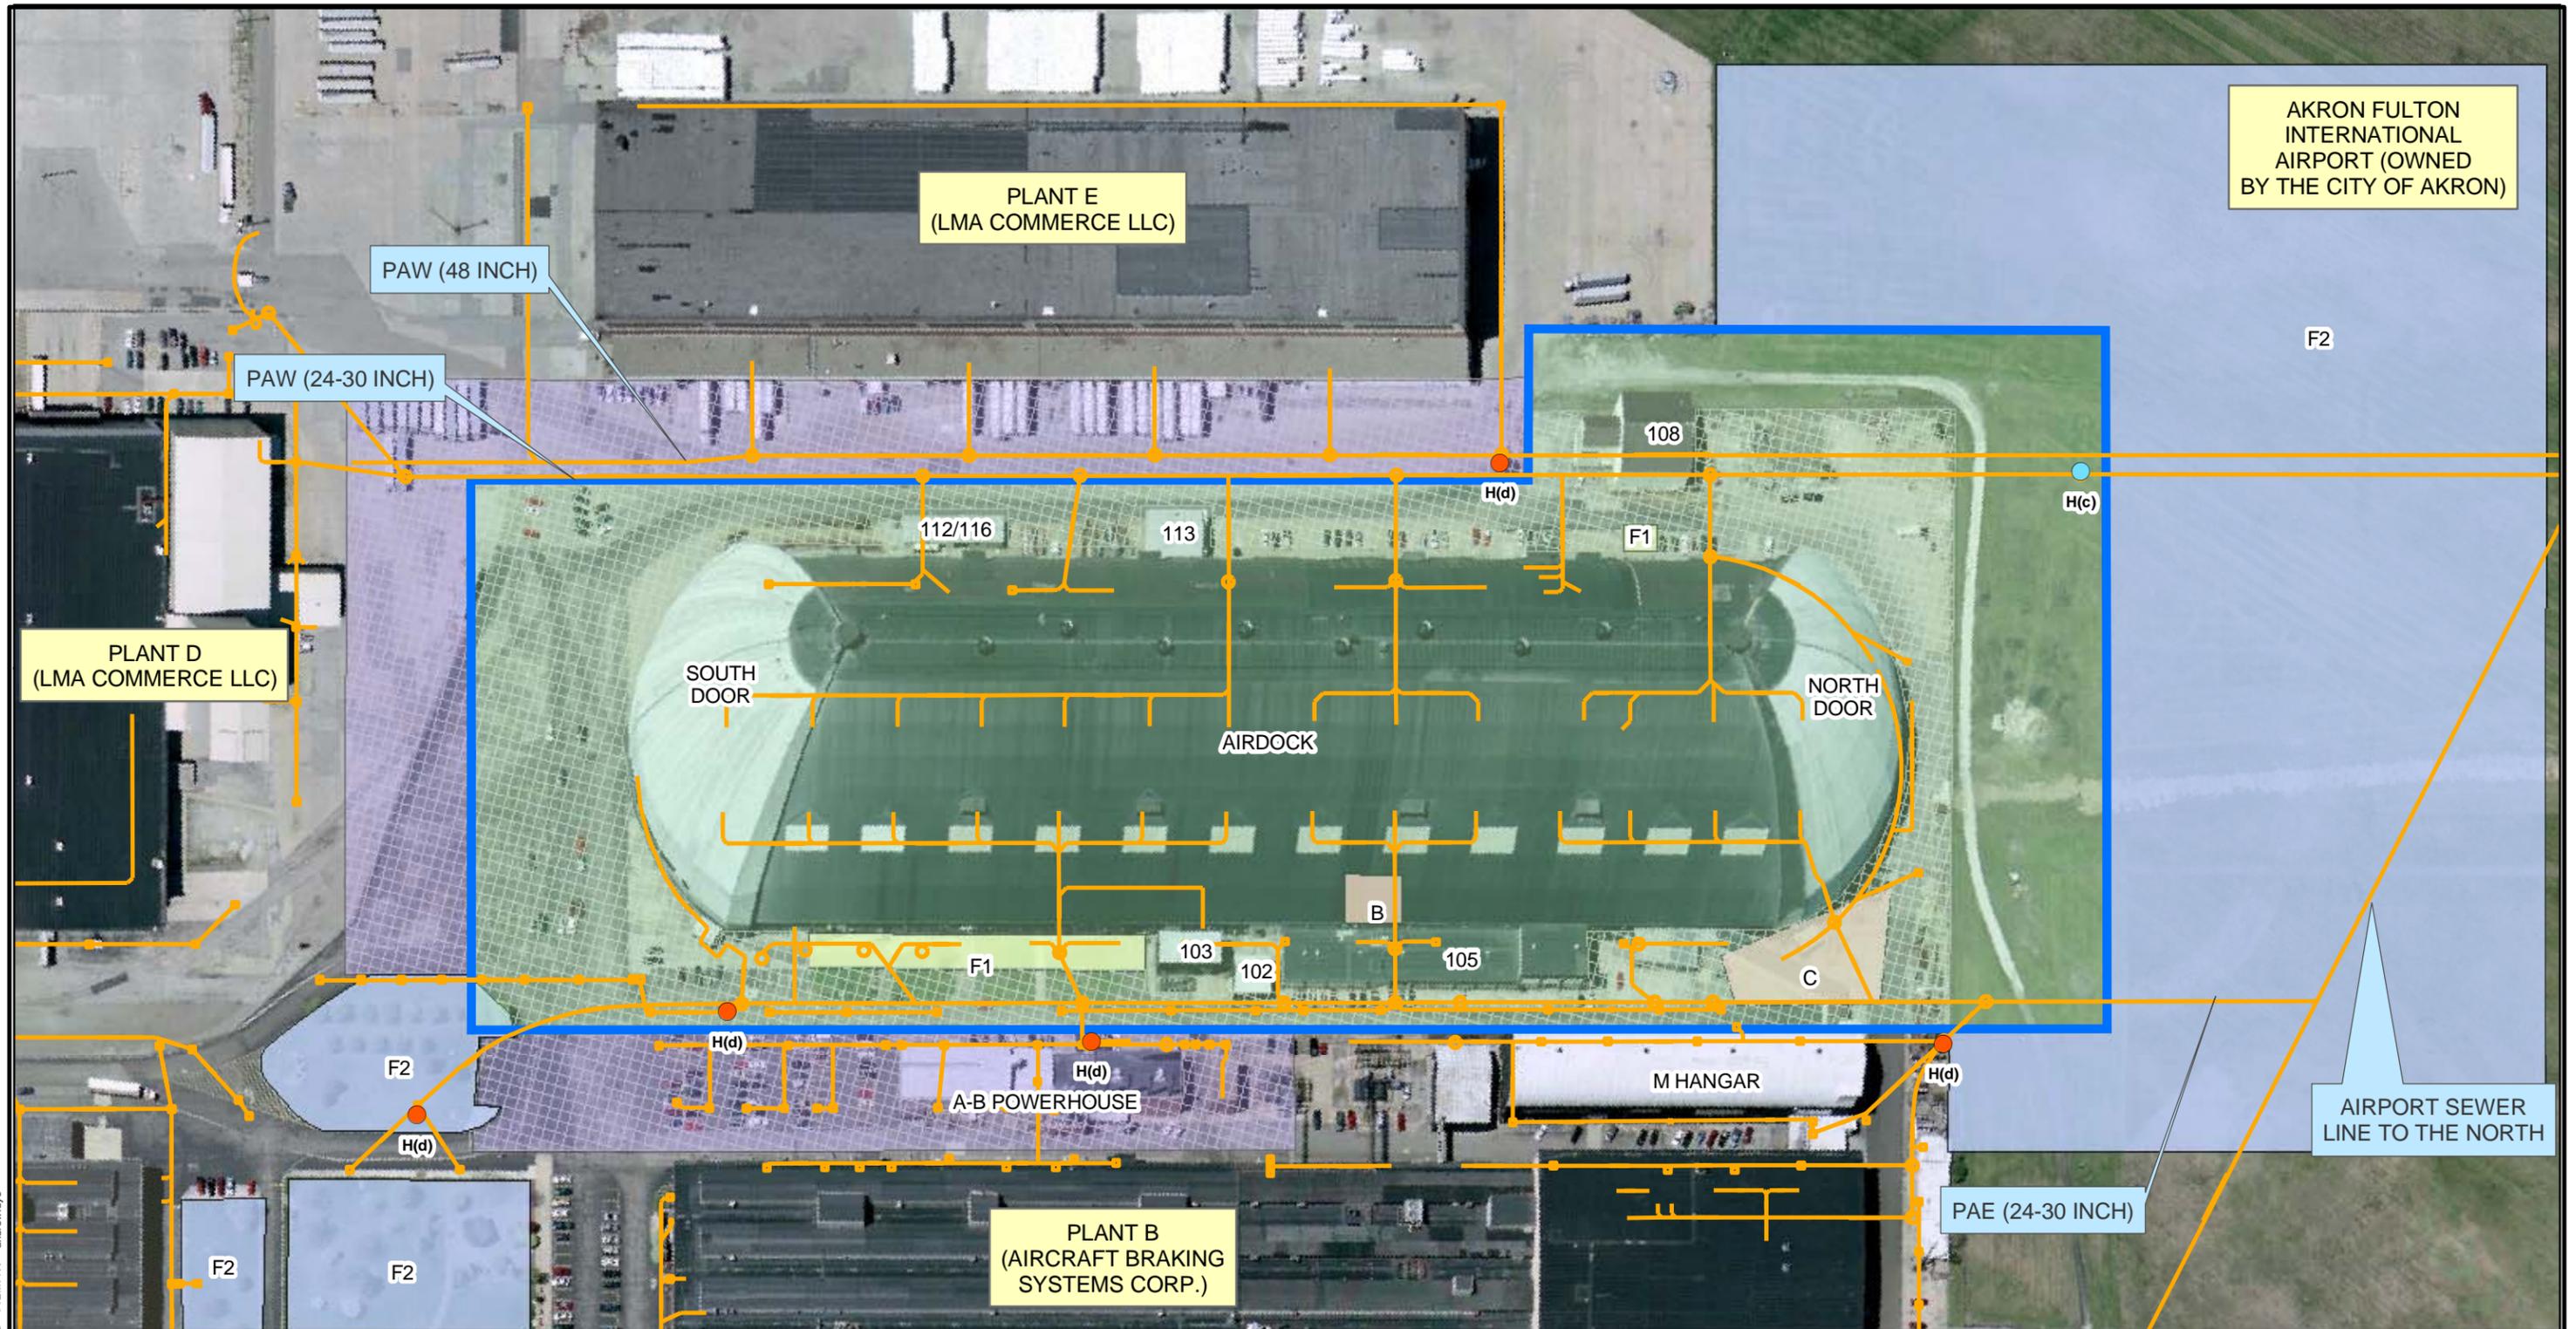
FIGURE 1
SITE AERIAL PHOTOGRAPH

Areas subject to the remaining elements of the exterior remediation plan are depicted on Figure 2. The general concepts outlined in the remaining plan are consistent with the June 8, 2005, *Airdock Exterior Remediation Plan*. The VAP risk assessment (Tetra Tech 2007) provides support for a risk-based disposal application under §761.61 (c) for exterior areas with PCB impacts. Remaining remedial activities and the applicable cleanup standards, as appropriate, for each activity are described below. Details of certain remedy elements will be presented in future risk-based approvals.

A post-cleaning stormwater sampling point is anticipated as the northernmost manhole (point H(c)) of the Plant A West (PAW) 24-30-inch storm sewer depicted on Figure 2. Background sampling will also occur for possible PCB loading to the sewer system from legacy releases or from other active sources (see upstream manhole sampling points designated “H(d)” on Figure 2).

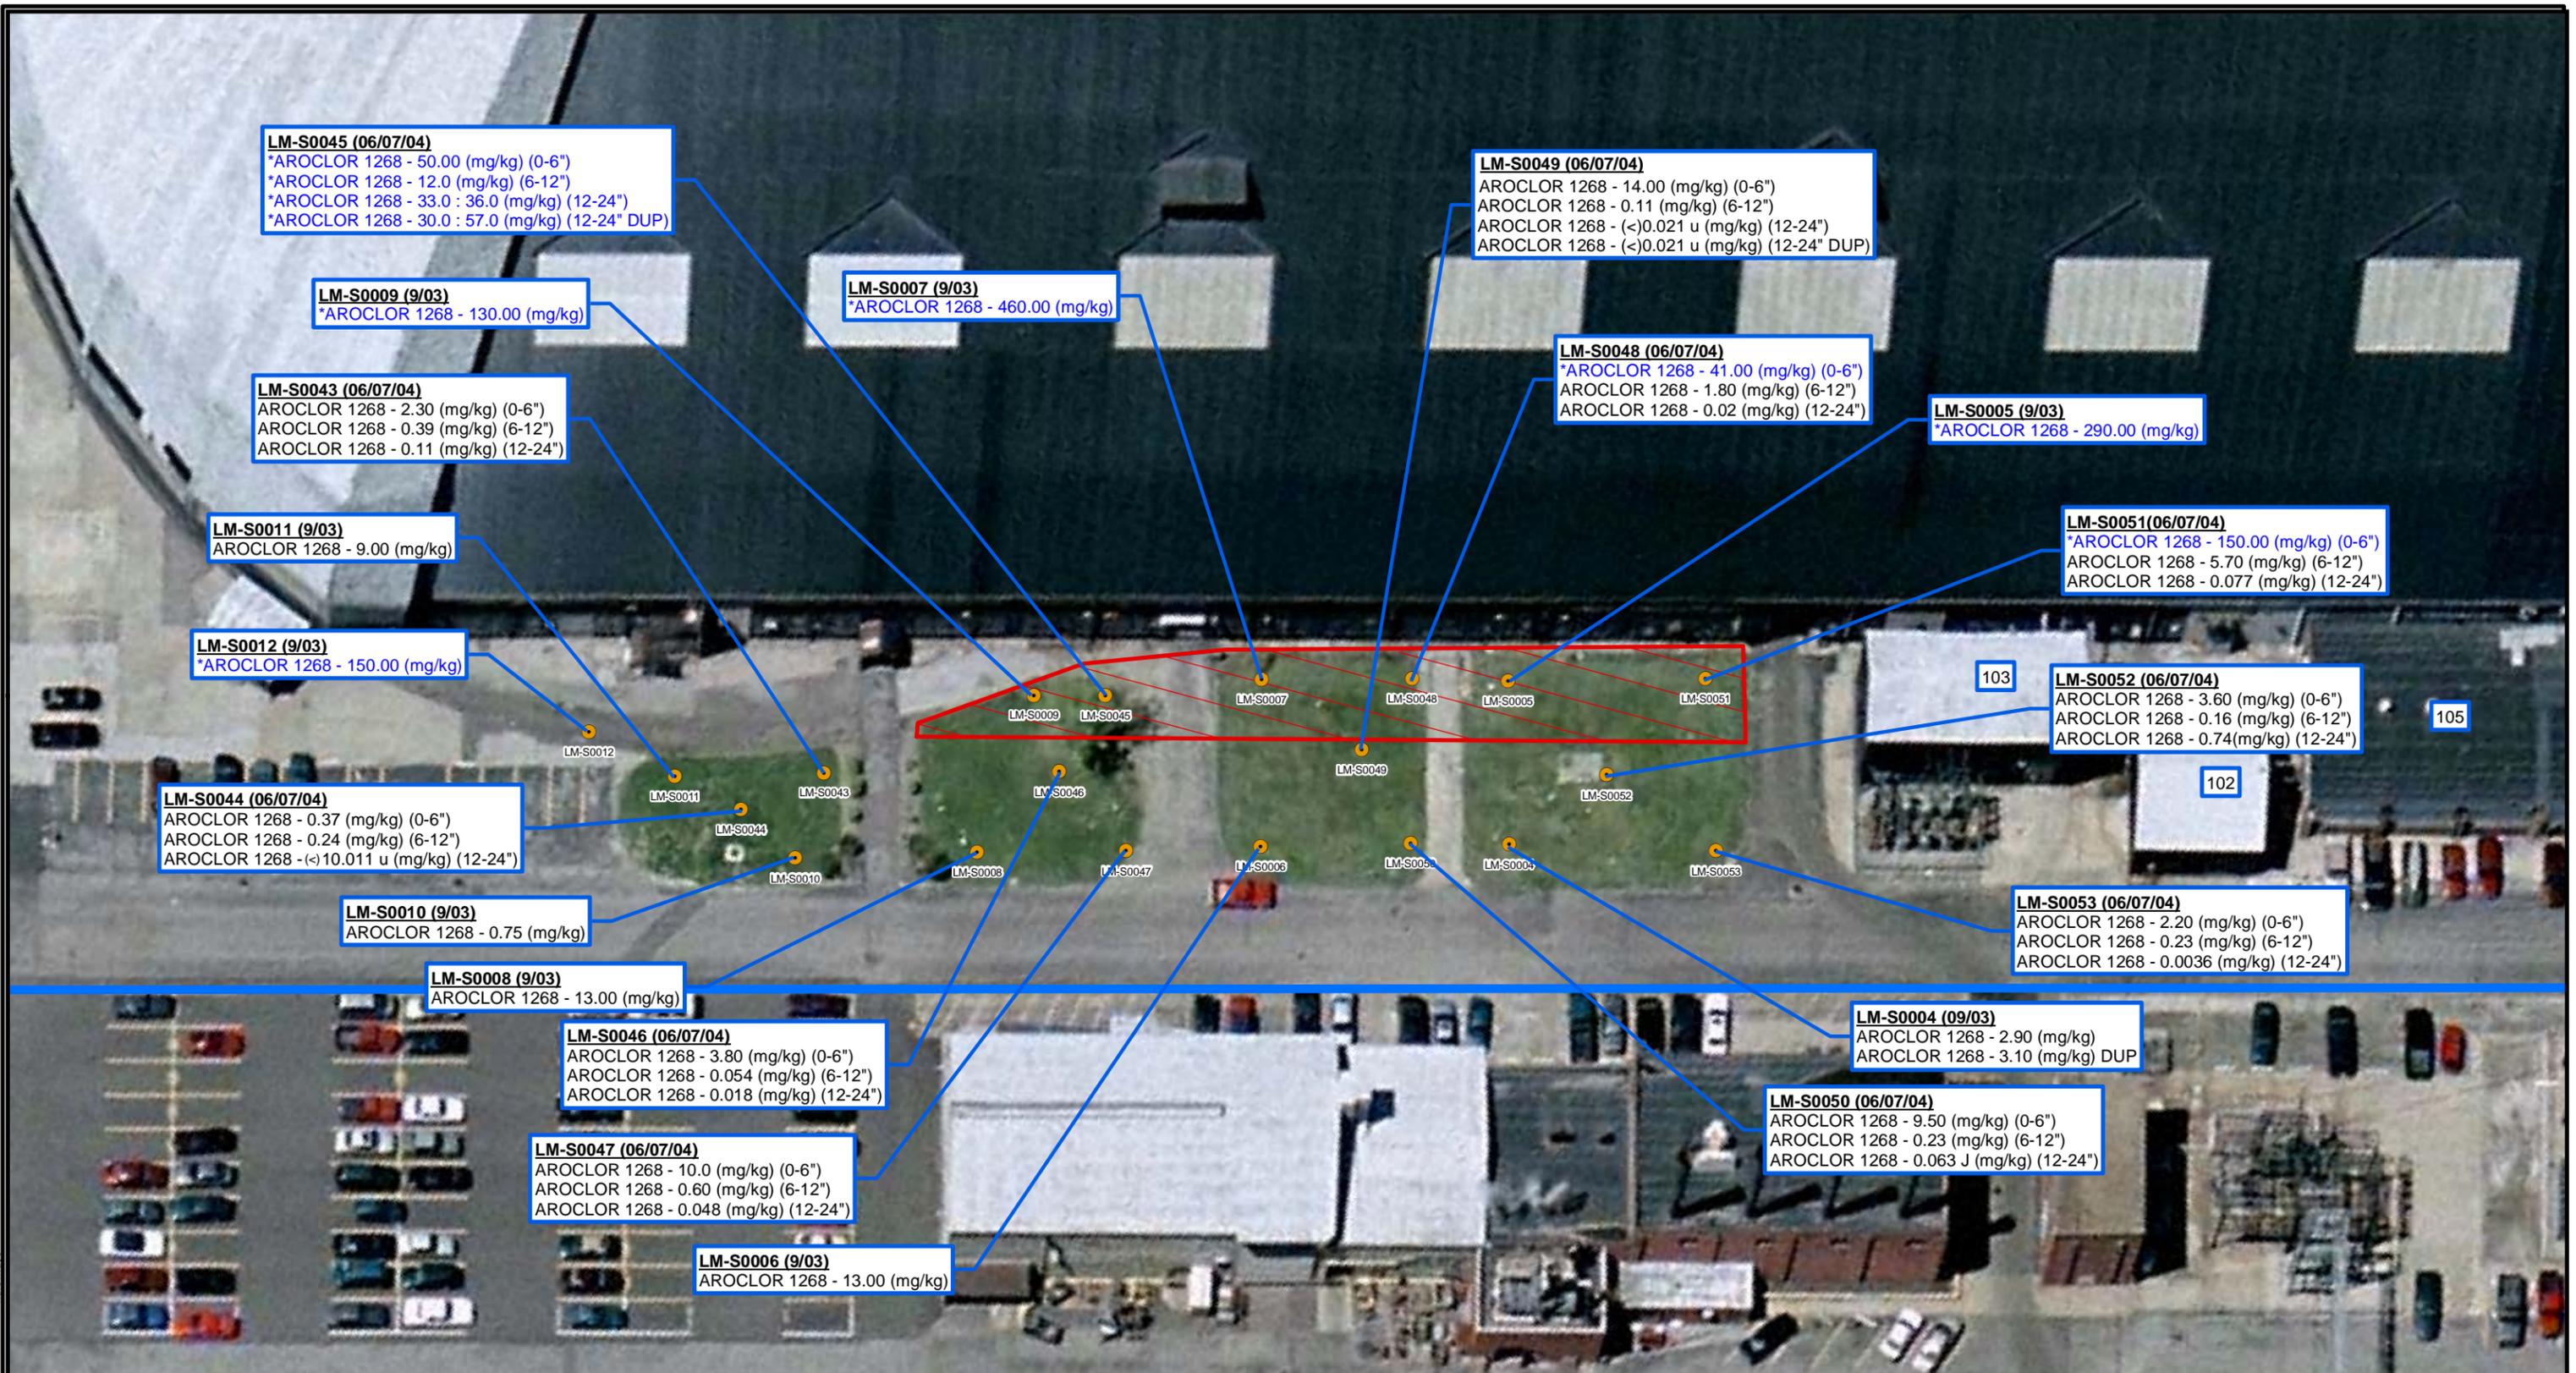
A soil removal action will occur in the grassy area directly outside the southeastern area of the Airdock (Figure 3) and from an isolated area below pavement on the northwest corner of the Airdock (designated with the box labeled F1 on Figure 2). Soil samples have been collected from 20 locations at different depth intervals and analyzed for PCBs, including Aroclor 1268. The sampling and analysis data show that PCB concentrations in soil decline rapidly with depth and distance away from the building, a pattern consistent with the non-mobility of the chemical.

The property-specific risk assessment (Tetra Tech 2007) demonstrates that removal of soil with PCBs from the 250- by 25-foot area and from isolated hot spot SC-8 will meet risk and hazard goals under the VAP, and consequently meet a risk-based cleanup approach under §761.61(c). Confirmatory soil samples will be collected from the excavated areas upon completion of the soil removal action in the Southeast Area and SC-8 Hot Spot area to confirm that the average PCB levels in soil meet the risk and hazard goals. Details of the risk analysis will be submitted in the risk-based approval request submitted to EPA during the third quarter of 2007.

LM-S0045 (06/07/04)
 *AROCOR 1268 - 50.00 (mg/kg) (0-6")
 *AROCOR 1268 - 12.0 (mg/kg) (6-12")
 *AROCOR 1268 - 33.0 : 36.0 (mg/kg) (12-24")
 *AROCOR 1268 - 30.0 : 57.0 (mg/kg) (12-24" DUP)

LM-S0049 (06/07/04)
 AROCLOR 1268 - 14.00 (mg/kg) (0-6")
 AROCLOR 1268 - 0.11 (mg/kg) (6-12")
 AROCLOR 1268 - (<)0.021 u (mg/kg) (12-24")
 AROCLOR 1268 - (<)0.021 u (mg/kg) (12-24" DUP)

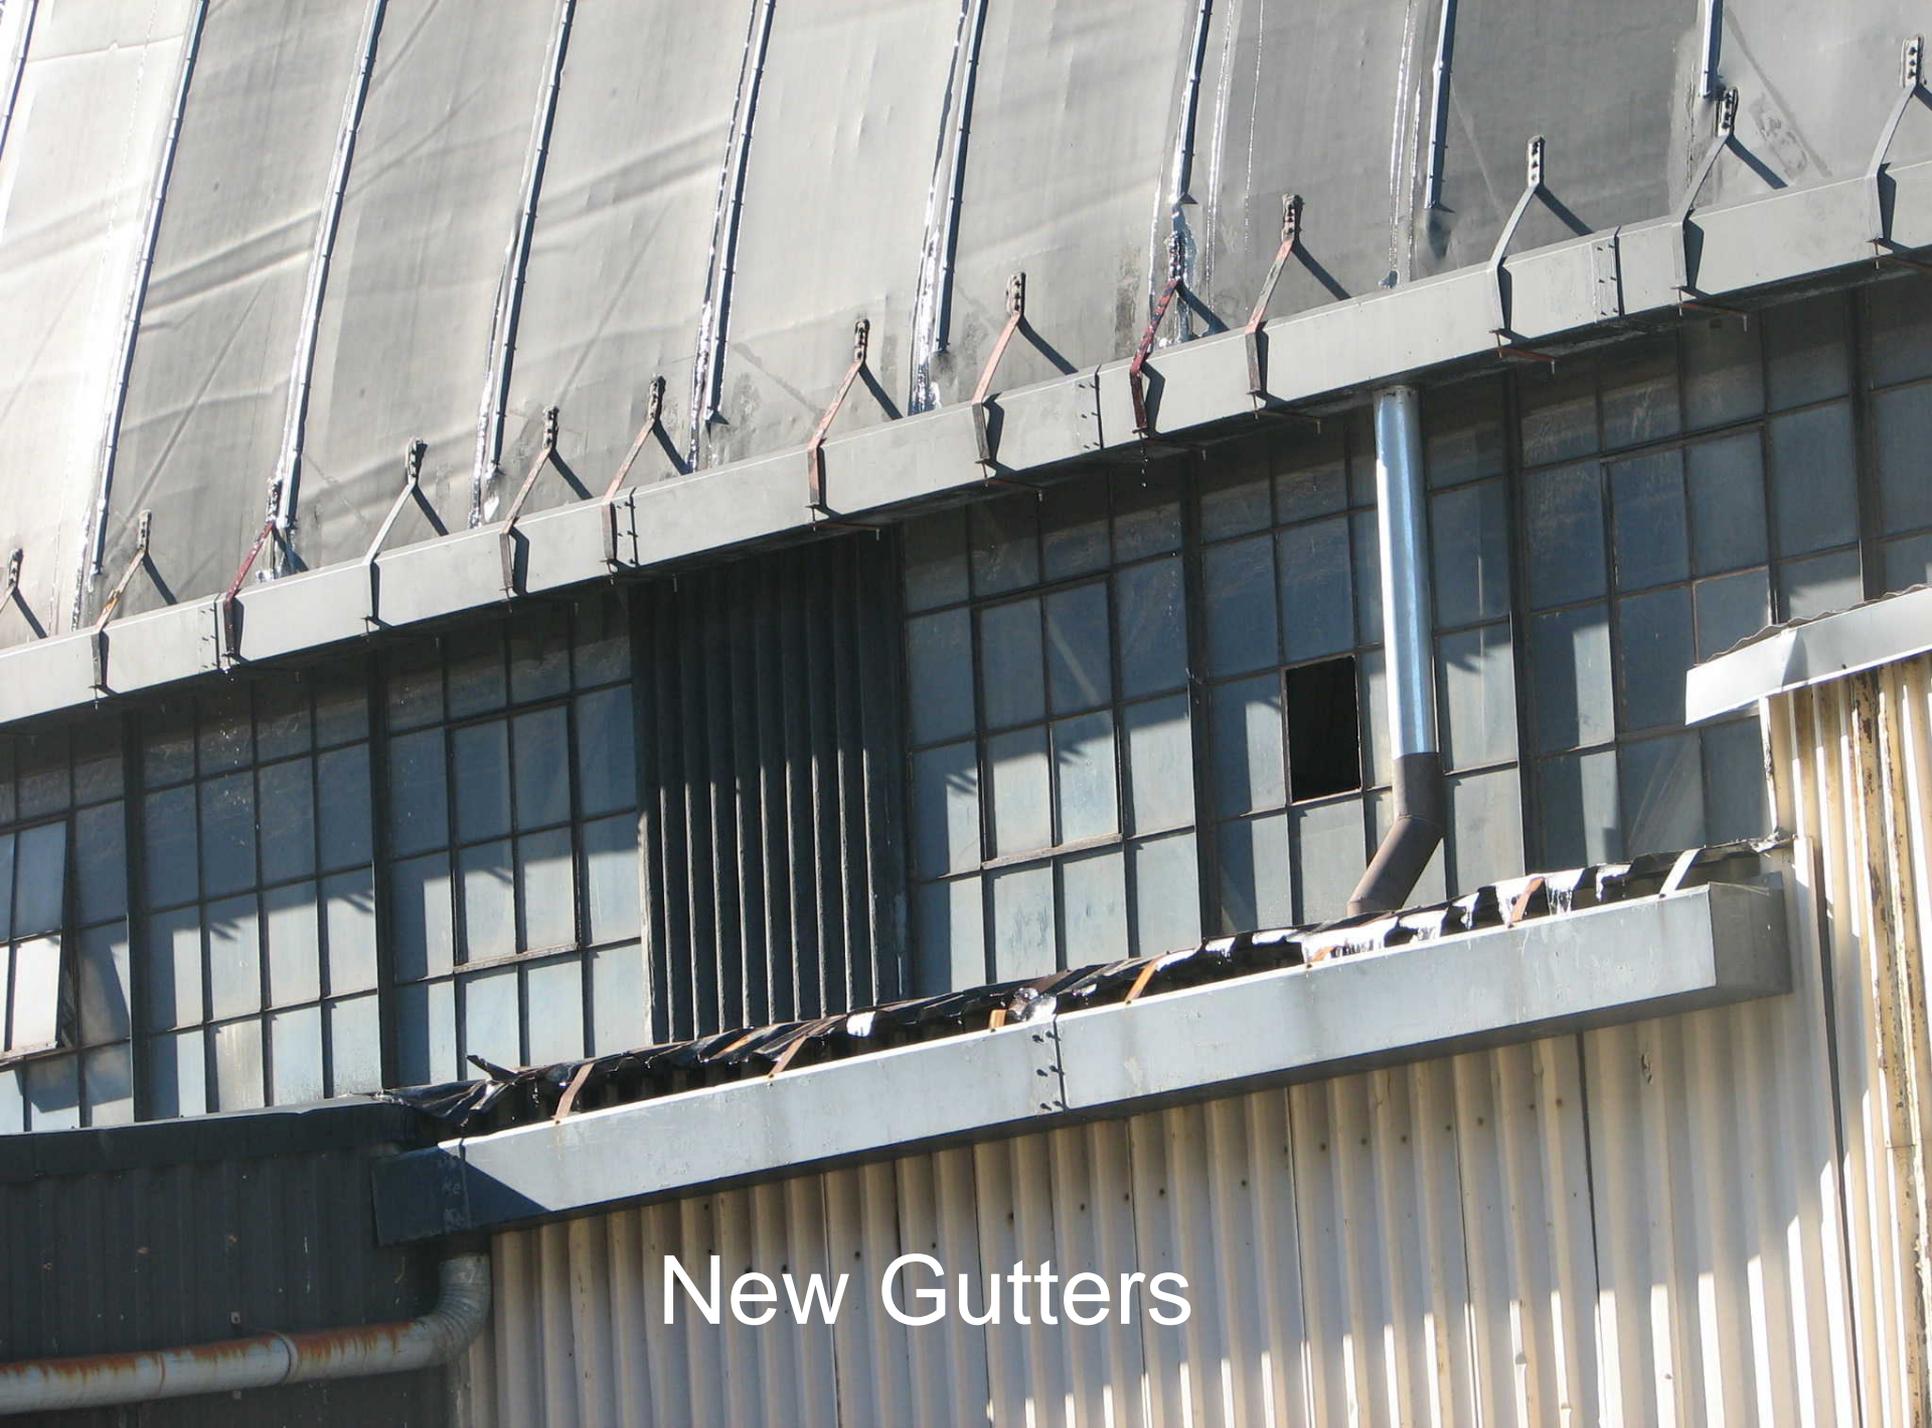
New Gutters

The Airdock gutters and downspouts needed repair to prevent rainwater from washing down the vertical siding and windows. Replacement of the west side and east side gutter and downspout systems was completed in 2005. All removed gutters, downspouts, and associated debris were disposed of as PCB waste in accordance with 40 CFR 761.61(b).

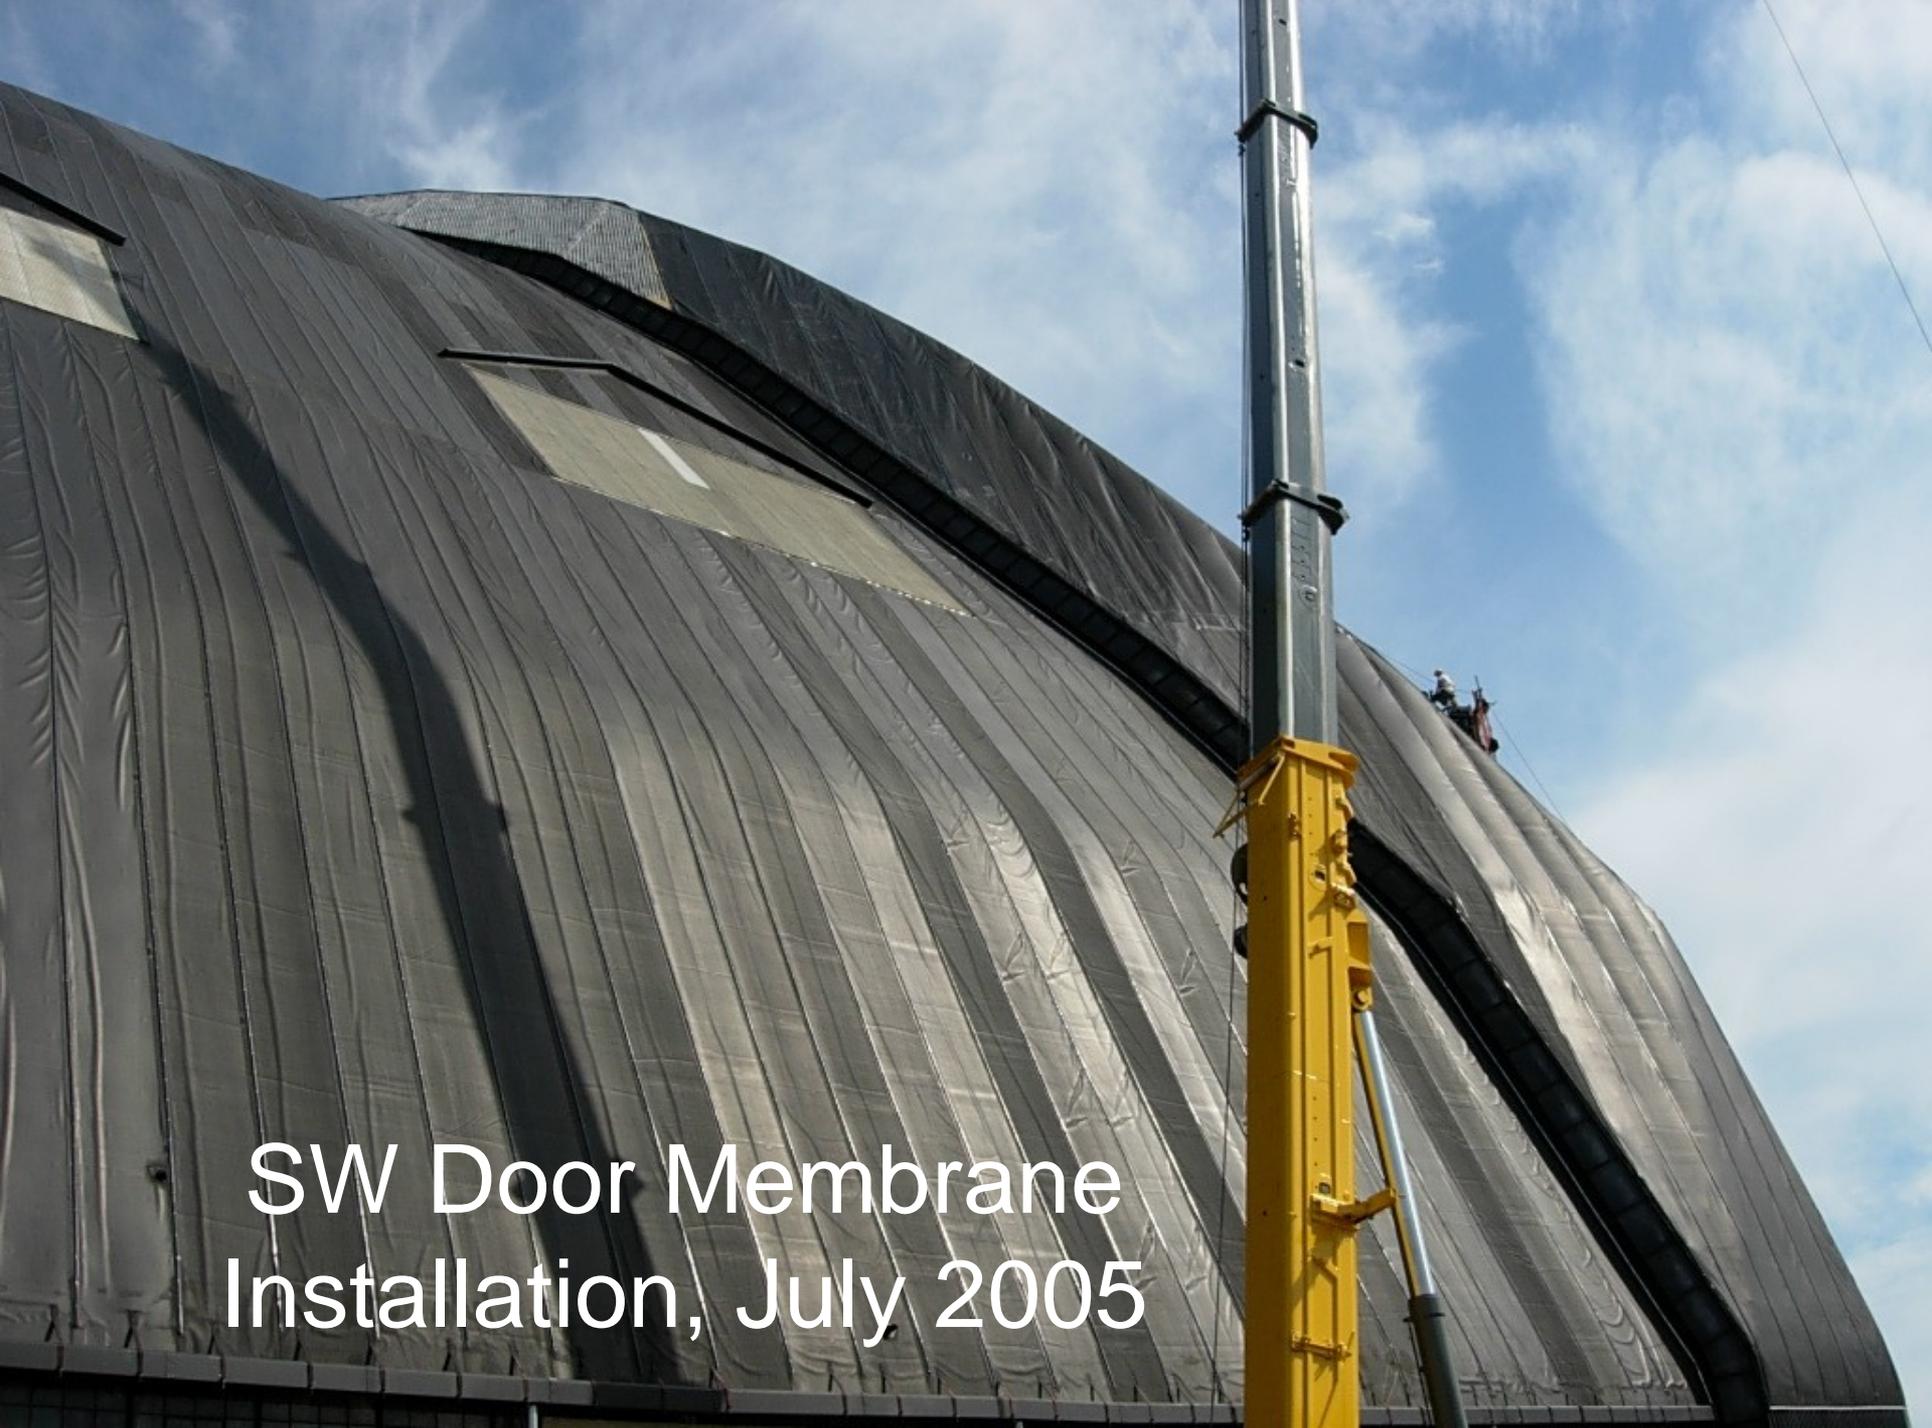
SW Door Membrane
Installation, July 2005

Except for the four doors covered with foam since 1985, the roof has been encapsulated with a rolled rubber membrane, completed in 2005. In 2005, the rolled rubber membrane material was applied over the four doors, including the rear-facing lip of each door. A portion of the northeast door rear lip was damaged in 2006; repairs to this area are being completed during the second quarter of 2007.

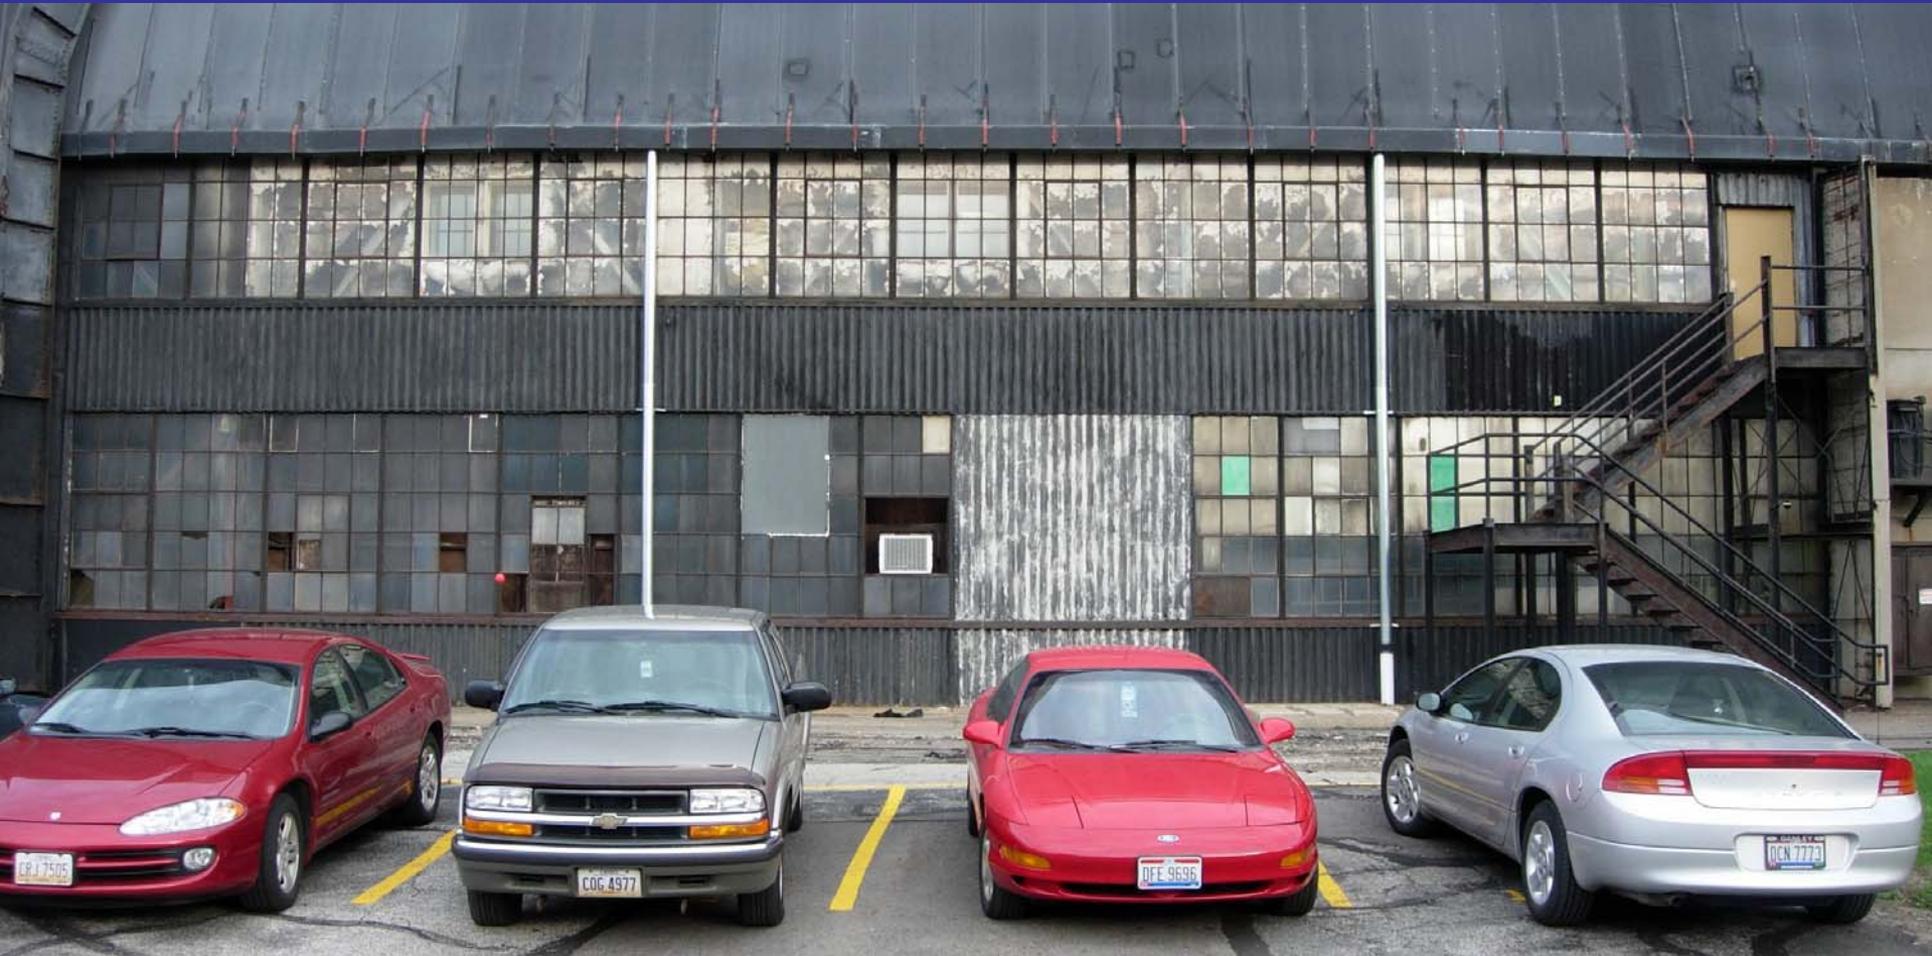
1E-2E, April 2004

Original Siding

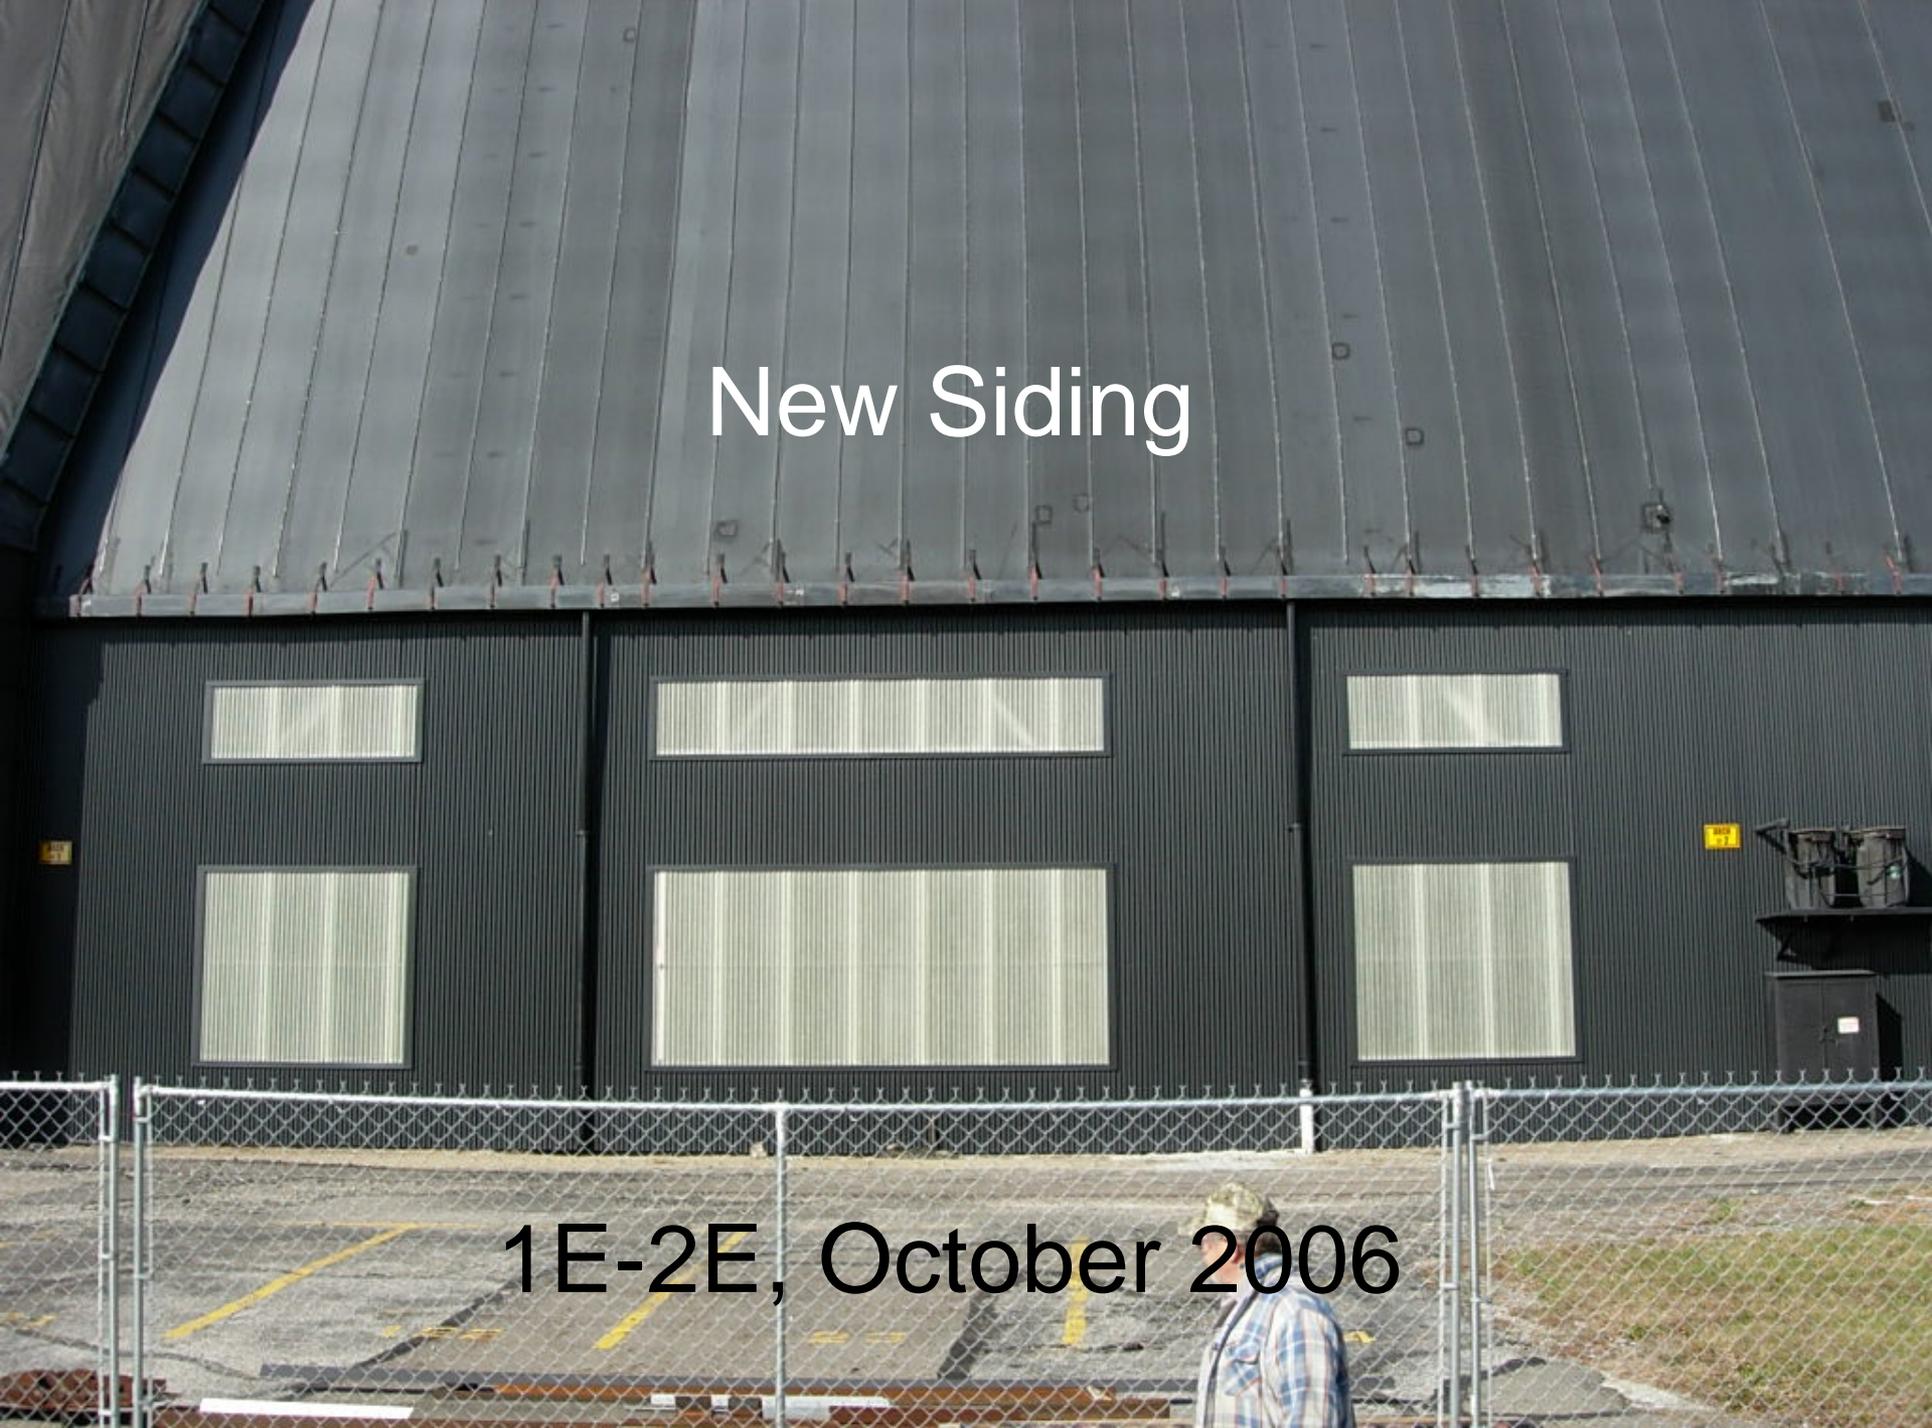
1E-2E, October 2006

New Siding

The Airdock roof membrane ends at the gutter approximately 24 feet above the ground. The bottom 24 feet of the Airdock exterior is vertical and consists of windows, doors, siding, and associated structures and equipment. On the Airdock doors, the rubber roof membrane ends just above the vertical translucent panels. Between 2005 and 2006, all of the Airdock's vertical siding panels were replaced below the gutter on the arched segments, including all translucent panels and exposed siding on the doors. Also replaced (because these materials were RPM) were the siding and roofing material for two of the four door motor buildings and the electrical substation building. The new siding is corrugated painted aluminum with translucent fiberglass reinforced plastic (FRP) panels.

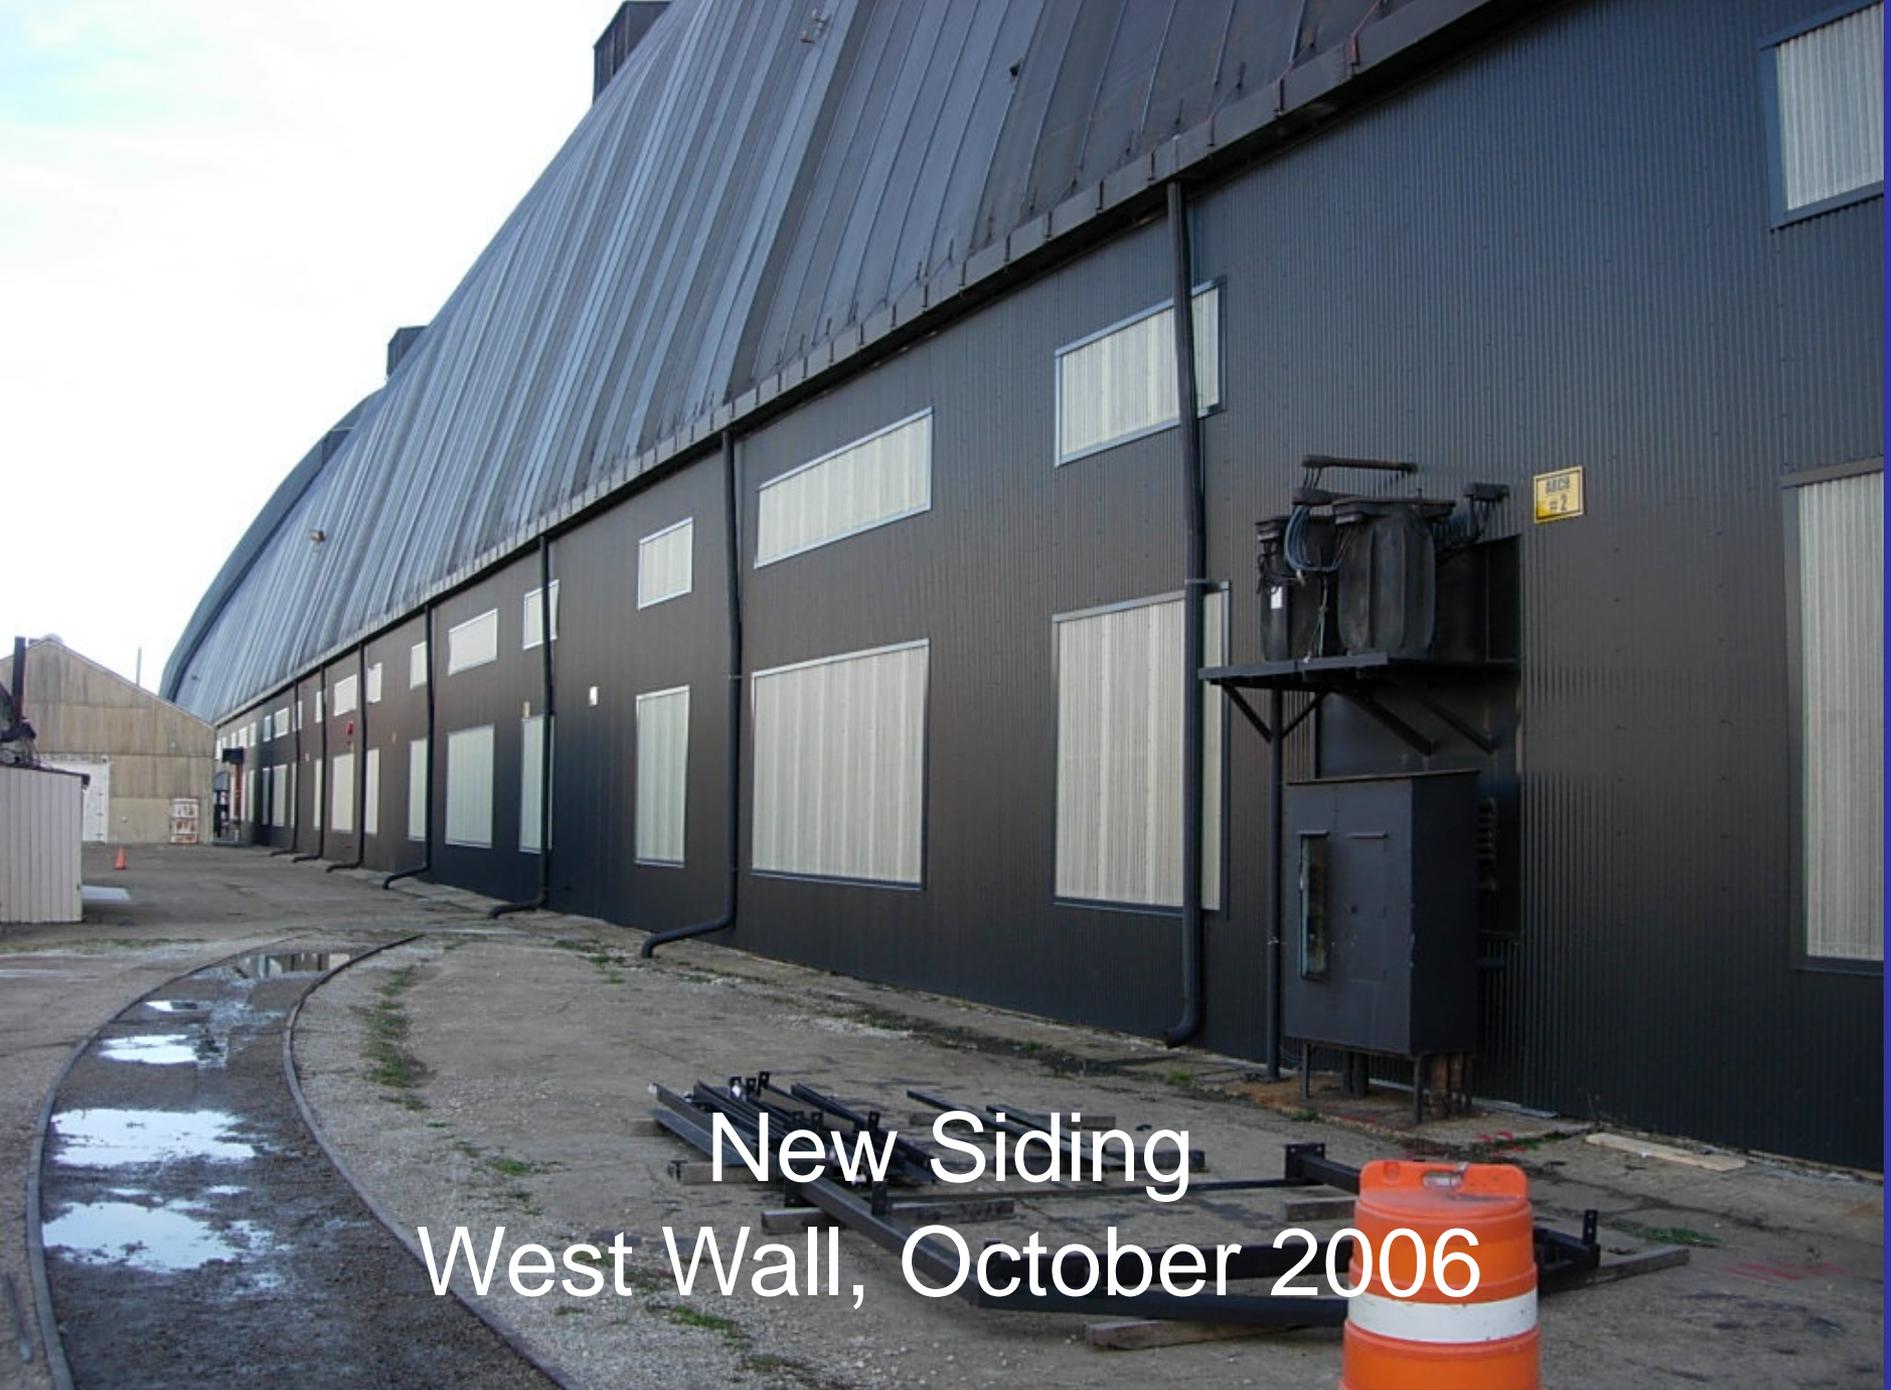
New Siding
West Wall, October 2006
