Akron Airdock PCB Exterior Remediation Strategy

June 22, 2007

Lockheed Martin Corporation
1210 Massillon Road
Akron, Ohio 44315

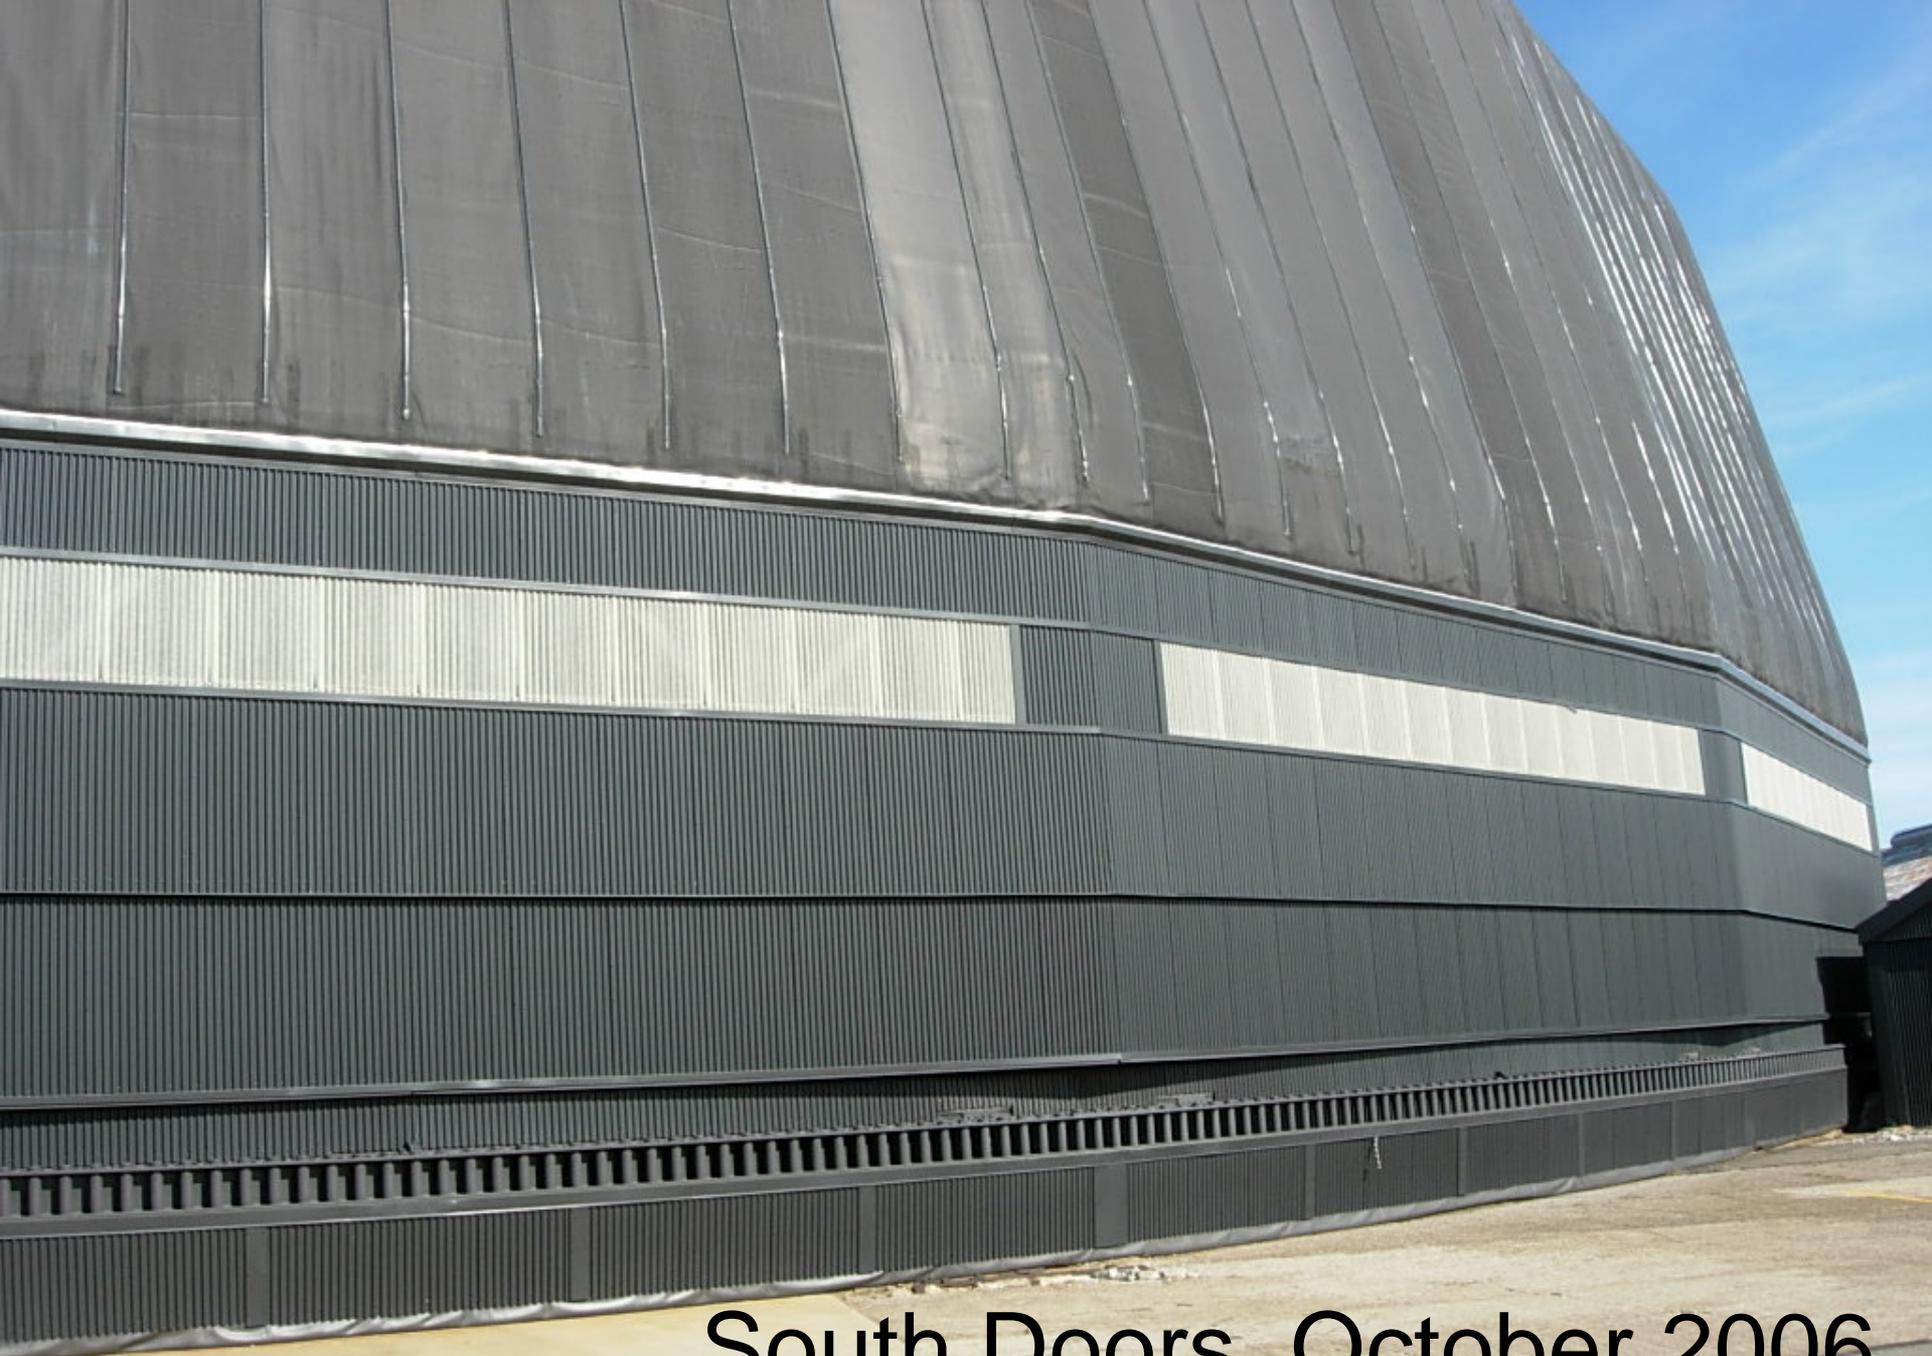
South Doors, October 2006

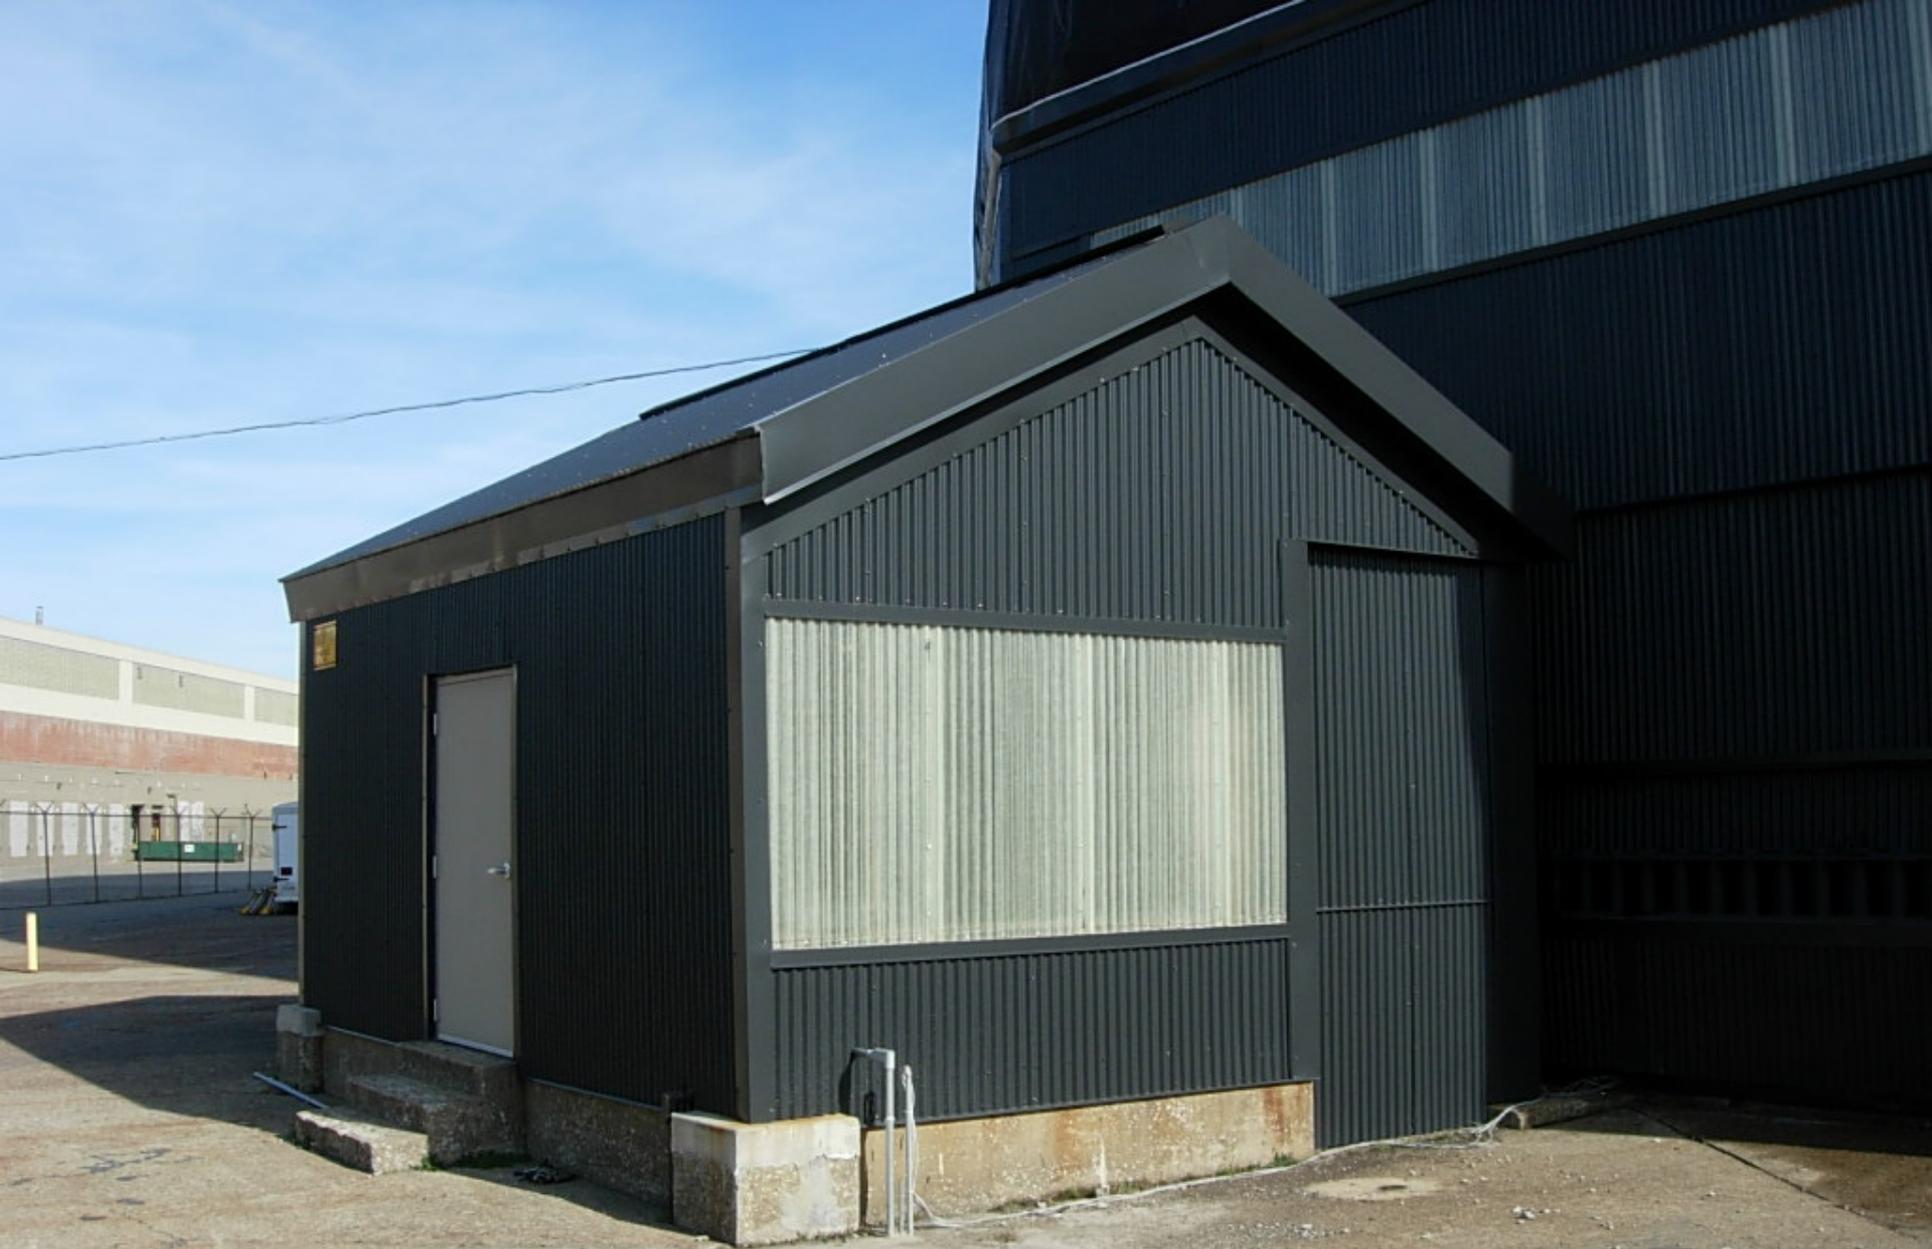
South West Motor House, October 2006

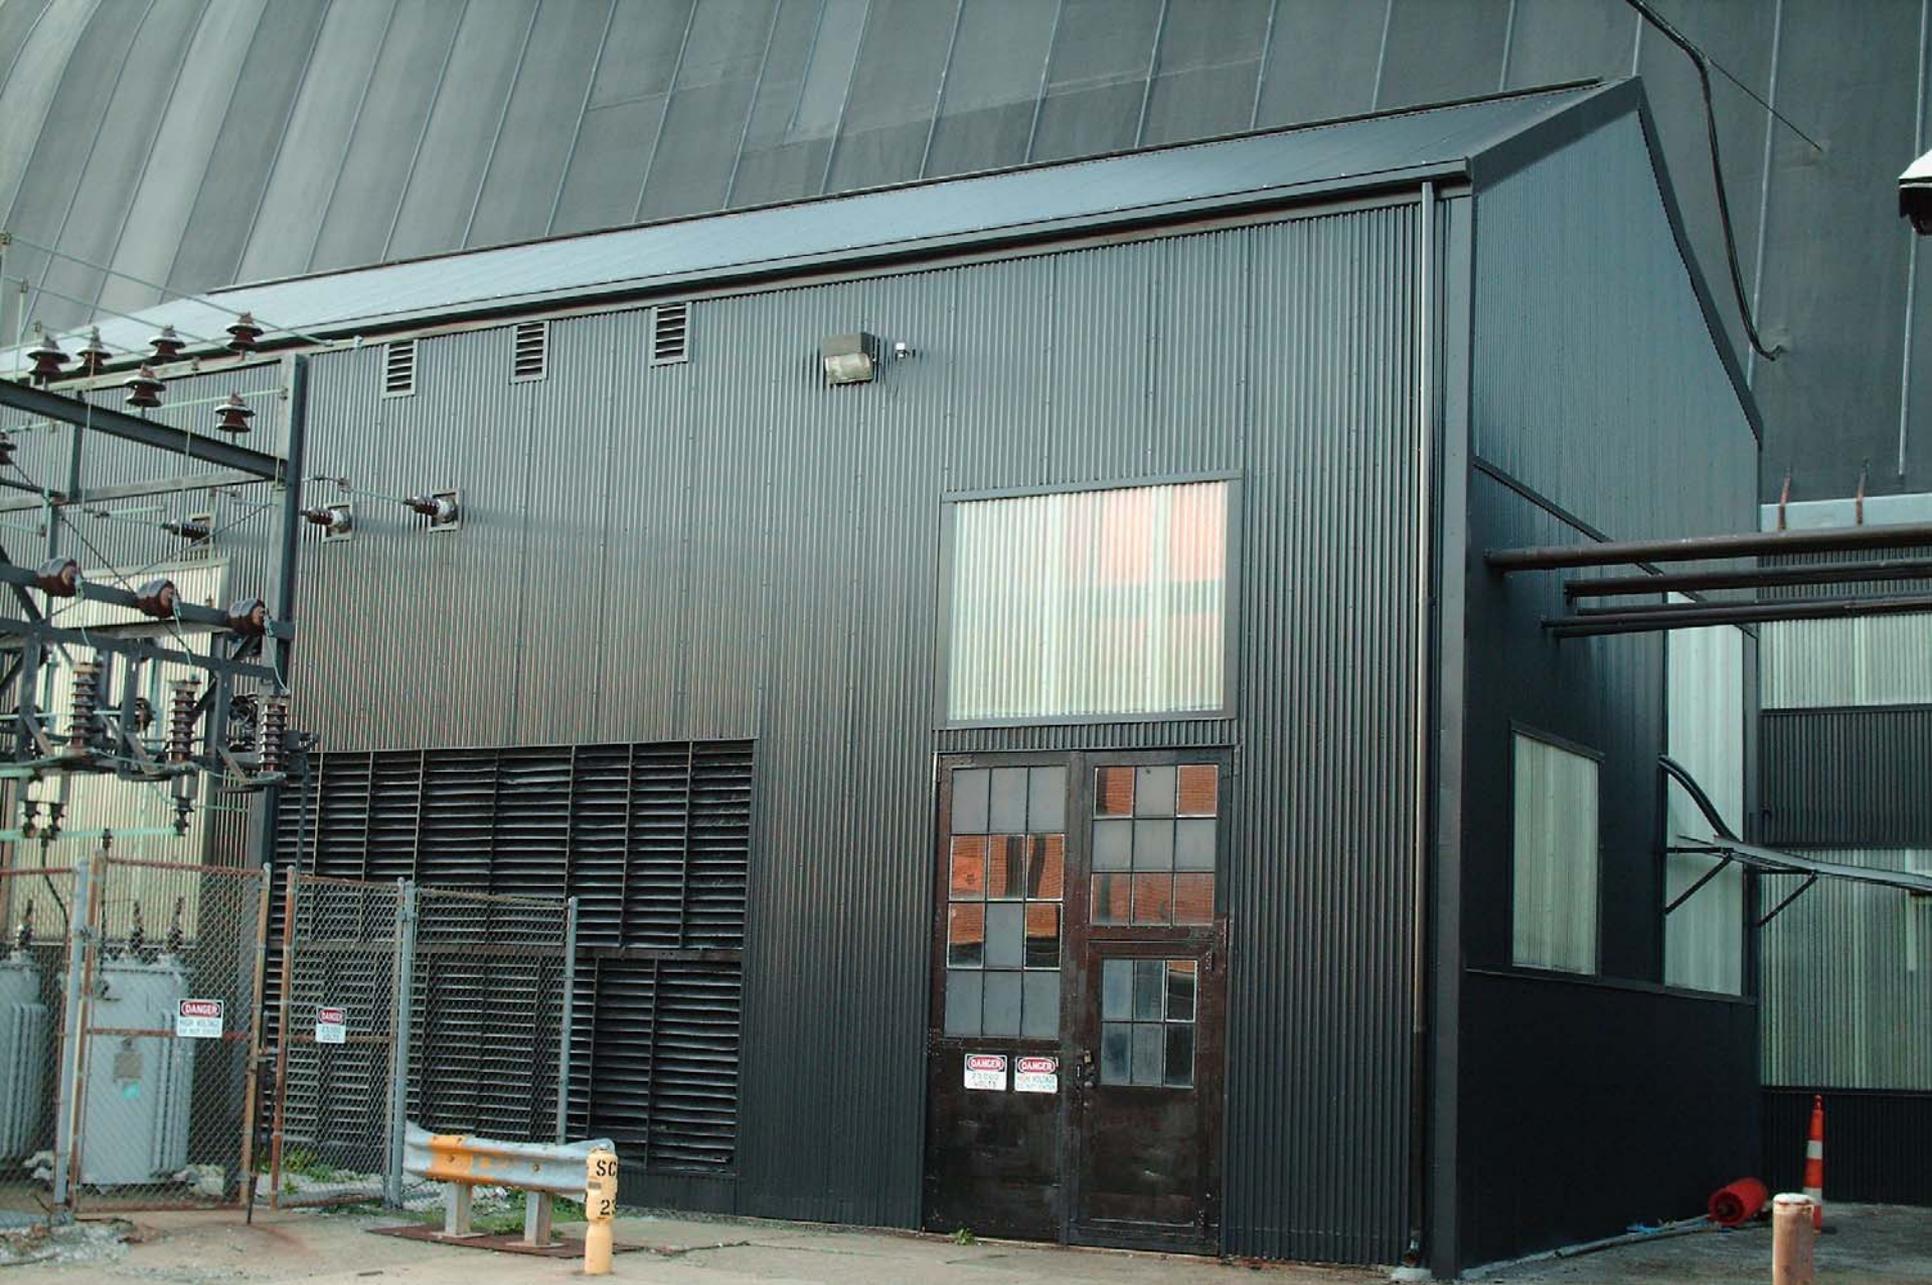
Substation, October 2006

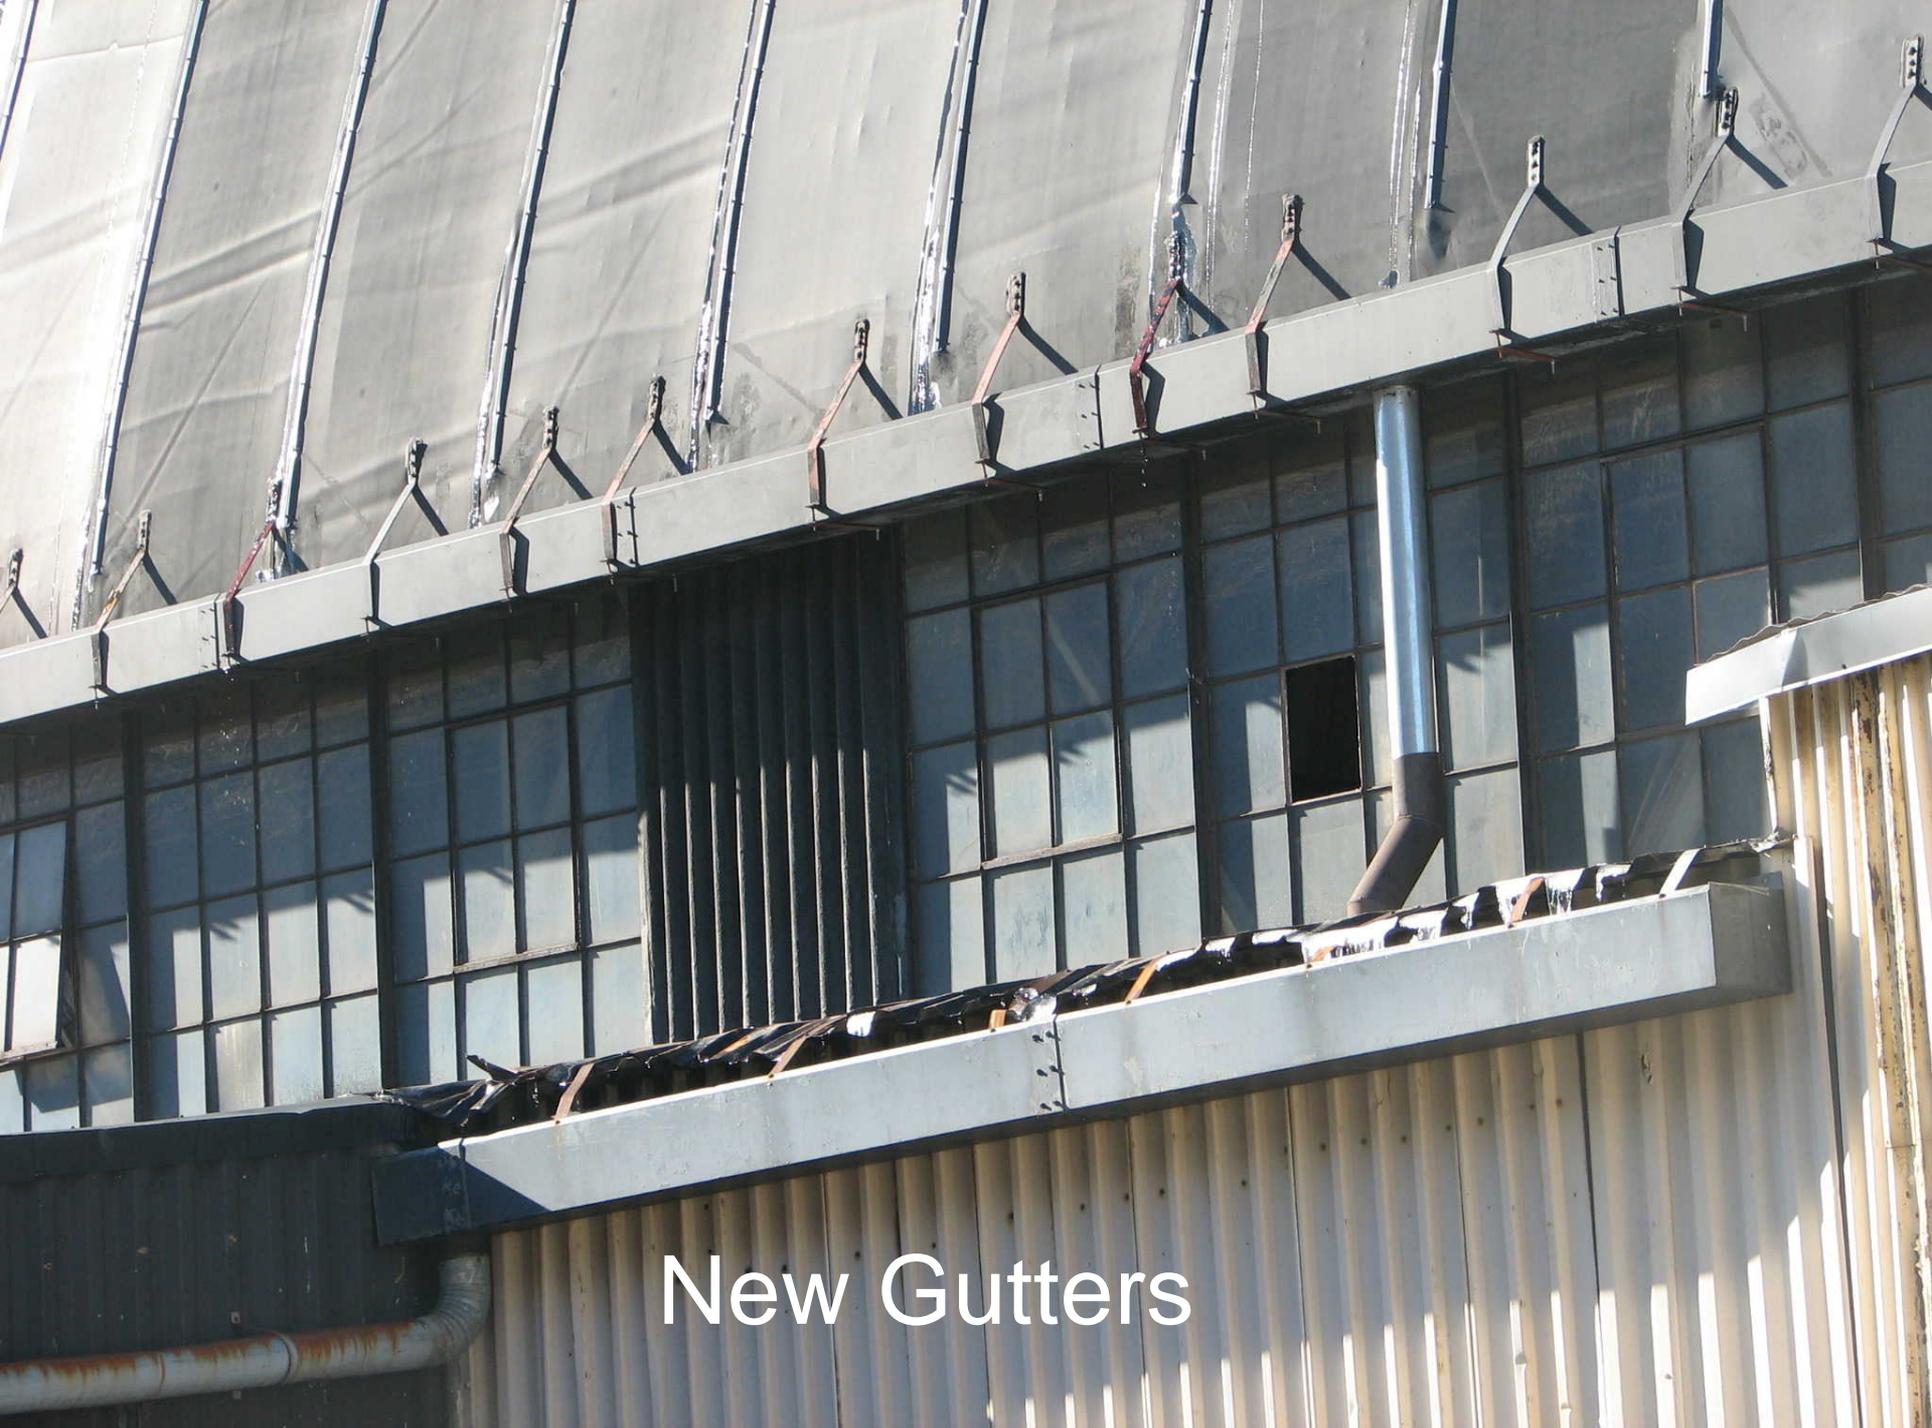
New Gutters

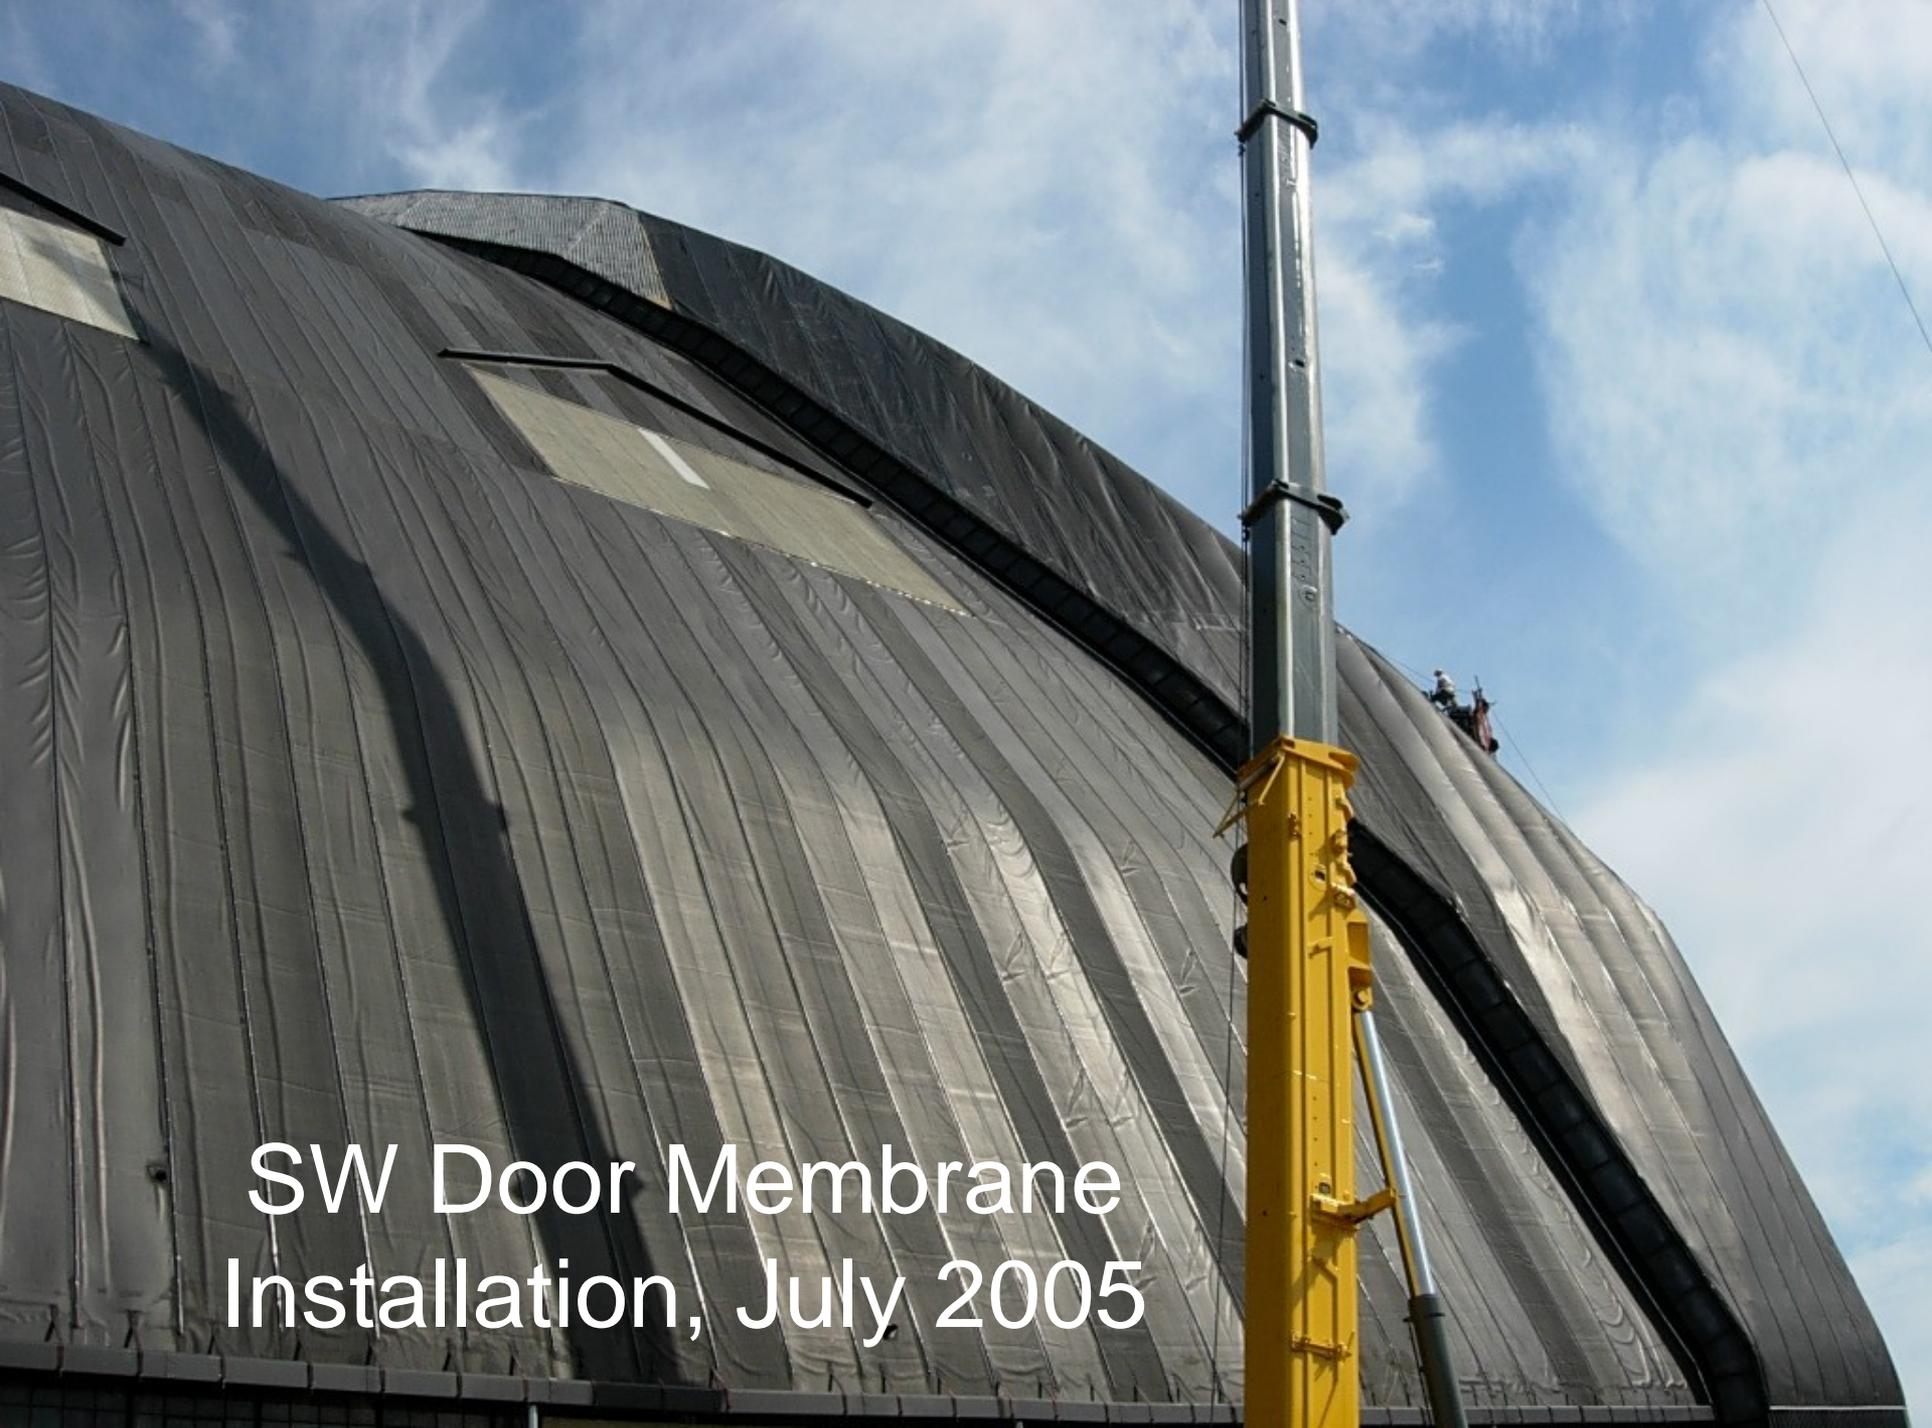
SW Door Membrane
Installation, July 2005

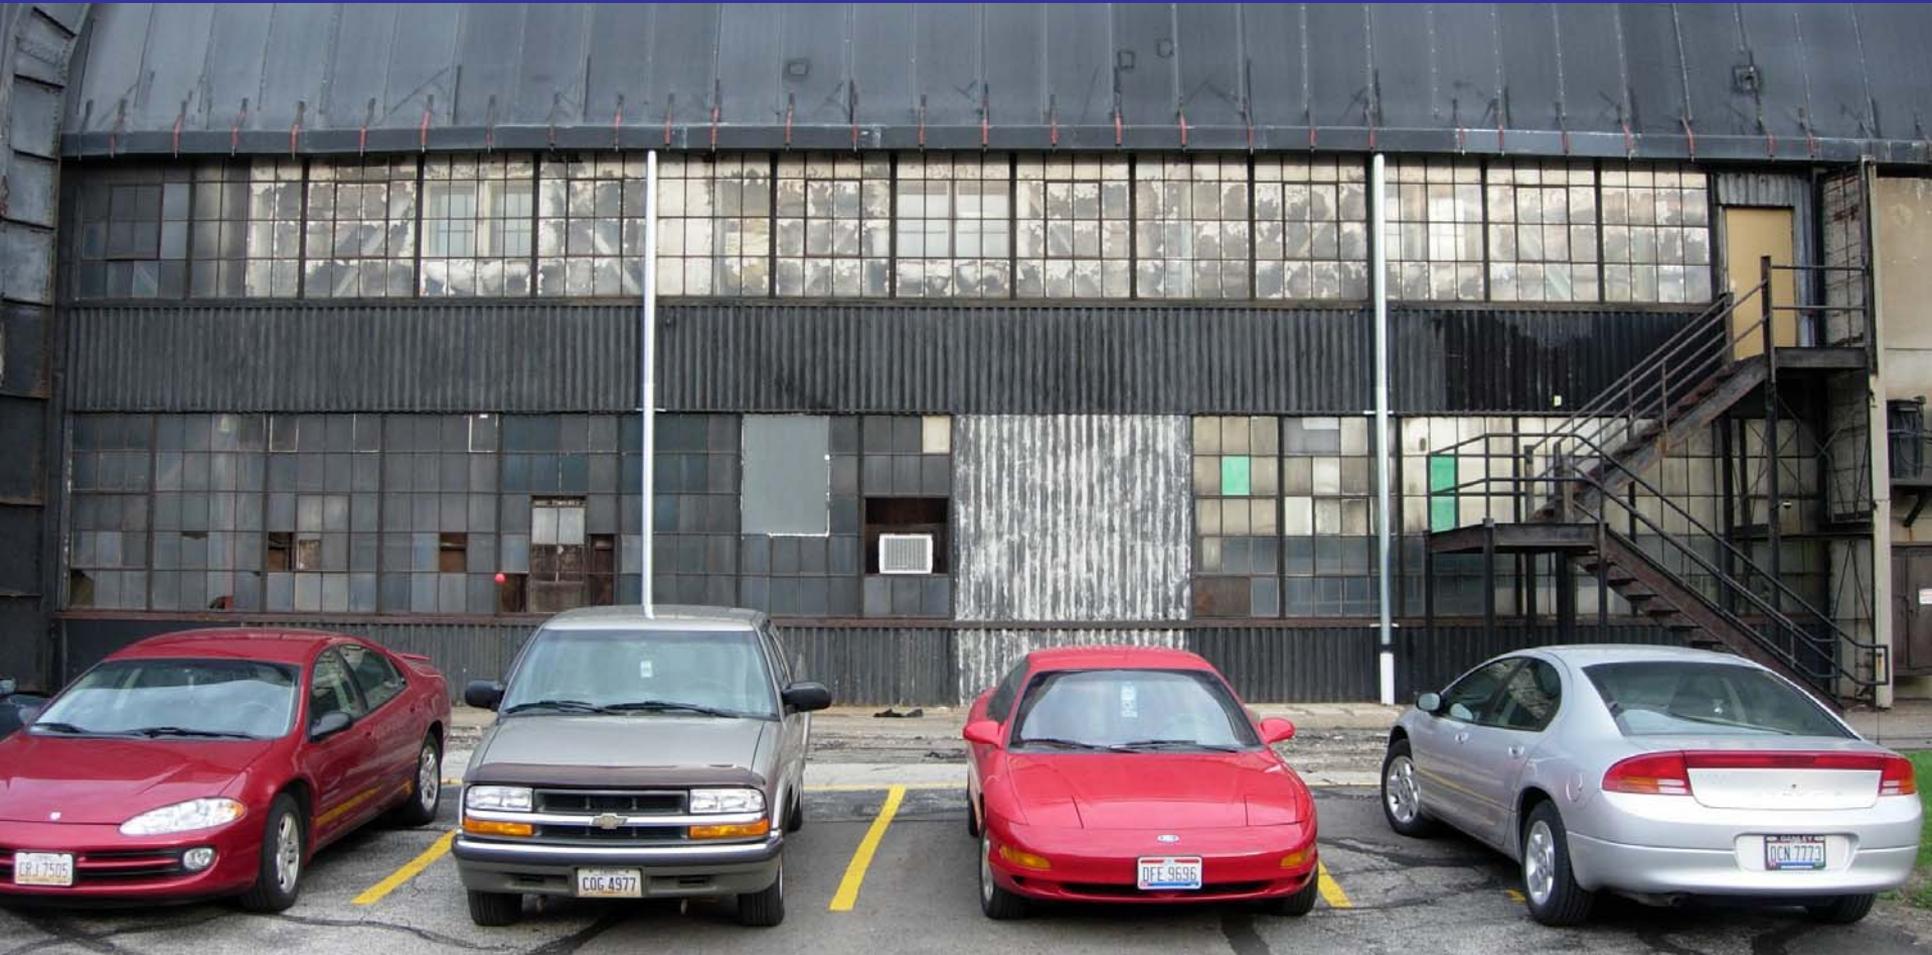
1E-2E, April 2004

Original Siding

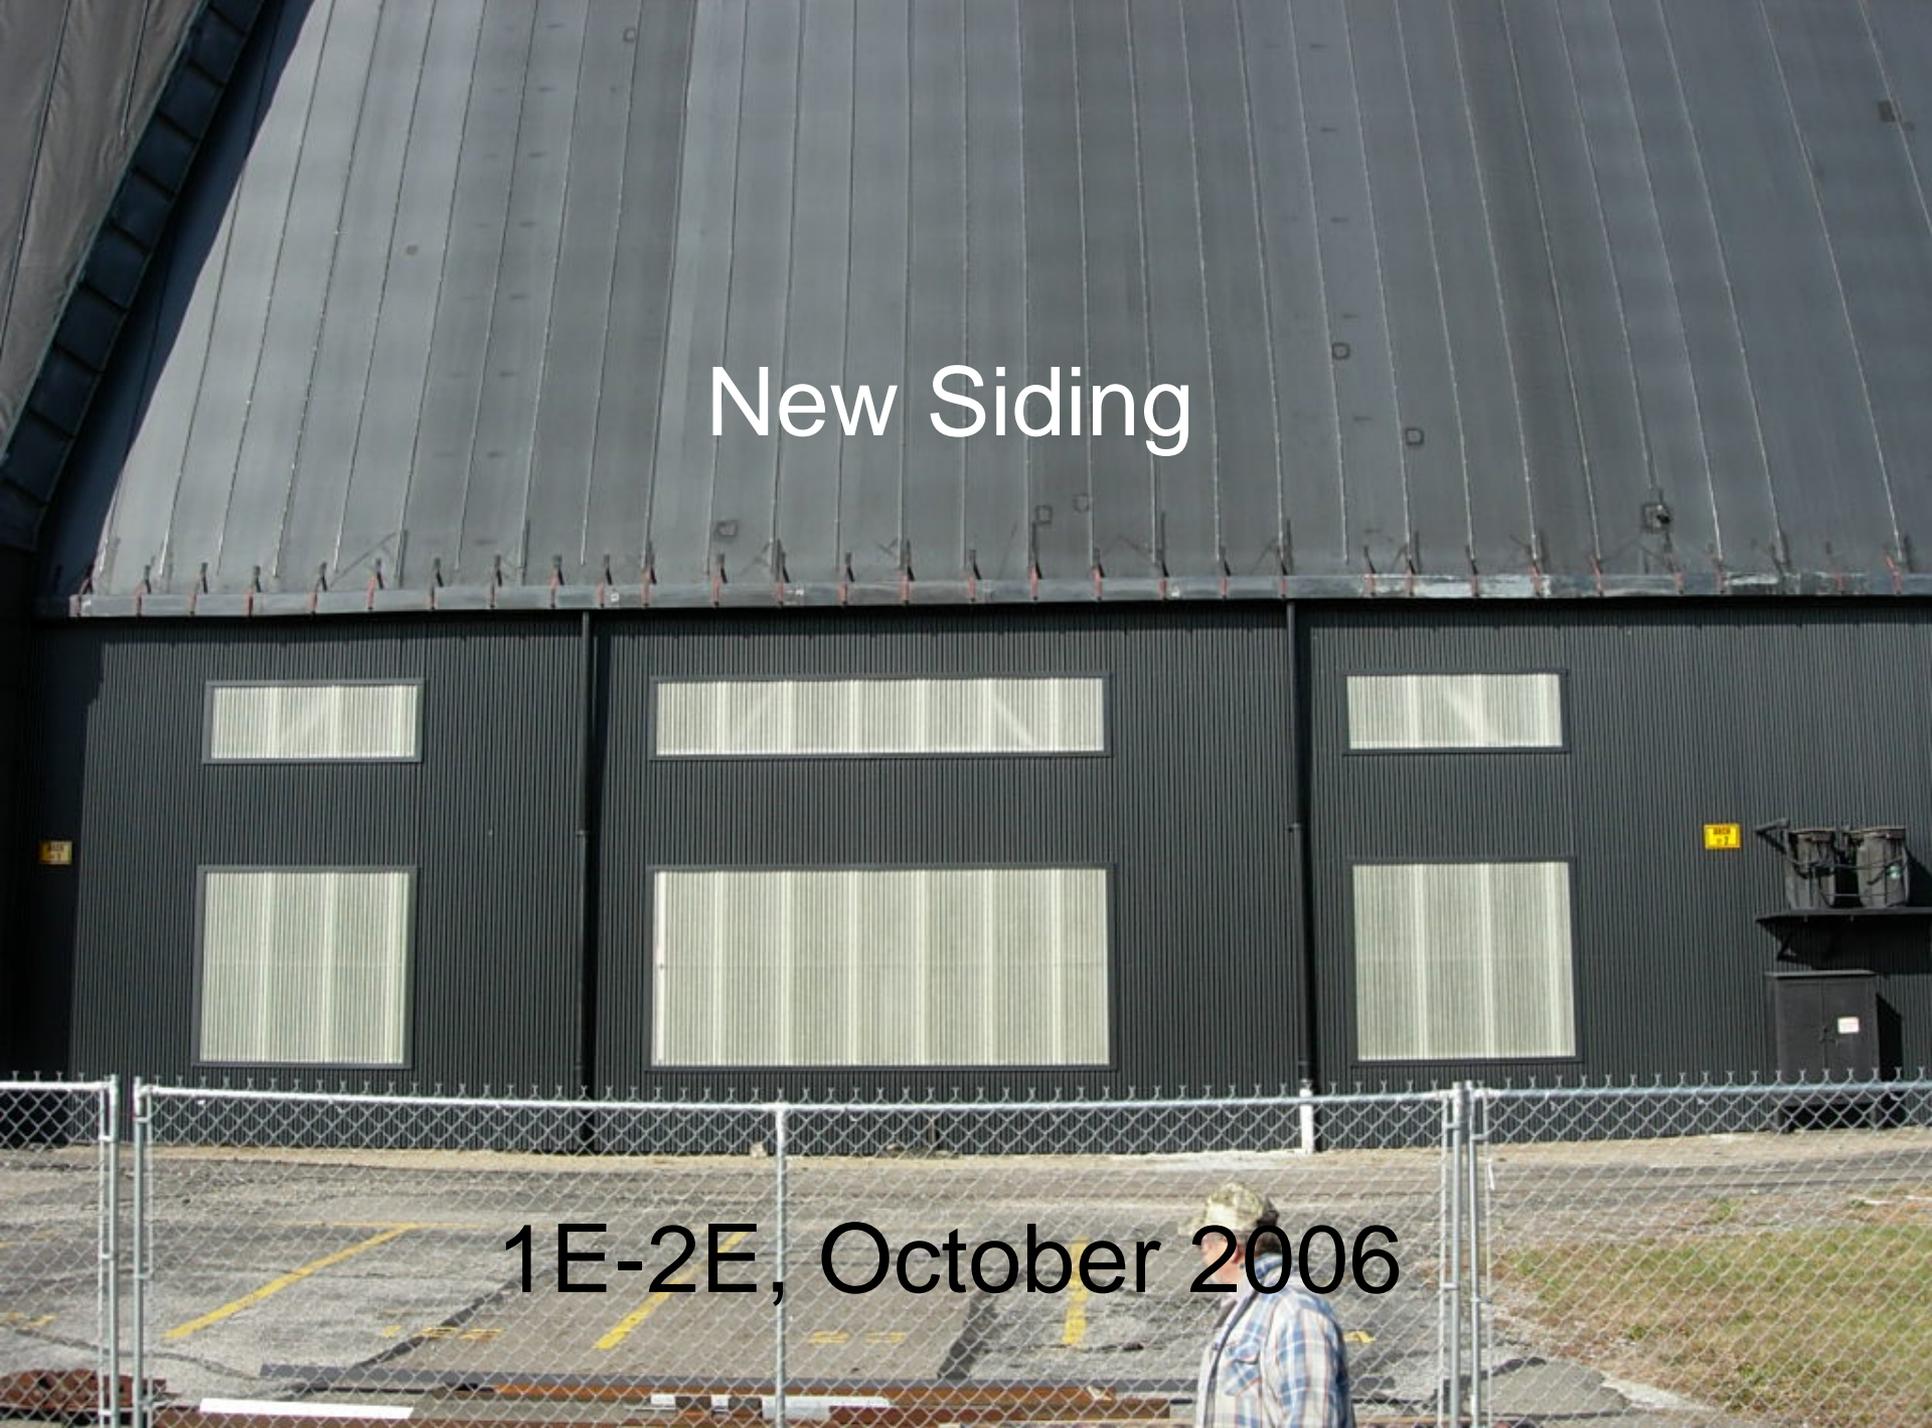
1E-2E, October 2006

New Siding

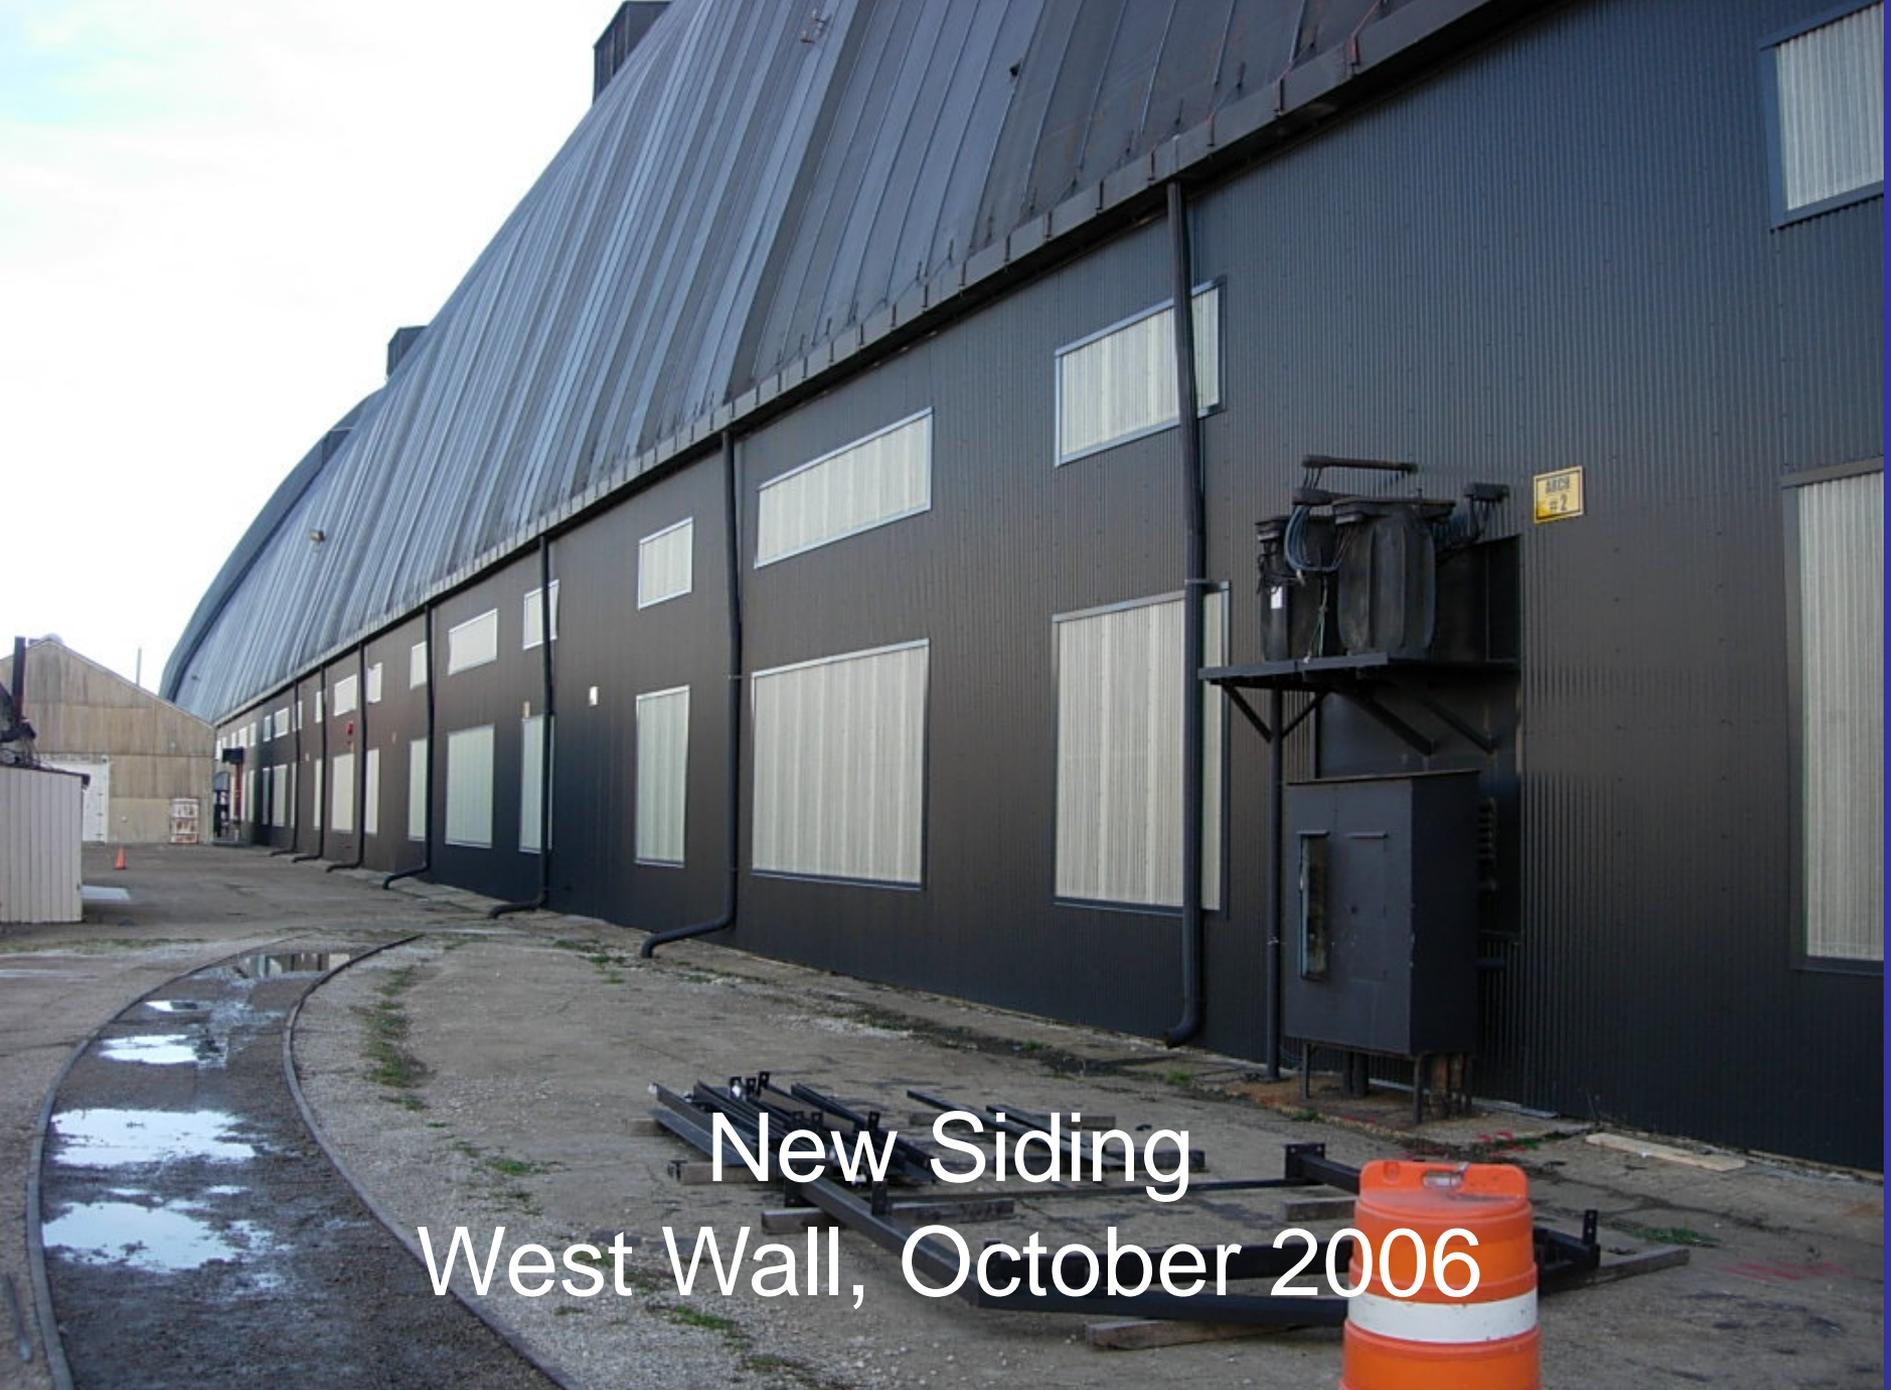
New Siding
West Wall, October 2006

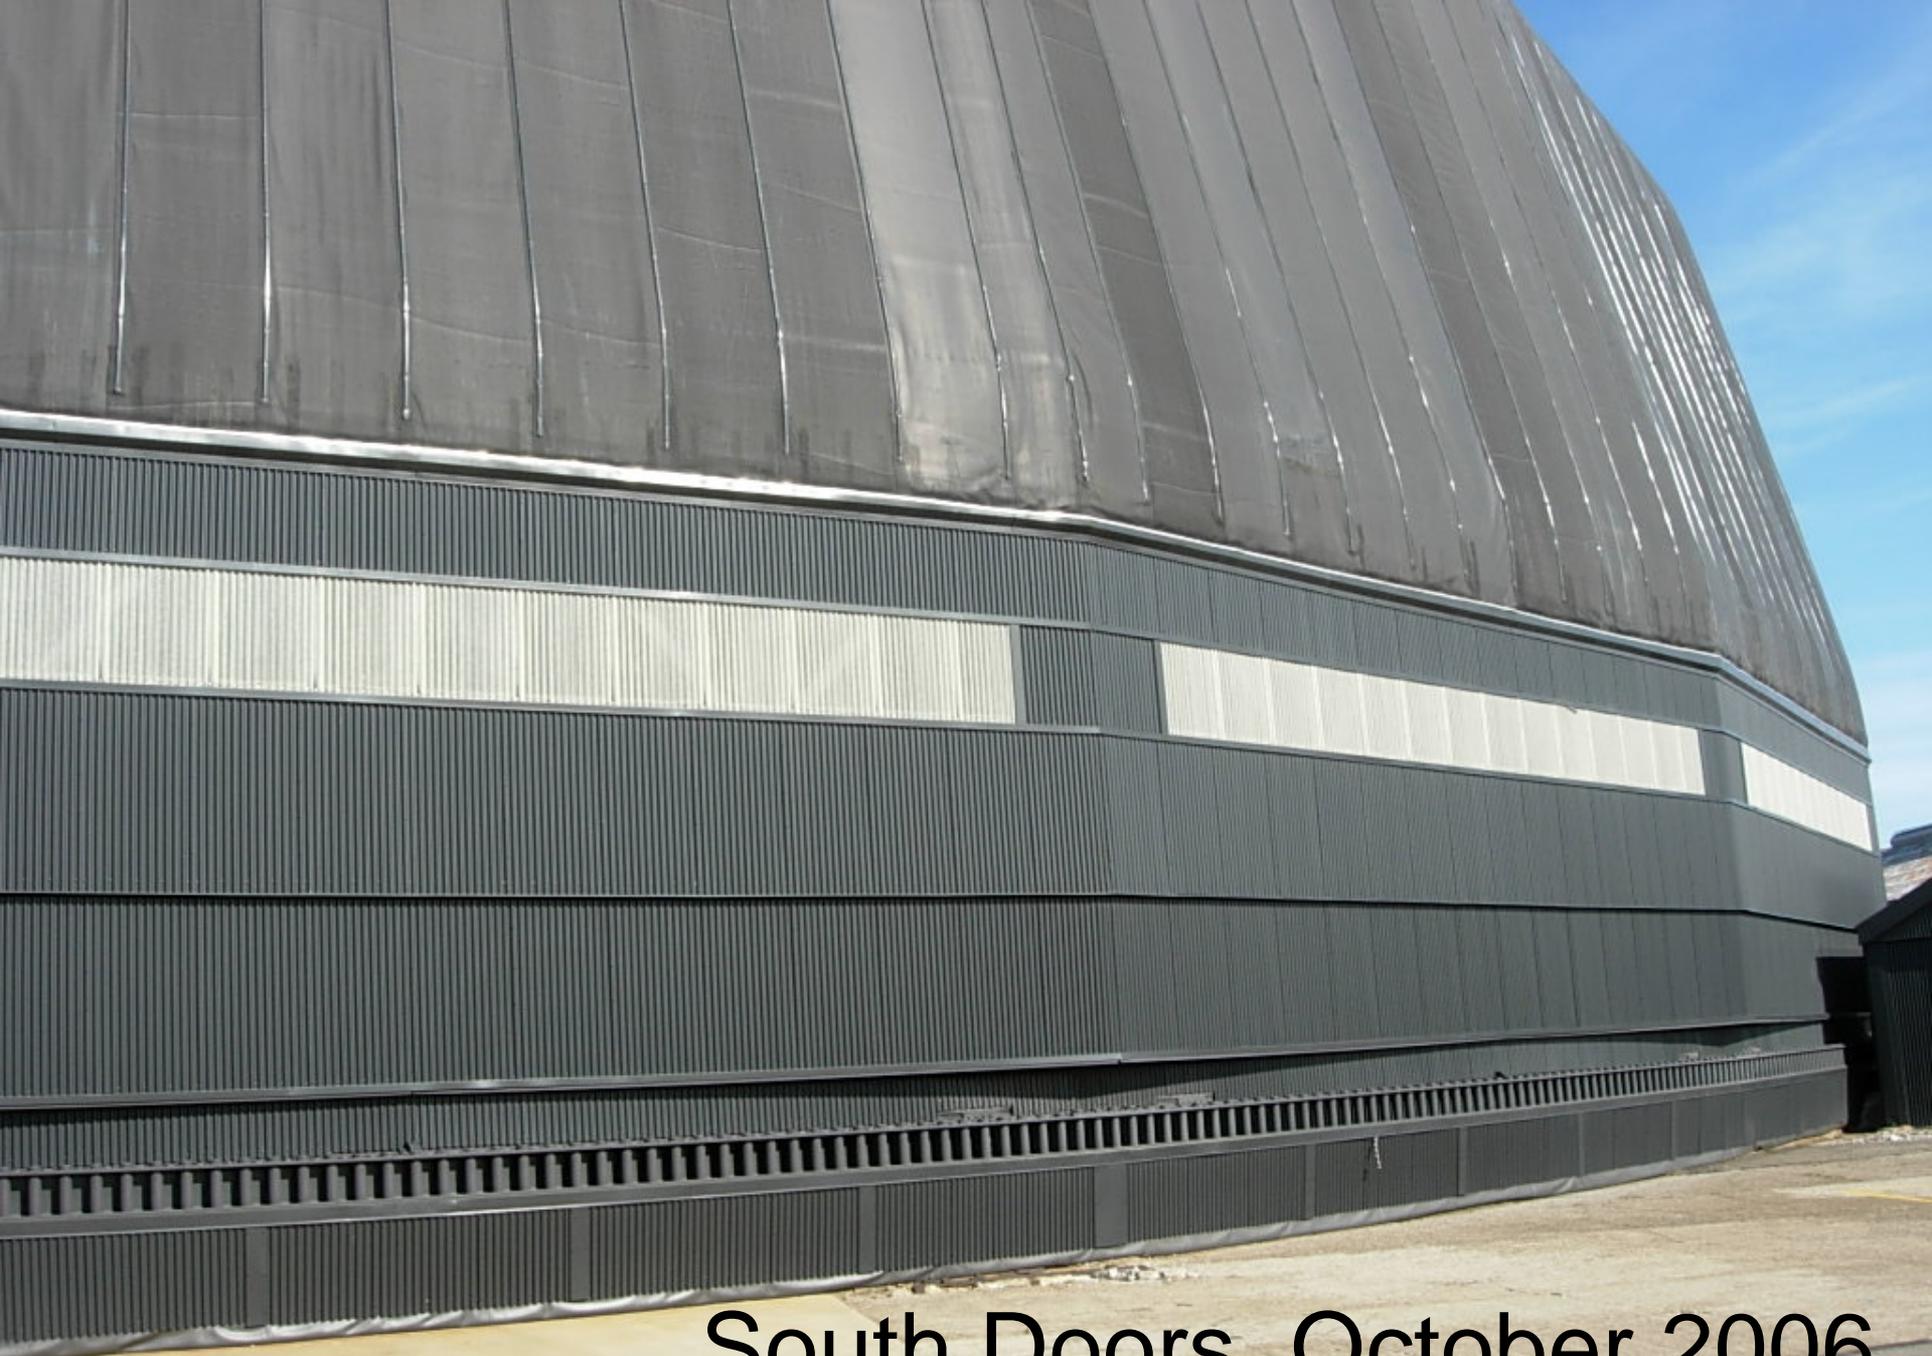
South Doors, October 2006
