Akron Airdock PCB Exterior Remediation Strategy

June 22, 2007

Lockheed Martin Corporation
1210 Massillon Road
Akron, Ohio 44315

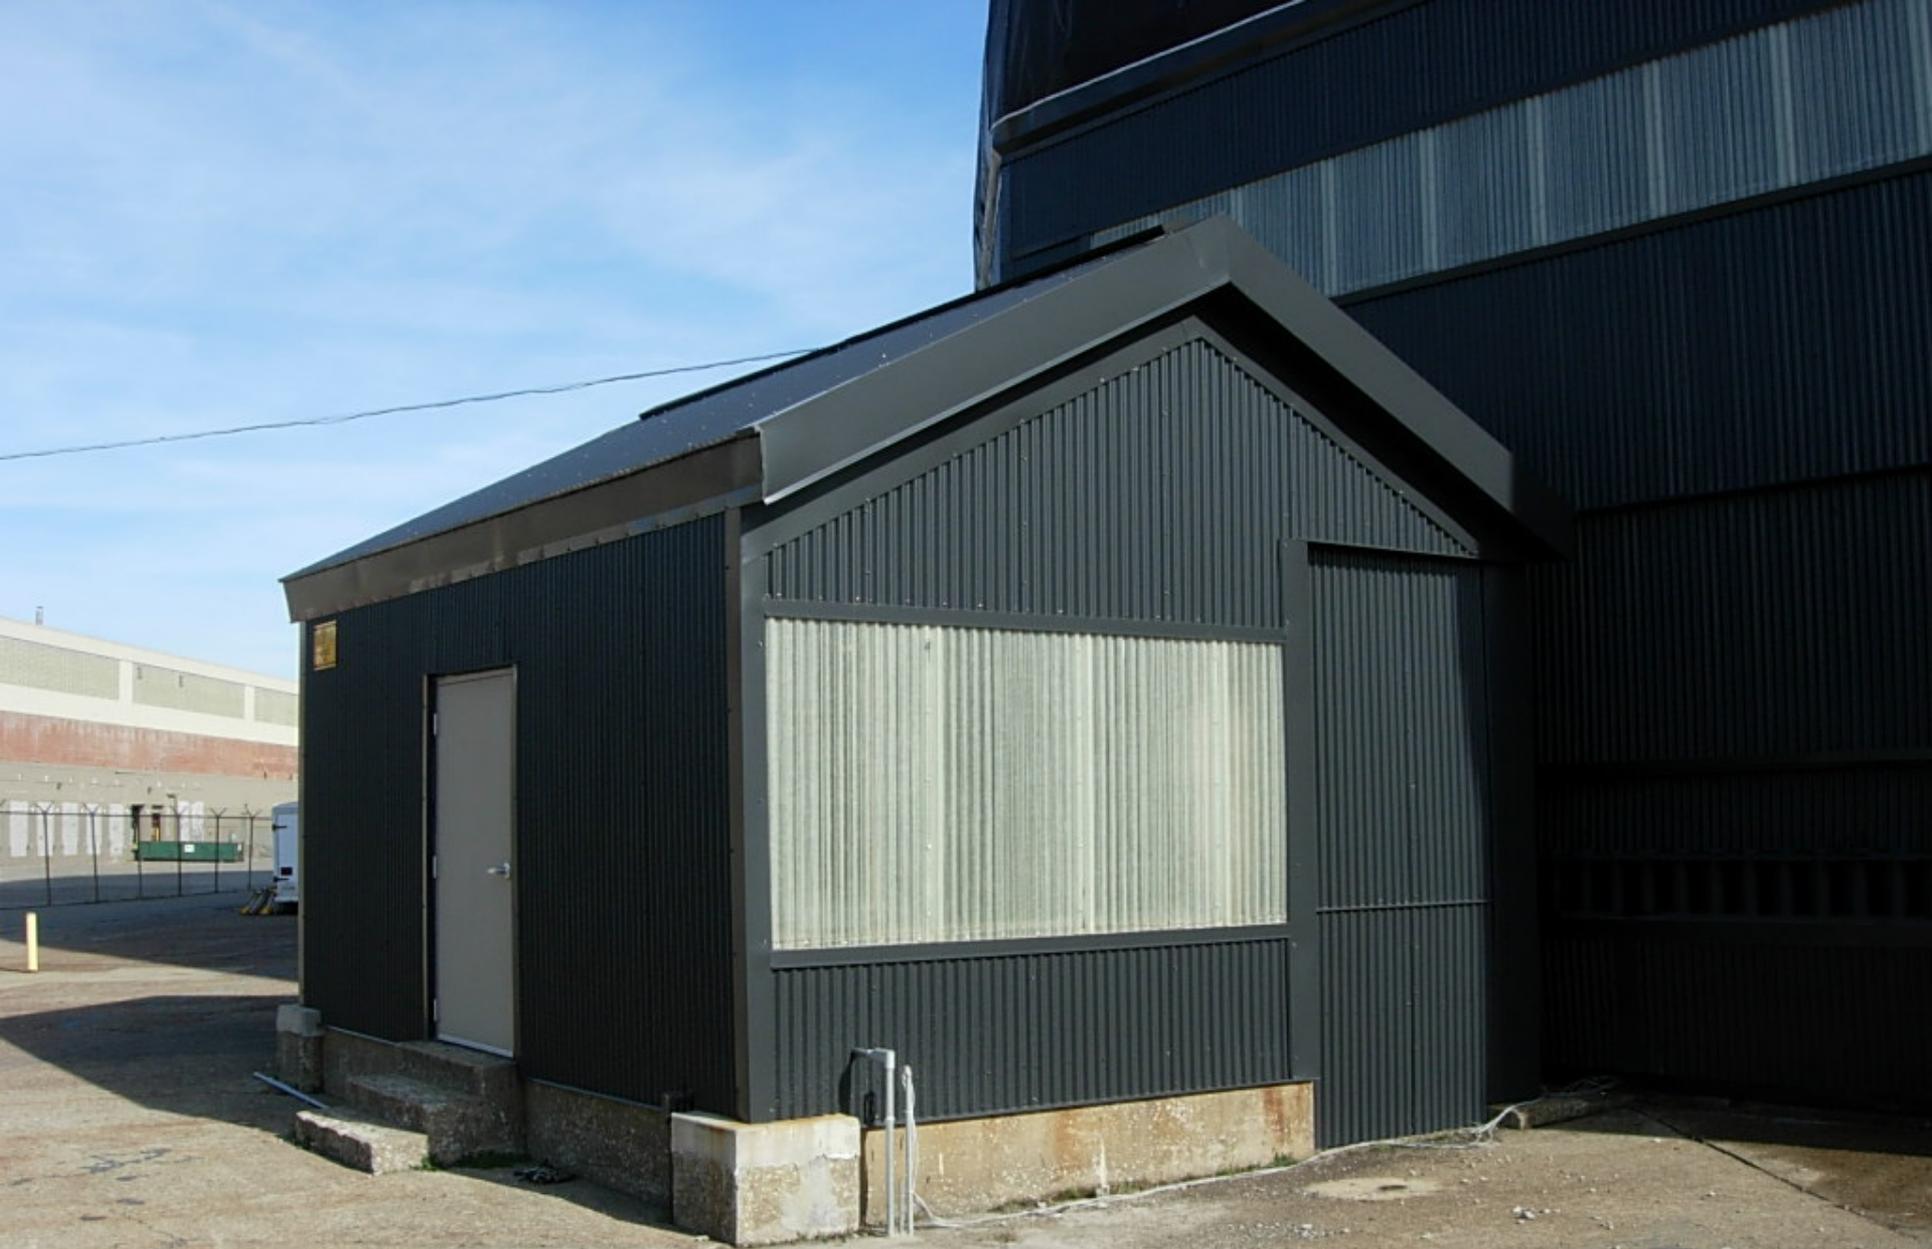
South West Motor House, October 2006

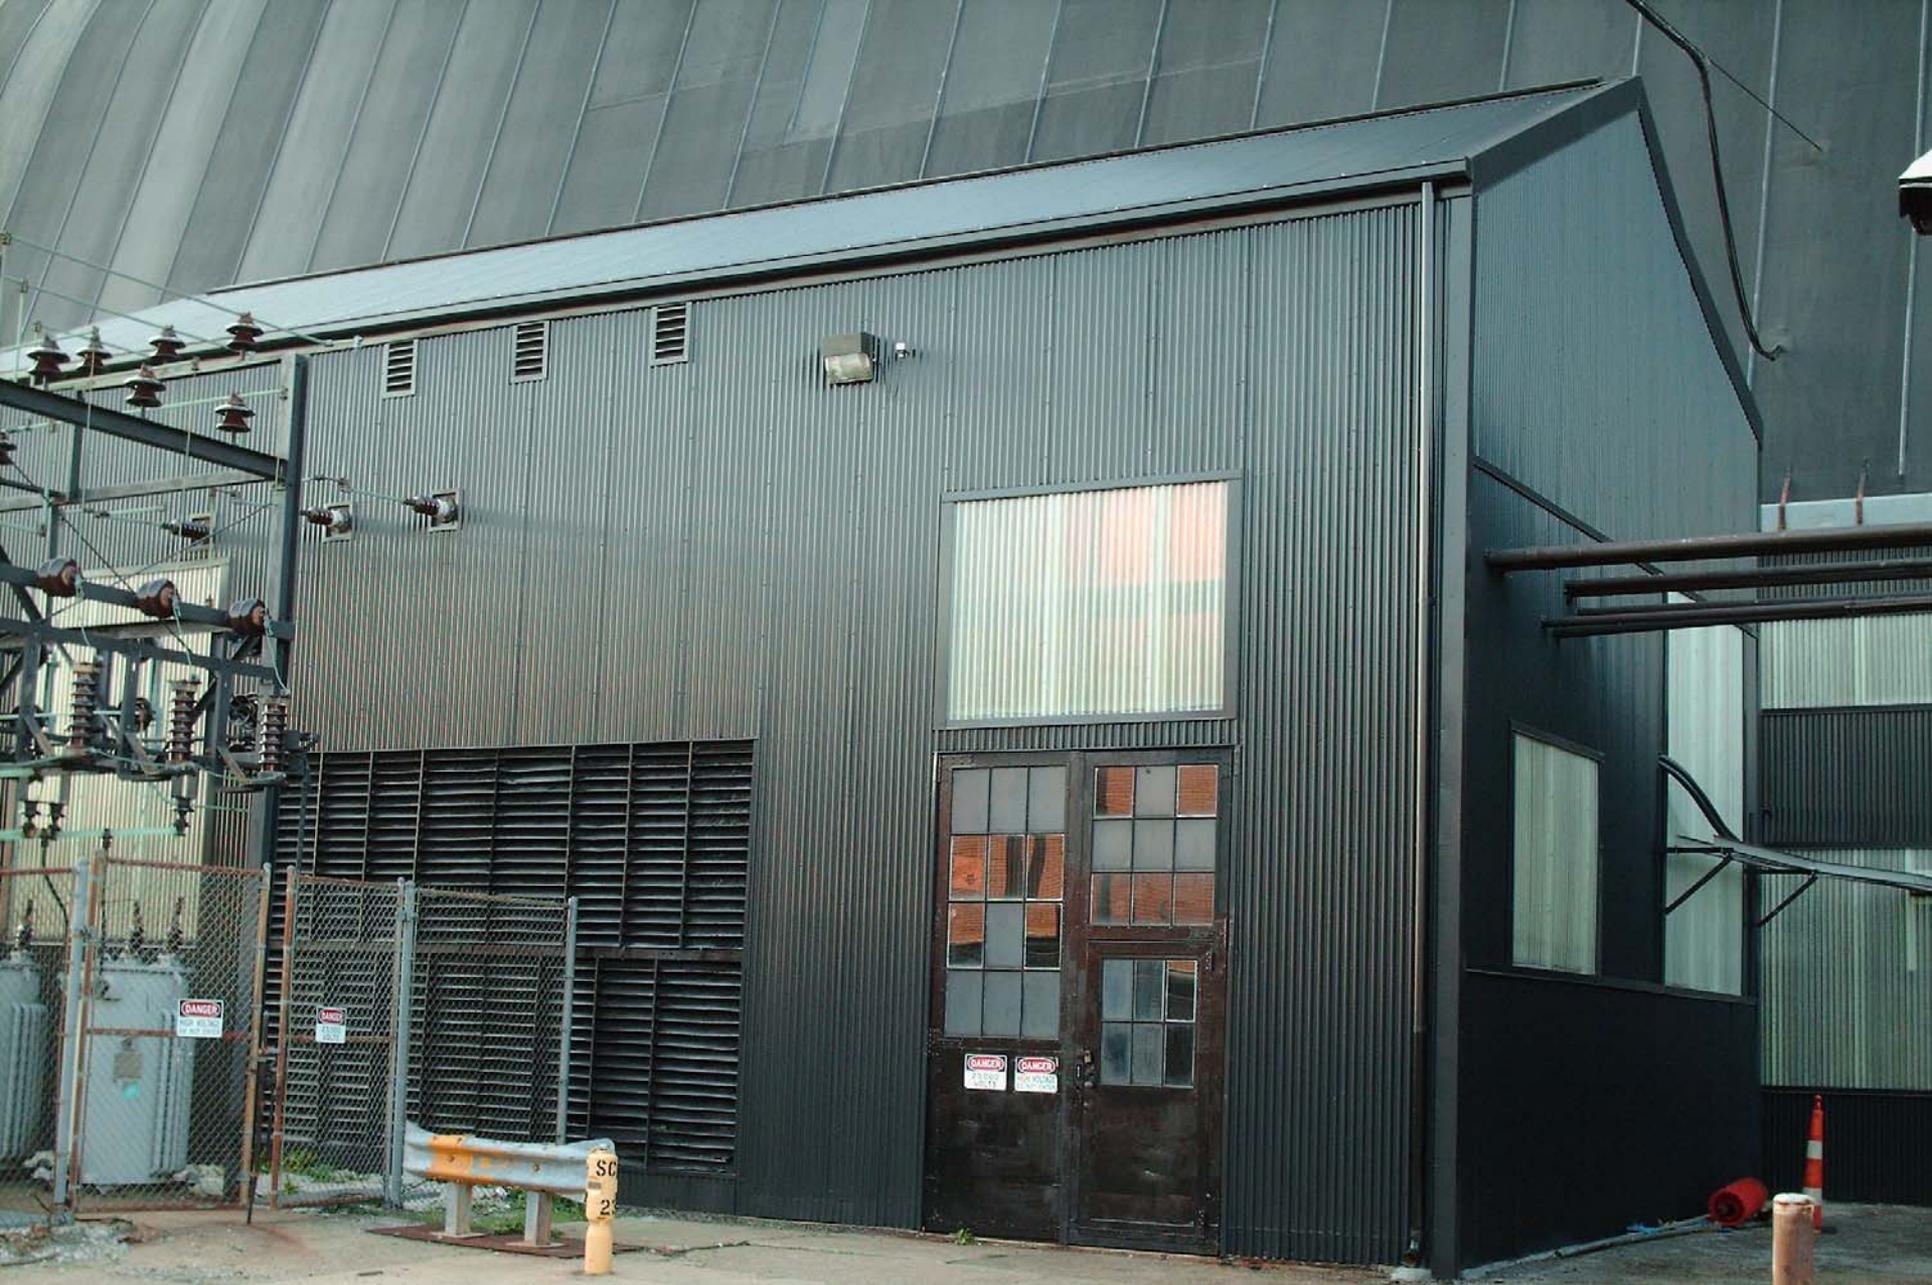
Substation, October 2006
