Lockheed Martin Corporation Beaumont Site 1 & 2 Safety & Toxics Assessment Beaumont, California

March 19, 2003

TC 12866-03

Tetra Tech, Inc.
San Bernardino, California

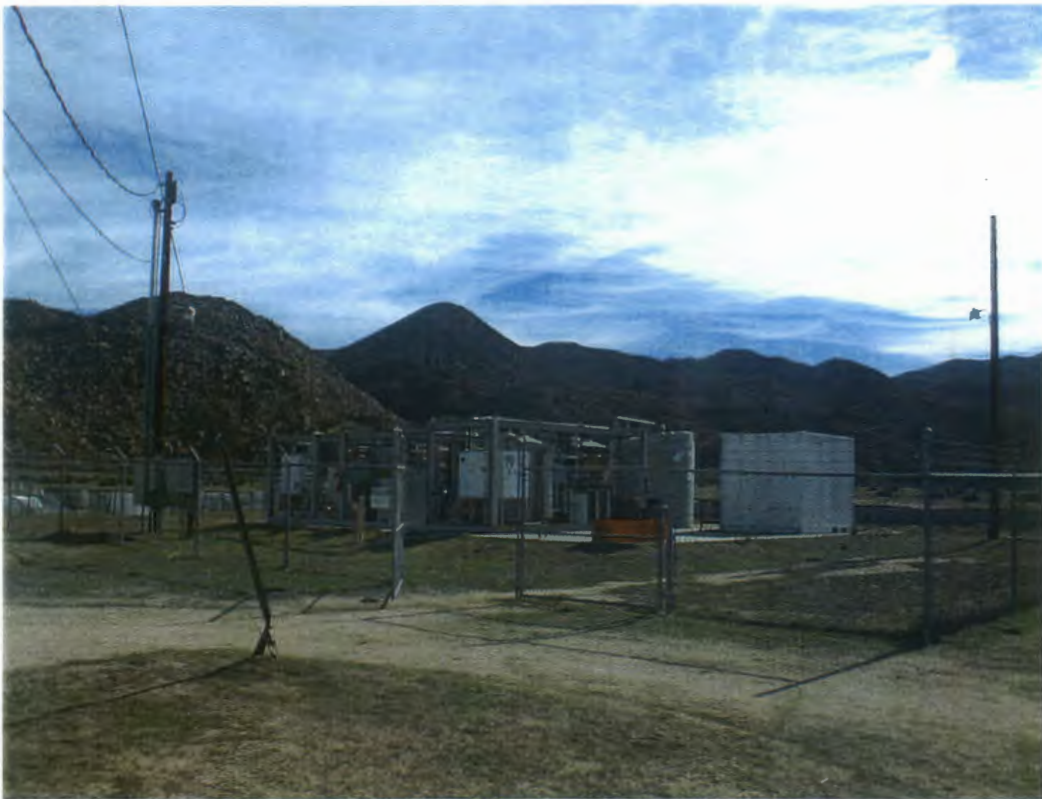
Photograph 1. Catalytic Oxidizer (Remediation System)

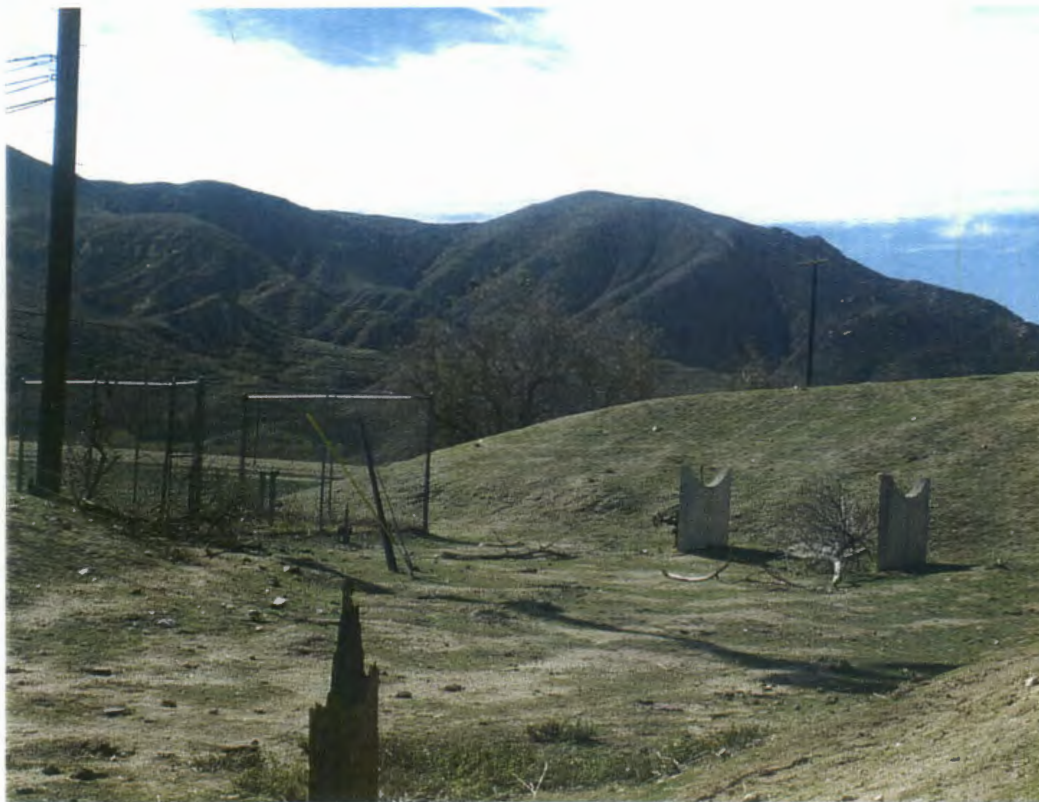
Photograph 3. Tank Saddles and Electrical Enclosure (Old Structure)

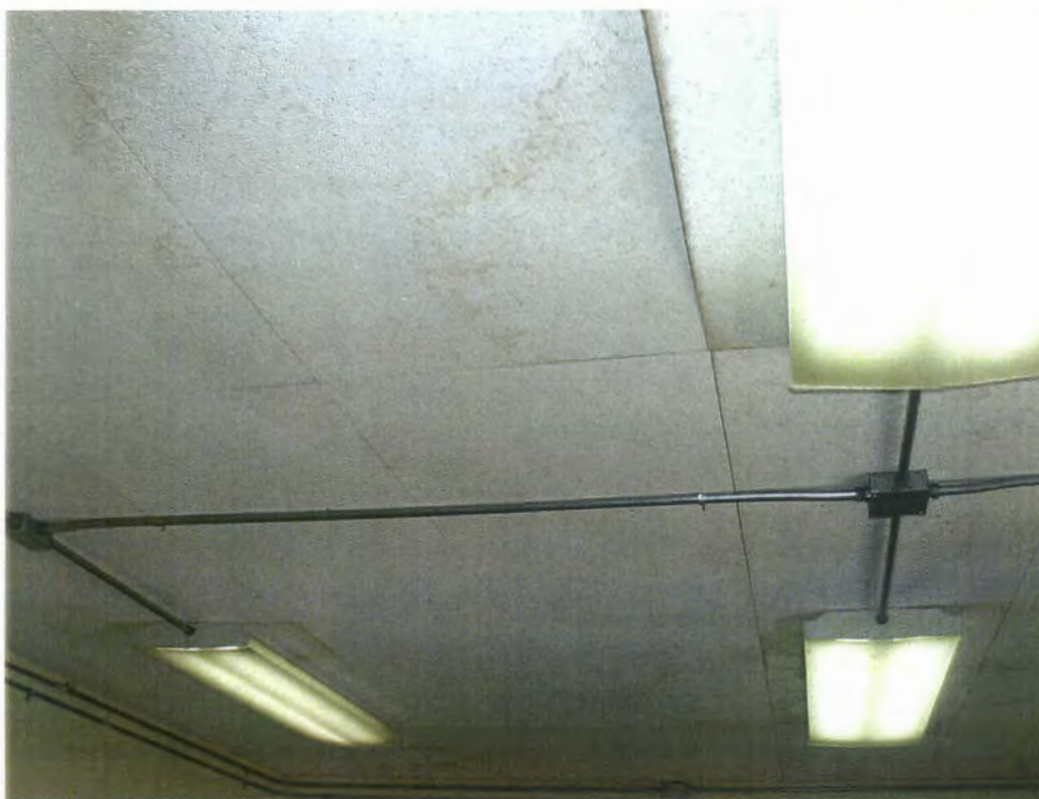
Photograph 4. Fluorescent Light Fixtures (Toxics)

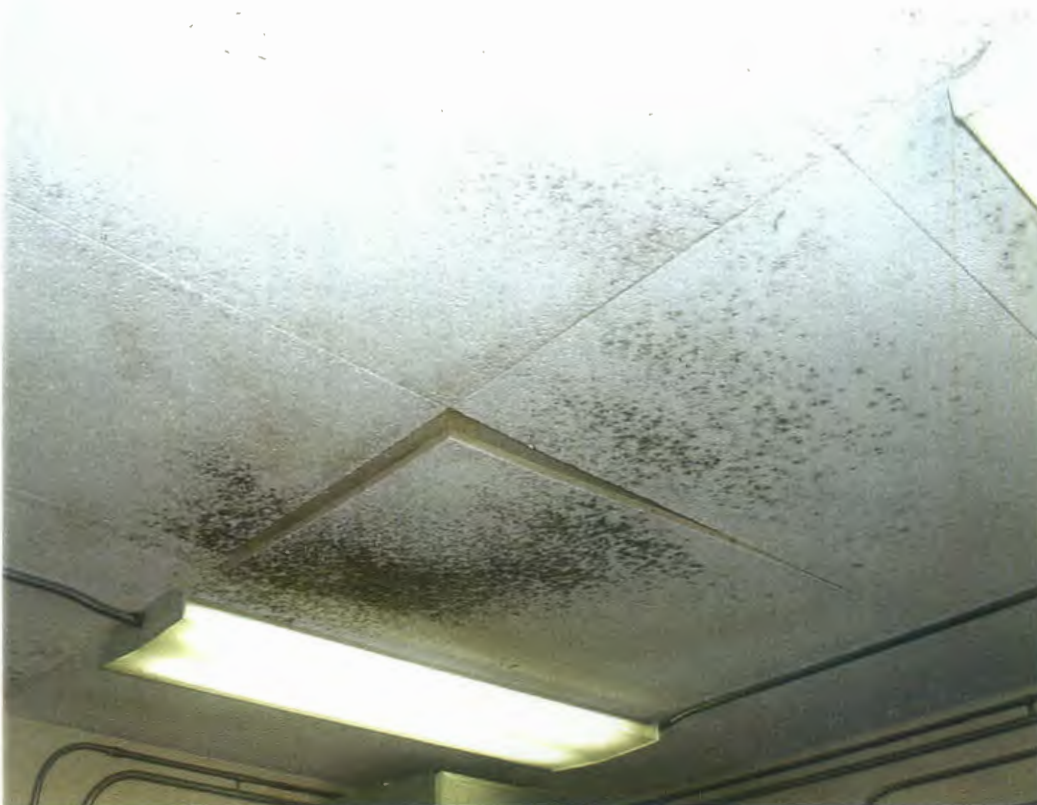
Photograph 5. Mold (Toxics)

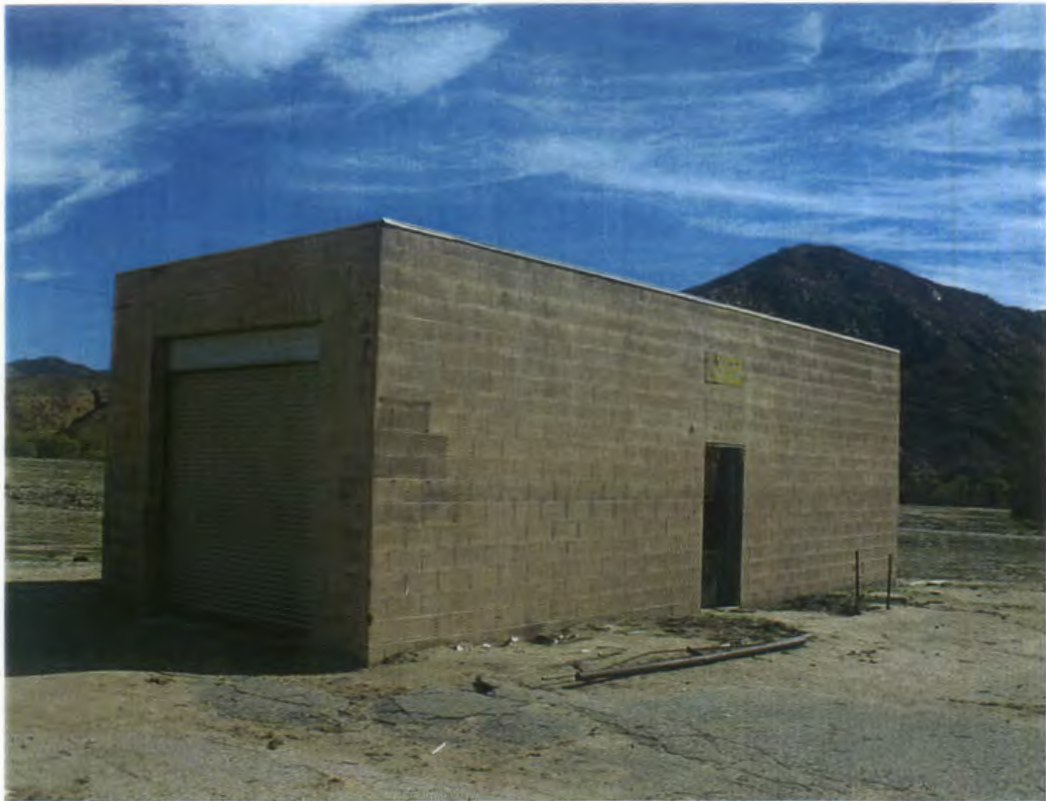
Photograph 9. Building 312 (Old Structure)

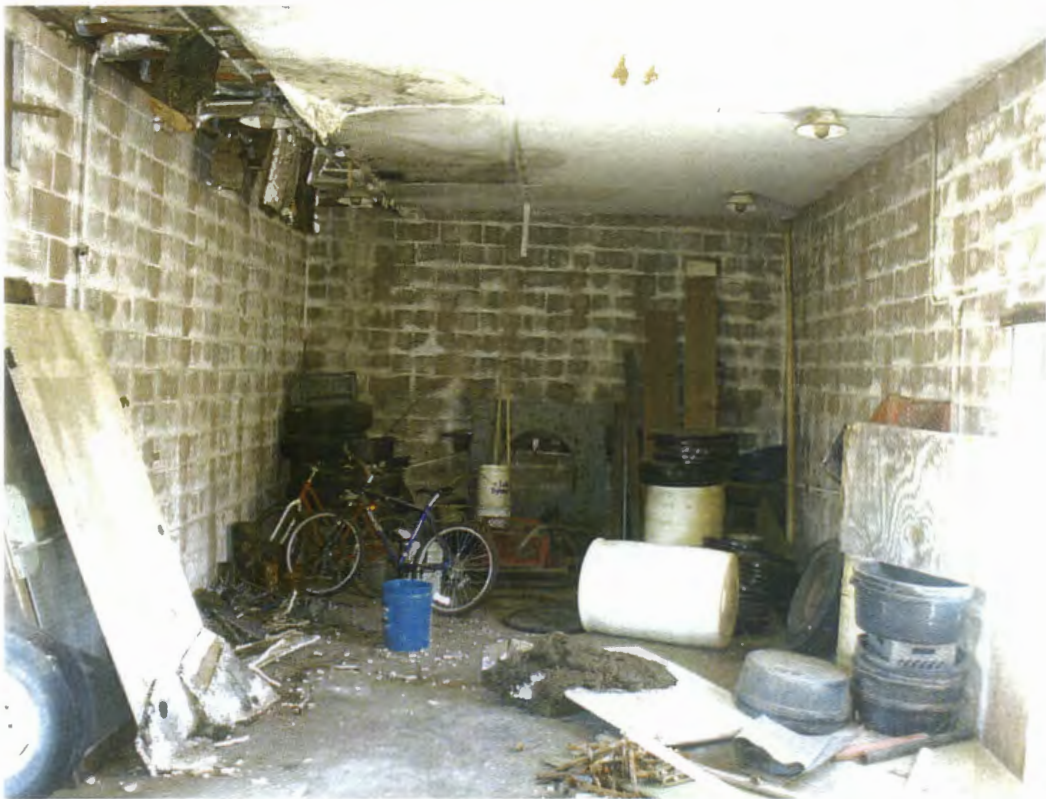
Photograph 10. Building 312 Interior (Old Structure)

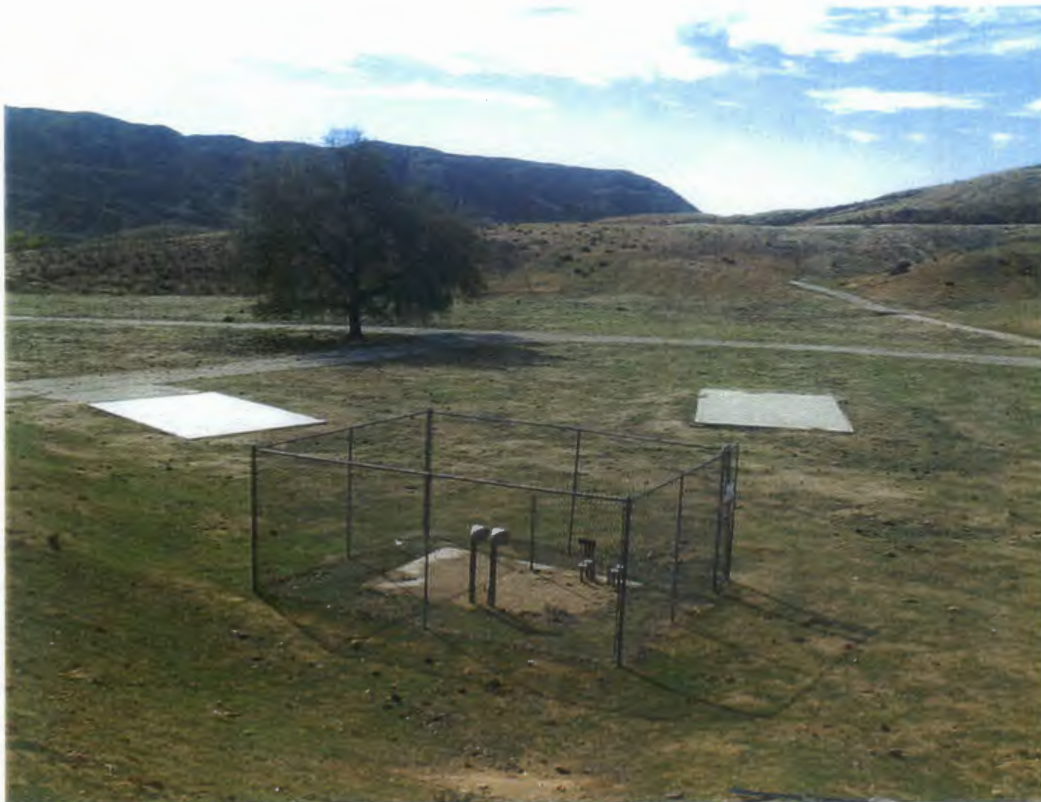
Photograph 11. Former Transformer Location (Toxics) and Former Building Pads (Old Structure)

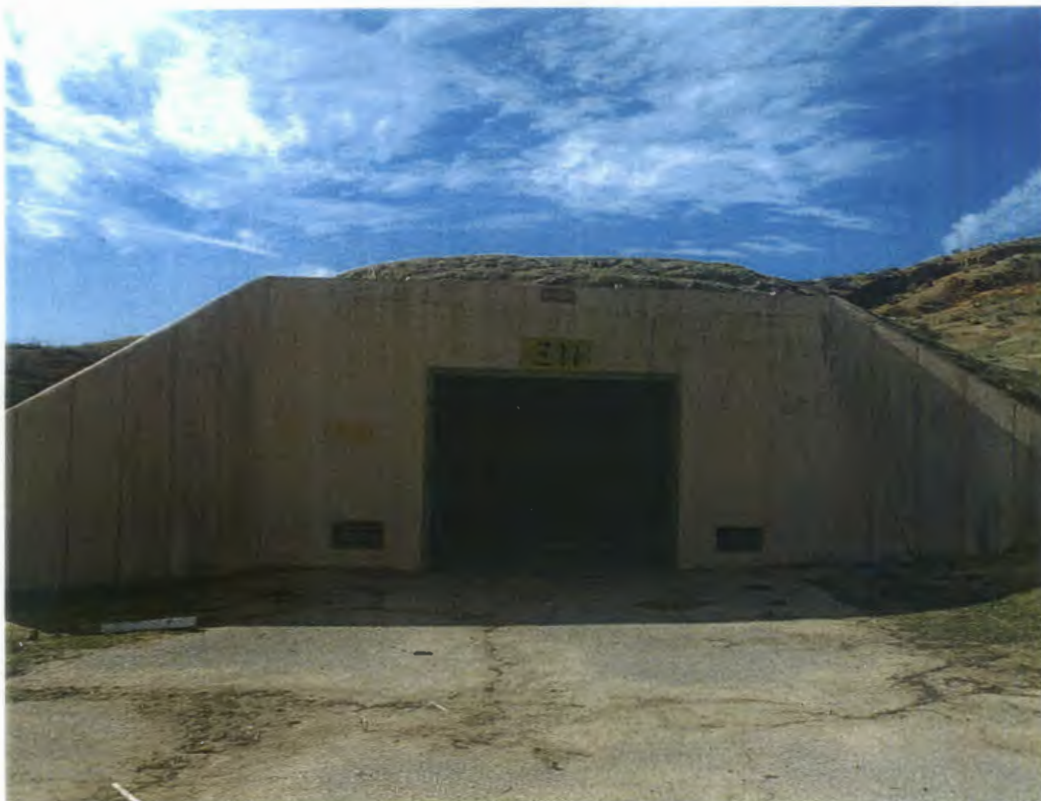
Photograph 13. Building 325 Bunker (Old Structure)

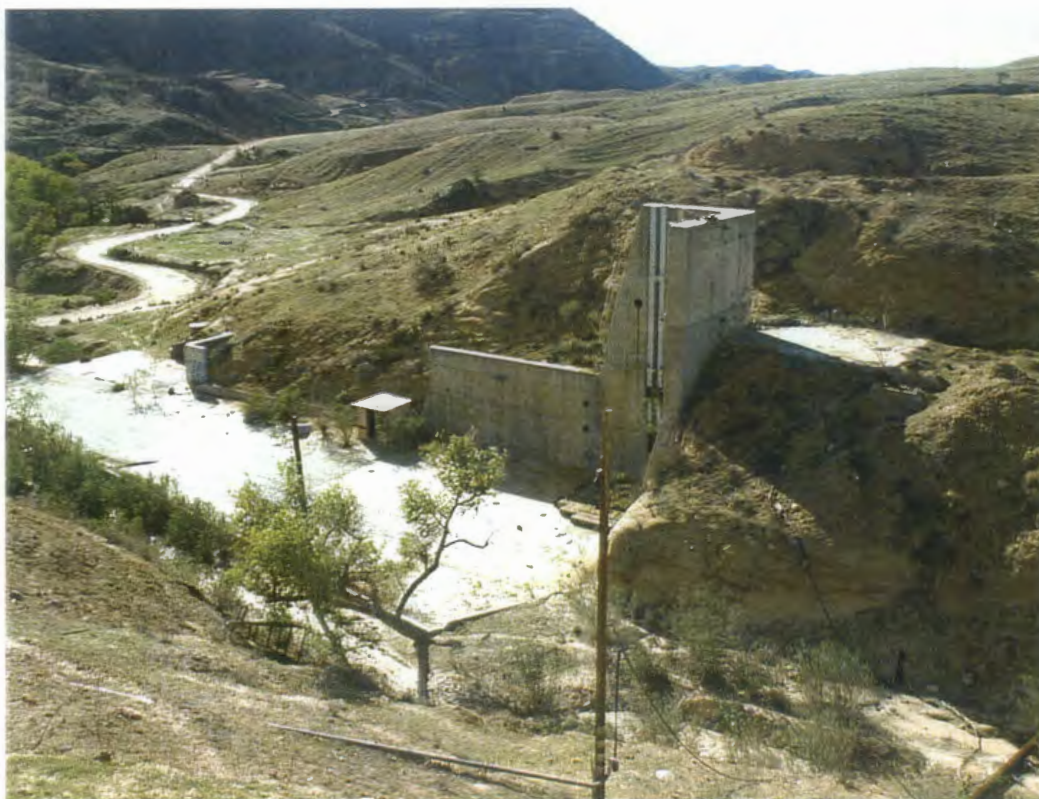
Photograph 14. Typical Rocket Test Facility (Old Structure)

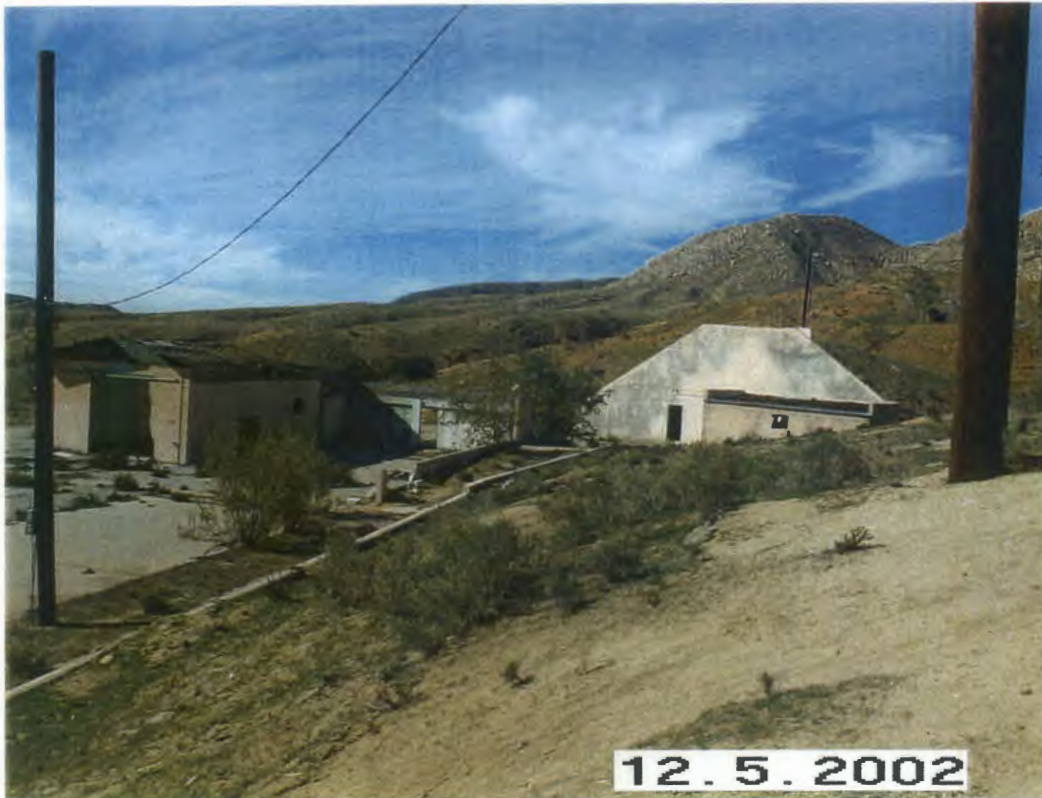
Photograph 15. Buildings 305 and 306 (Old Structure)

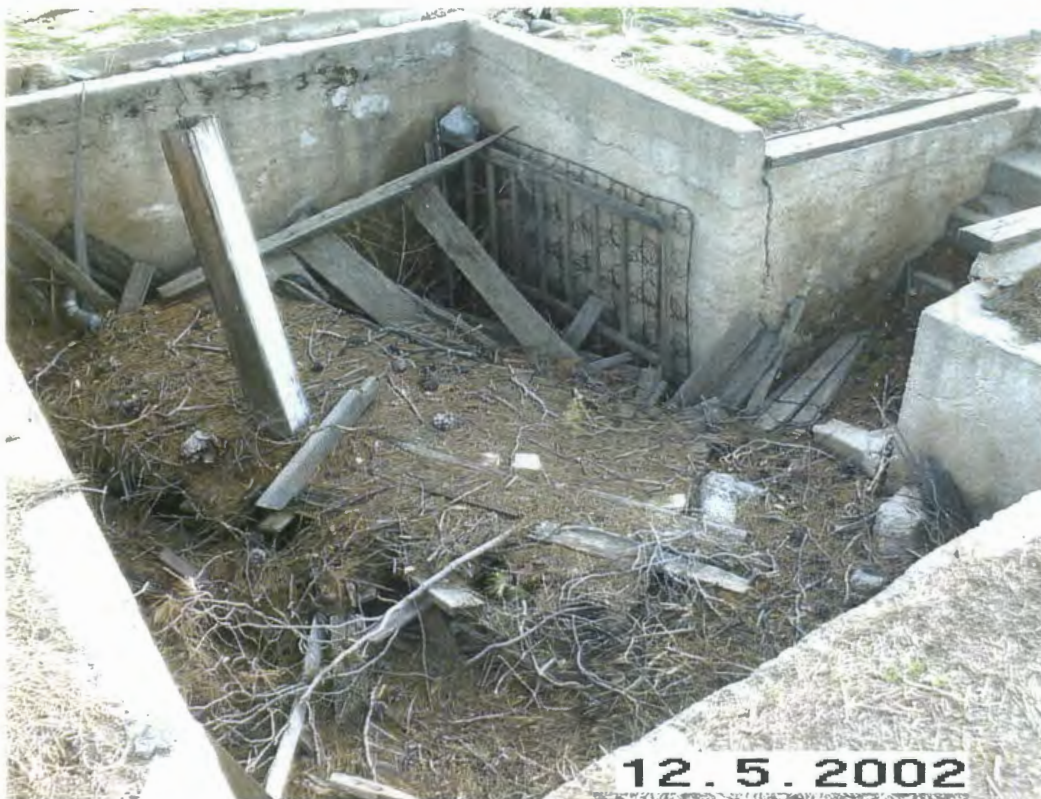
Photograph 16. Typical Concrete Foundation and Debris (Old Structure/Debris)

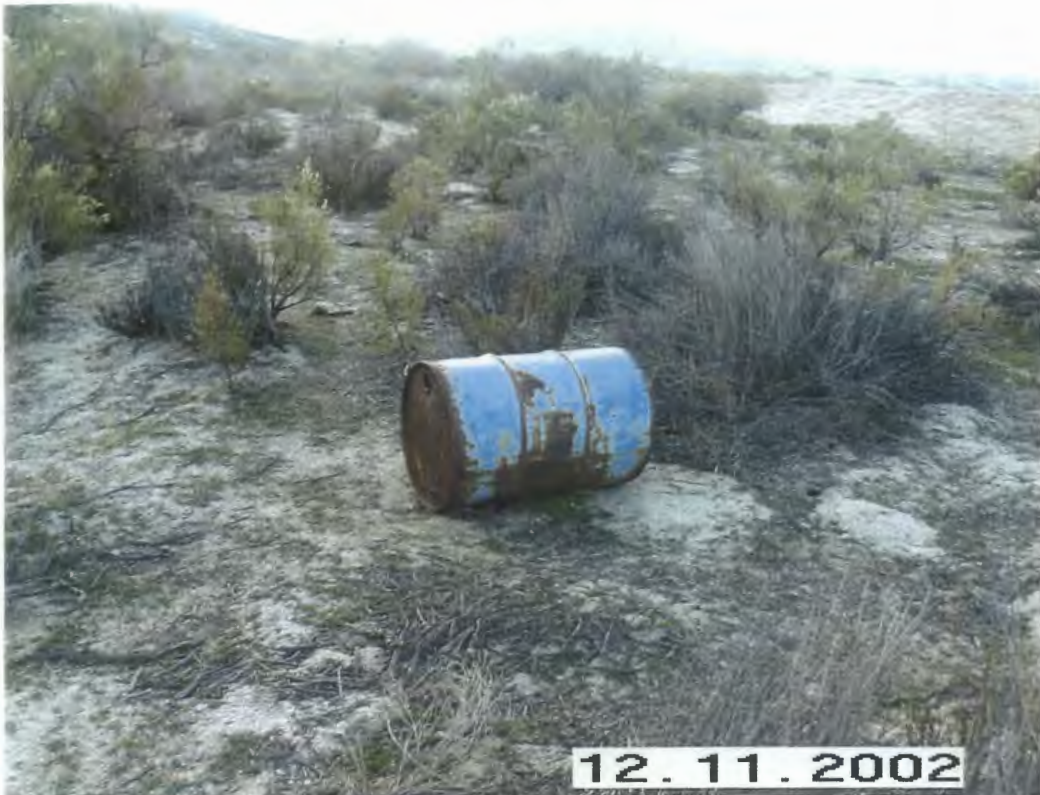
Photograph 17. Typical Drum (Debris)

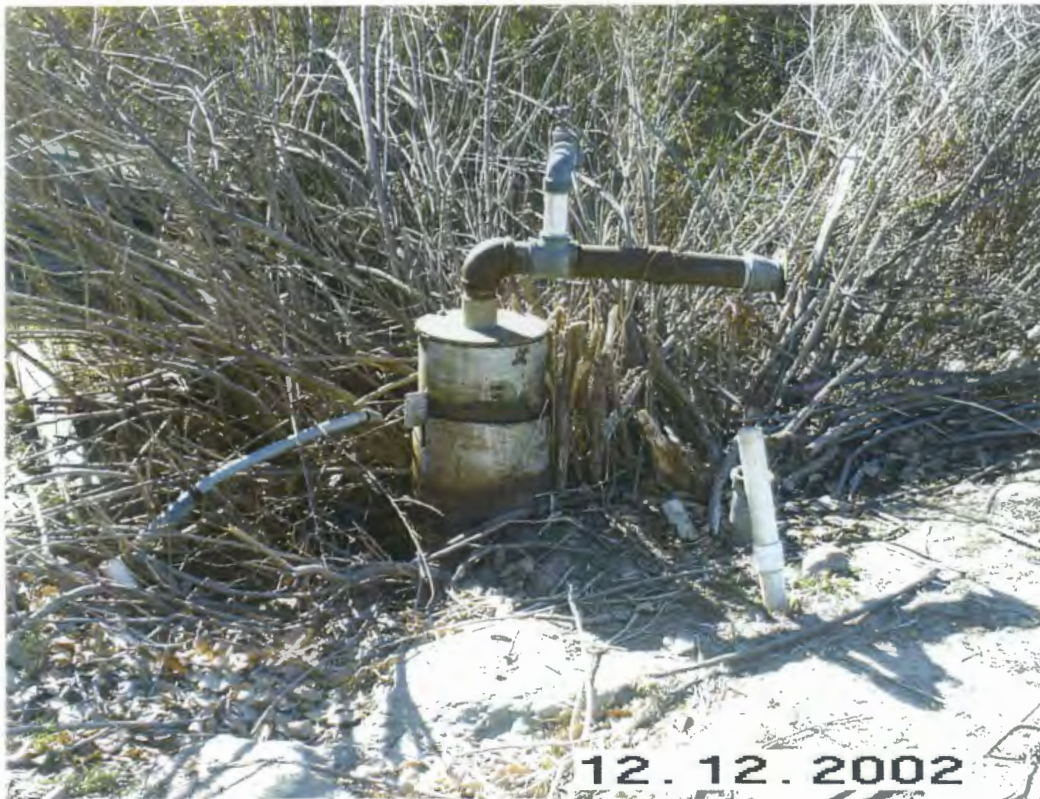
Photograph 18. Well (Old Structure)

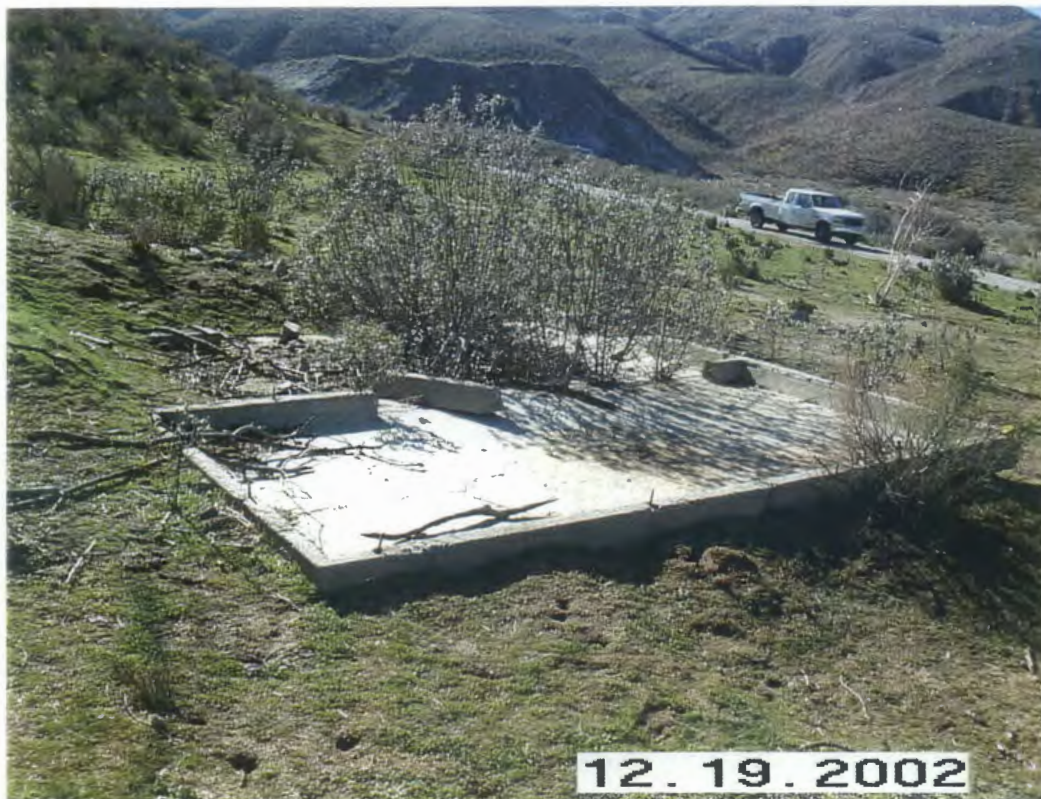
Photograph 19. Typical Pad with Protruding Bolts (Old Structure)

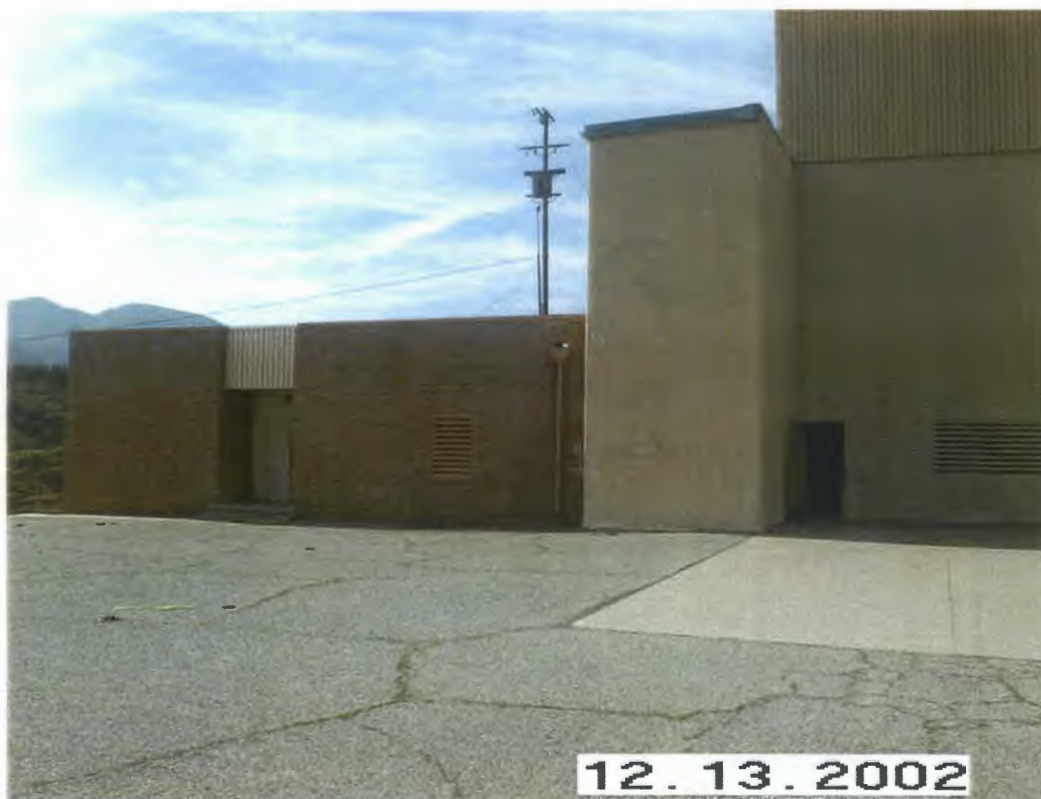
Photograph 20. Betatron Building 303 (Old Structure)

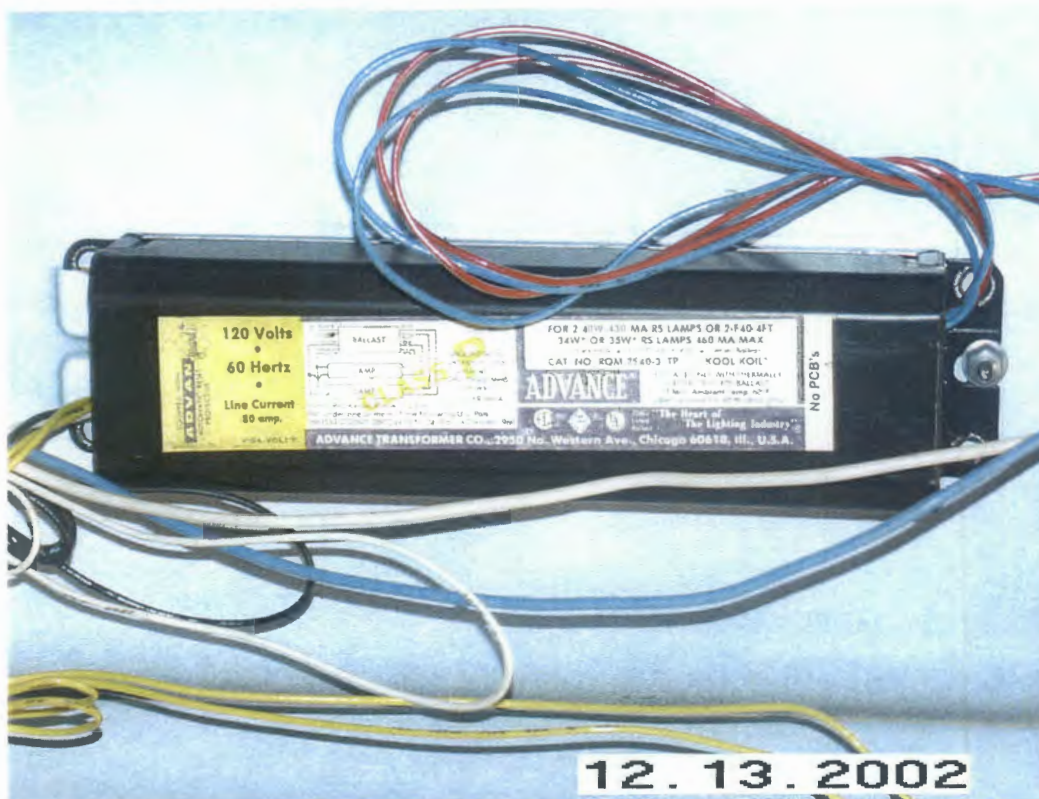
Photograph 21. Fluorescent Light Ballast (Toxic)

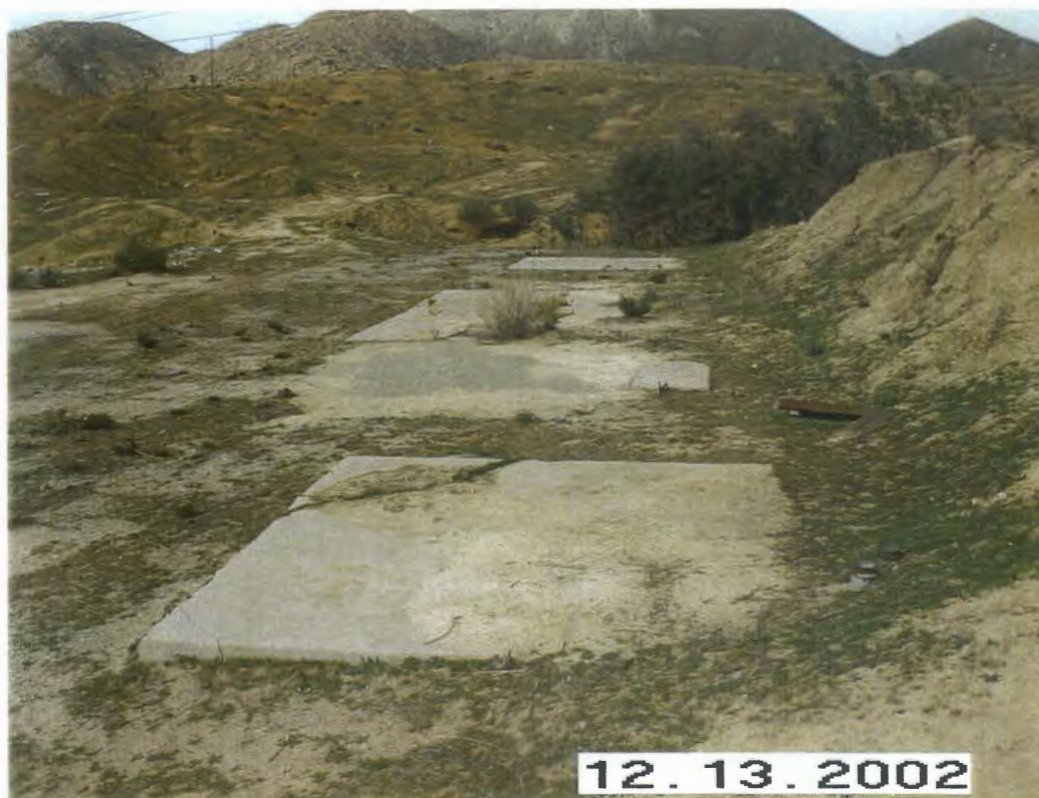
Photograph 22. Concrete Pads (Old Structure)

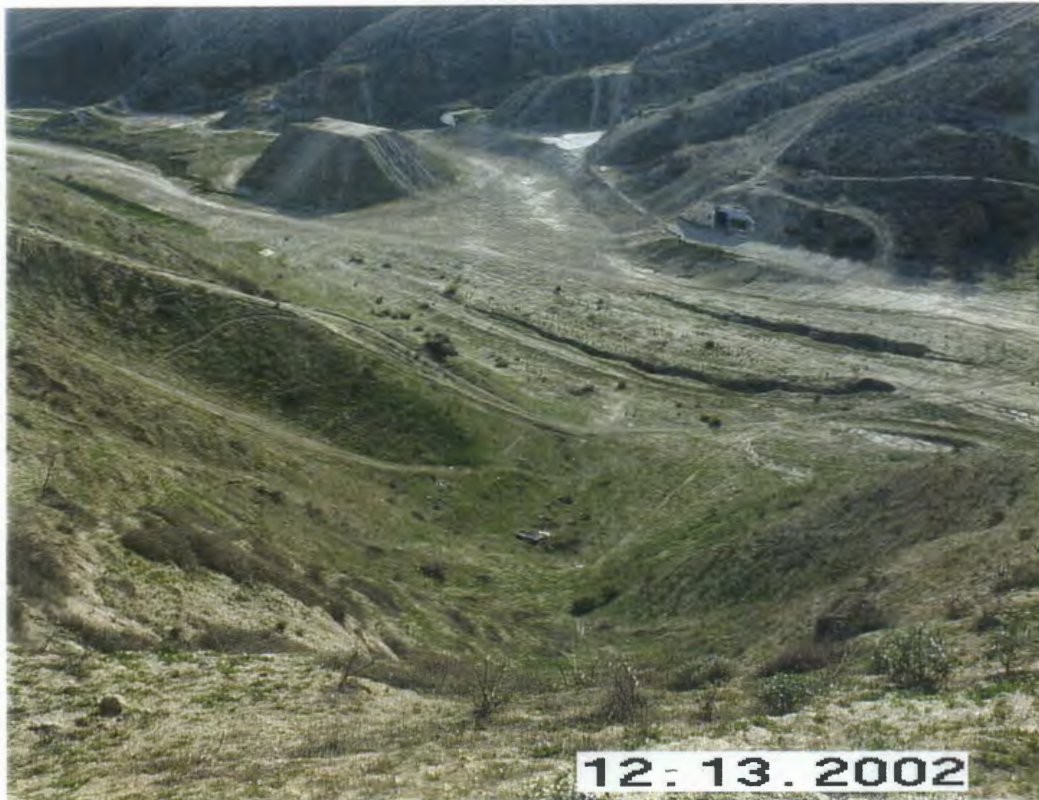
Photograph 3. View of a Bunker, Two Test Bays, and Pyramid located in the Western Canyon

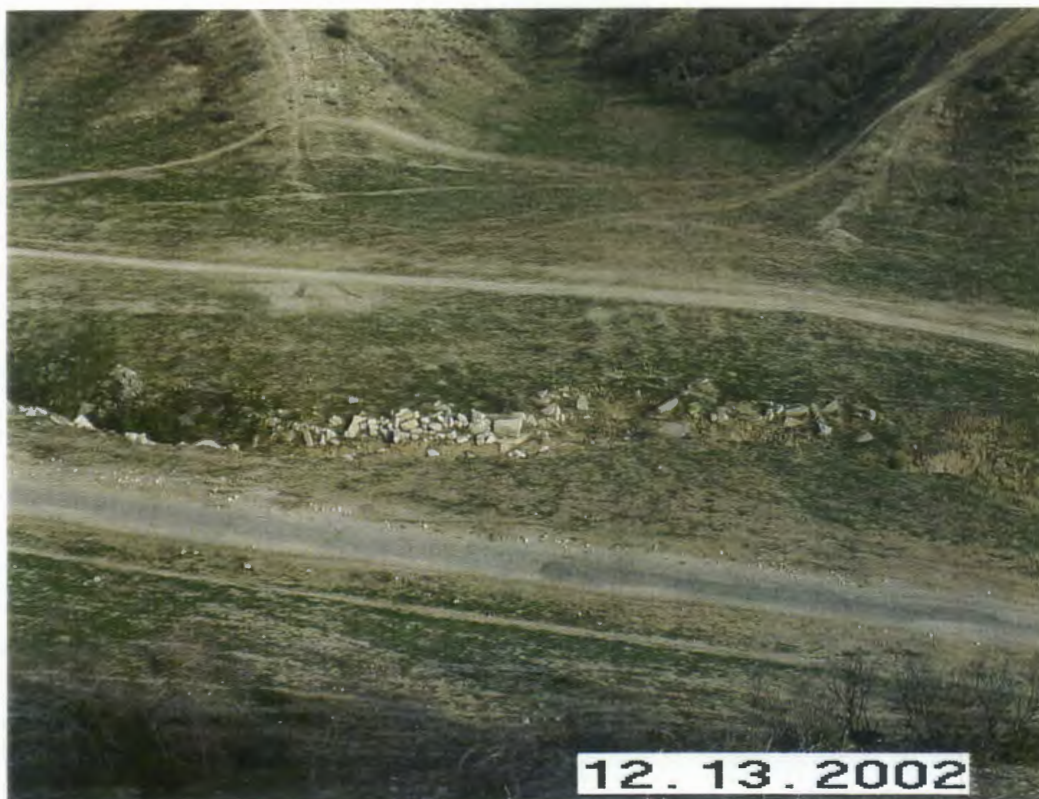
Photograph 4. Typical Concrete Debris Located in the Wash (Debris)

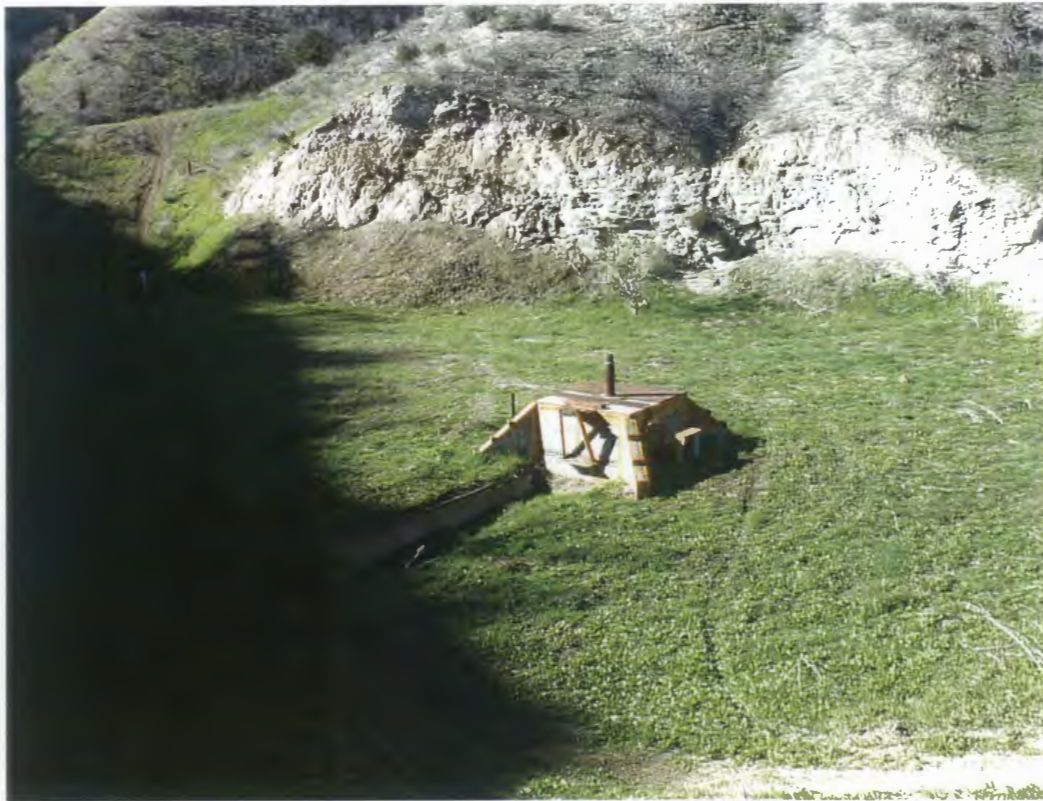
Photograph 7. Centrifuge GPS pt. 9 (Old Structure)

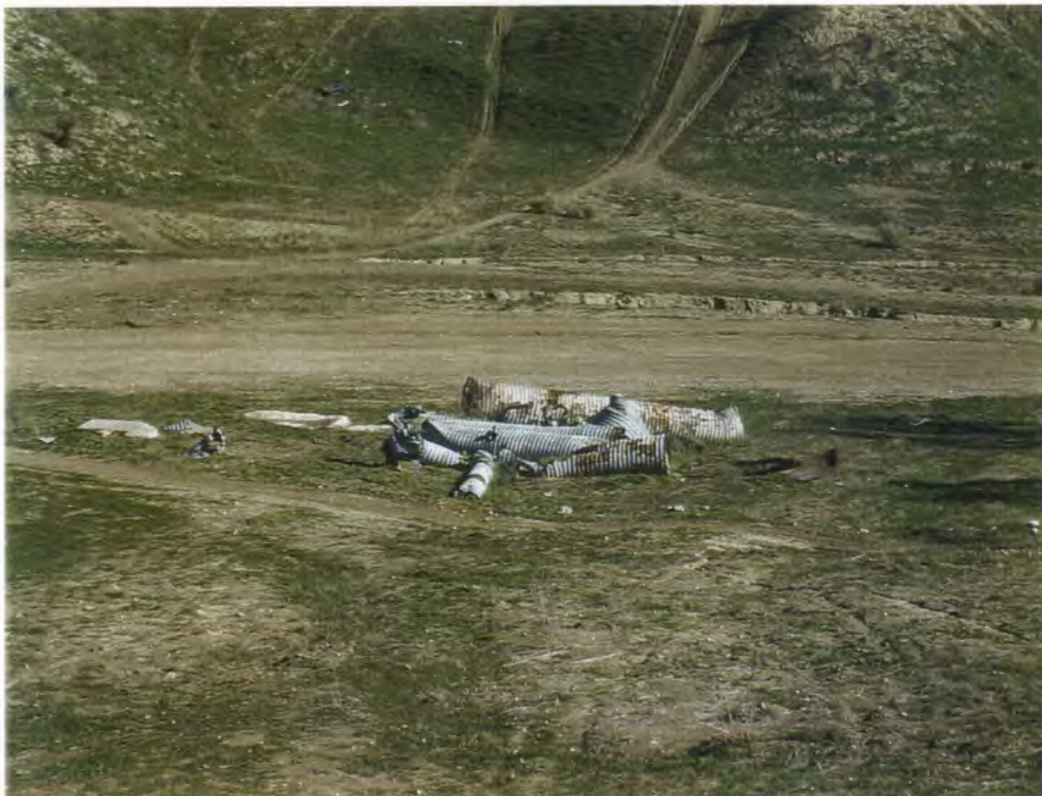
Photograph 8. Typical Debris, GPS pt. 15 (Debris)

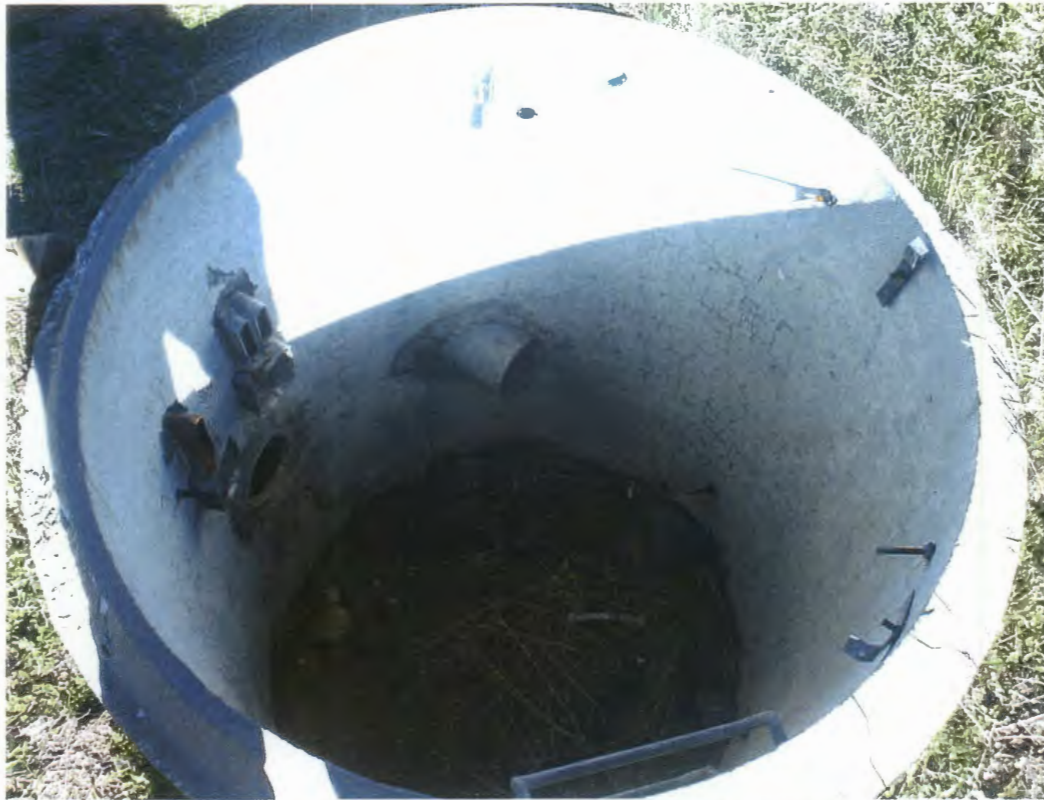
Photograph 11. Concrete Vault for Instrumentation at Test Bay (Old Structure)

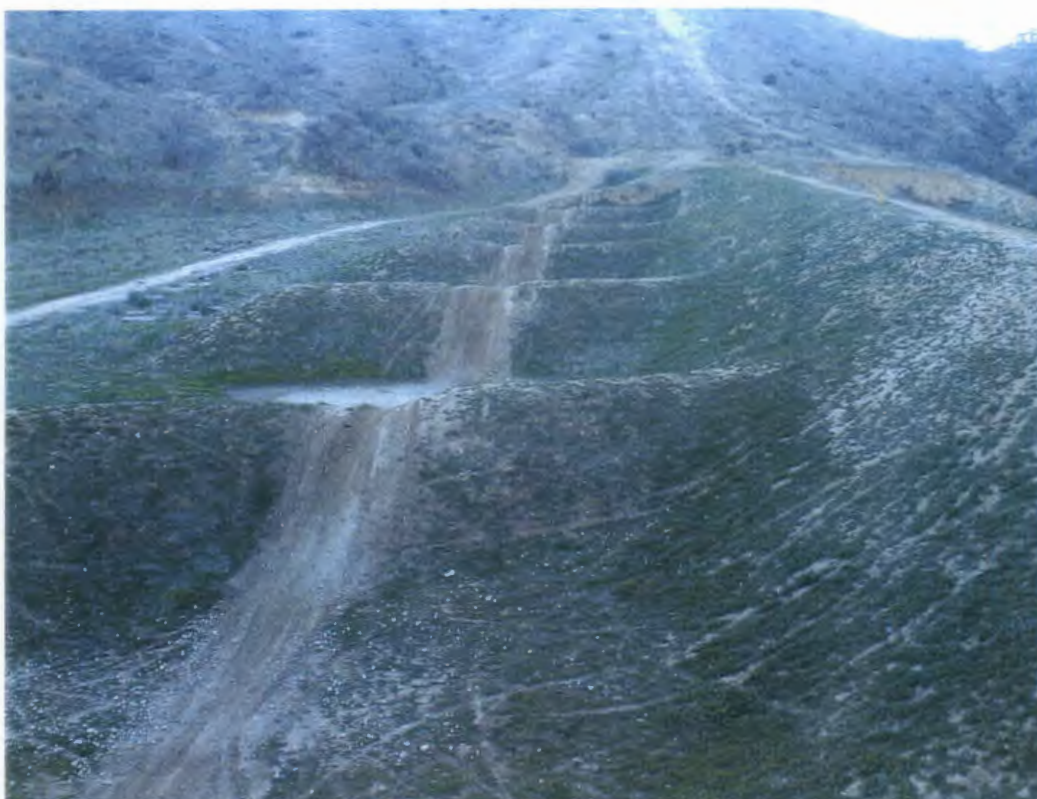
Photograph 13. Revetments at Conditioning Chambers

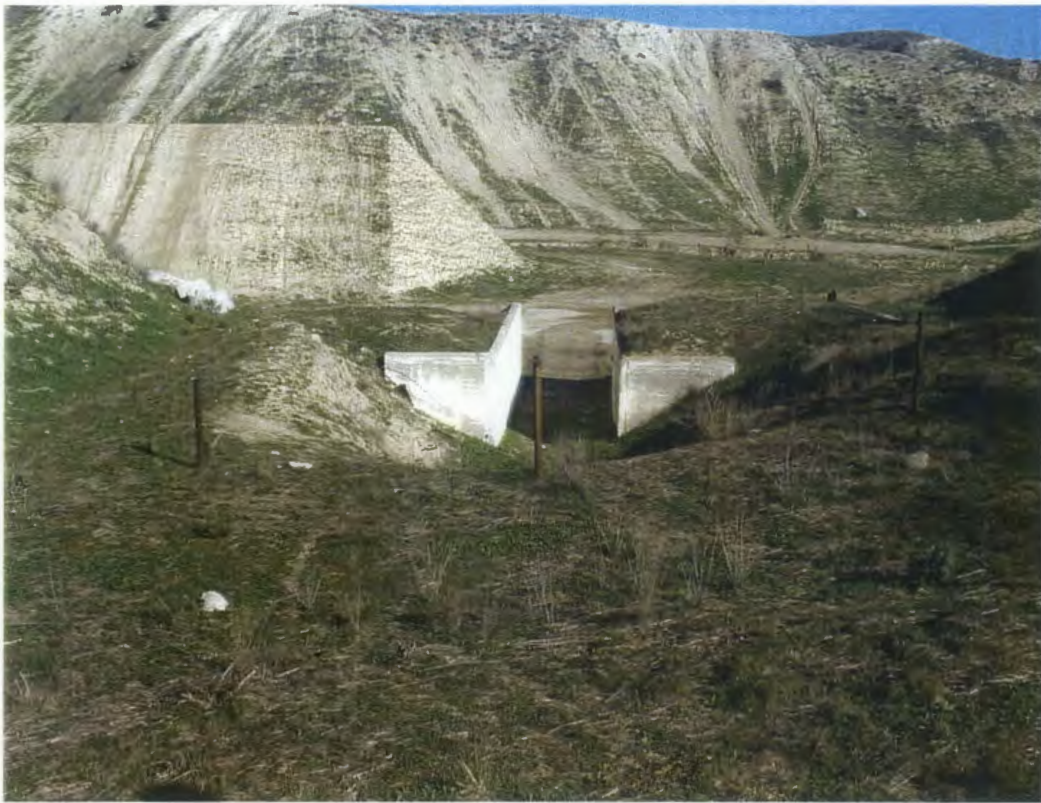
Photograph 15. Test Bay (Old Structure)

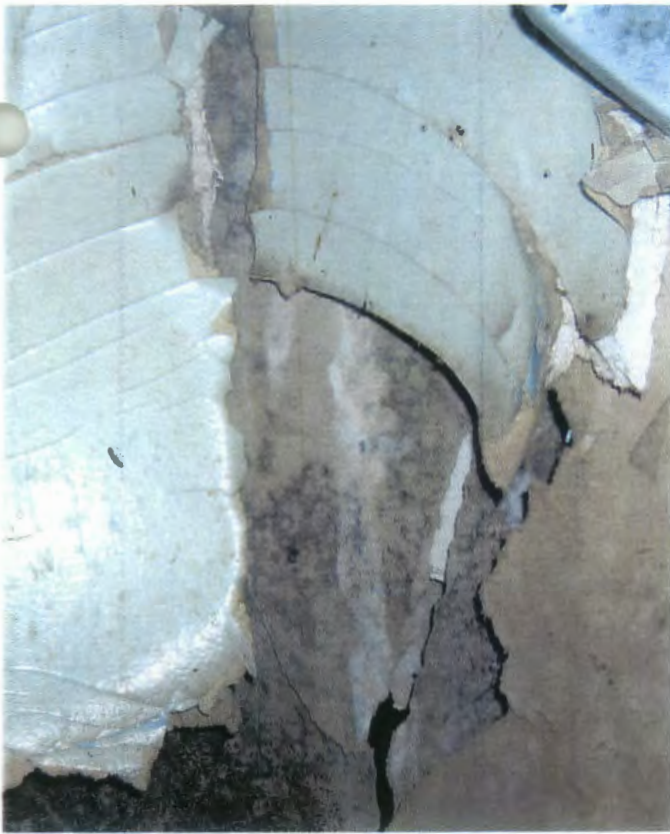
Site 1, Bldg 305, Asbestos Containing Drywall Joint Compound & Mold Growth

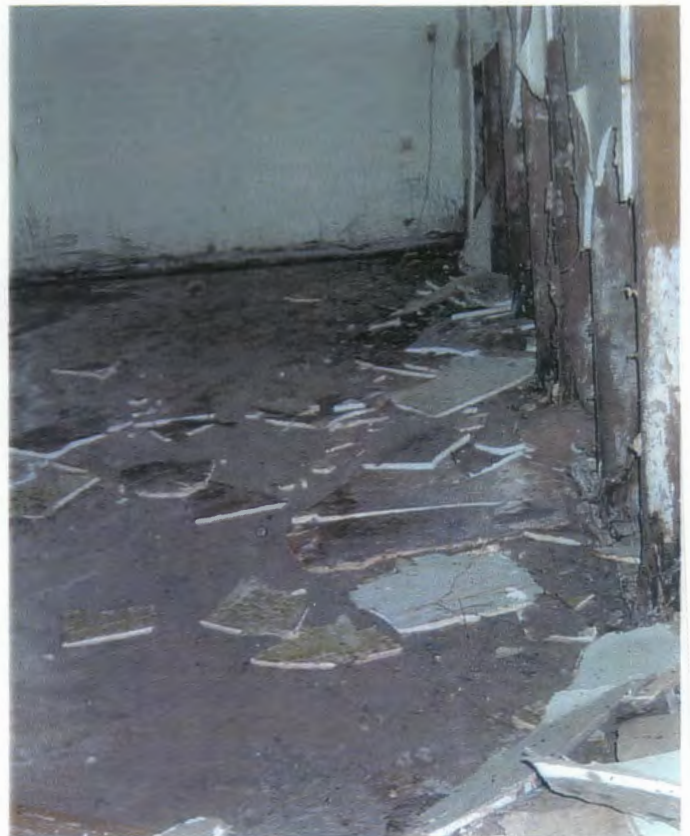
Site 1, Bldg 305, Asbestos Containing Drywall Joint Compound & Mold Growth

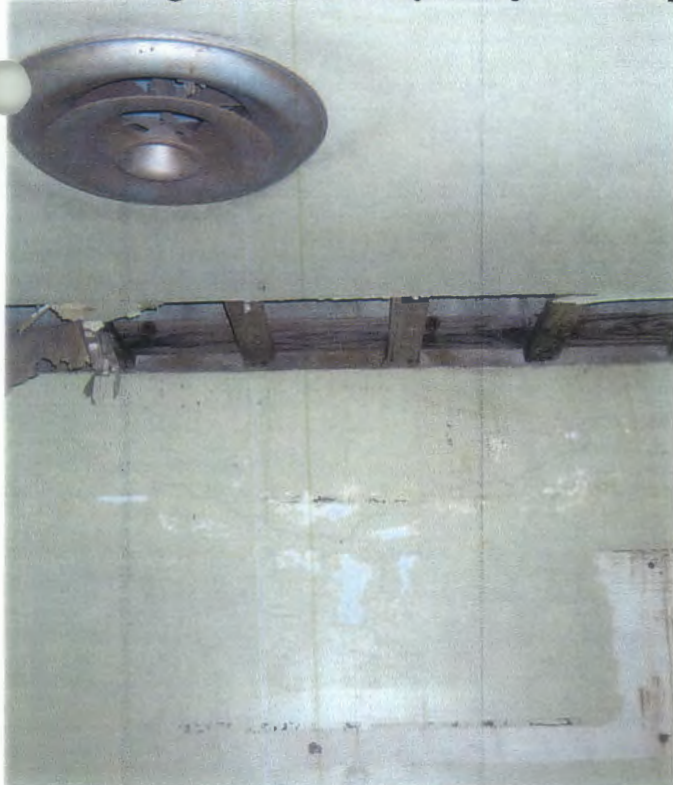
303 Damaged asbestos drywall joint comp

Site 1, Bldg. 303, damaged asbestos containing drywall joint compound

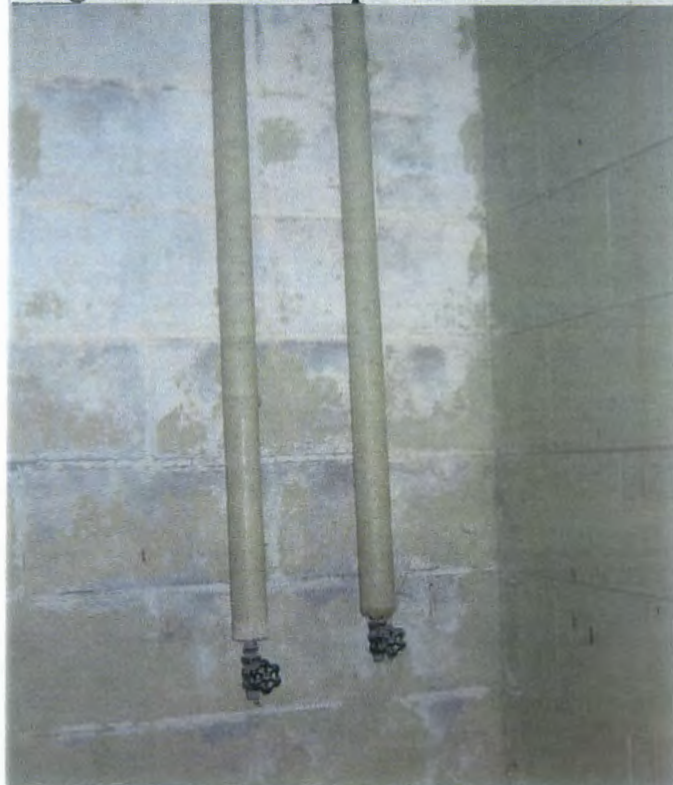
Bldg 303 Asbestos Pipe Elbow Insulation

Site 1, Bldg. 303, Asbestos Containing Pipe Elbow Insulation
