Lockheed Martin Corporation Beaumont Site 1 & 2 Safety & Toxics Assessment Beaumont, California

March 19, 2003

TC 12866-03

Tetra Tech, Inc.
San Bernardino, California

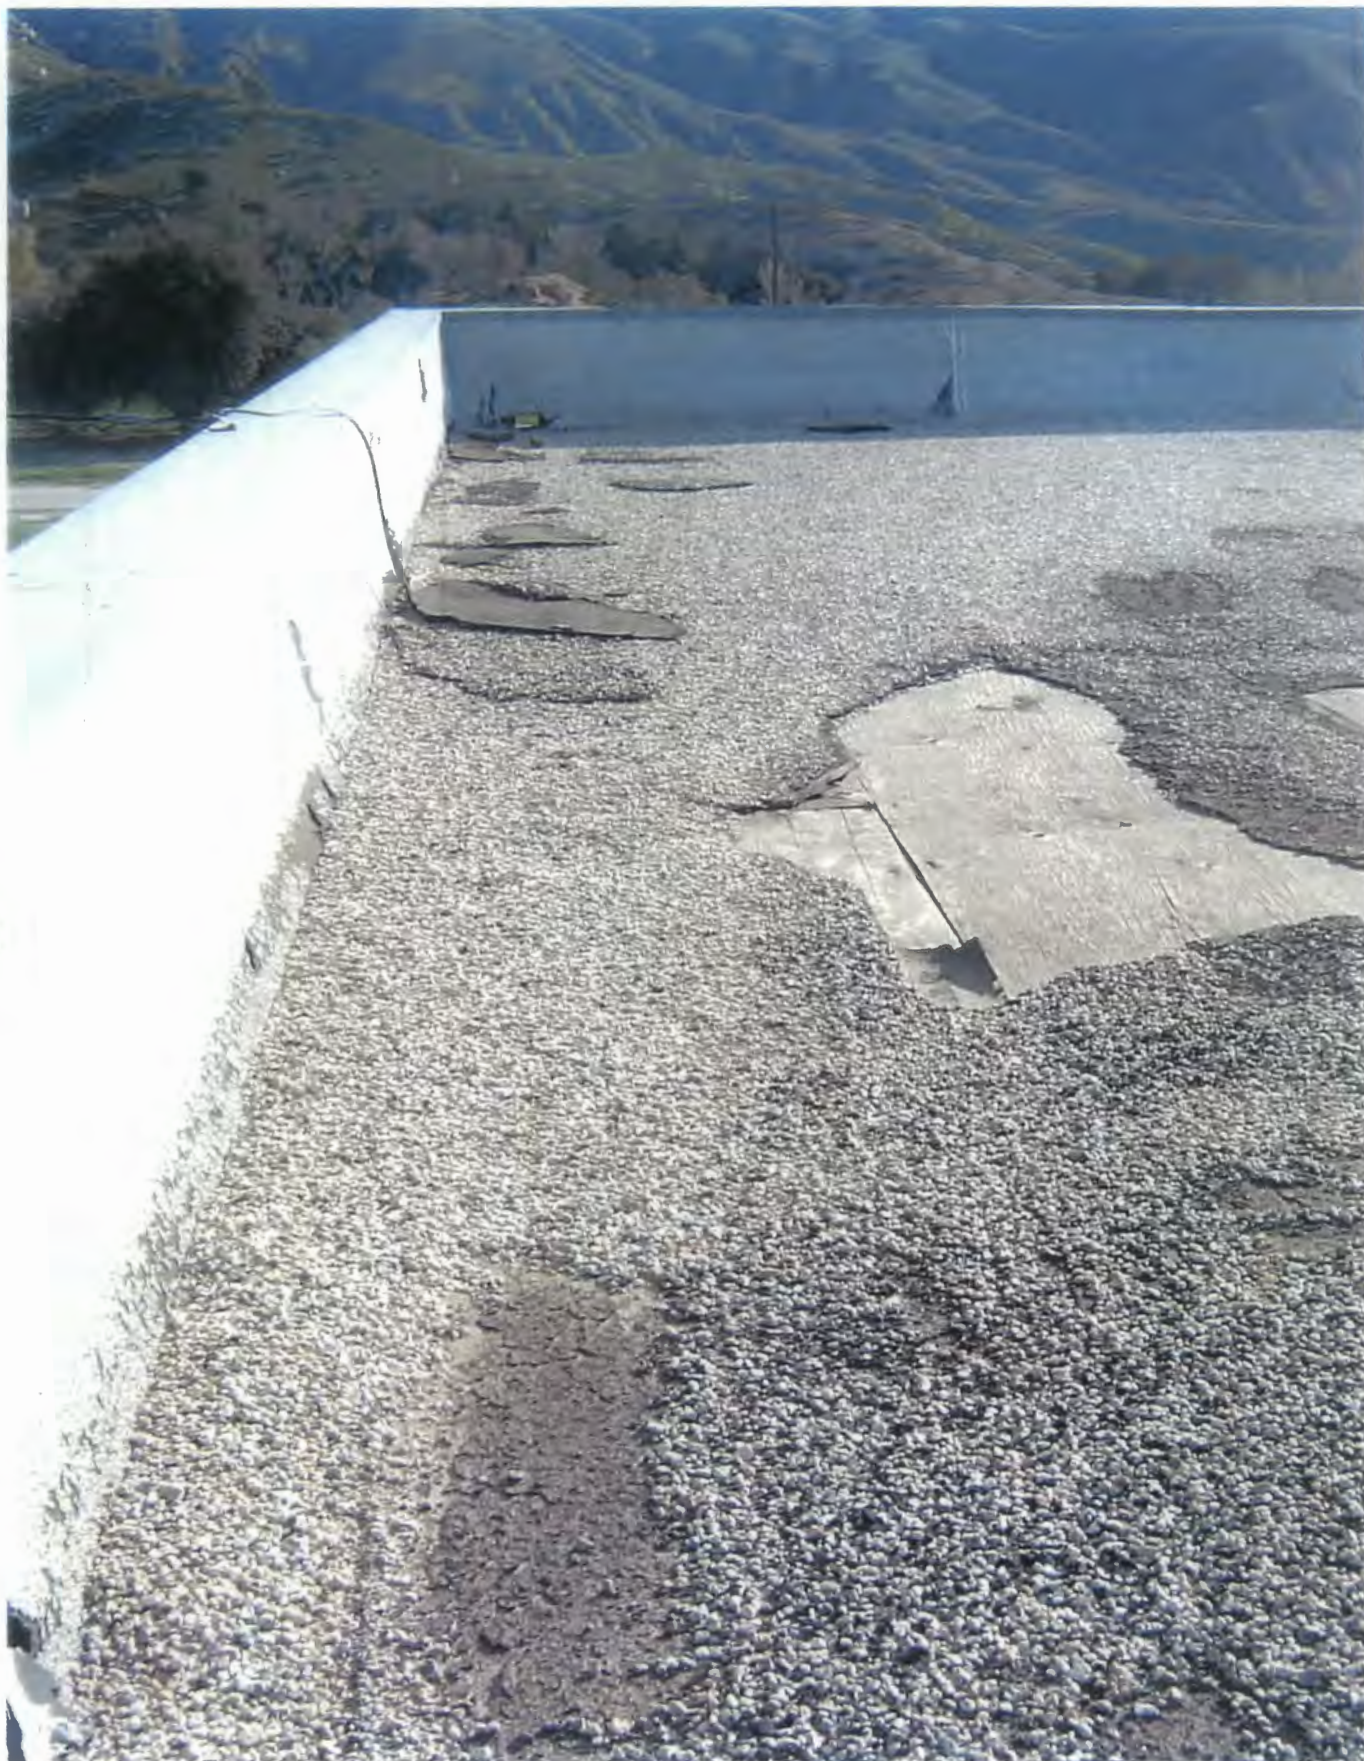
Site 1, Bldg. 312, Asbestos Containing Gray Roof Patch/Penetration Mastics

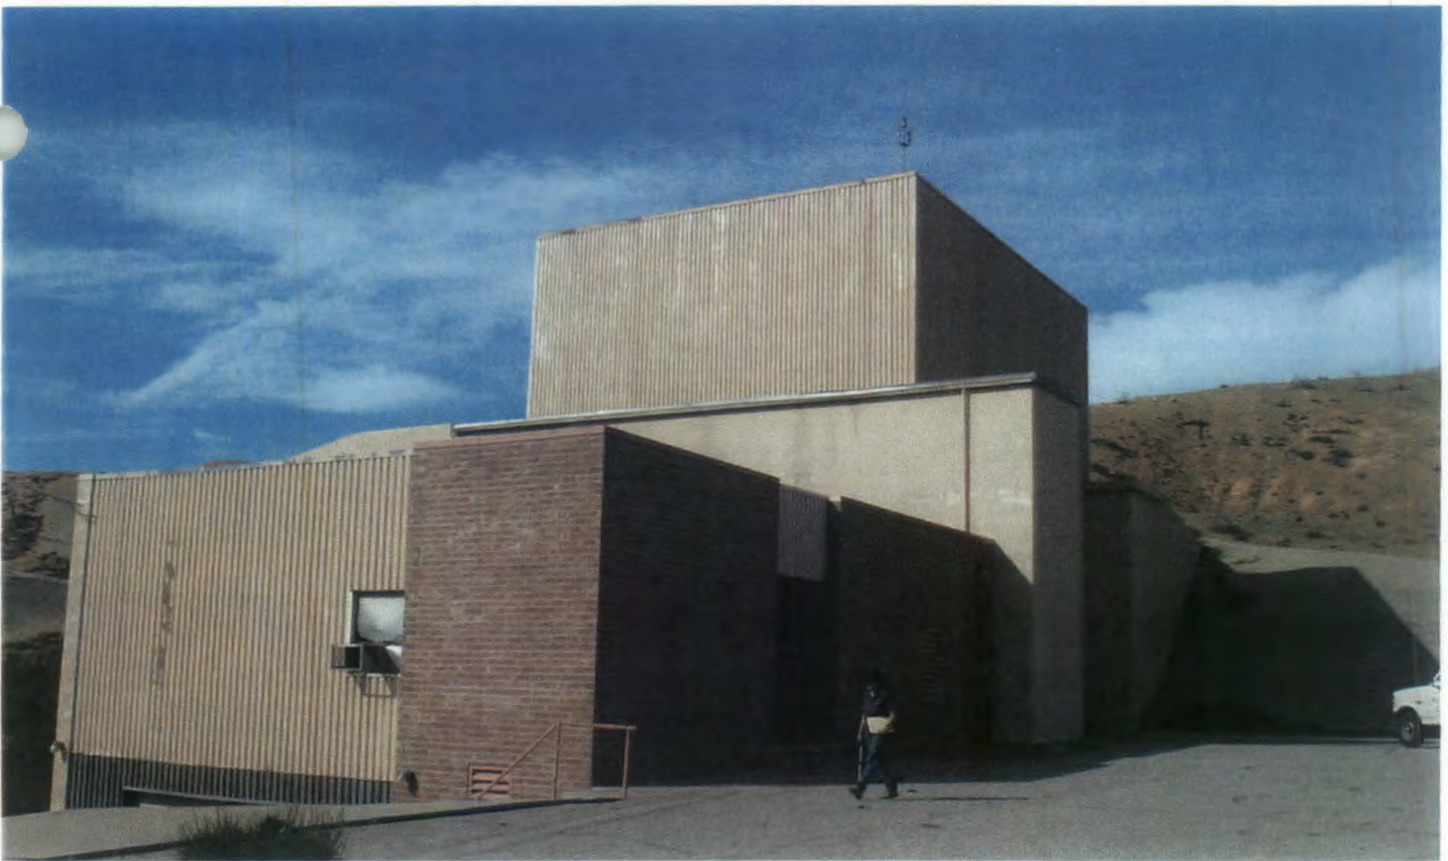
Site 1, Bldg. 303, Exterior Lead Paint on Steel/Concrete Walls; Asbestos Containing Red Brick Grout/Mortar & Asbestos Containing Wall Putty/Caulking

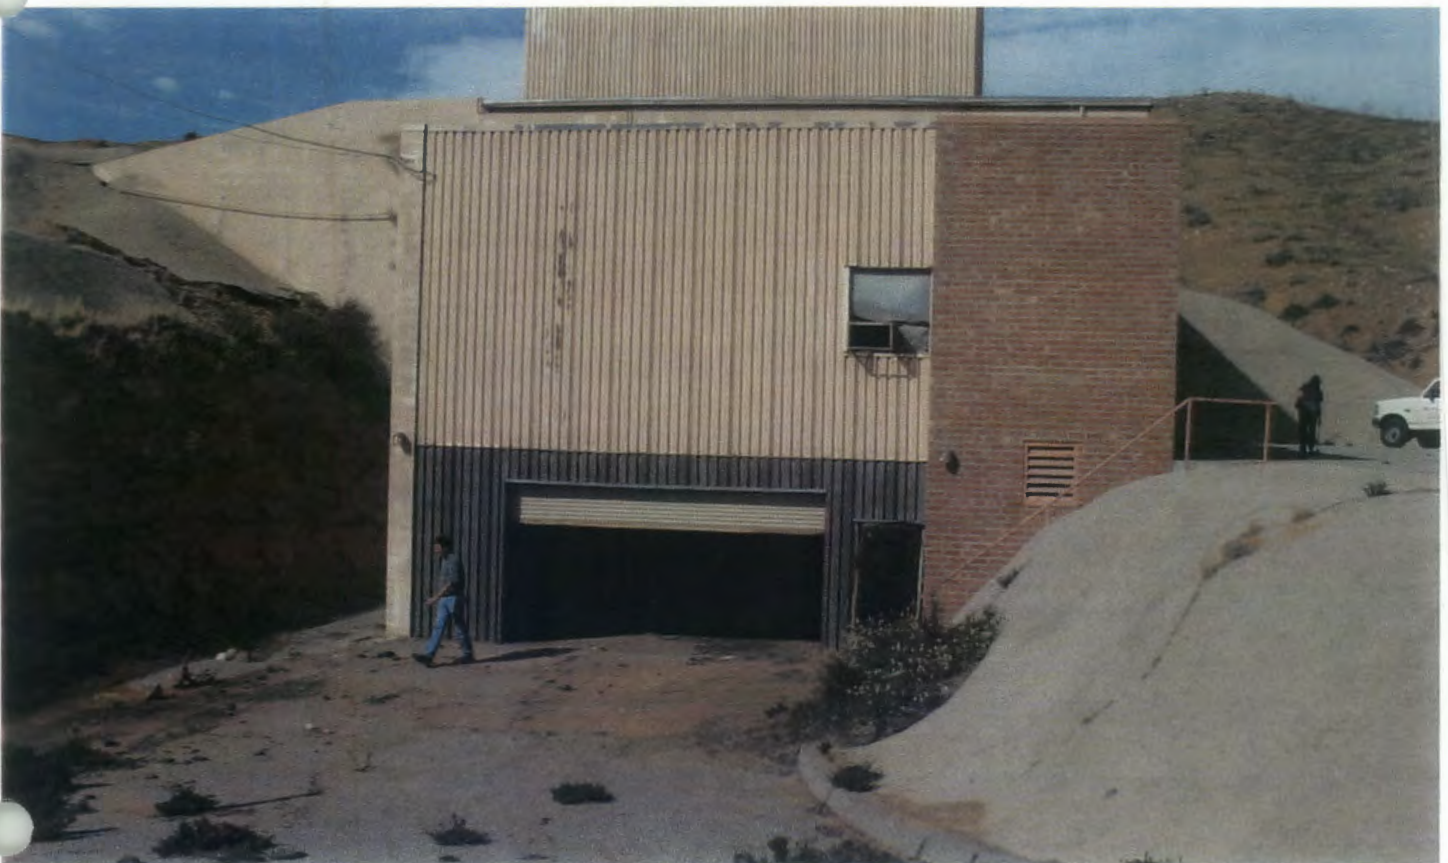
Site 1, Bldg. 303, Exterior Lead Paint on Steel/Concrete Walls; Asbestos Containing Red Brick Grout/Mortar & Asbestos Containing Wall Putty/Caulking

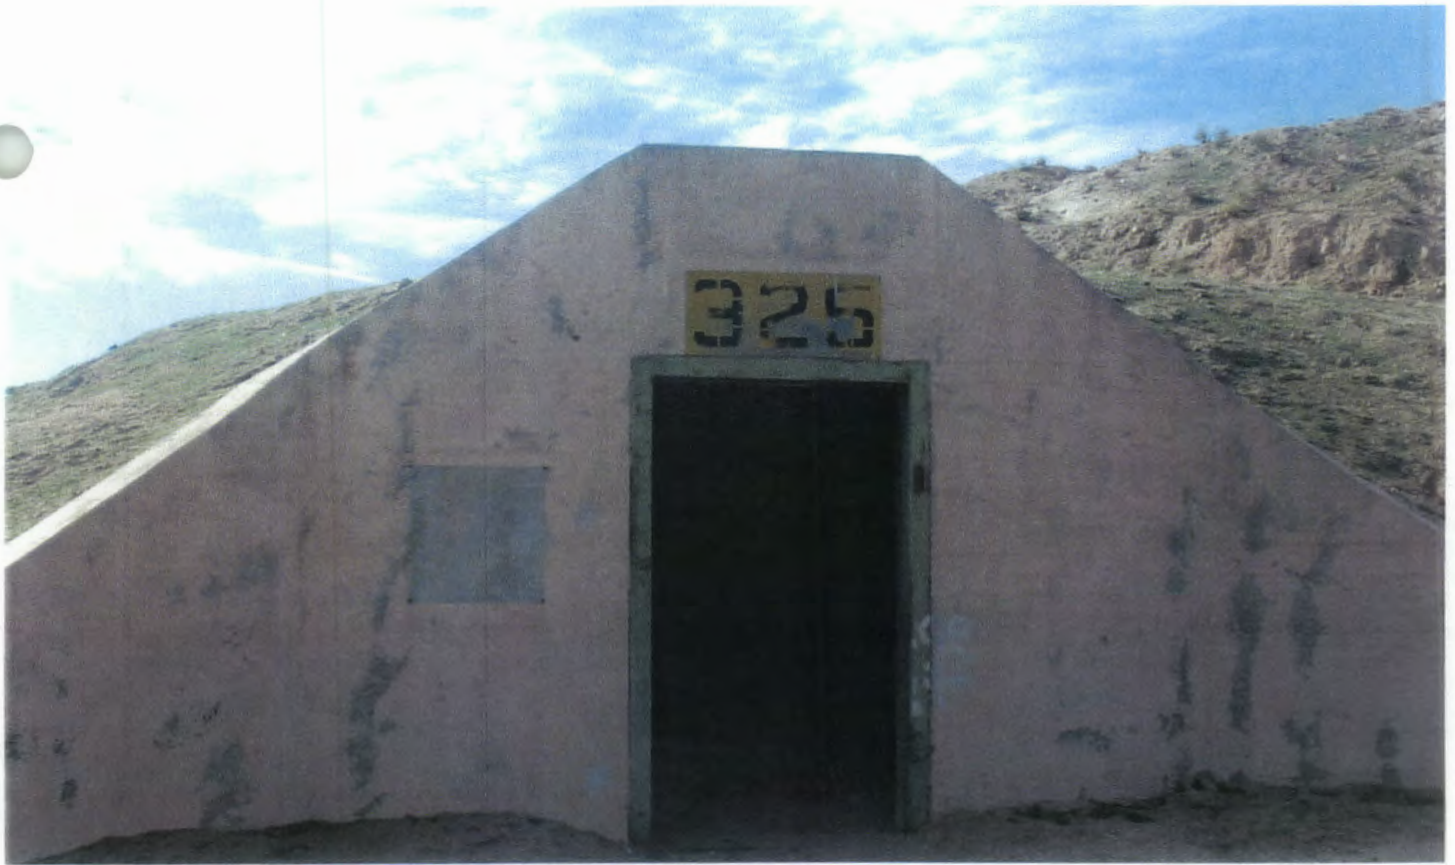
Site 1, Bldg. 325, Lead Paint on Walls & Components

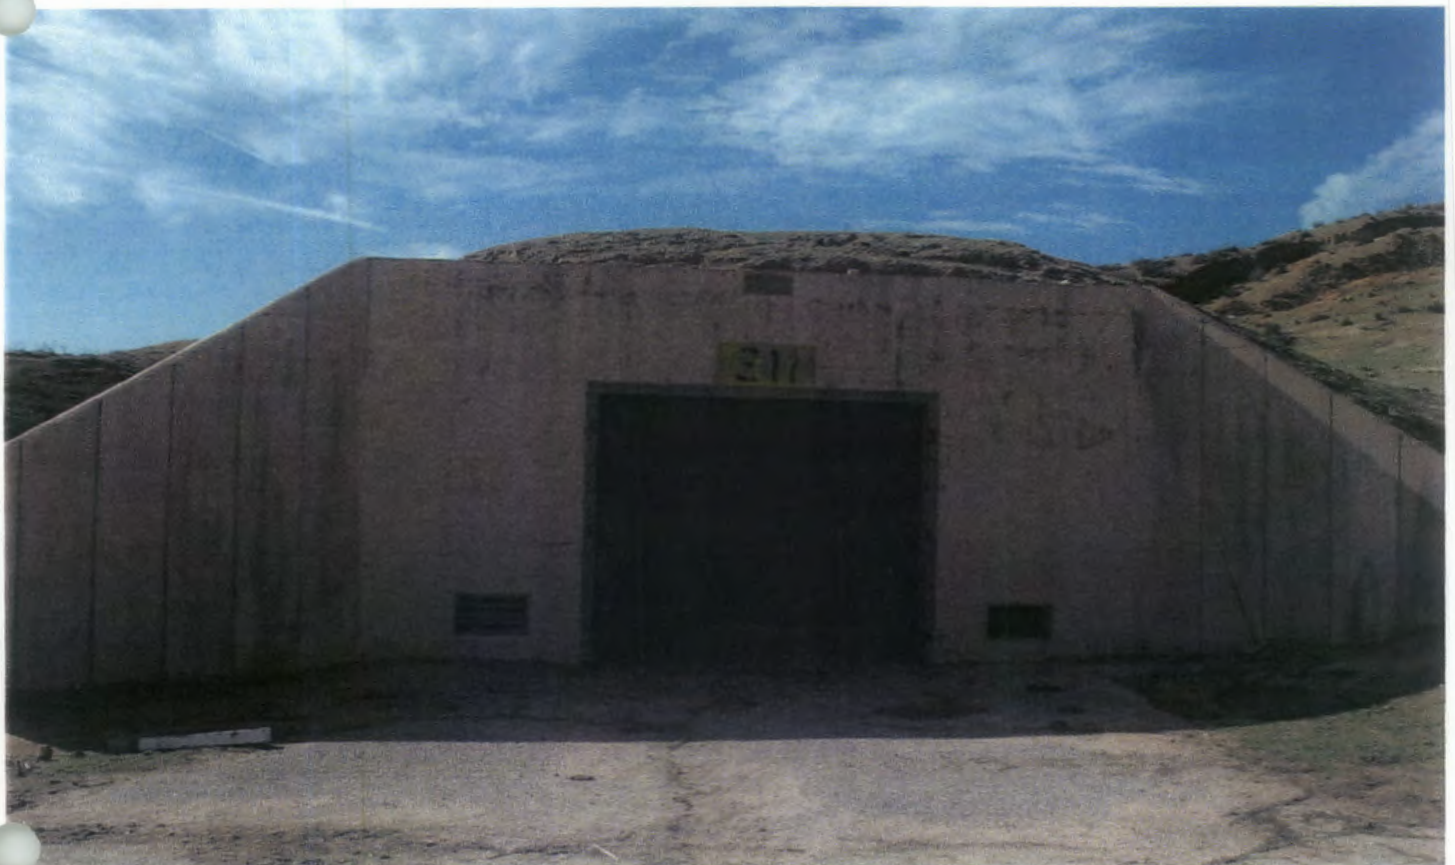
Site 1, Bldg. 311, Lead Paint on Walls & Components; Asbestos Containing Exterior Textured Paint

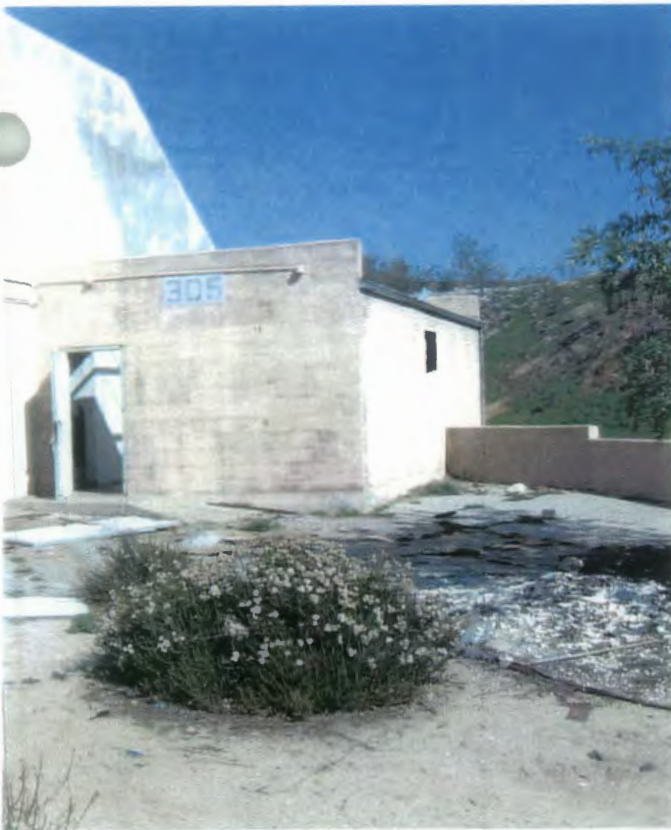
Site 1, Bldg. 305, Lead Paint on Exterior Walls

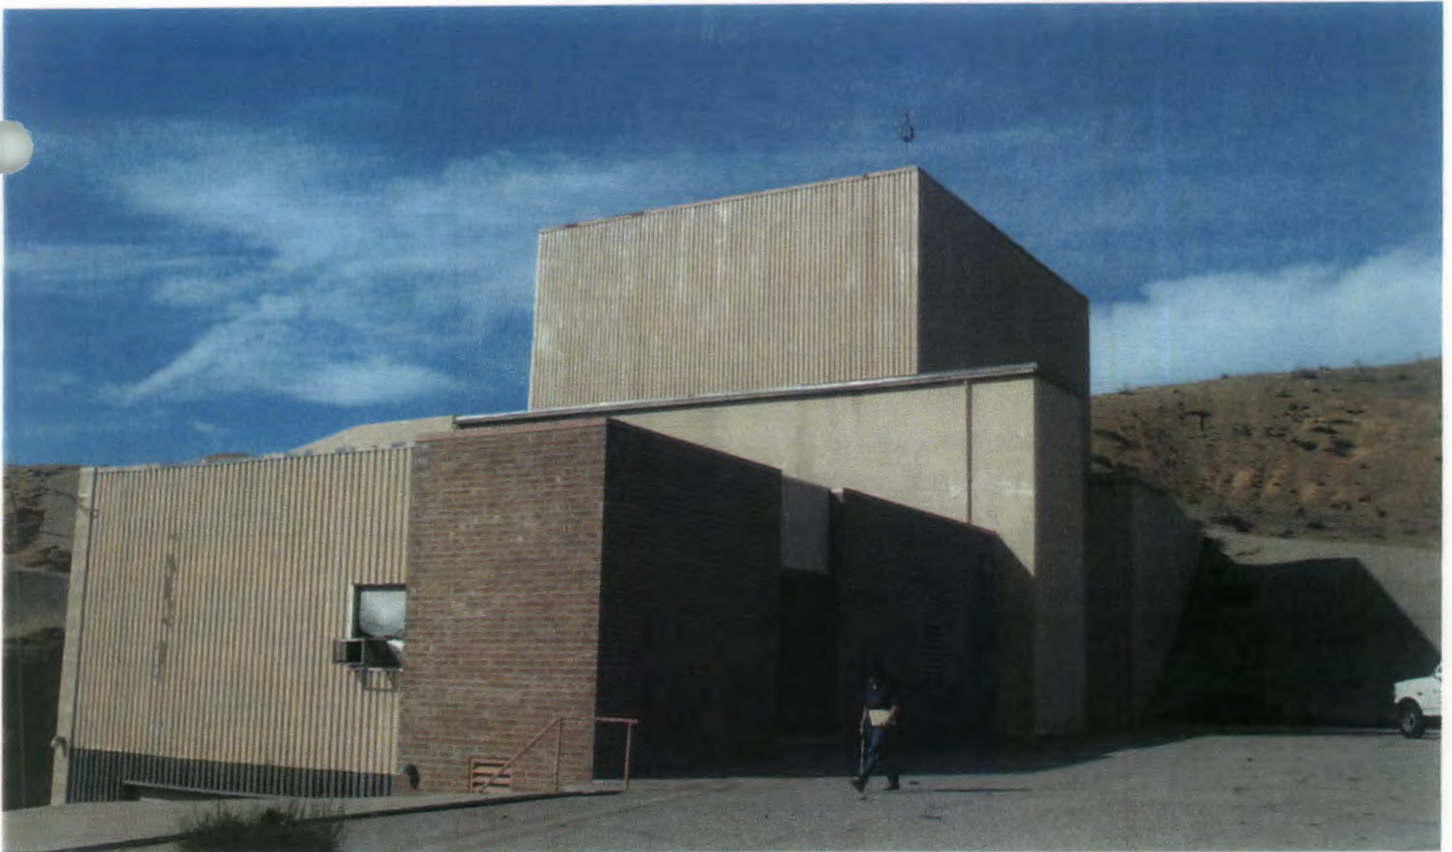
Site 1, Bldg. 303, Exterior Lead Paint on Steel/Concrete Walls; Asbestos Containing Red Brick Grout/Mortar & Asbestos Containing Wall Putty/Caulking

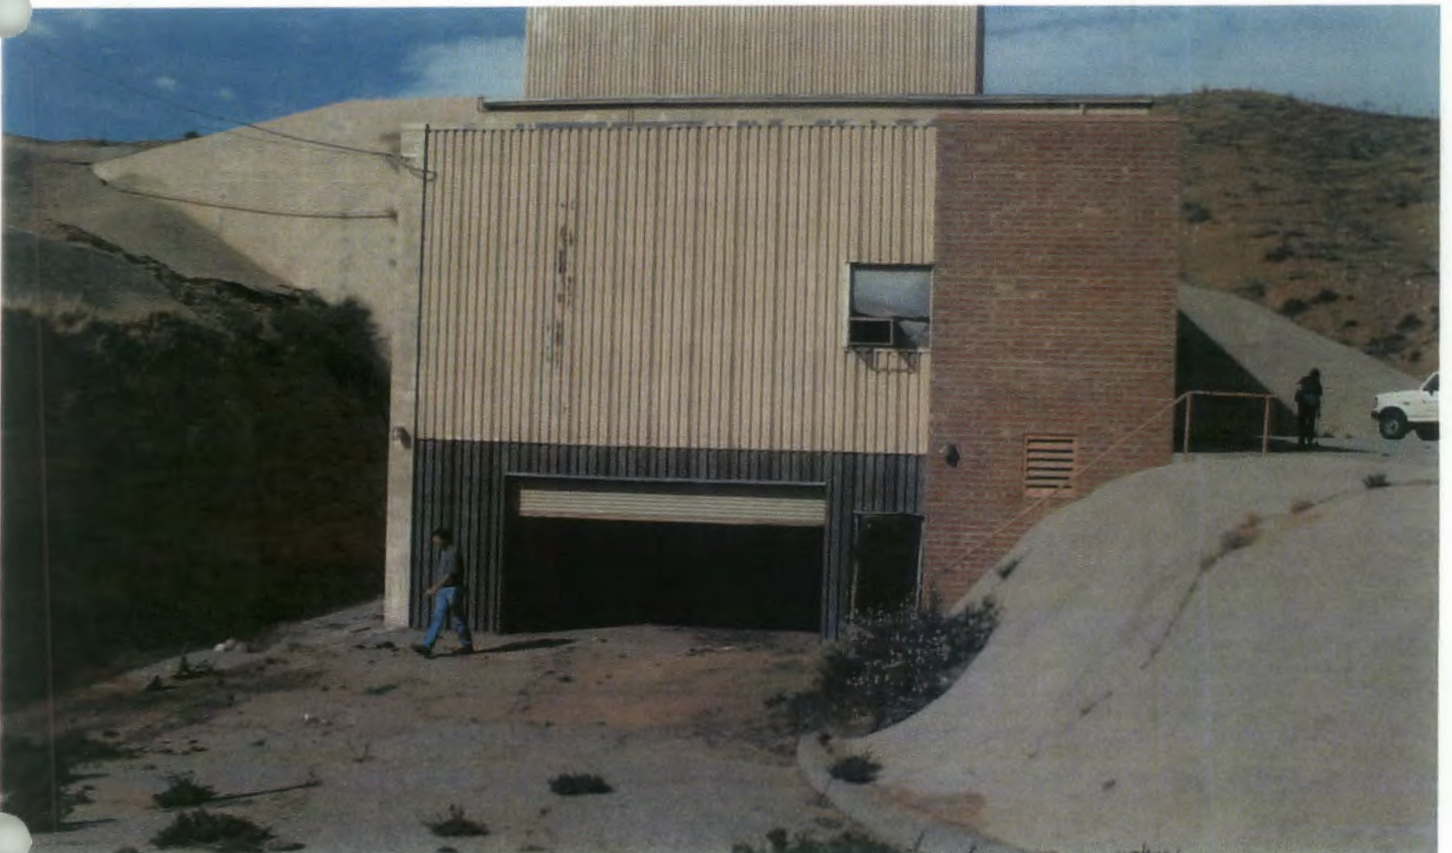
Site 1, Bldg. 303, Exterior Lead Paint on Steel/Concrete Walls; Asbestos Containing Red Brick Grout/Mortar & Asbestos Containing Wall Putty/Caulking

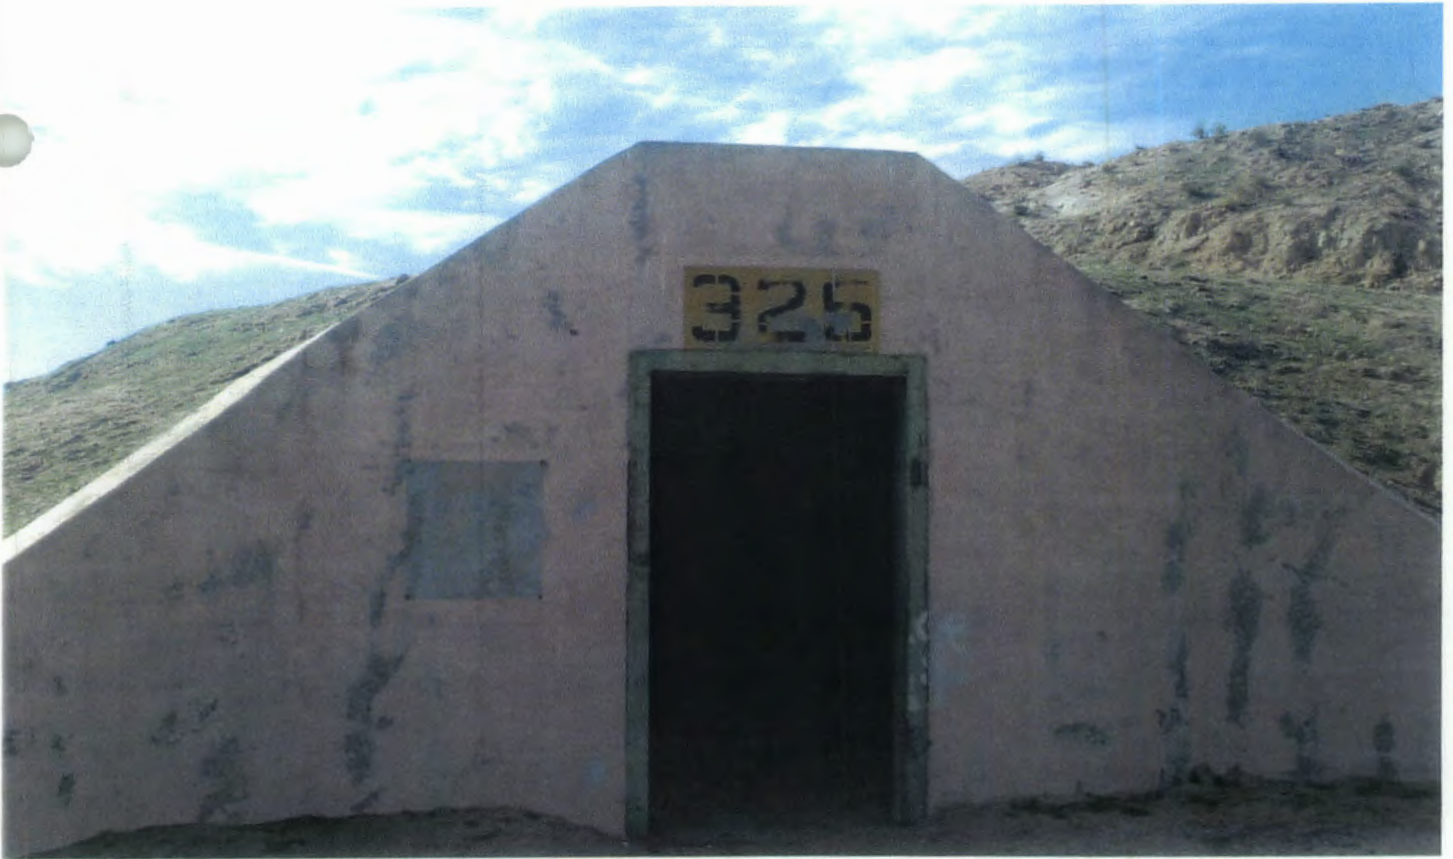
Site 1, Bldg. 325, Lead Paint on Walls & Components

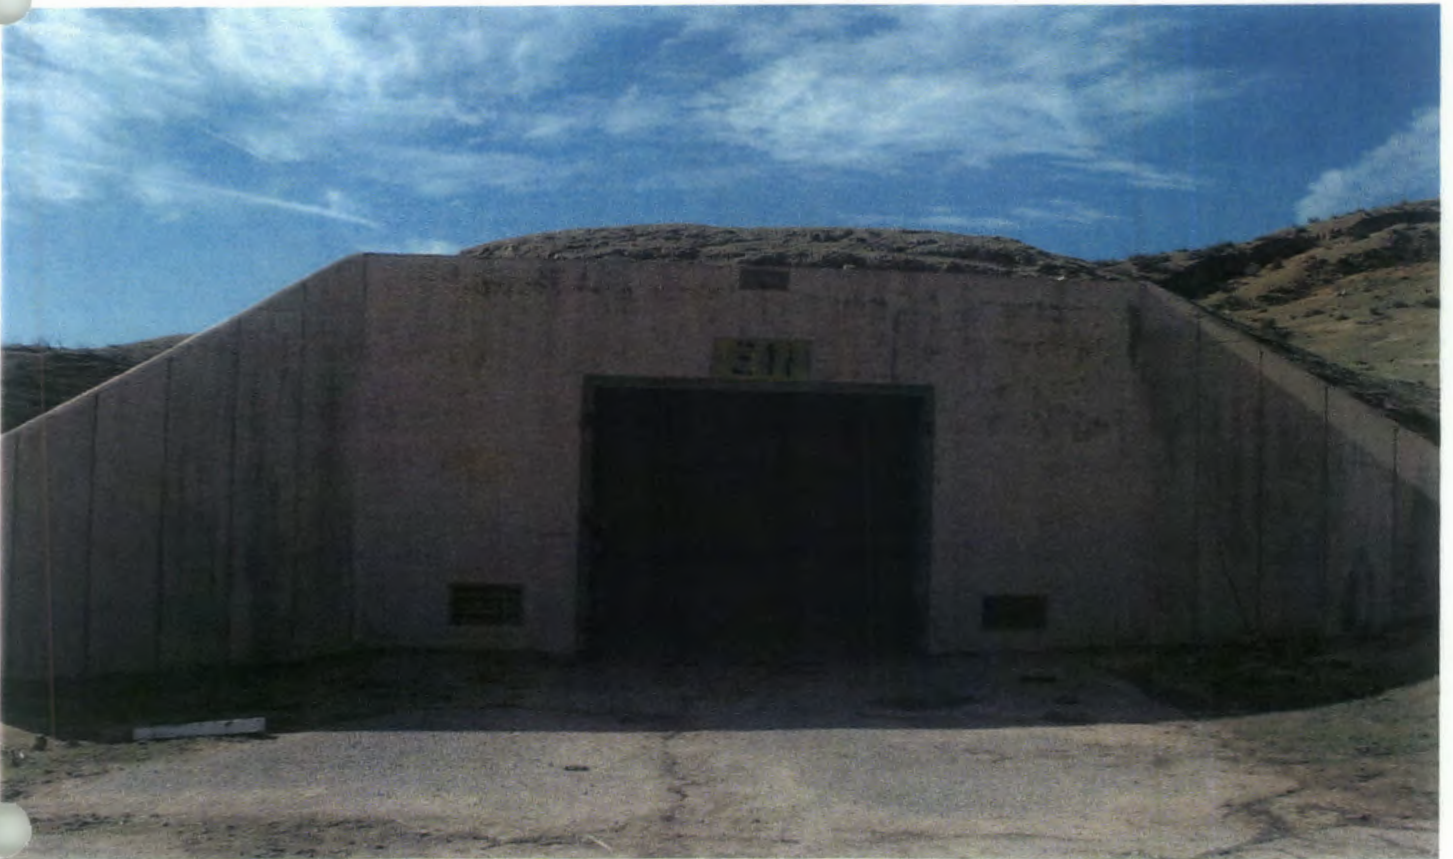
Site 1, Bldg. 311, Lead Paint on Walls & Components; Asbestos Containing Exterior Textured Paint

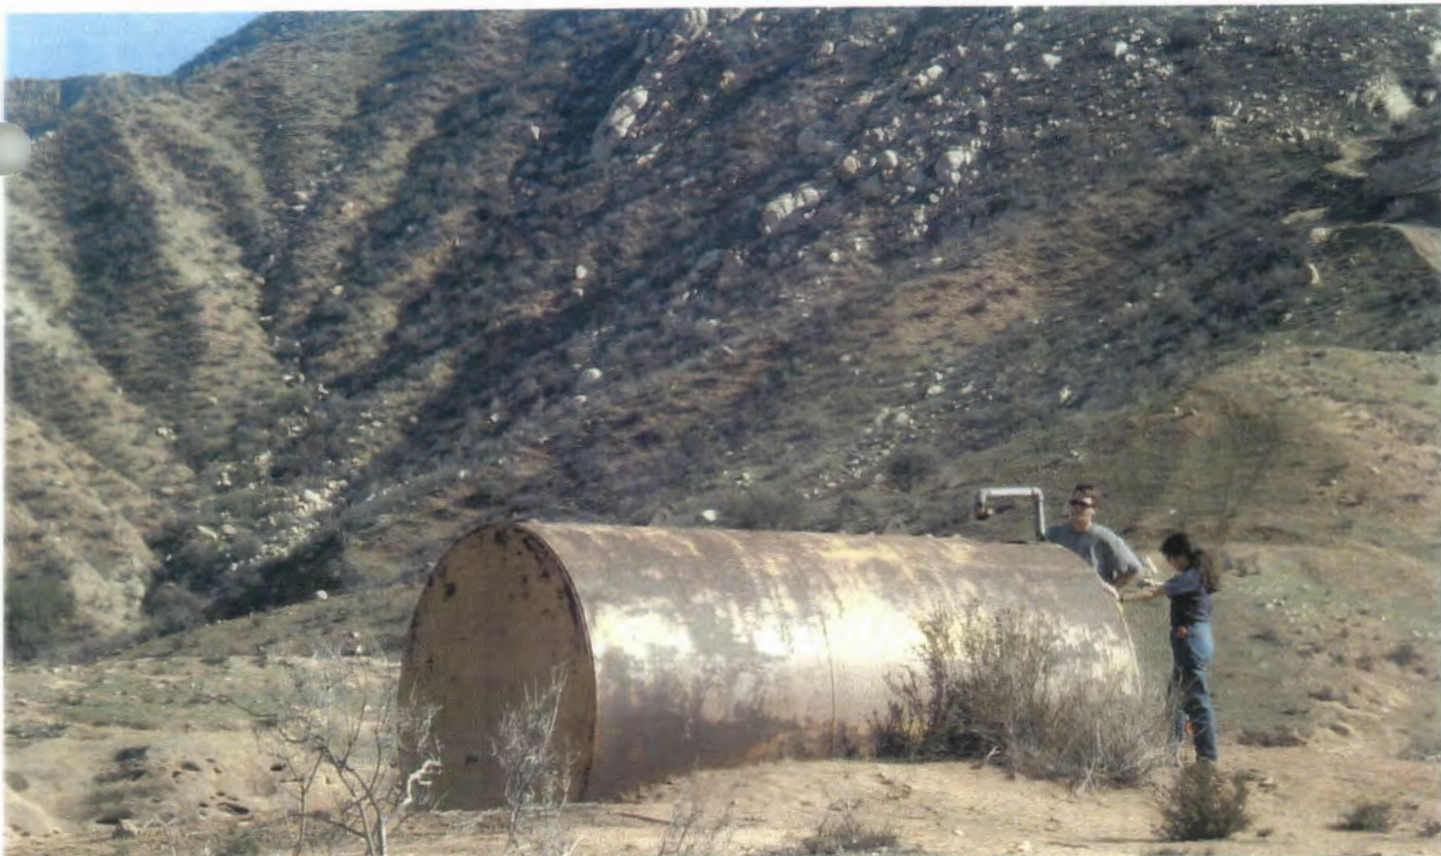
Site 1, Lead Paint on Steel/Metal Components

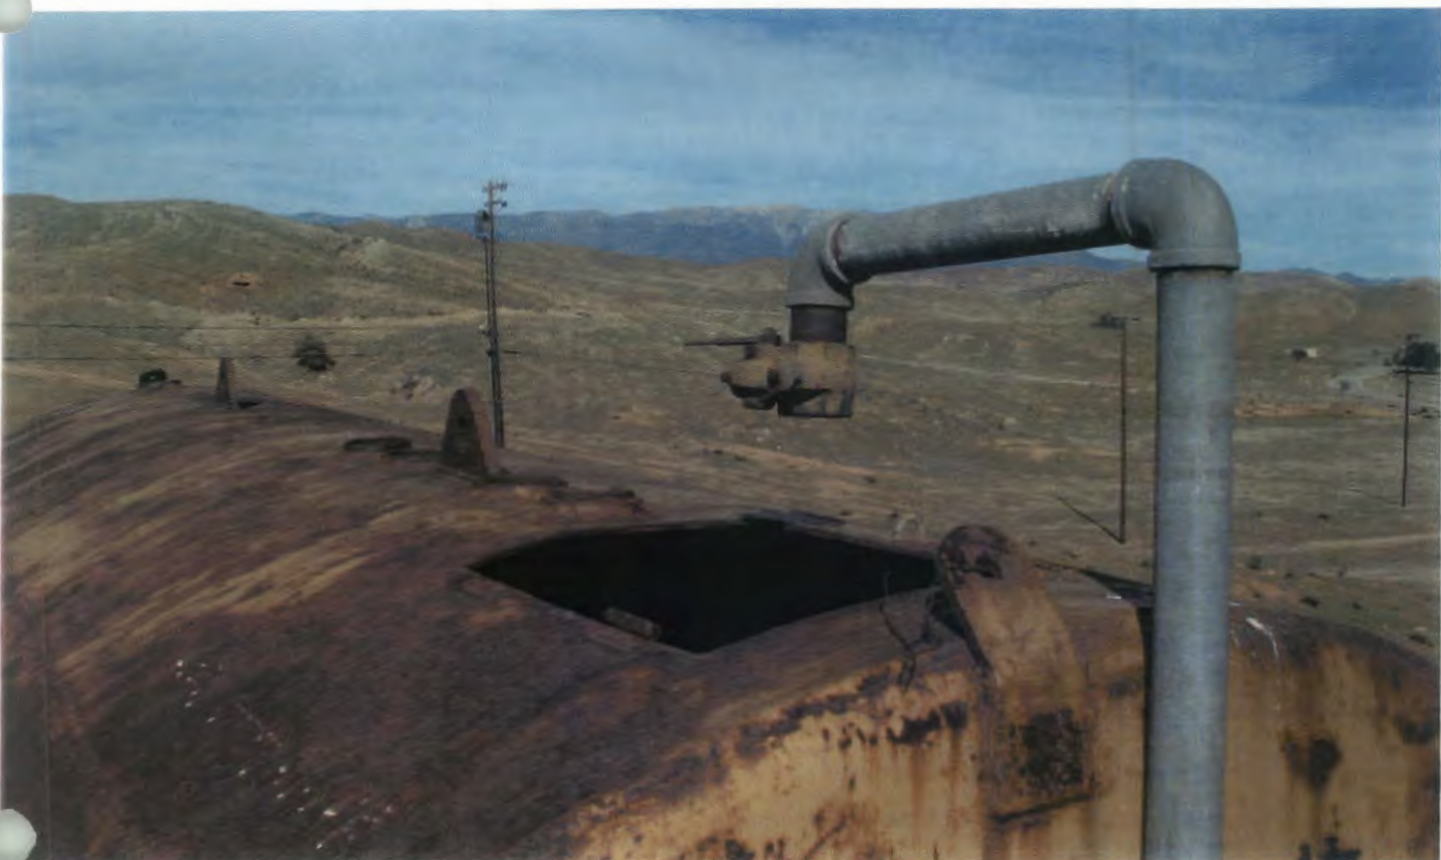
Site 1, Lead Paint on Steel/Metal Components

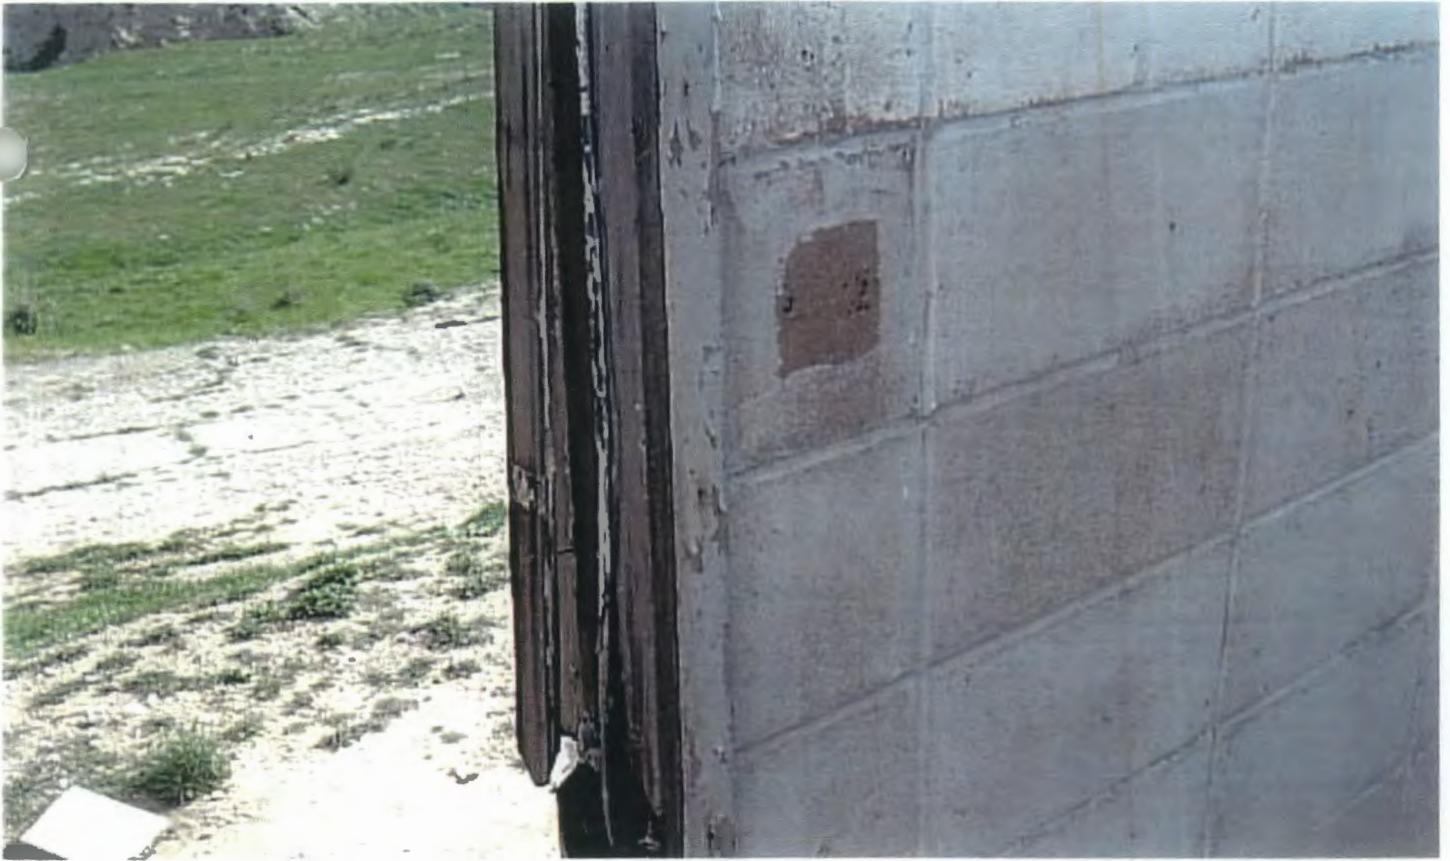
Site 2, Bldg 37, Lead Paint on Door Frame

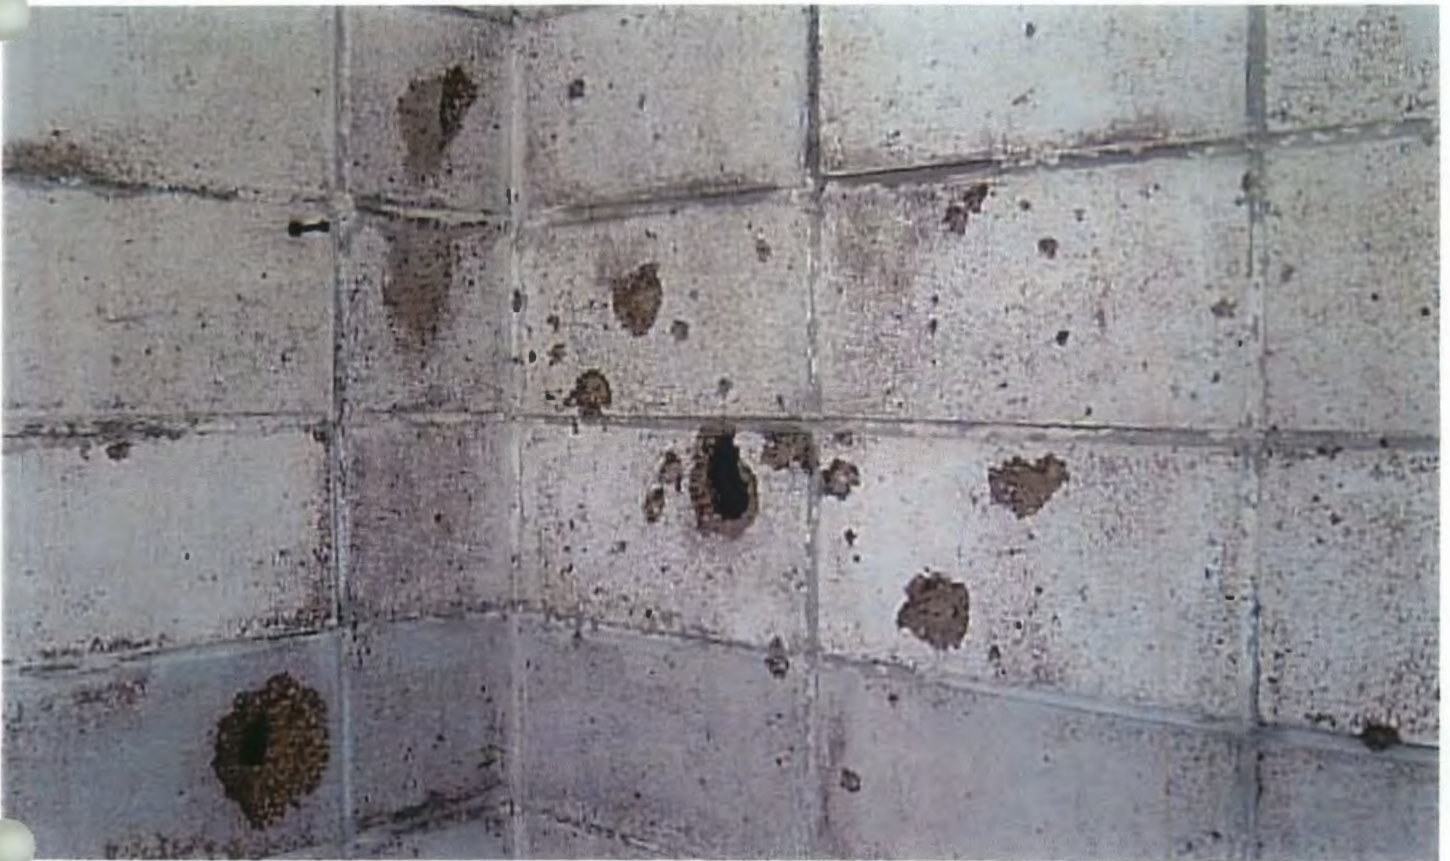
Site 2, Bldg 37, Lead Paint on Interior Walls
