2014 Annual Munitions and Explosives of Concern Inspection Report Potrero Canyon (Lockheed Martin Beaumont Site 1) Beaumont, California

2014 MUNITIONS AND EXPLOSIVES OF CONCERN INSPECTION REPORT POTRERO CANYON (LOCKHEED MARTIN BEAUMONT SITE 1) BEAUMONT, CALIFORNIA

September 2014

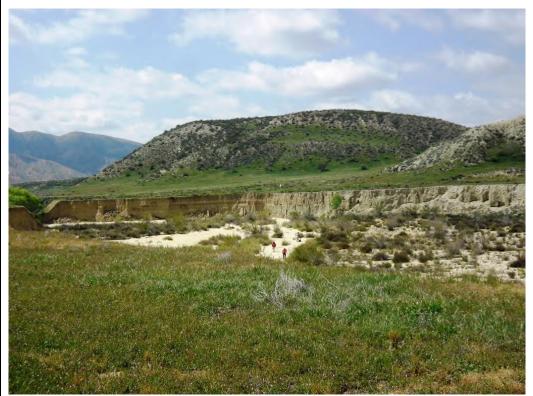
Team Performing Survey in Area A

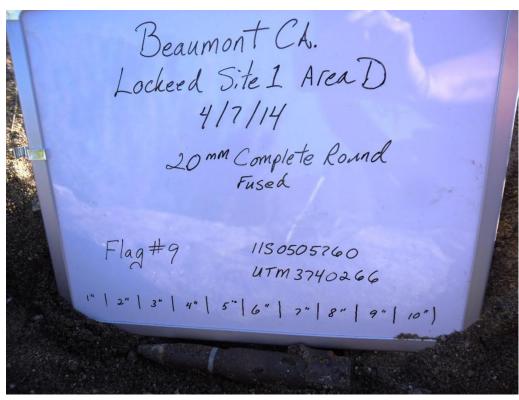
PHOTO - 002

20mm Cartridge Unfired (MEC)

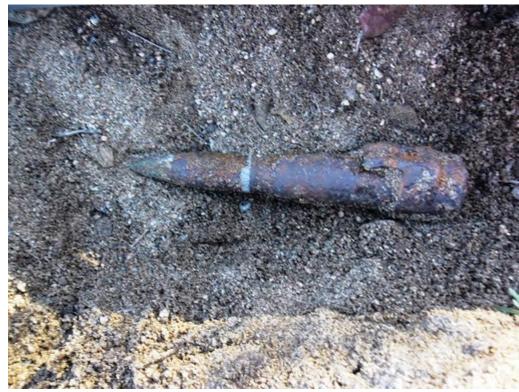
PHOTO - 003

20mm Cartridge Unfired(MEC)

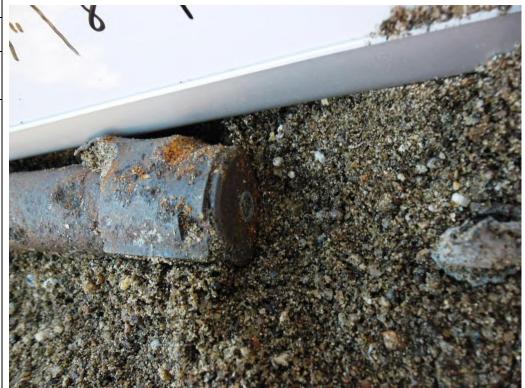
PHOTO - 005

20mm Cartridge Unfired (MEC)

Depth: 6 Inches

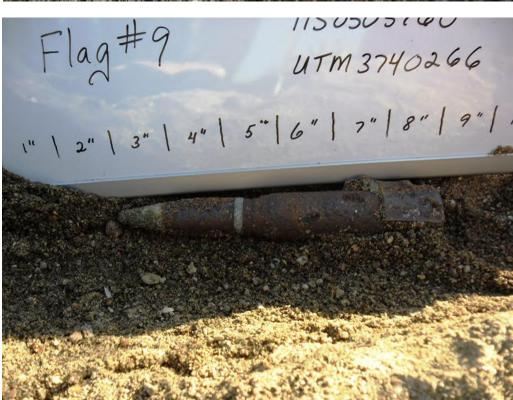
PHOTO - 006

20mm Cartridge Unfired (MEC)

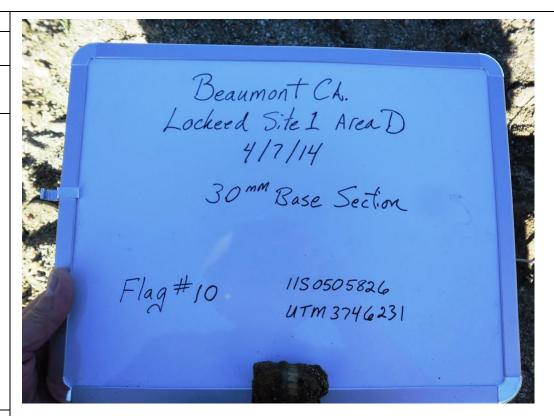
PHOTO - 007

Two of the five subsurface anomalies excavated in Area D were determined to be MD, one 30mm projectile base (Appendix B, Photos 7 and 8), and one unidentified munition related item (Appendix B, Photos 9 and 10). Two anomalies were determined to be MEC, one complete 20mm cartridge (Appendix B, Photos 2-6) and two linked 20mm cartridges with one complete round and one broken round (Appendix B, Photos 11-14). All three of these 20 mm cartridges have reasonably identifiable characteristics of the Training Practice (TP) variety that does not have a fuze or contain explosives, only propellant powder. Differentiation of the High Explosive (HE) from the TP variety is not always certain, particularly when the cartridges are in a degraded

30mm Projectile Base (MD)

Depth: 6 Inches

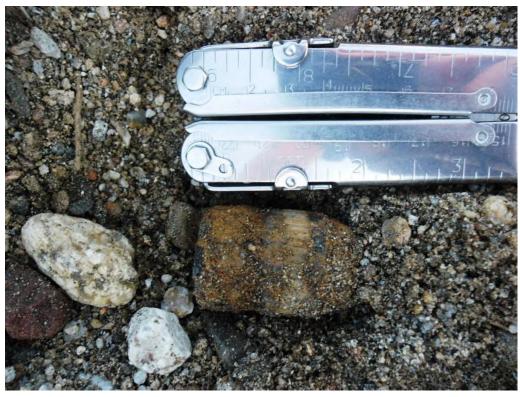
PHOTO - 008

30mm Projectile Base (MD)

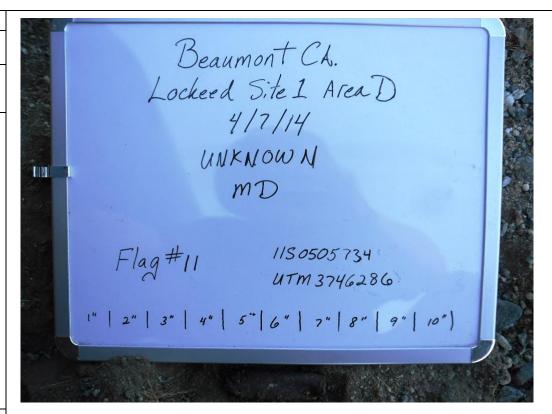
PHOTO - 009

Unknown Munition Item (MD)

Depth: 6 Inches

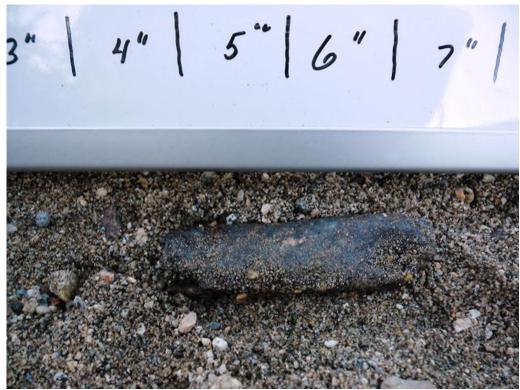
PHOTO - 010

Unknown Munition Item (MD)

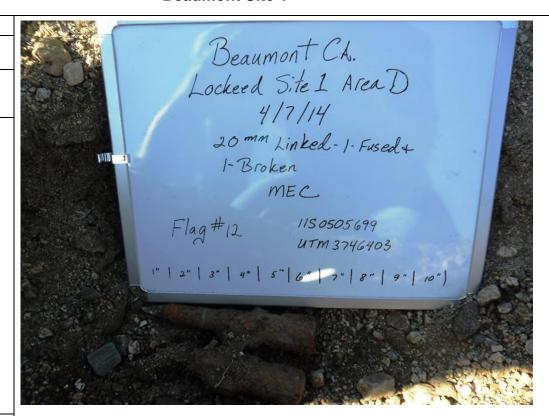
PHOTO - 011

((2) 20mm Linked Cartridges, Unfired (MEC)

Depth: 12 Inches

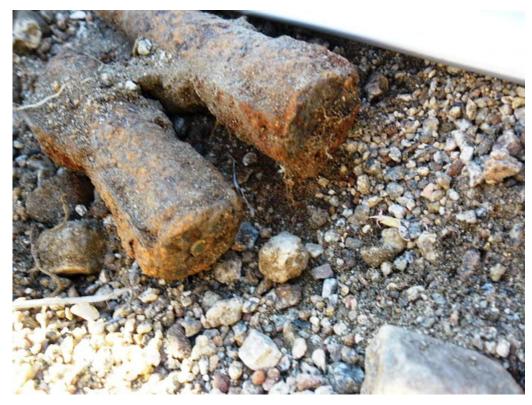
PHOTO - 012

((2) 20mm Linked Cartridges, Unfired (MEC)

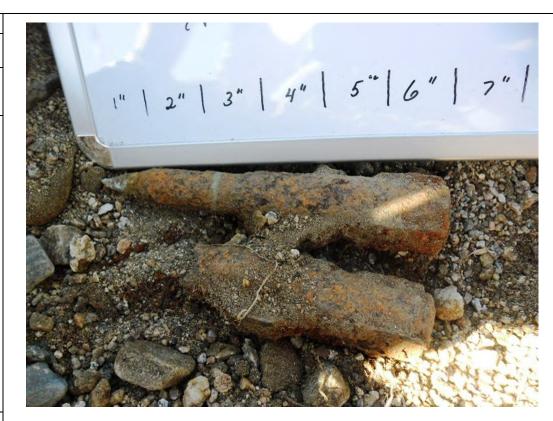
PHOTO - 013

(MEC)

Depth: 12 Inches

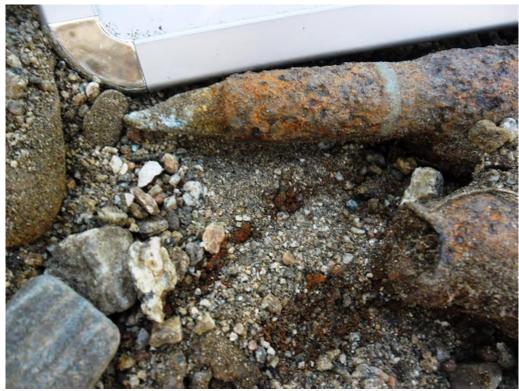
PHOTO - 014

(2) 20mm Projectiles Linked (MEC)

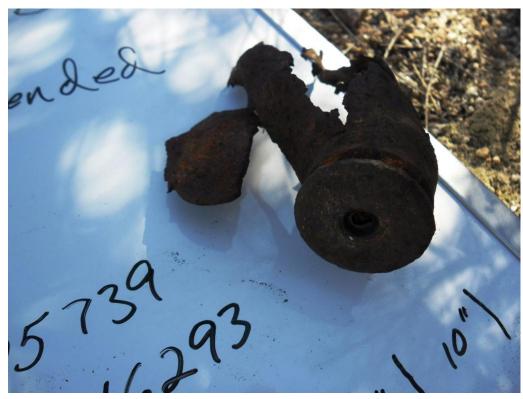
PHOTO - 016

20mm Cartridge Case, No Powder or Primer (MD)

Depth: Surface

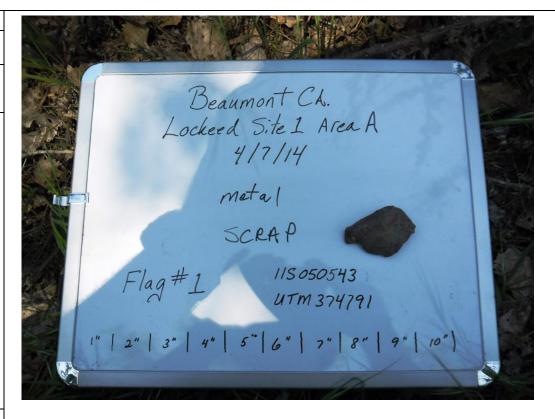
PHOTO - 017

Scrap Metal

Depth: 3 Inches

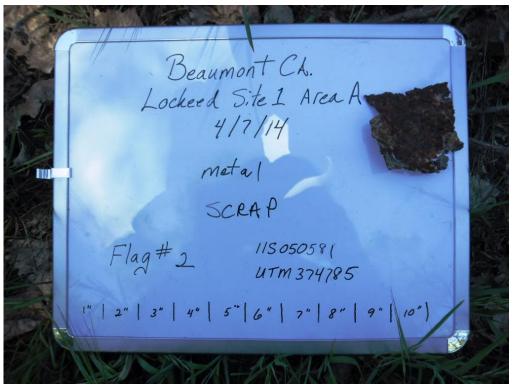
PHOTO - 018

Scrap Metal

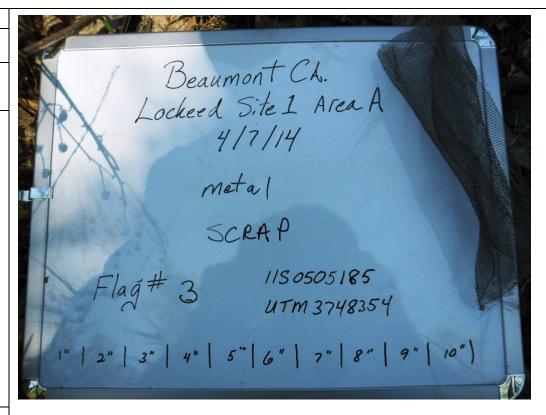
PHOTO - 019

Scrap Metal

Depth: 6 Inches

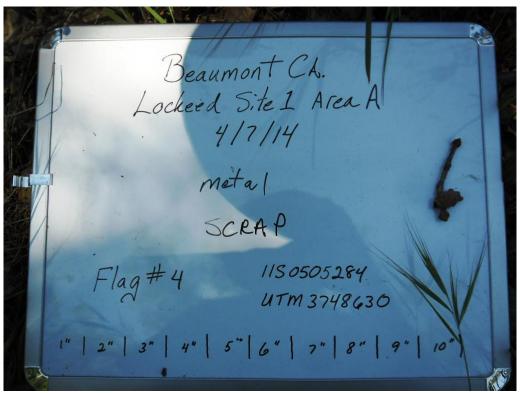
PHOTO - 020

Scrap Metal

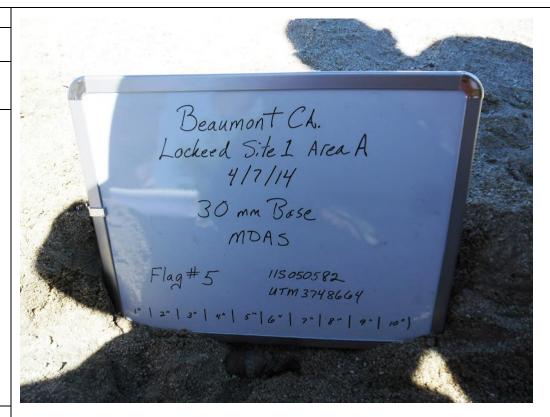
PHOTO - 021

30mm Projectile Base (MD)

Depth: 8 Inches

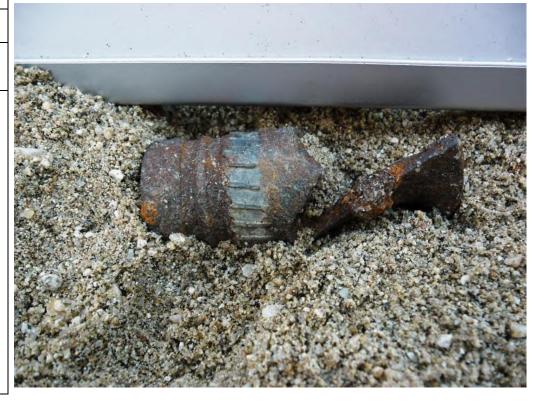
PHOTO - 022

30mm Projectile Base (MD)

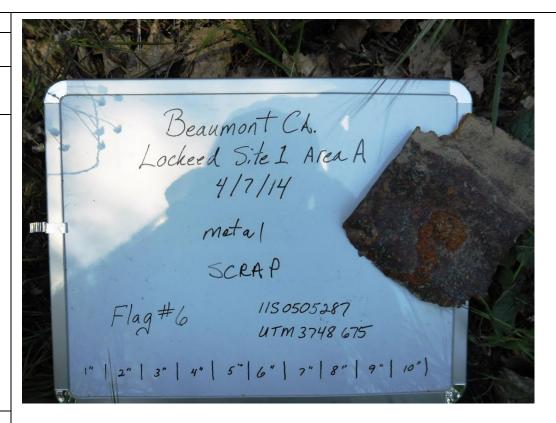
PHOTO - 023

Scrap Metal

Depth: 6 Inches

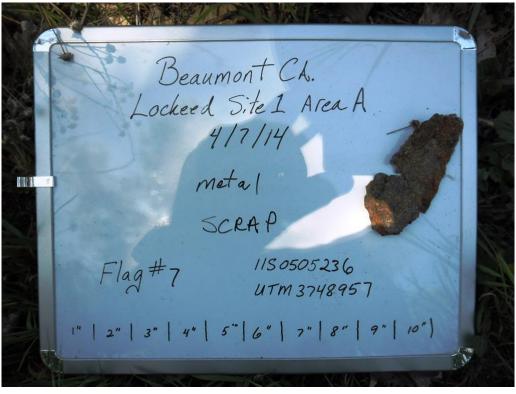
PHOTO - 024

Scrap Metal

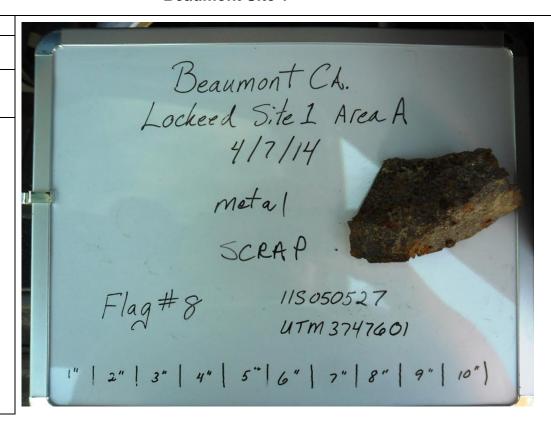
PHOTO - 025

Scrap Metal
