SUMMARY REPORT

FOLLOW-ON MUNITIONS AND EXPLOSIVES OF CONCERN (MEC) EVALUATION

AREA C– PROPELLANT BURN PIT AREA

**Lockheed Martin Corporation
Former Beaumont Site No. 1
Beaumont, California**

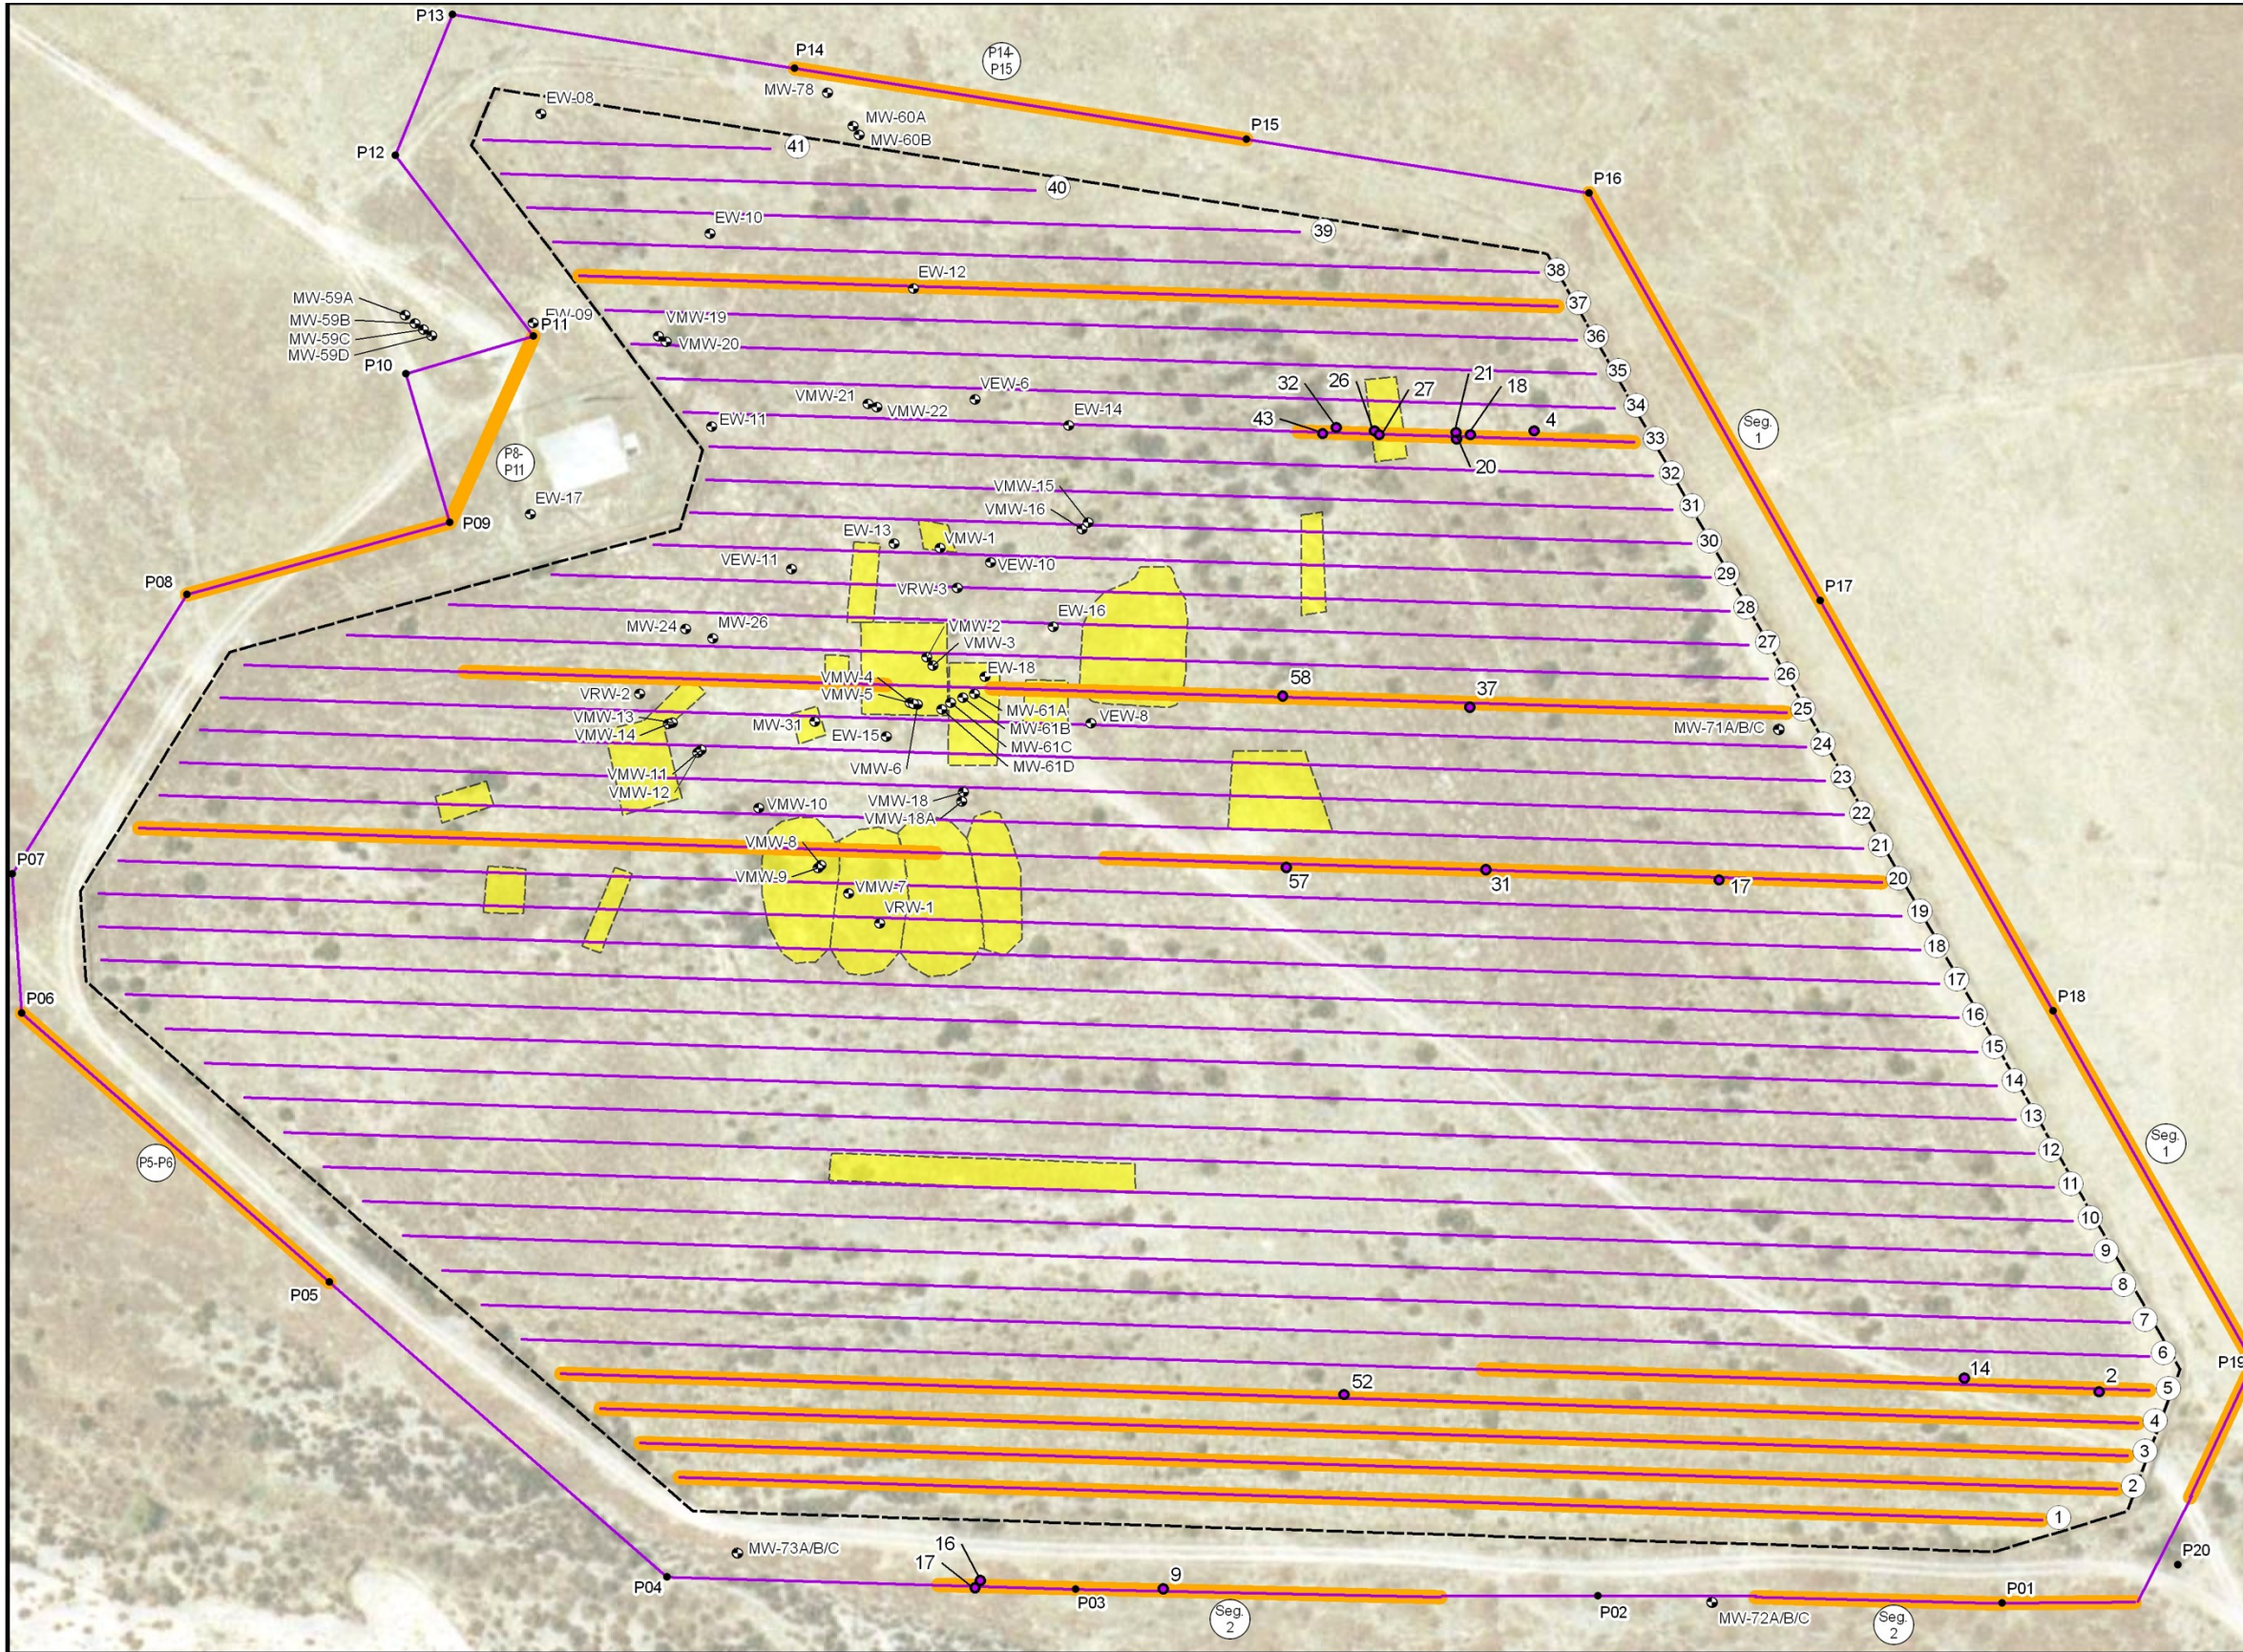
Figure ES-1
Burn Pit Area
Evaluation Summary

During the evaluation, approximately 25% (about 4 of 16.75 acres) of the BPA was surface swept and approximately six percent (about 1 acre) of the BPA was intrusively evaluated including a perimeter transect just outside of the area boundary. A total of 1,997 anomalies, approximately six percent of an estimated 33,000 anomalies in the BPA were identified and 911 were intrusively investigated. Nineteen of the items excavated were identified as MD including 3 pieces of projectile fragmentation (frag), 6 small pieces of unidentified frag and 10 empty, non-ferrous 30mm casings. All MD was found at depths \leq 12 inches bgs, with 16 of the 19 items being \leq 6 inches bgs. No MEC was found during the evaluation. The results of the MEC Evaluation are shown on Figure ES-1 and summarized in Table ES-1.

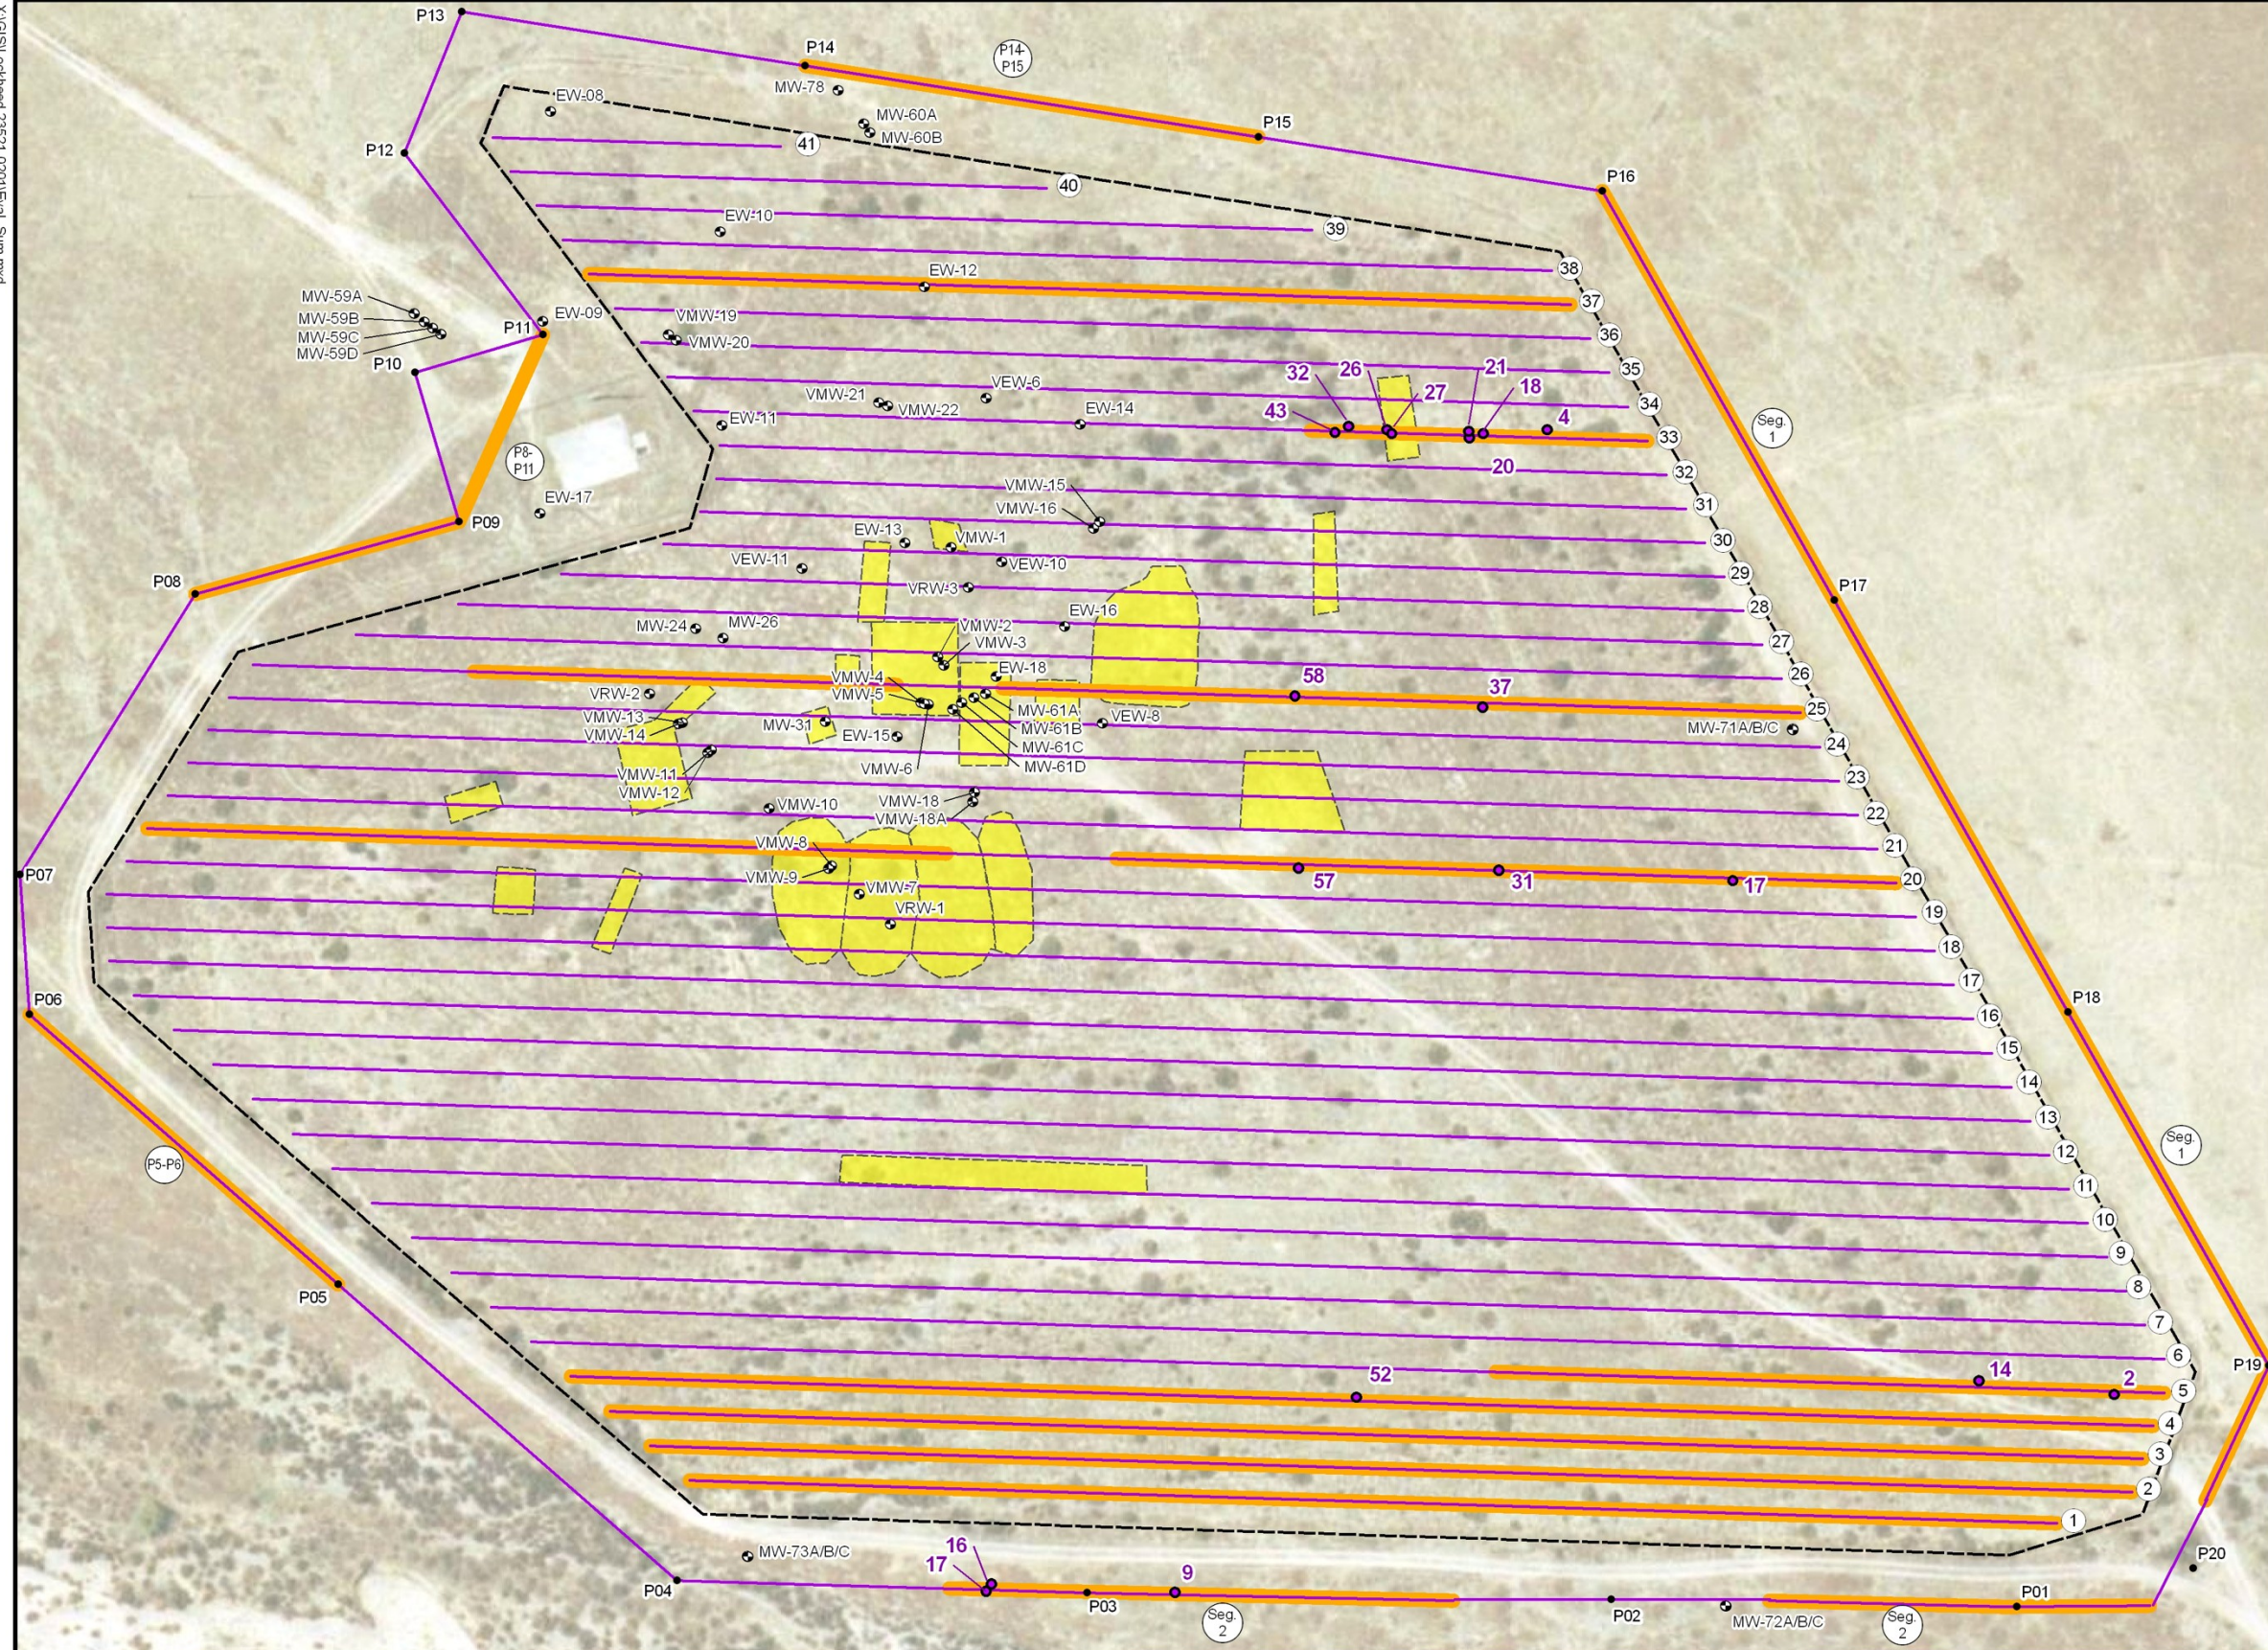
Figure 4-1
Burn Pit Area
Evaluation Summary

Eight of the 30mm shell casings were found near the previously identified location of a lone burn pit located in the northeastern corner of the BPA (See Figure 4-1). One shell casing was found in the eastern central portion of the BPA and the final casing was found in the southeastern corner of the area. There were no historical burn pits near the locations where these last two shell casings were found. Two pieces of frag identified as projectile frag were found on two adjacent transects near the southern edge of the BPA, about 300 feet apart. There were no historical burn pits in or near this area. The third piece of projectile frag was found near the eastern central portion of the site on Transect 20. A second piece of unidentified frag was found about 100 feet west along this same transect. Both pieces of frag were located near a former burn pit. Two pieces of unidentified frag were found on Transect 25, approximately 100 feet north of Transect 20. These items were also located near a former burn pit. The final three

pieces of unidentified frag were found on the perimeter transect near the southeast corner of the BPA. There are no historical burn pits in or near this area.

Figure 4-1 shows the areas of the BPA that were evaluated, along with the locations of the MD items found. The results of the MEC evaluation are summarized in Tables 4-1 and 4-2. Daily Reports and Quality Control Reports for the MEC evaluation are included in Appendix B and photographs showing items of interest from the evaluation are presented in the photo log in Appendix C.
