# **RADIOLOGICAL SURVEY REPORT FOR FORMER BUILDING D LOCKHEED MARTIN MIDDLE RIVER COMPLEX**

**2323 Eastern Boulevard  
Middle River, Maryland**

Environmental Engineers & Scientists  
TC#13724-01/April 2004

**Final  
Radiological Survey Report for Former Building D  
Lockheed Martin Middle River Complex  
2323 Eastern Boulevard  
Middle River, Maryland**

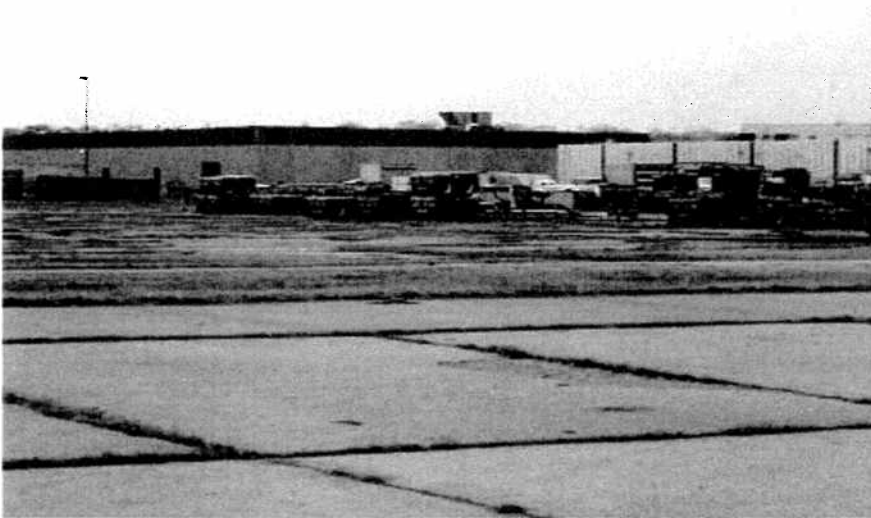
**Photo No.:** 2

**Comments:** The view of the southeast corner of the lot from the south gate of D Lot. The foreground concrete slab is the old parking area and the building foundation is to the left of the small grassy areas.

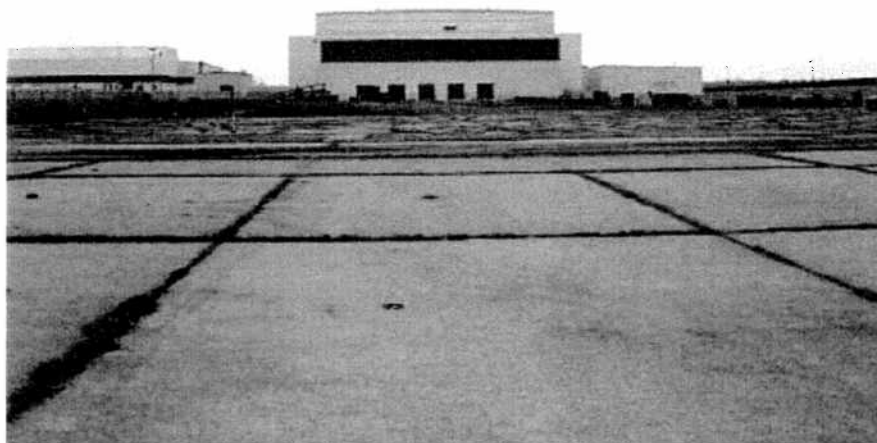
**Photo No.:** 3

**Comments:** The view of the north area of the foundation slab from the south gate of D Lot. The foreground concrete slab is the old parking area and the building foundation is beyond the small grassy areas.

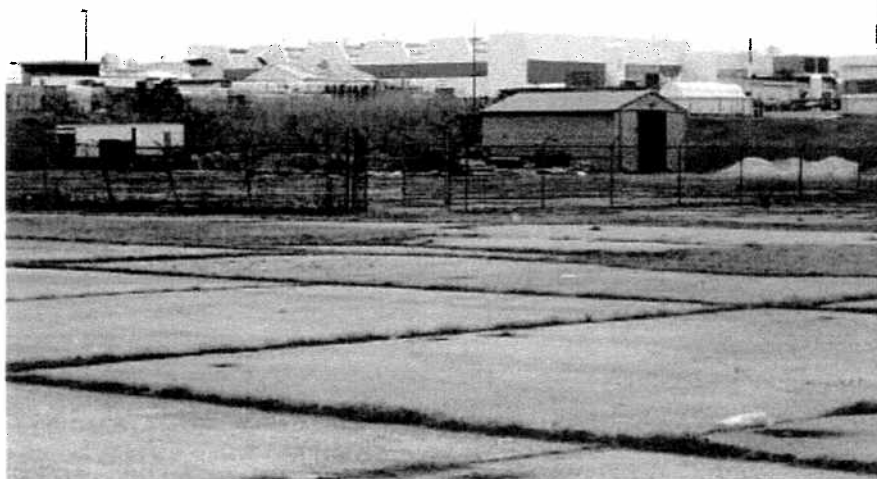
**Photo No.:** 4

**Comments:** The view of the northwest area of the foundation slab from the south gate of D Lot. The foreground concrete slab is the old parking area and the building foundation is along the fence line to the left.

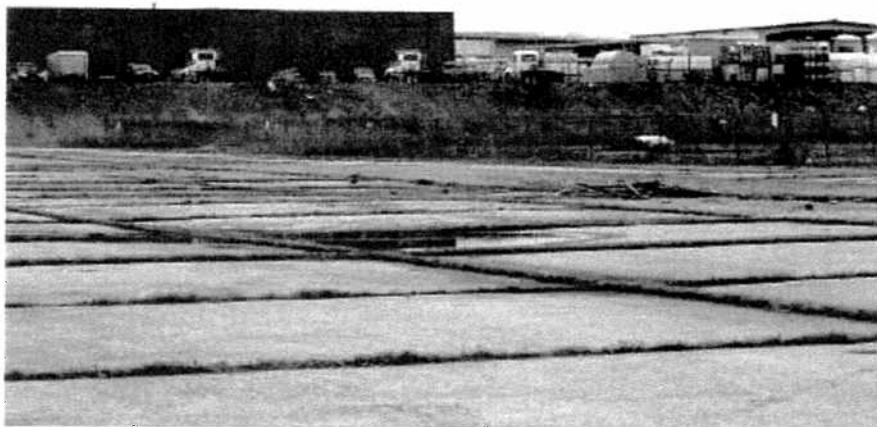
**Comments:** The view of the southwest area of the foundation slab from the south gate of D Lot. The foreground concrete slab is the old parking area and the building foundation is along and beyond the fence.

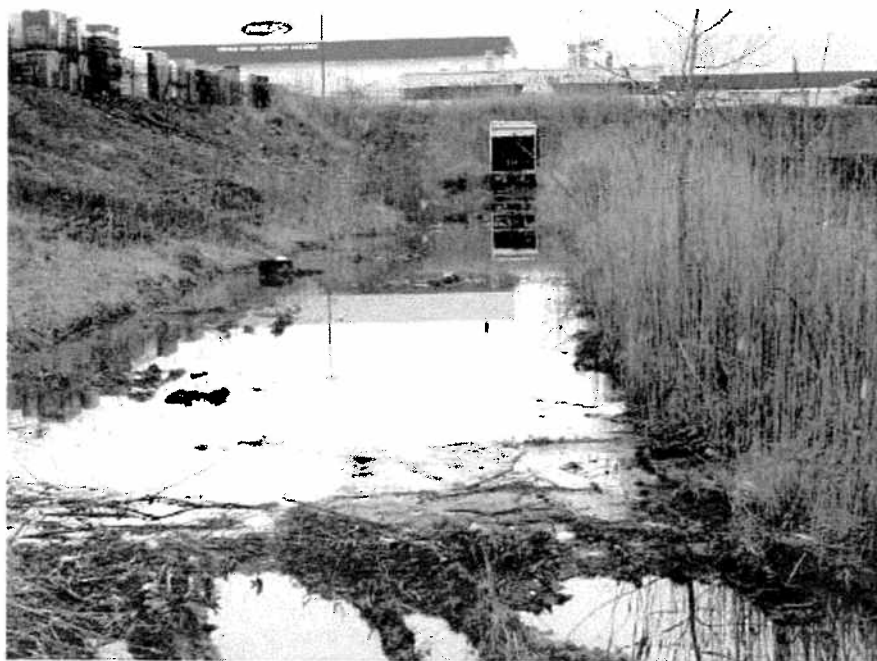
**Photo No.:** 6

**Comments:** The view northward from the southwest corner of the foundation slab. This is the secondary area of concern where radiological operations were known to occur. Beta and alpha measurements were not possible in this area because the slab was not dry. A gamma walkover survey was performed of this area and the observations were consistent with background readings.

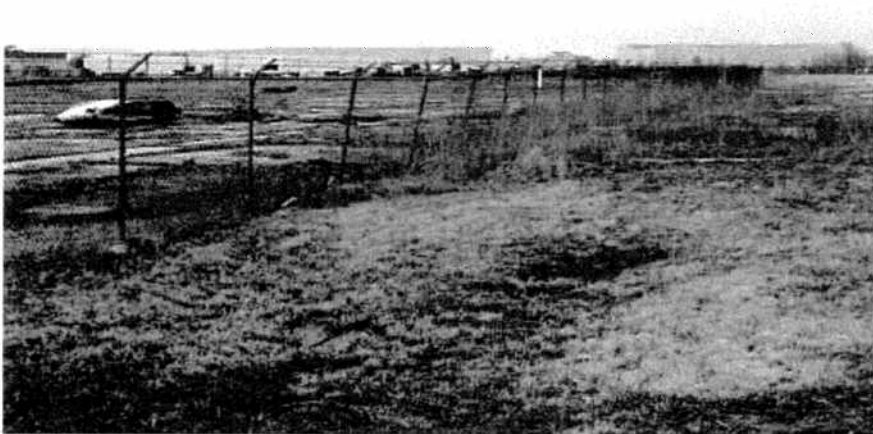
**Comments:** The view of the foundation slab from the southwest corner of the foundation slab. The main area of concern is just on the other side of the fence.

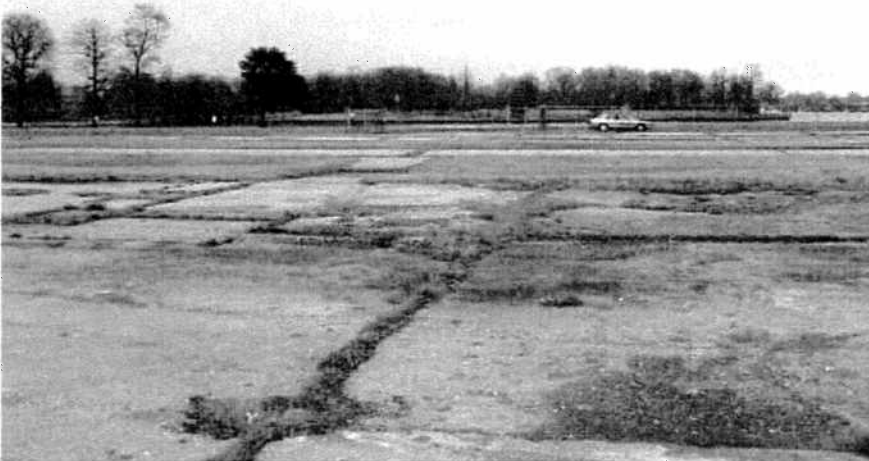
**Photo No.:** 8

**Comments:** The view of the south gate of D Lot from the background area.

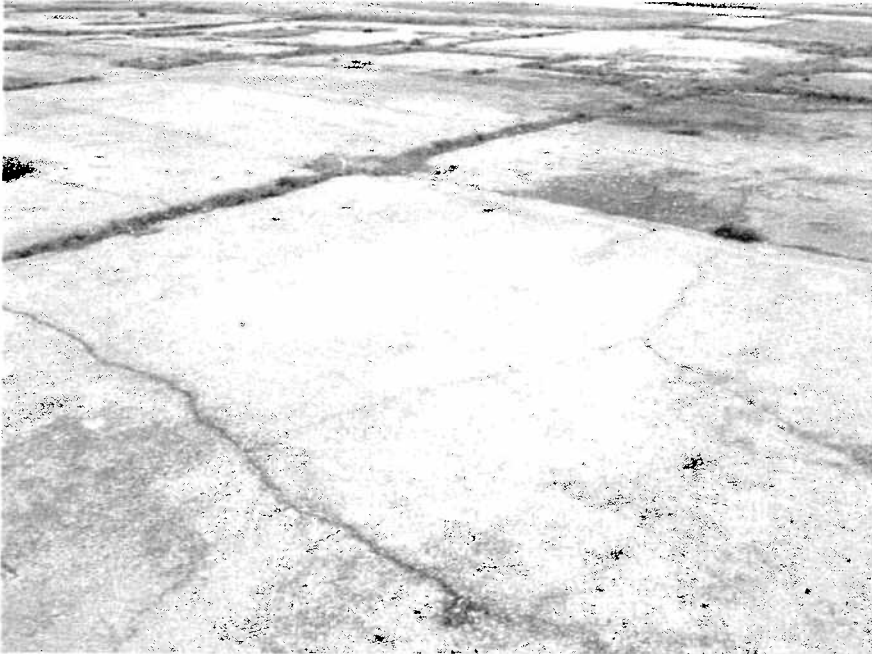
**Photo No.:** 9

**Comments:** A view of the background area, with the corners marked with white paint.

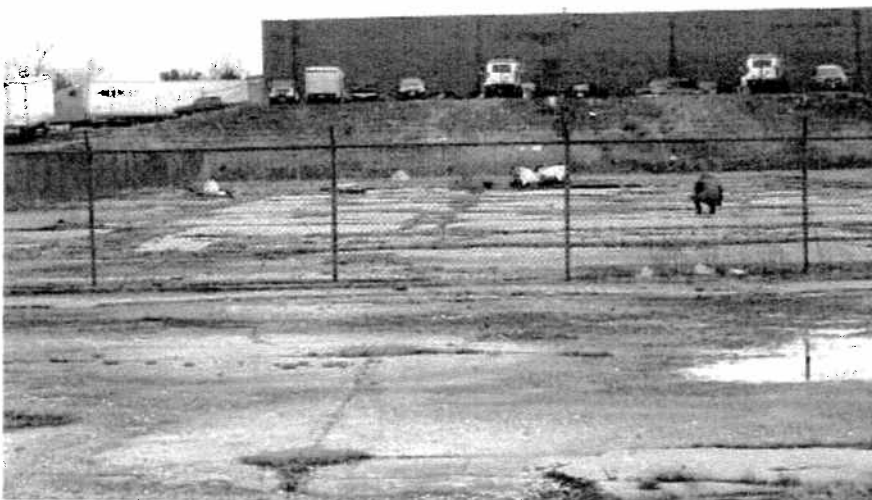
**Photo No.:** 10

**Comments:** The view of the main area of concern from the background area. The gamma walkover survey of the bricked area near the fence had slightly elevated readings compared to background. The contact exposure rate was 6 to 7  $\mu\text{R/hr}$  and the background rate was 3 to 5  $\mu\text{R/hr}$ .

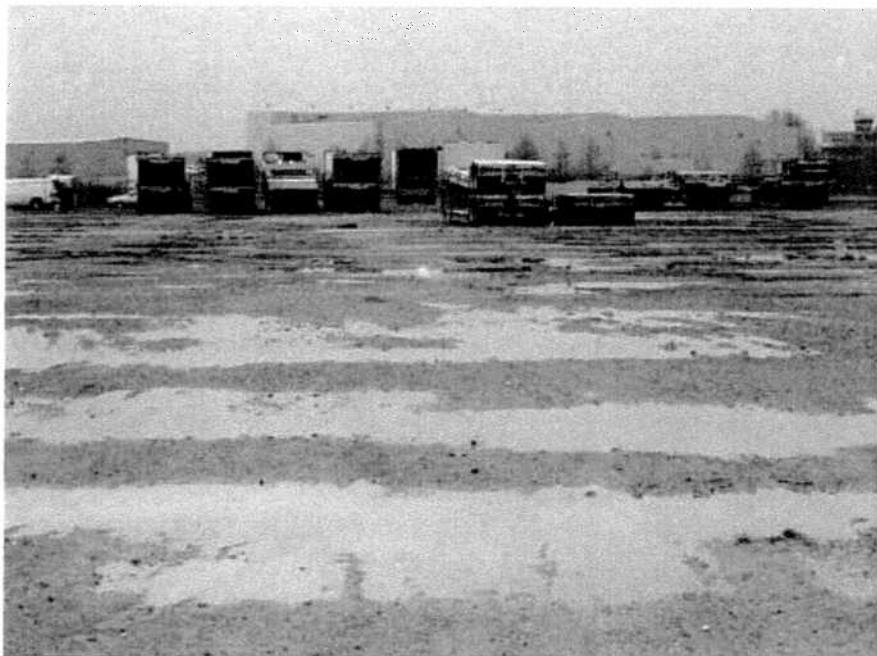
**Photo No.:** 11

**Comments:** The view of the northeast corner of the slab from the middle of the foundation slab at the north edge.

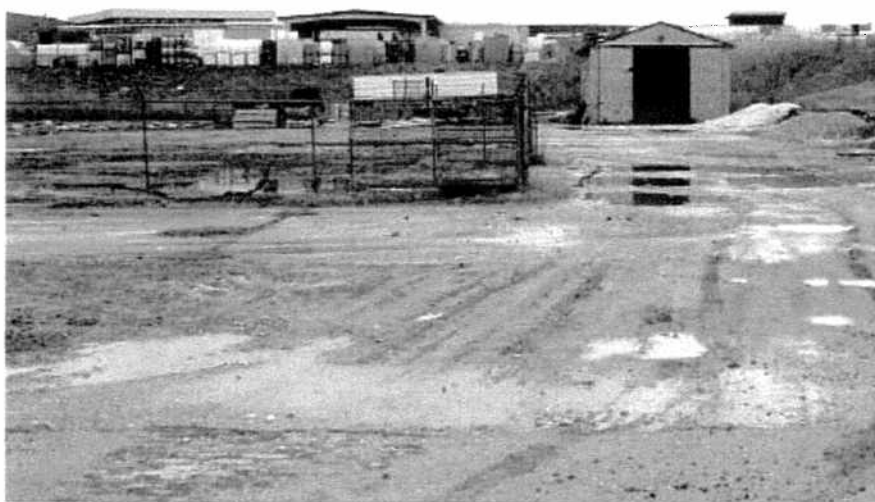
**Photo No.:** 12

**Comments:** The view of the northwest corner of the slab from the middle of the foundation slab at the north edge. The gamma walkover survey of the grassy area in the left foreground of the picture had slightly elevated readings compared to background. The contact exposure rate was 7 to 8  $\mu\text{R/hr}$  and the background rate was 4 to 5  $\mu\text{R/hr}$ .

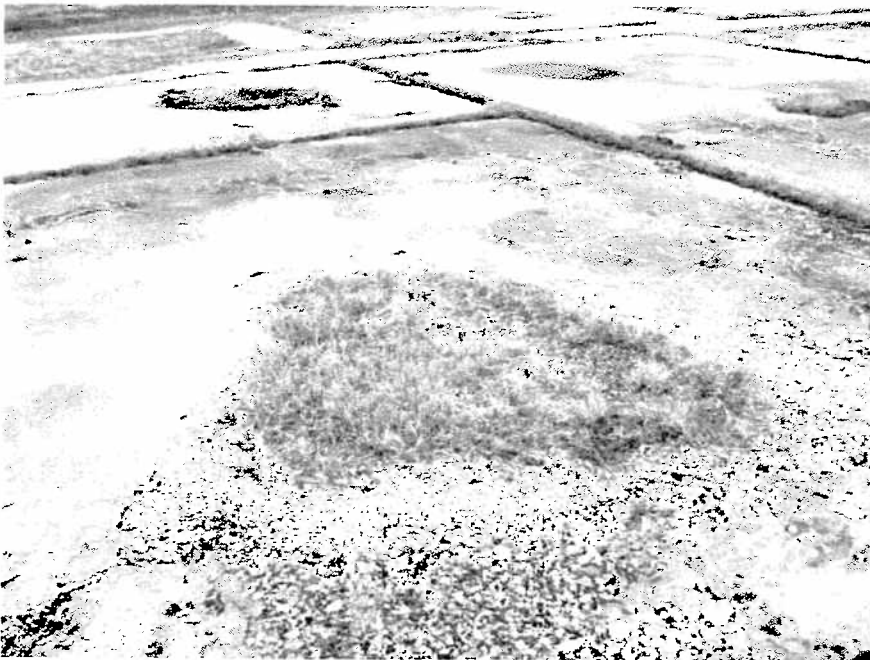
**Photo No.:** 26

**Comments:** Many of the individual slabs of the foundation slab in the main area of concern were deteriorating. Grass was growing in the middle of many of the individual slabs that had crumbled. Areas like this could not be surveyed with the floor monitor.

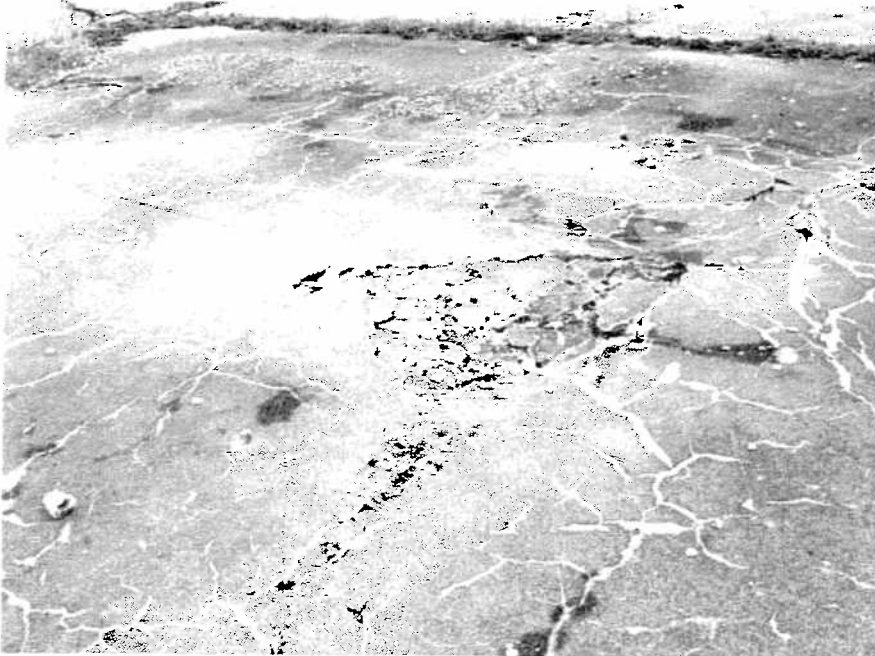
**Photo No.:** 27

**Comments:** Many of the individual slabs of the foundation slab in the main area of concern were starting to crumble. The top few centimeters of this slab were “puffed” and would crumble if stepped on. Areas like this could not be surveyed with the floor monitor.

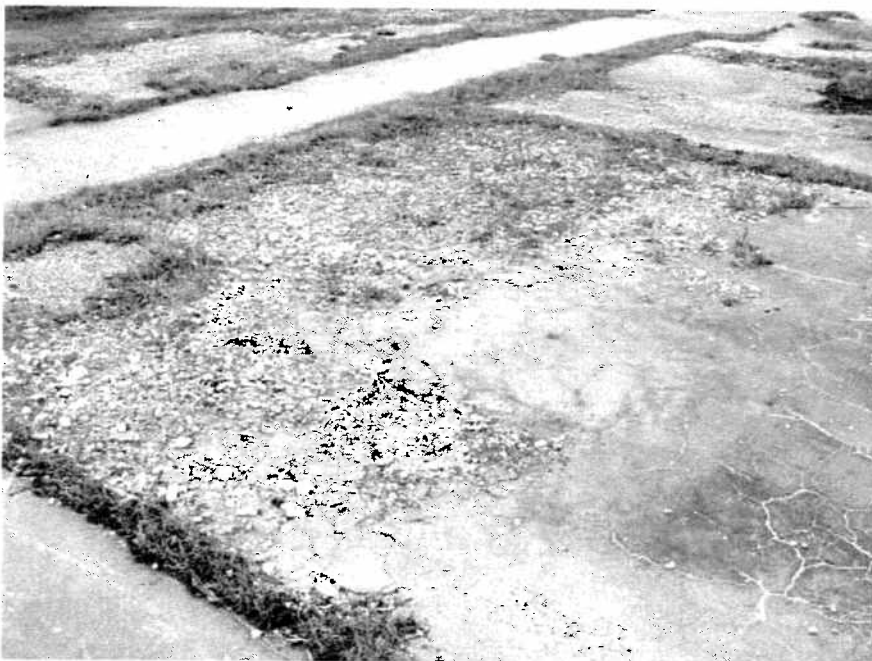
**Photo No.:** 28

**Comments:** Many of the individual slabs of the foundation slab in the main area of concern were deteriorating from the edges in. The solid portion of this slab could be surveyed with the floor monitor.

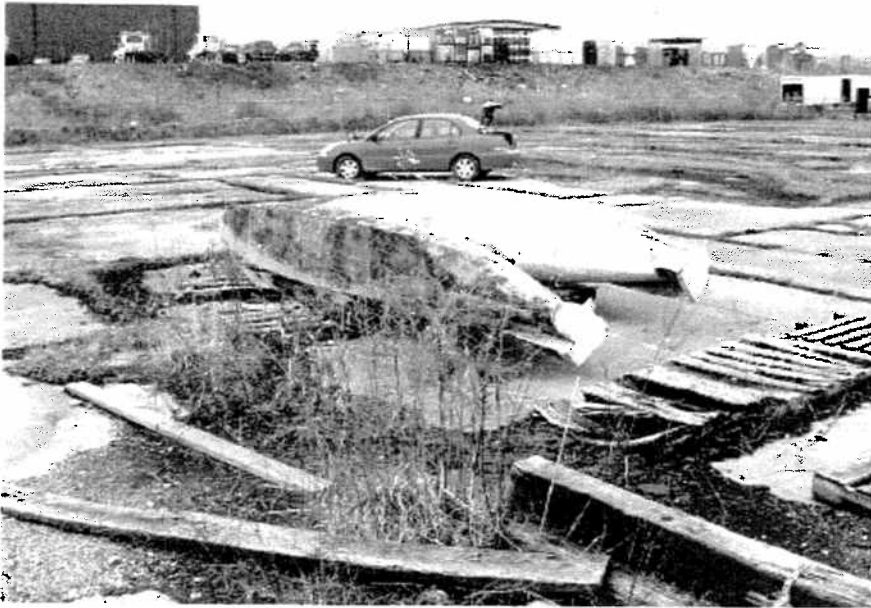
**Photo No.:** 29

**Comments:** Many pallets and other debris were present in the main area of concern. The gamma walkover survey of this area was as close as conditions allowed.

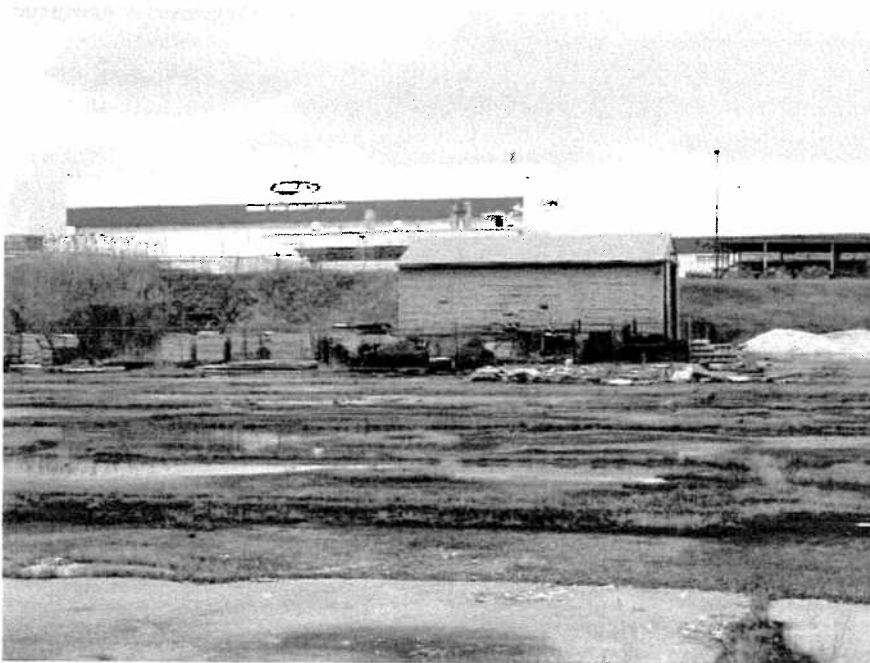
**Photo No.:** 30

**Comments:** The view of the northwest corner of the slab from the middle of the main area of concern. The shed apparently contained sand or salt for adverse weather conditions. Other building materials and debris were located in this area. This area was not surveyed during the gamma walkover survey.

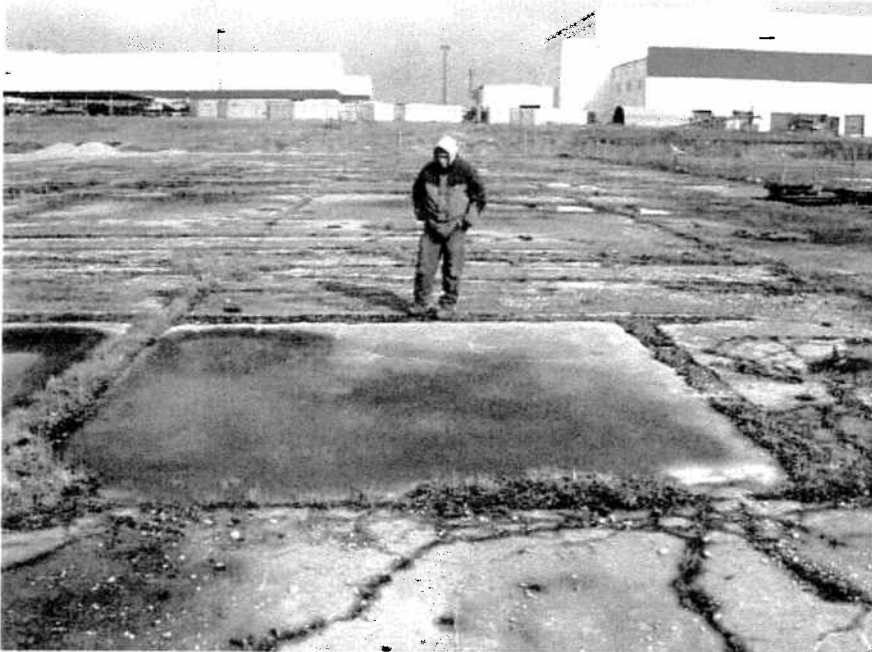
**Photo No.:** 33

**Comments:** This area was surveyed with the floor monitor for alpha and beta contamination, and designated as Area 1. Measurements elevated above background were not observed.

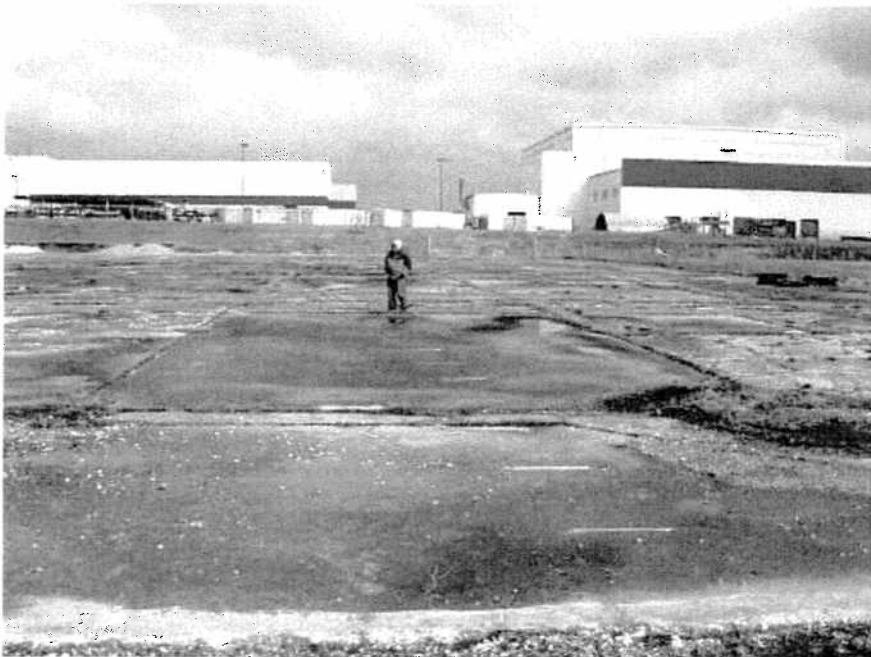
**Photo No.:** 34

**Comments:** This area was surveyed with the floor monitor for alpha and beta contamination, and designated as Area 2. Measurements elevated above background were not observed.

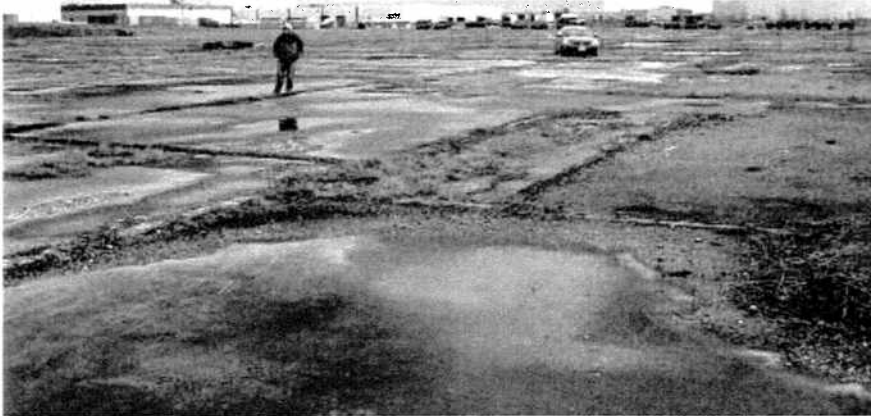
**Comments:** This area was surveyed with the floor monitor for alpha and beta contamination, and designated as Area 3. Measurements elevated above background were not observed.

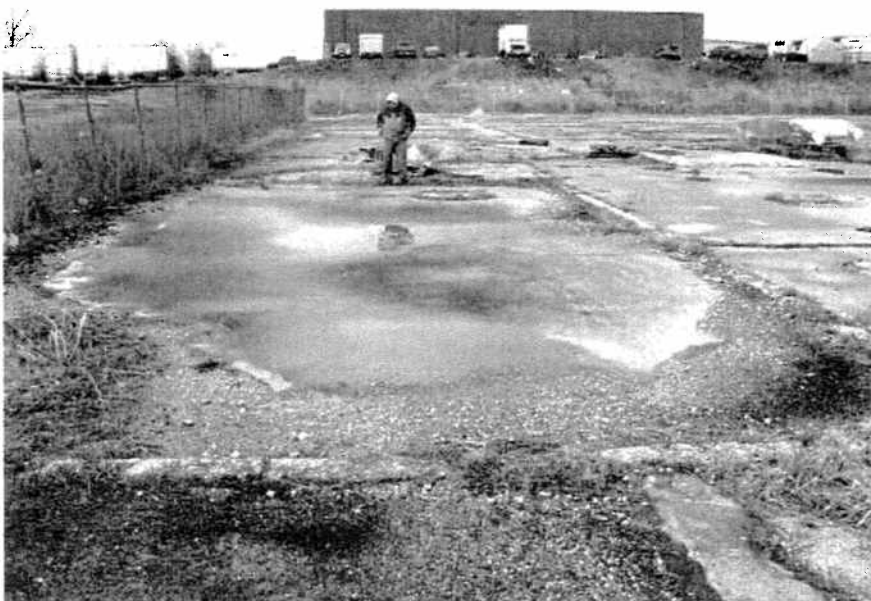
**Photo No.:** 36

**Comments:** This area was surveyed with the floor monitor for alpha and beta contamination, and designated as Area 11. Measurements elevated above background were not observed.

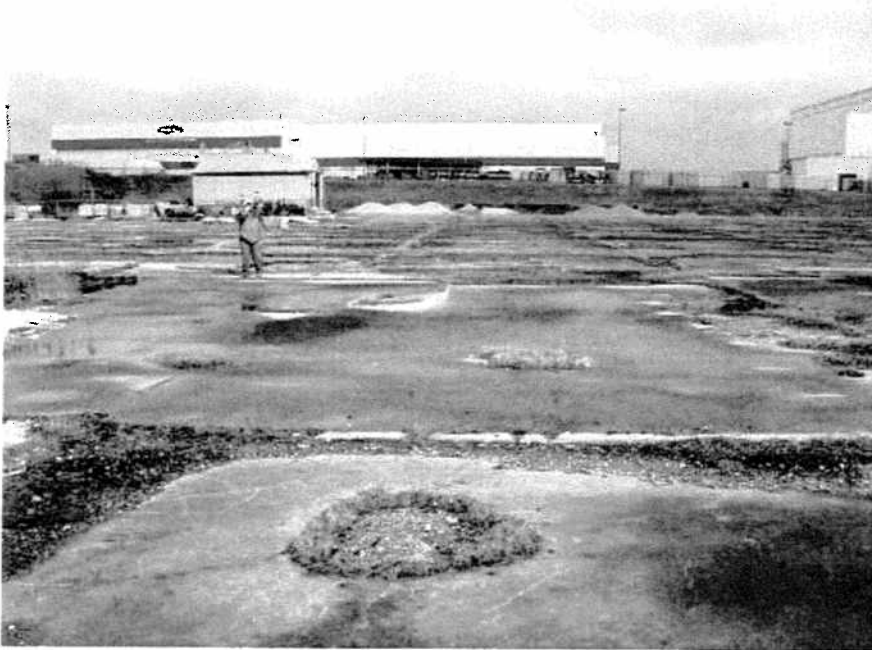
**Photo No.:** 37

**Comments:** This area was surveyed with the floor monitor for alpha and beta contamination, and designated as Area 5. Measurements elevated above background were not observed.

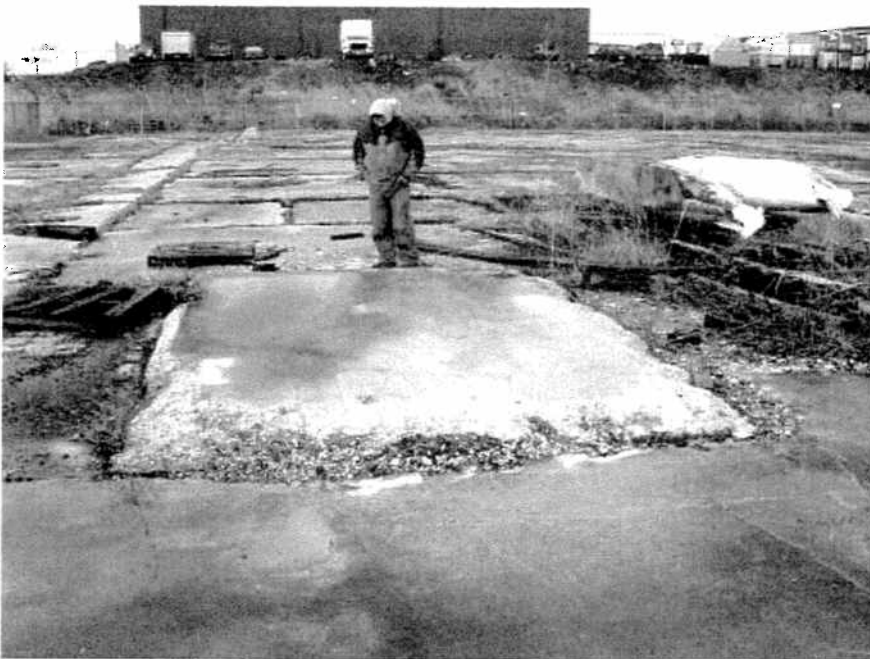
**Photo No.:** 38

**Comments:** This area was surveyed with the floor monitor for alpha and beta contamination, and designated as Area 6. Measurements elevated above background were not observed.

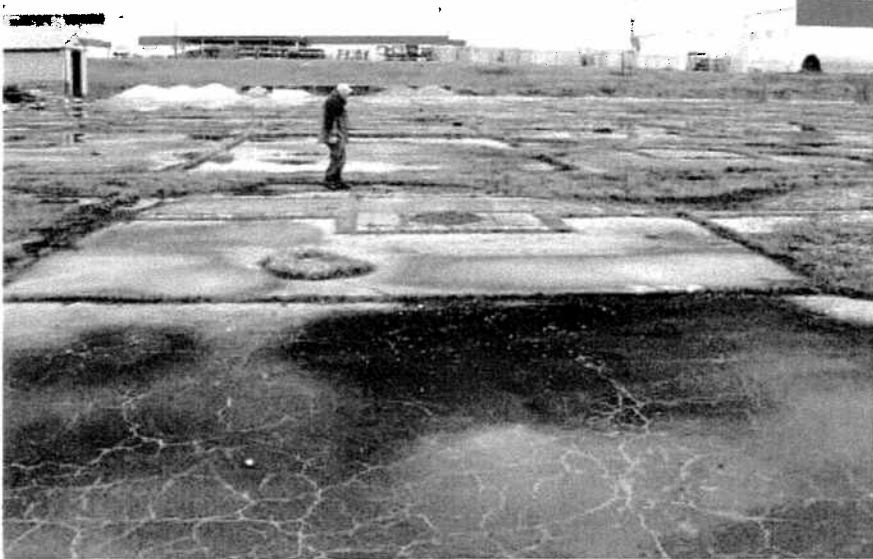
**Photo No.:** 39

**Comments:** This area was surveyed with the floor monitor for alpha and beta contamination, and designated as Area 4. Measurements elevated above background were not observed.

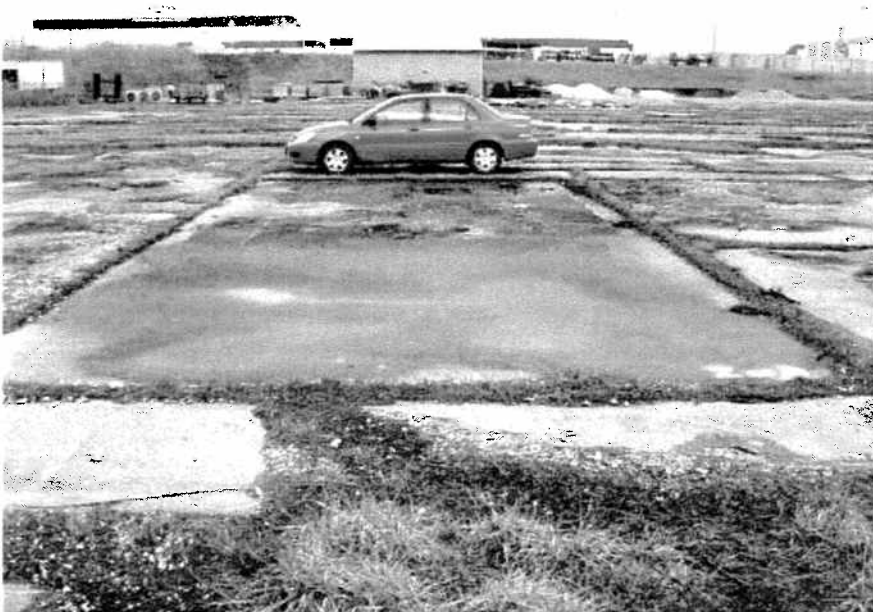
**Photo No.:** 40

**Comments:** This area was surveyed with the floor monitor for alpha and beta contamination, and designated as Area 7. Measurements elevated above background were not observed.

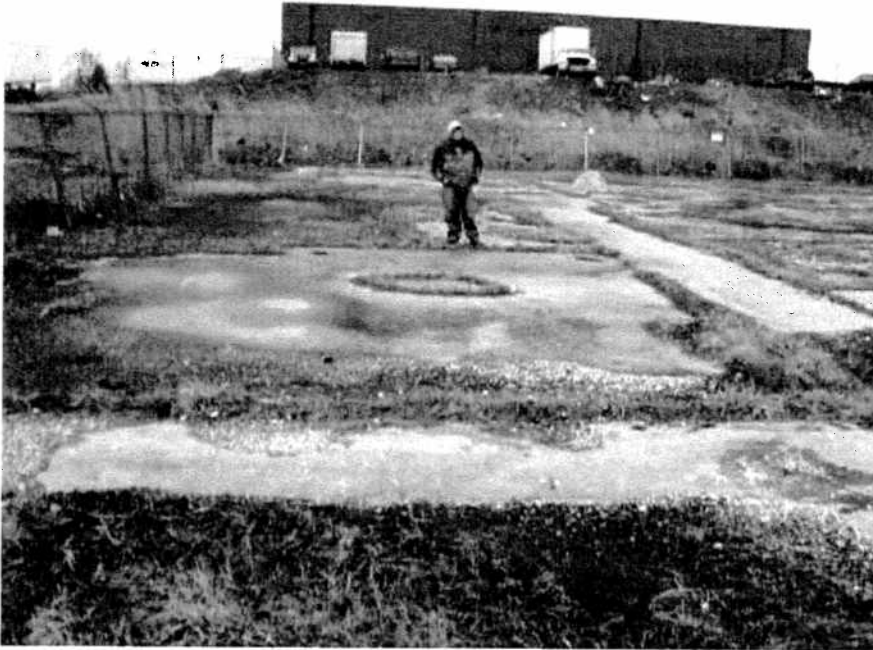
**Photo No.:** 41

**Comments:** This area was surveyed with the floor monitor for alpha and beta contamination, and designated as Area 8. Measurements elevated above background were not observed.

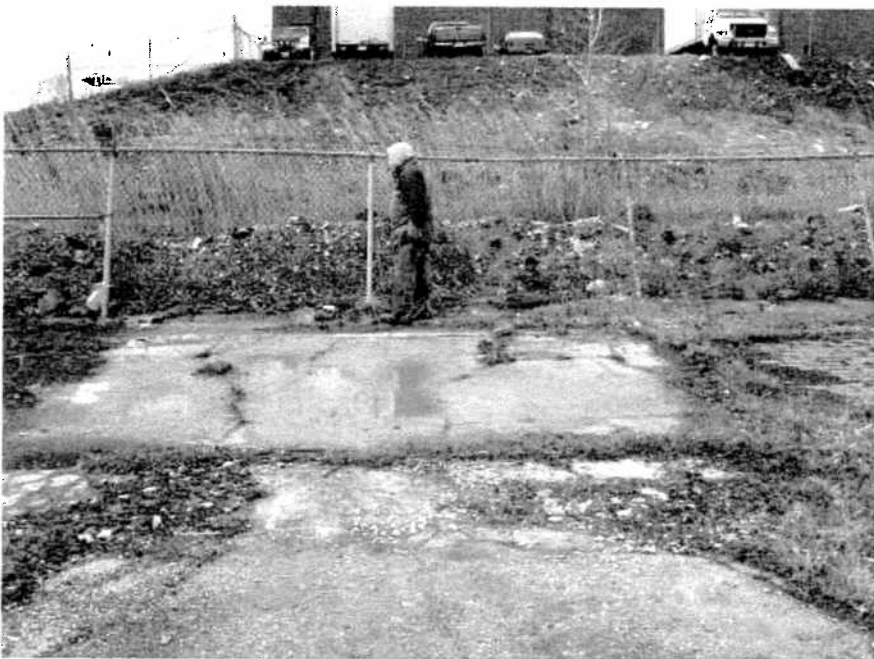
**Photo No.:** 42

**Comments:** This area was surveyed with the floor monitor for alpha and beta contamination, and designated as Area 9. Measurements elevated above background were not observed.

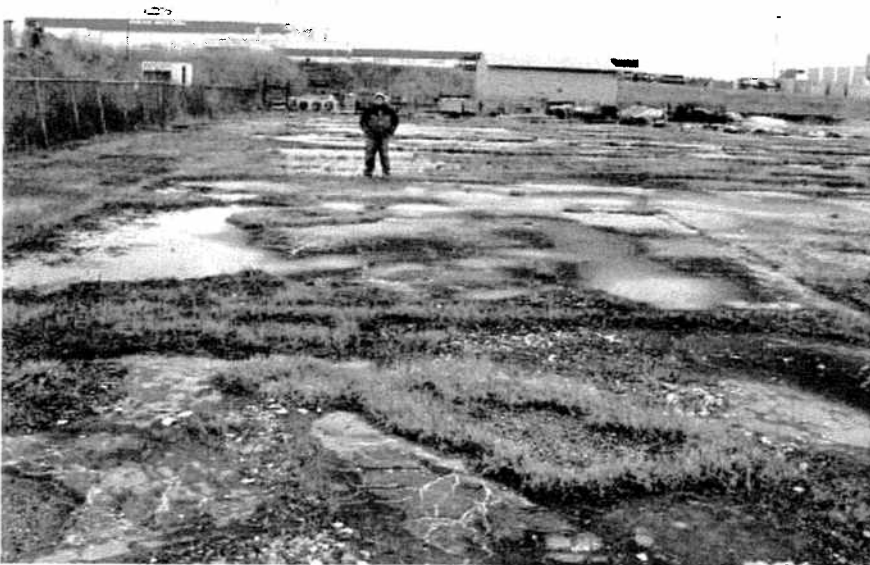
**Comments:** This area was surveyed with the floor monitor for alpha and beta contamination, and designated as Area 10. Measurements elevated above background were not observed.
