Subject: Transmittal of the Cow Pen Creek Bank Stabilization and Floodplain  
Reconstruction Monitoring: 2018 Report  
Lockheed Martin Corporation – Middle River Complex  
2323 Eastern Boulevard, Middle River, Baltimore County, Maryland

**COW PEN CREEK  
BANK STABILIZATION AND FLOODPLAIN  
RECONSTRUCTION MONITORING: 2018 REPORT  
LOCKHEED MARTIN MIDDLE RIVER COMPLEX  
2323 EASTERN BOULEVARD  
MIDDLE RIVER, MARYLAND**

December 2018

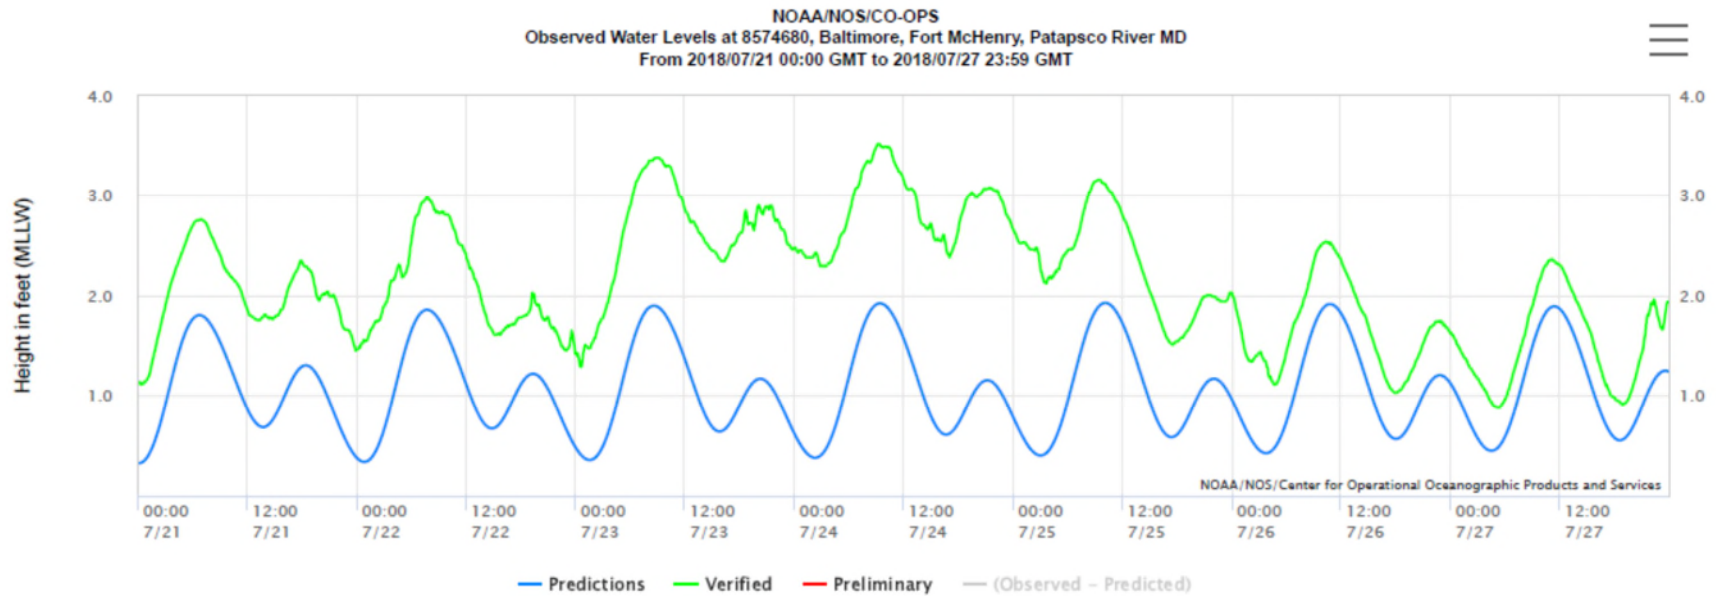
Observed tidal water levels at NOAA's Fort McHenry station, Patapsco River, were above long-term predicted levels during the July 26-27, 2018, monitoring period, with an average of 0.55 feet above predicted tide levels (Figure 3-2). Tide levels during the days preceding the monitoring were even higher. An examination of Fort McHenry water level data for May-July 2018 showed that higher-than-predicted water levels were common during this period.

**Figure 3-2 Observed water levels at NOAA's tidal observation station at Baltimore, Fort McHenry, Patapsco River July 21-27, 2018. Observed values (green line) are compared with long-term predicted levels (blue line). NOAA data from <https://tidesandcurrents.noaa.gov/waterlevels.html?id=8574680&units=standard&bdate=20180721&edate=20180727&timezone=GMT&datum=MLLW&interval=6&action=>**

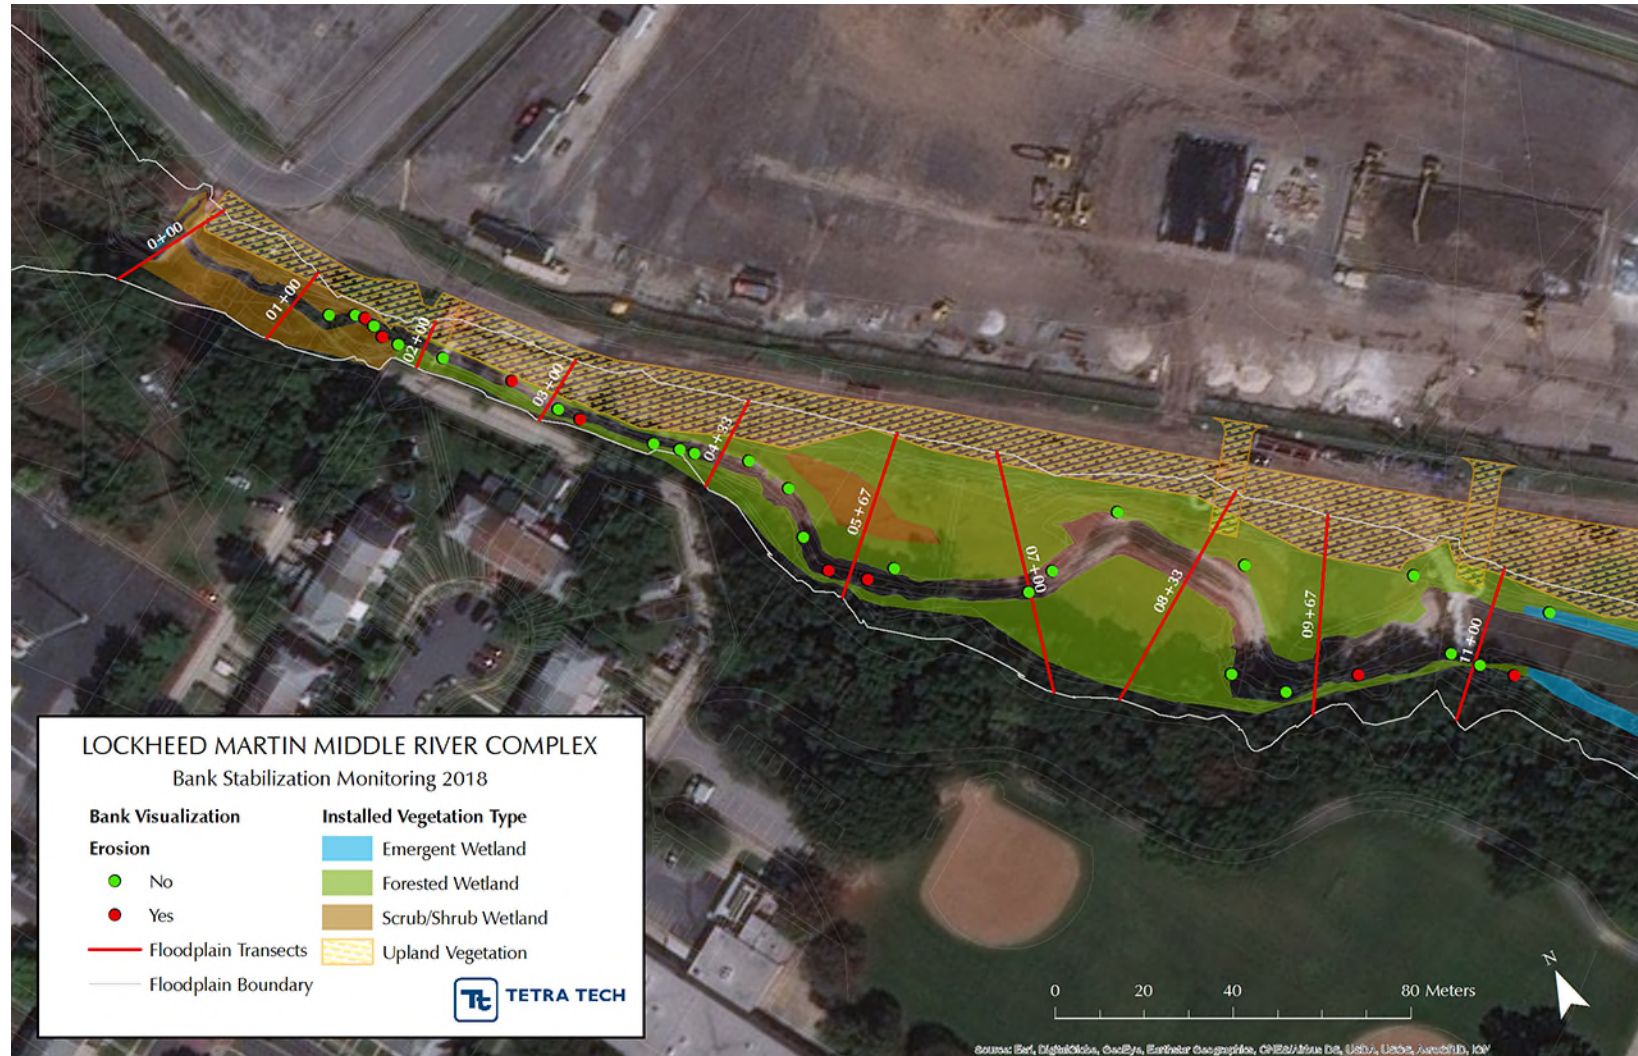
**Figure 4-3 Map of Cow Pen Creek study area showing locations of bank erosion, noted as lower endpoints of segments assessed along both streambanks. Upland and wetland vegetation types are from revegetation plan, Nov. 20, 2017**

Bank erosion (Figure 4-3) was observed along 8.1% (187 feet) of total bank length, 7% (160 feet) without vegetation, and 1.2% (27 feet) with vegetation. On the left bank, only one small area (noted as 9 linear feet) was eroding from under matting due to runoff (Figure A-2). On the right bank, erosion was noted in several sections (178 linear feet total), the longest (53 linear feet) of which was associated with a red clay bank, which had matting installed on the lower bank (Figure A-25).

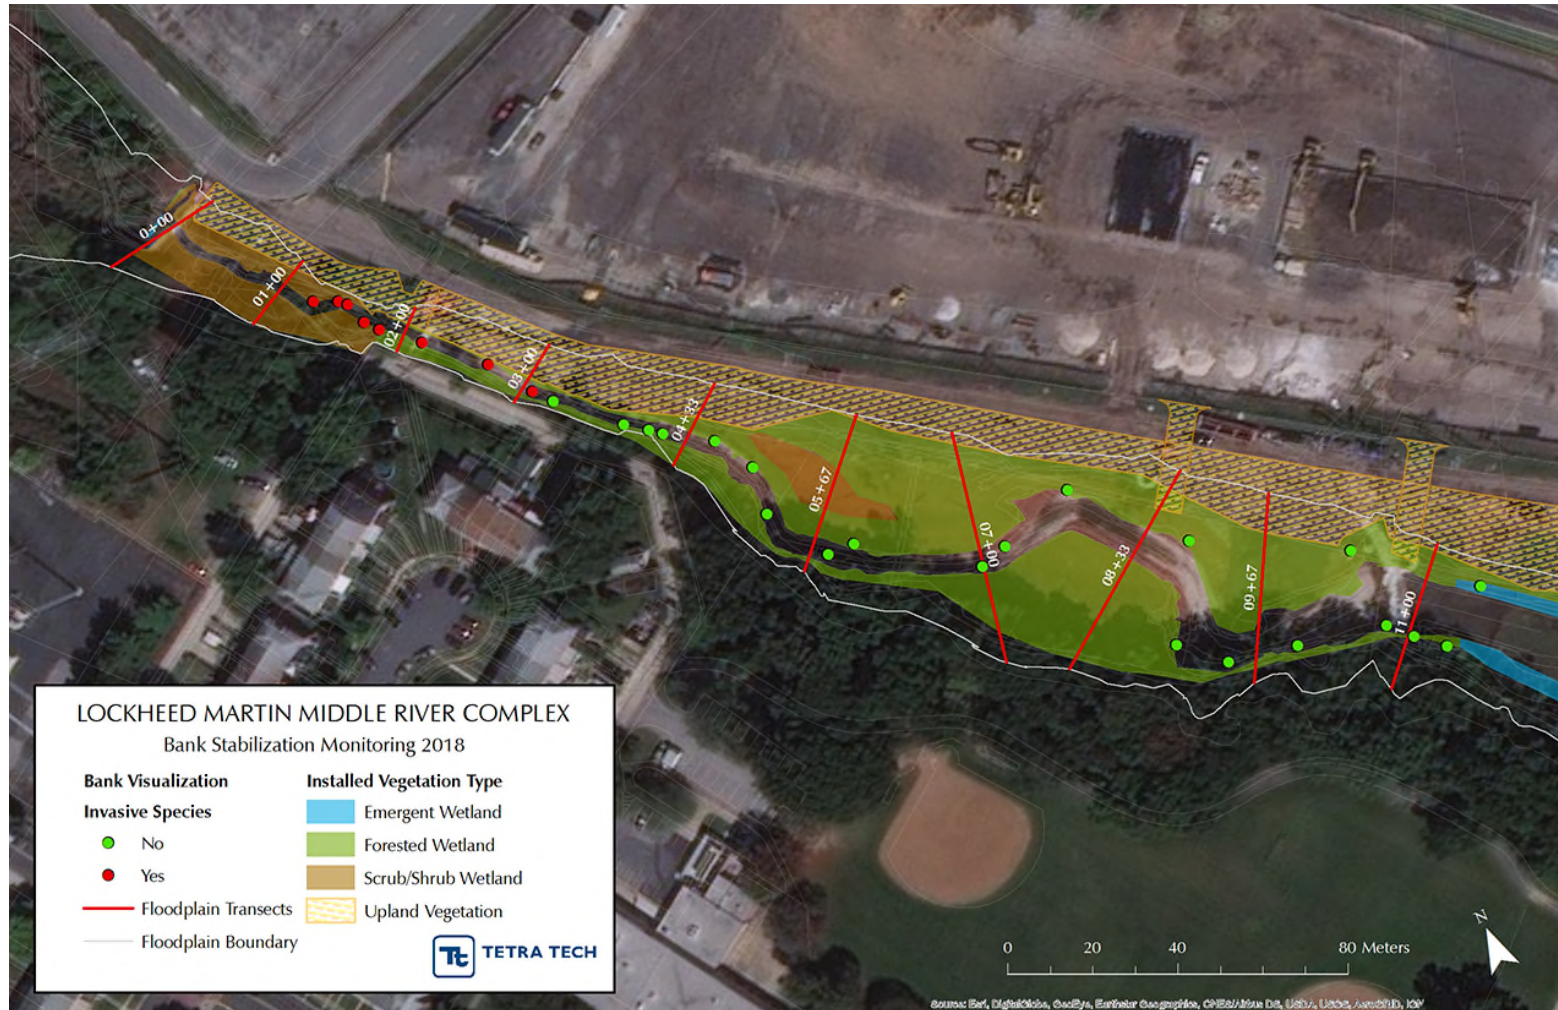
**Figure 4-4 Map of Cow Pen Creek study area showing locations of invasive plant species, noted as lower endpoints of segments assessed along both streambanks. Upland and wetland vegetation types are from revegetation plan, Nov. 20, 2017**

Phragmites was present along the streambank in some of the uppermost segments (see Figure 4-4); no other invasive plants were noted.

- Revisit areas noted with phragmites, determine whether treatments to date have effectively controlled growth of phragmites, and spray as needed to eliminate spreading.
- Address bare patches identified along streambank and in floodplain areas by replanting or reseeding.
- Address tree mortality, particularly in wet areas near the lower end of project area. Revise stabilization approach and species list, as this area is likely wetter than was originally anticipated. See the wetlands monitoring report for further discussion of tree mortality.

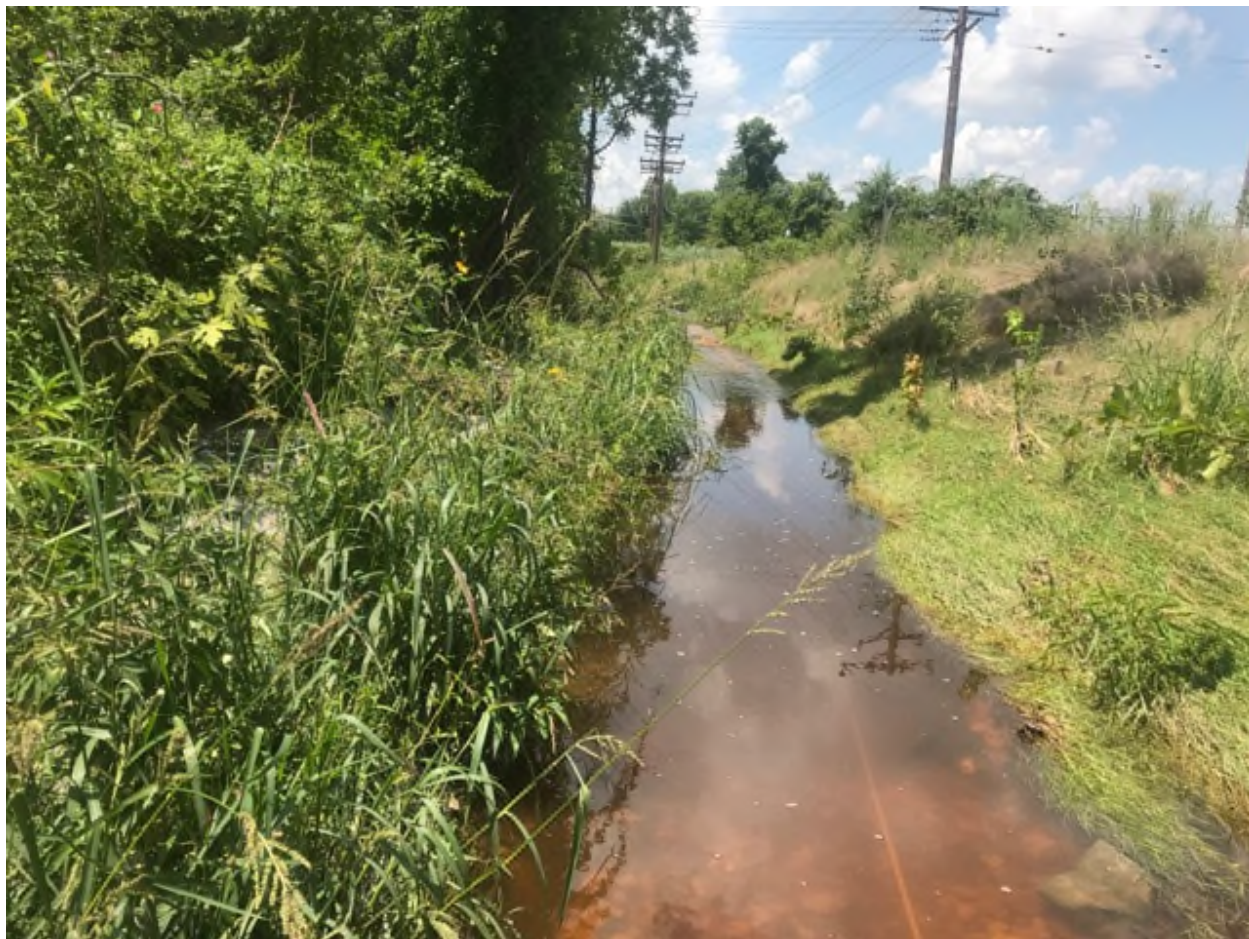
**Figure A-8. Right streambank, upstream view at station 03+05.**

rap along the right bank (see example, Figure A-10). A 119-foot portion of the lower right bank lacked vegetation but had matting in place and deposits of fine sediment (Figure A-19). Another two segments (93 feet total) of the lower right bank appeared to be unvegetated yet stable; these sections were near the downstream end of the project and were stabilized with matting, coir log, and wood (Figures A-26 and A-27). Overall, 1770 feet of the total bank length was vegetated, representing 82.6% of the unarmored bank length. Of this vegetated total bank length, 1743 feet were observed to be stable with no evidence of erosion. An example of stable, vegetated bank is shown on Figure A-8.

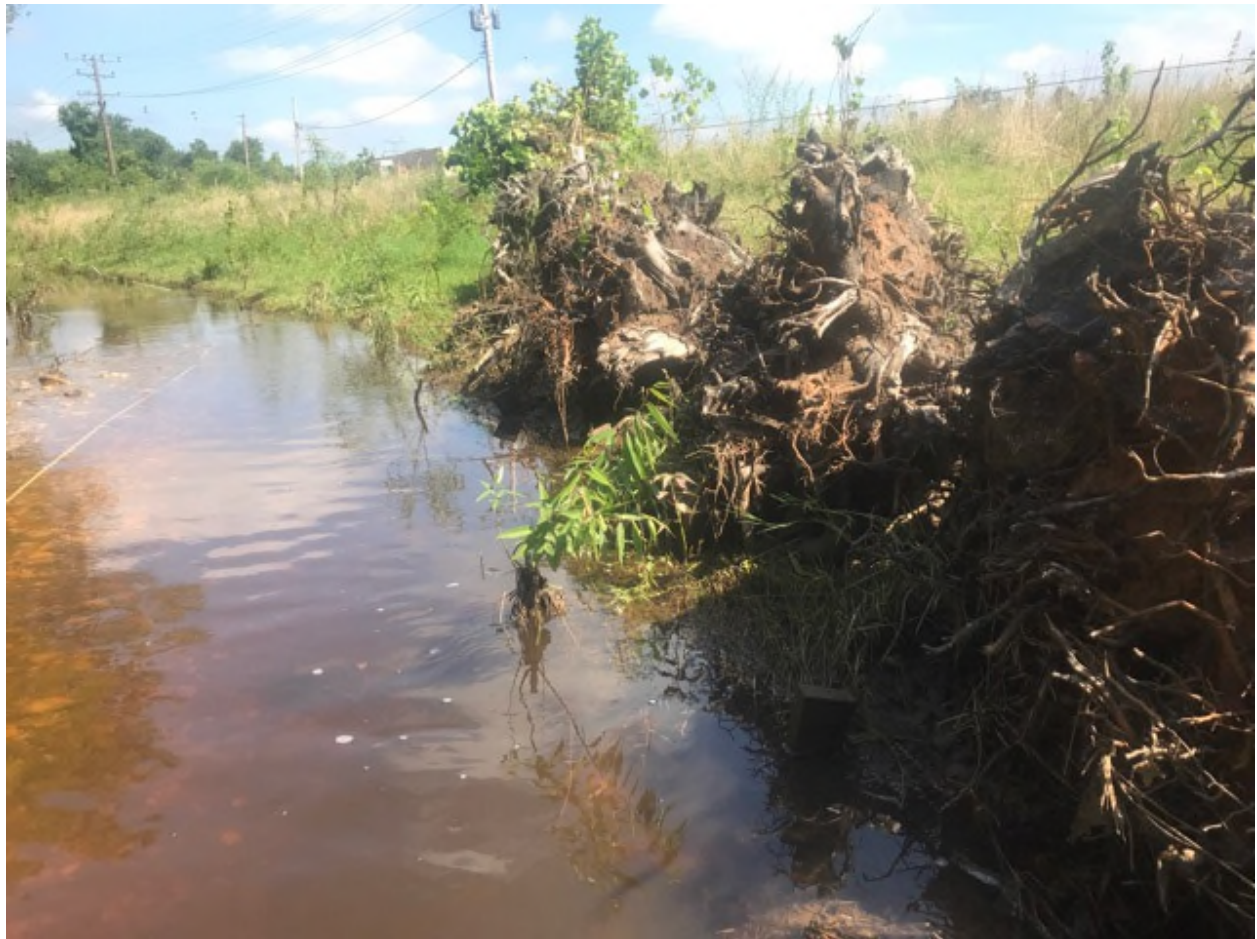
**Figure A-14. Left streambank, upstream view at station 04+88.**

Stable conditions were observed along 92% of total stream bank length (2113 of 2300 total feet). Stable banks without vegetation included several areas with structural stabilization treatments (158 feet total, 6.9% of total bank length), including a 34-foot section of the left bank armored with a rootwad structure (see Figure A-14) and several sections (124 feet total) of unvegetated rip-

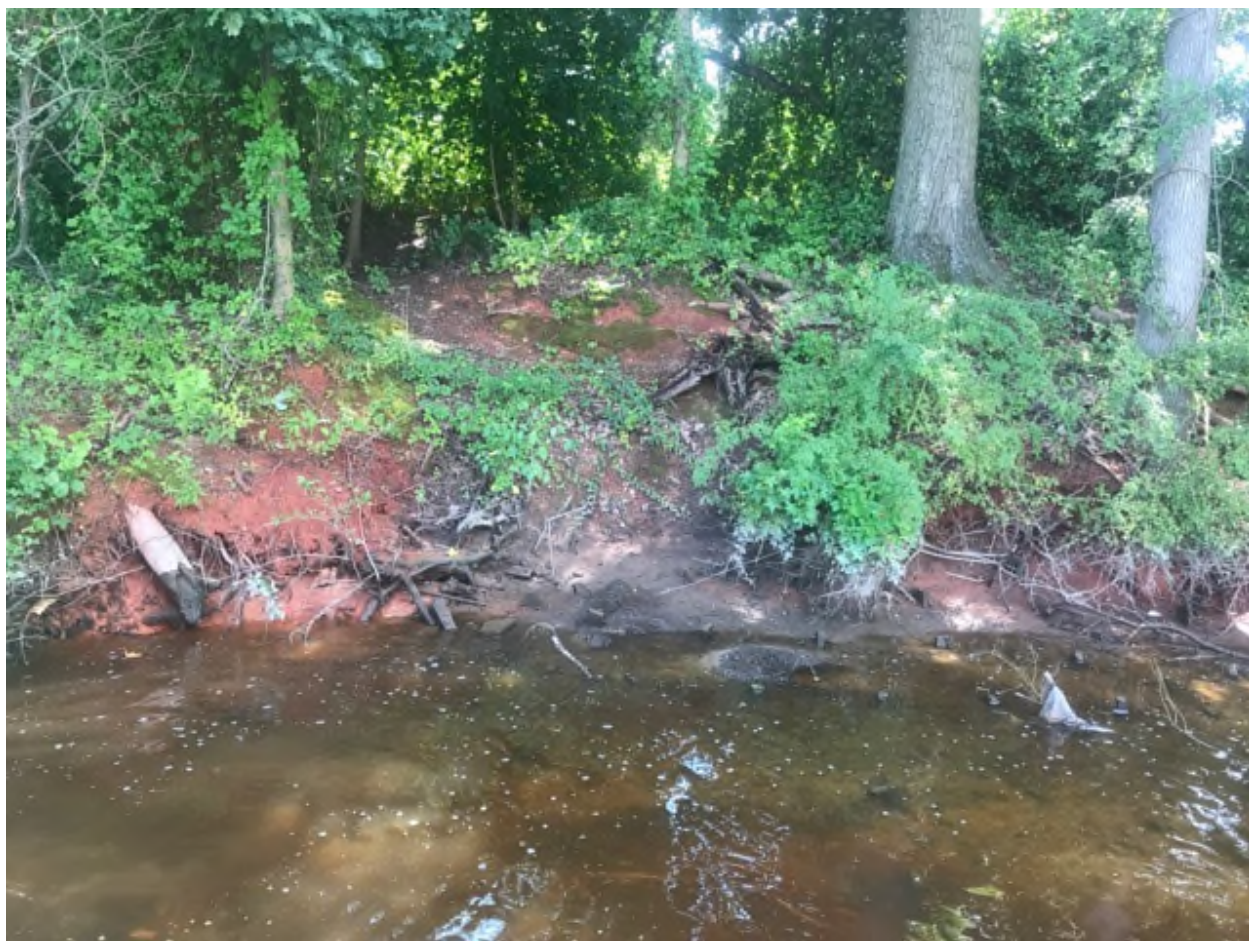
**Figure A-78. Barren area on the right streambank at station 05+25.**

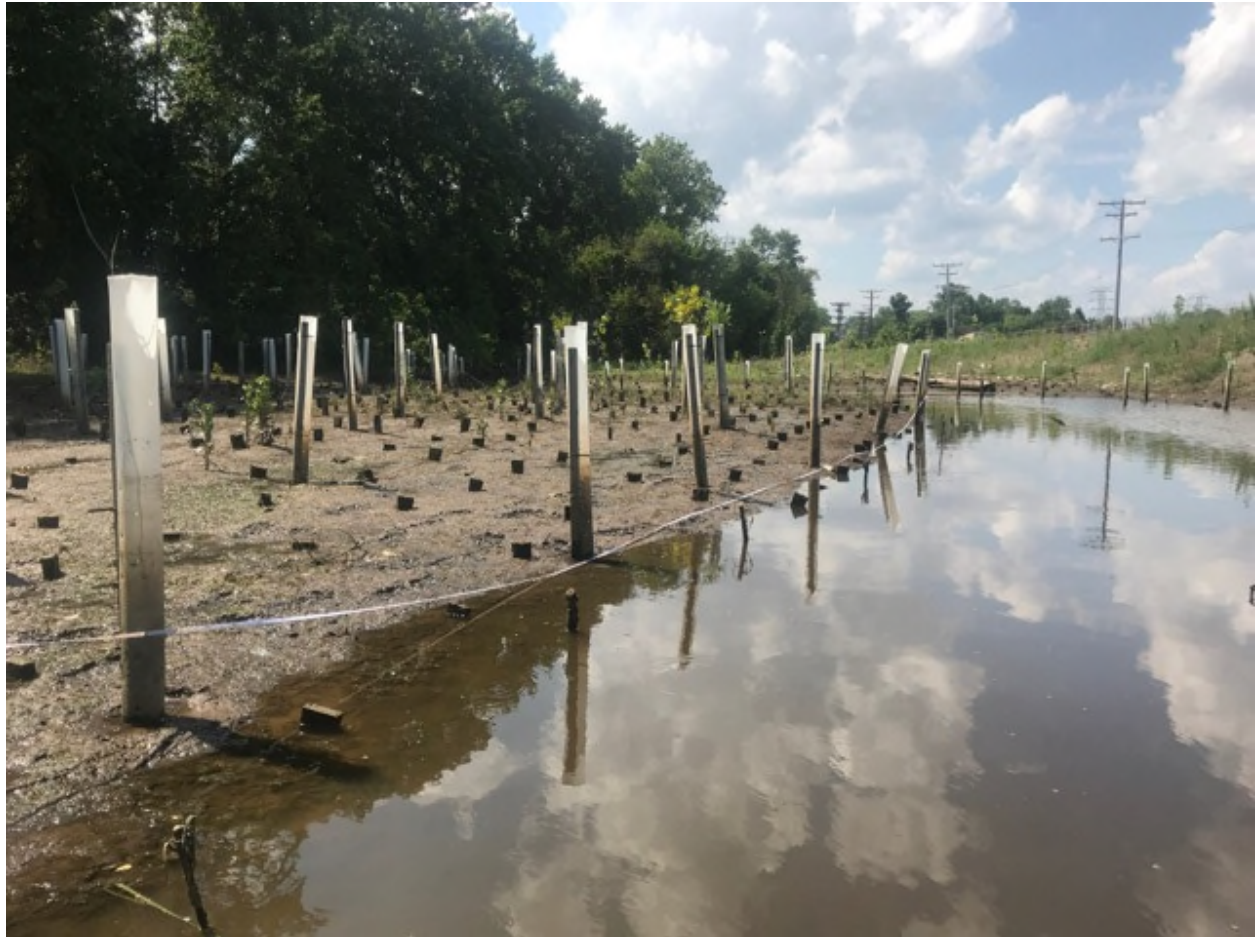
**Figure A-89. Barren wetland area on the right streambank at station 08+41.**
