Subject: Transmittal of the Cow Pen Creek Bank Stabilization and Floodplain Reconstruction Monitoring:
2019 Report
Lockheed Martin Corporation – Middle River Complex
2323 Eastern Boulevard, Middle River, Baltimore County, Maryland

**COW PEN CREEK
BANK STABILIZATION AND FLOODPLAIN
RECONSTRUCTION MONITORING: 2019 REPORT
LOCKHEED MARTIN MIDDLE RIVER COMPLEX
2323 EASTERN BOULEVARD
MIDDLE RIVER, MARYLAND**

Prepared by:
Tetra Tech, Inc.

January 2020

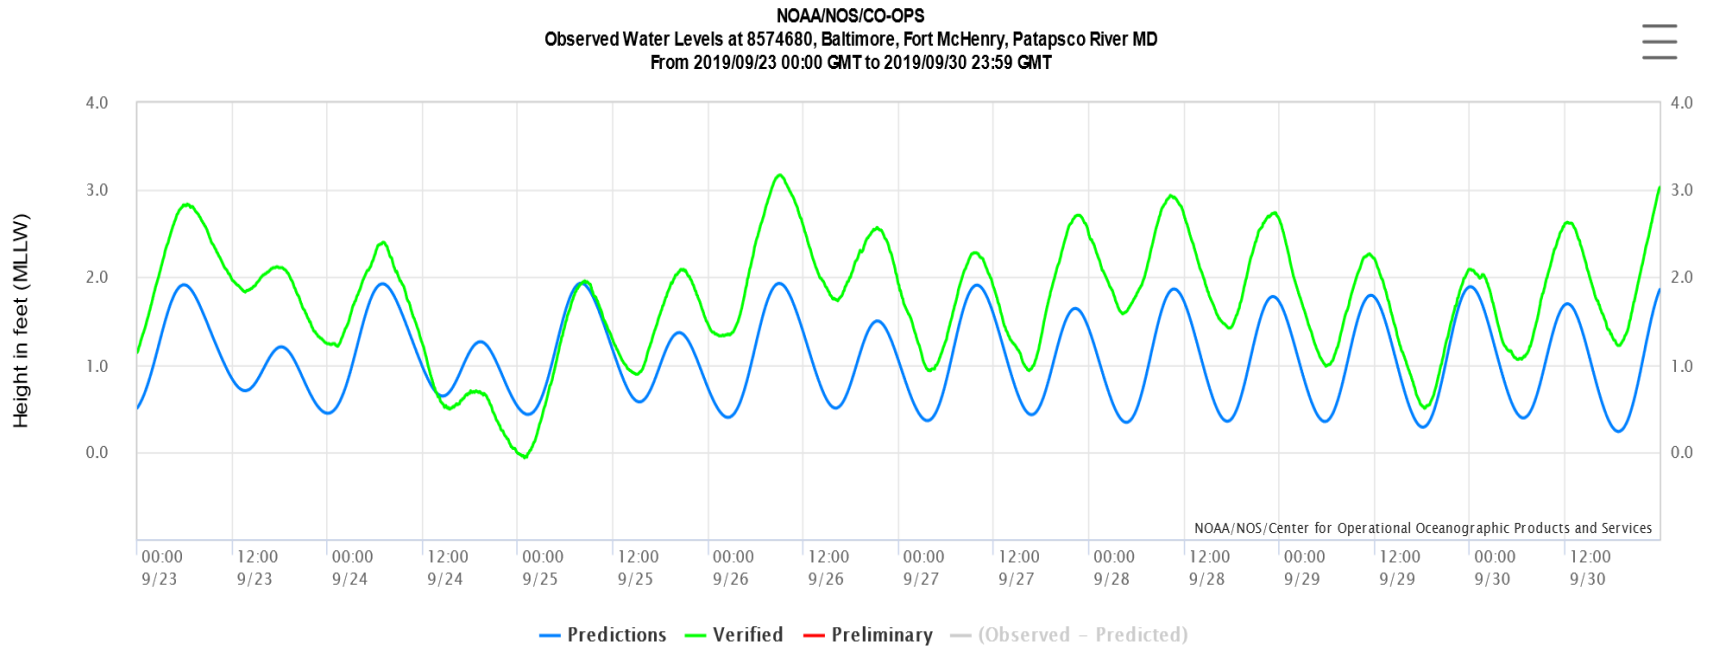
**Figure 3-4 Observed water levels at NOAA’s tidal observation station at Baltimore, Fort McHenry, Patapsco River September 23-30, 2019. Observed values (green line) are compared with long-term predicted levels (blue line).
NOAA data from**

Observed tidal water levels in Baltimore Harbor at NOAA's Fort McHenry station, Patapsco River, from September 23-30, 2019 are presented in Figure 3-4. Tide levels during the days preceding the monitoring were above long-term predicted levels.

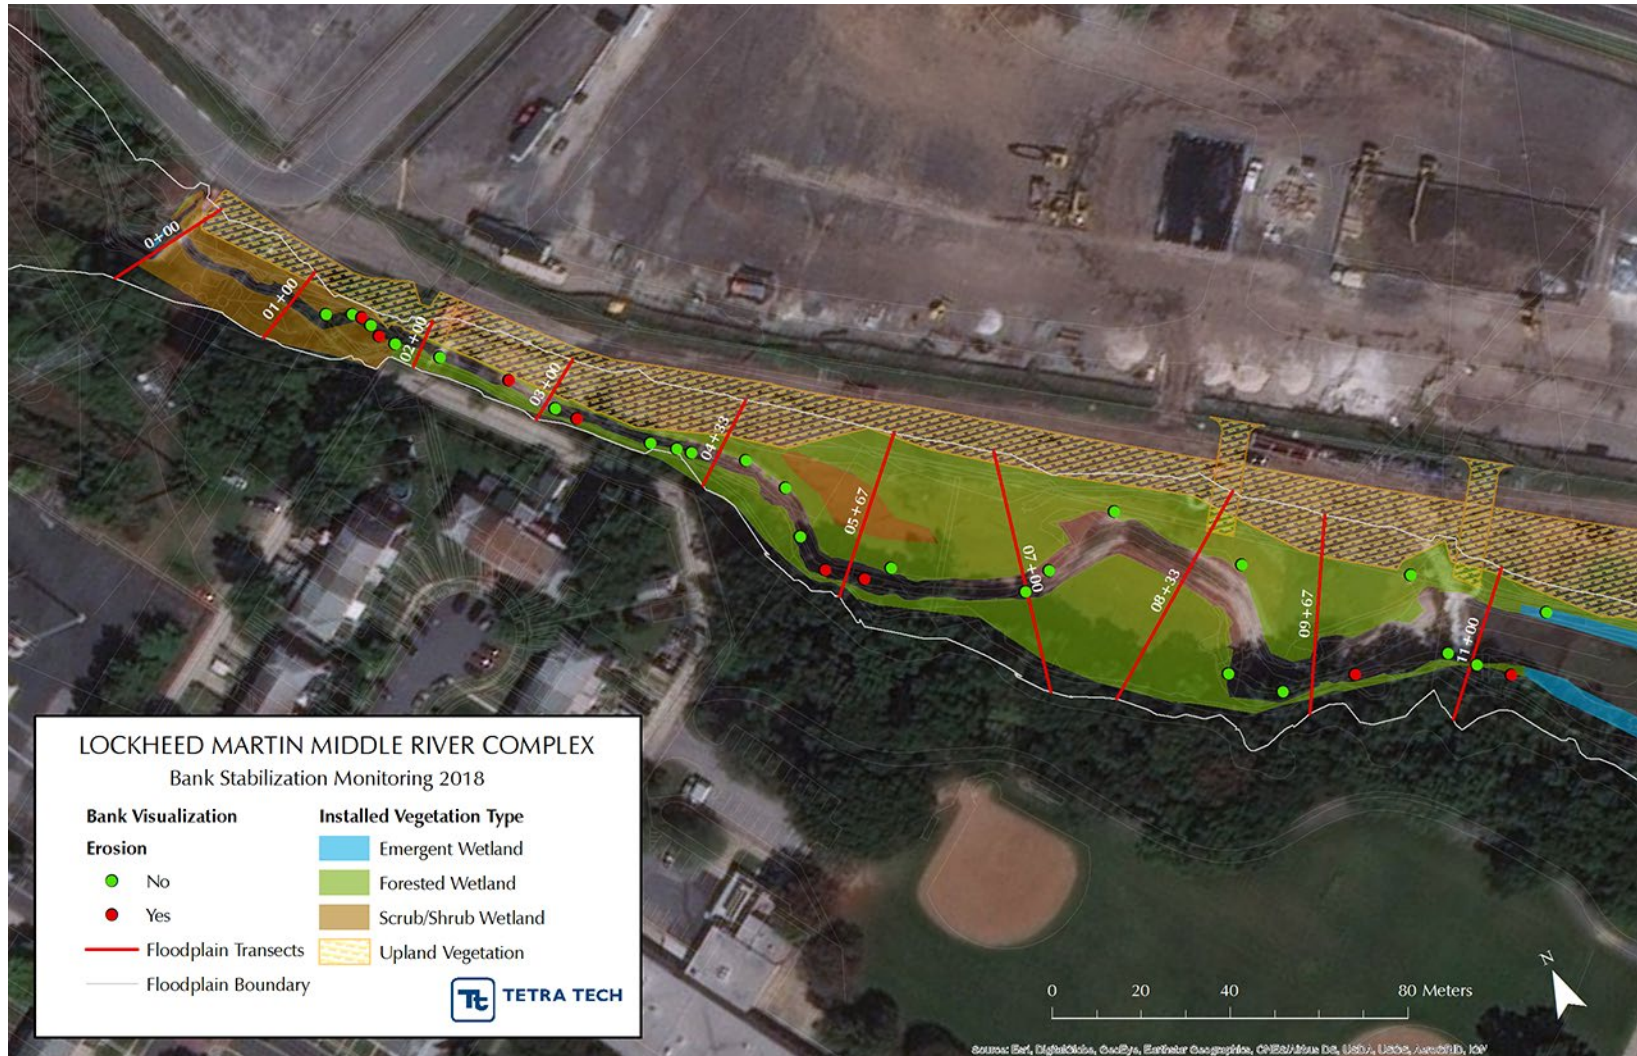
Figure 4-5. Map of Cow Pen Creek study area showing 2018 locations of bank erosion, noted as lower endpoints of segments assessed along both streambanks. Upland and wetland vegetation types are from November 2017 revegetation plan.

Bank erosion was observed along 8% (187 feet) of total bank length, with 7% (160 feet) without vegetation, and 1.2% (27 feet) with vegetation. On the left bank, only one small area (noted as 9 feet) was eroding from under matting due to runoff. On the right bank, erosion was noted in several sections (178 feet total), the longest (53 feet) of which was associated with a red clay bank, which had matting installed on the lower bank.

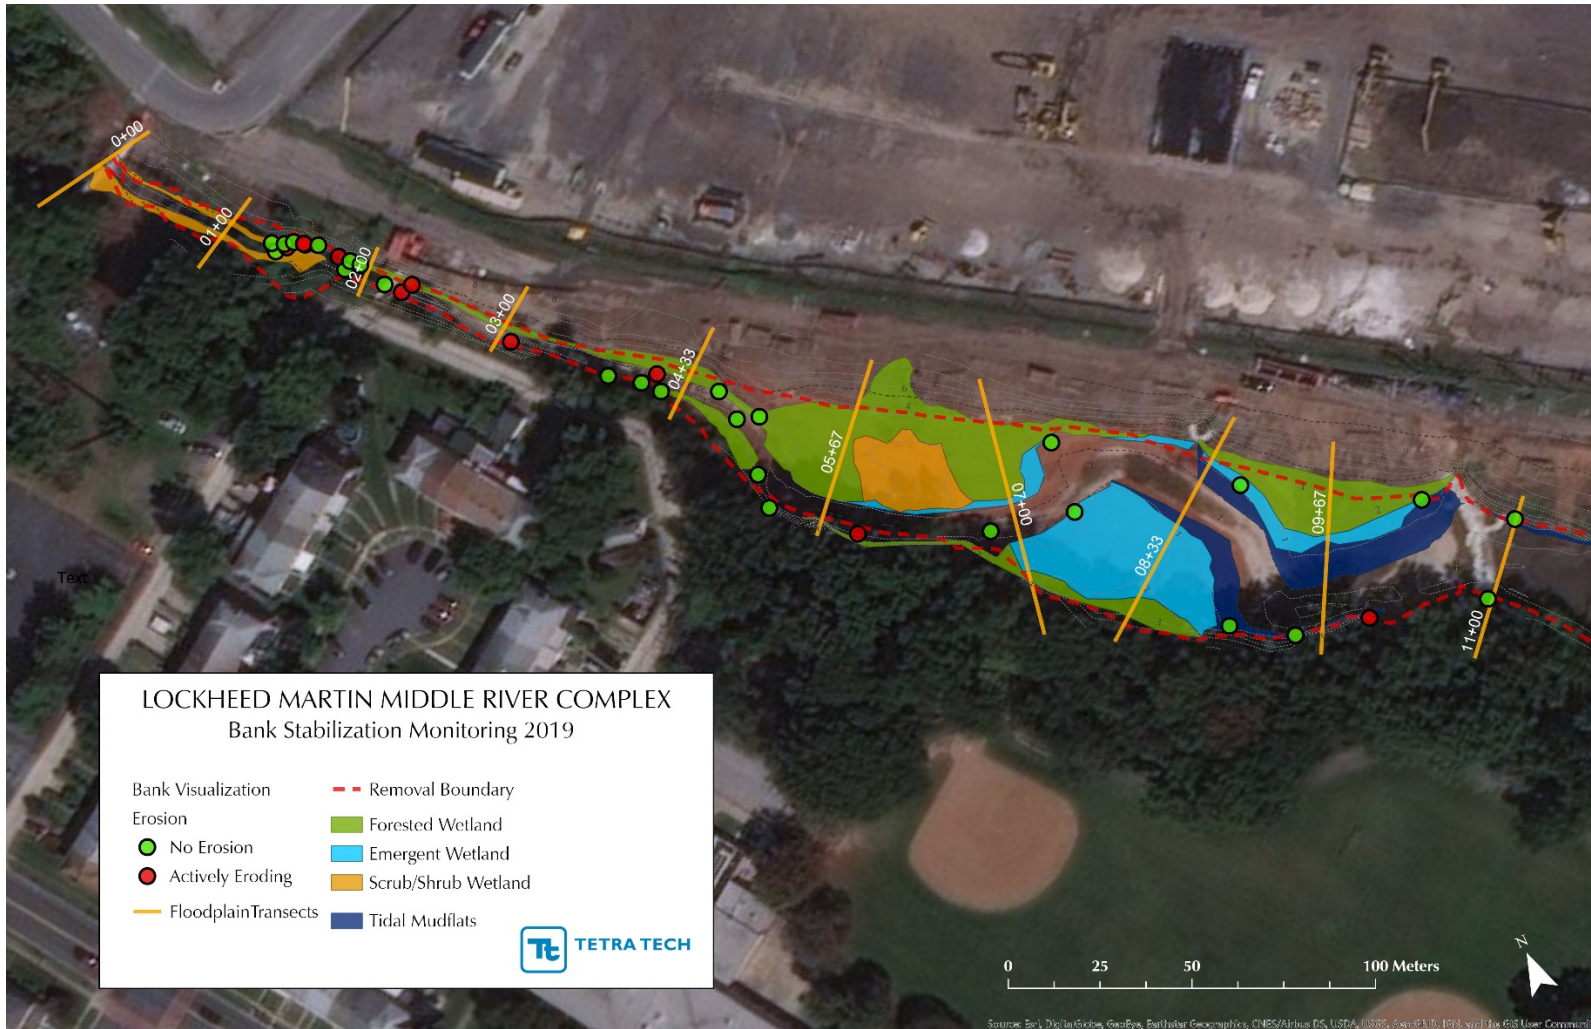
Figure 4-6. Map of Cow Pen Creek study area showing 2019 locations of bank erosion, noted as lower endpoints of segments assessed along both streambanks. Upland and wetland vegetation types are from the August 2019 wetland survey (Tetra Tech 2019).

Bank conditions were rated as stable along 90% of total stream bank length (1,975 of 2,197 total feet), and much of that length (1,931 feet) was vegetated. Stable banks without vegetation included one area with structural stabilization treatments (23 feet total, 1.2% of total bank length), namely a 23-foot section of the right bank armored with rip-rap and log structures. Another 19-foot portion of the right bank lacked vegetation but had matting in place, providing bank stabilization, and the presence of nearby small willows was noted.

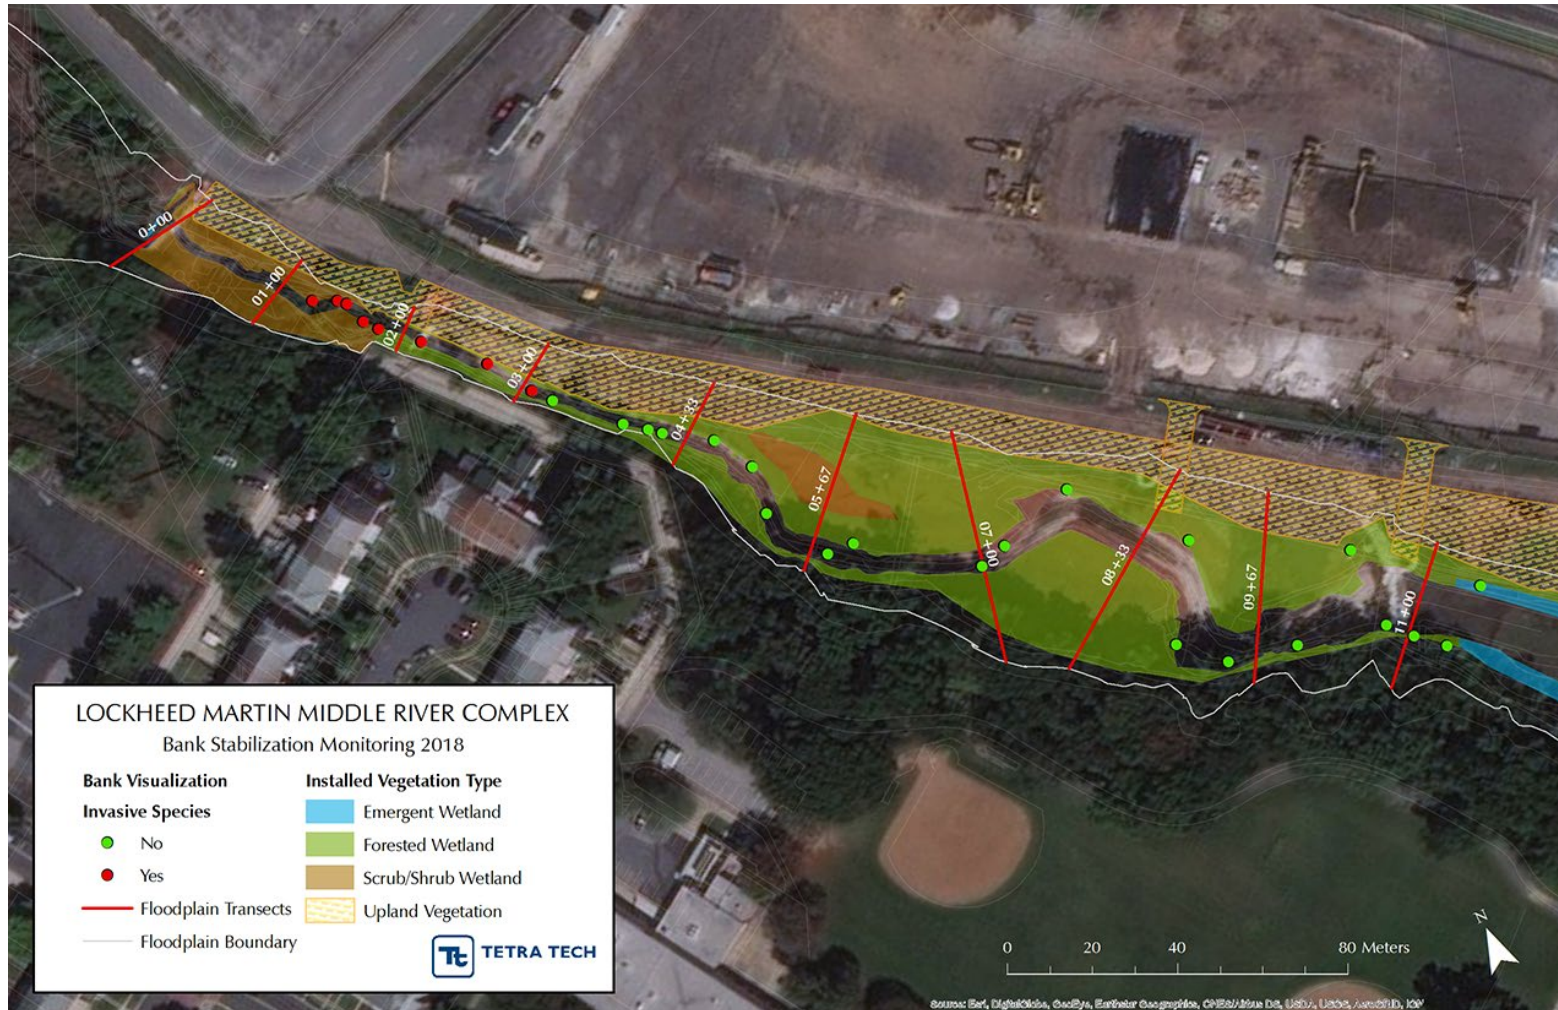
Figure 4-7. Map of Cow Pen Creek study area showing 2018 locations of invasive plant species, noted as lower endpoints of segments assessed along both streambanks. Upland and wetland vegetation types are from November 2017 revegetation plan (Tetra Tech 2017).

Common reed (*Phragmites australis*) was present along the streambank in some of the uppermost segments; no other invasive plants were noted.
