# Middle River Complex Photo Tour - Groundwater Treatment System Construction

August, 2013

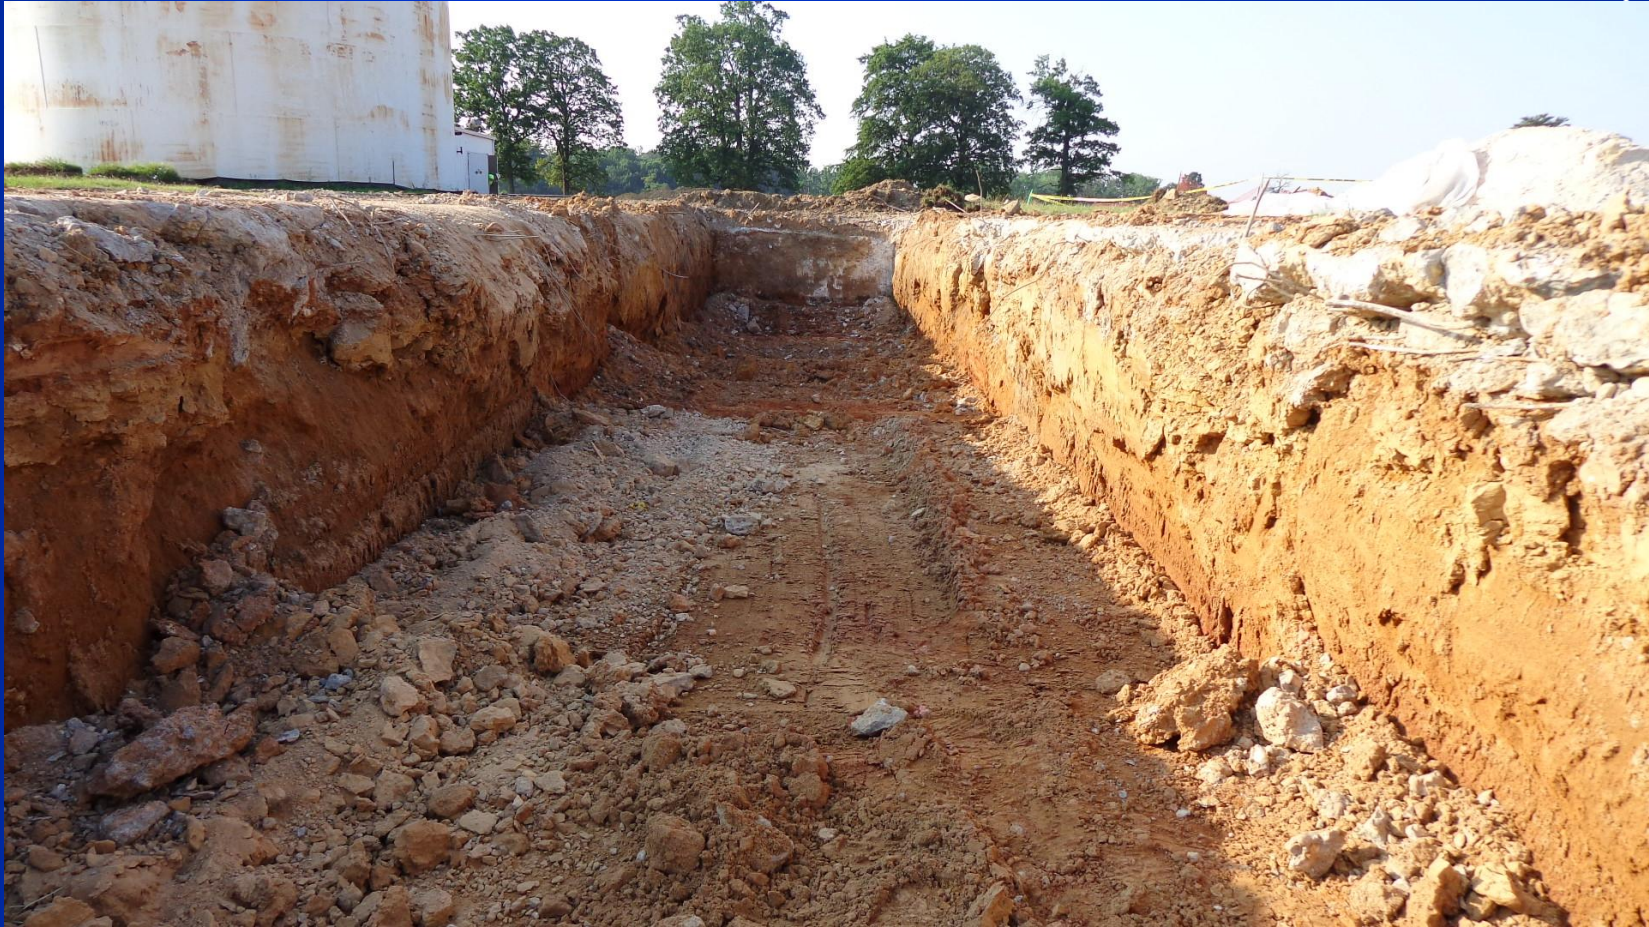
**Trench digging, soil evaluation and removal as needed, and site preparation began in June 2013 in preparation for groundwater treatment system construction. Initial work was performed at Block E, the location of the former Building D, in the area near the water tower.**

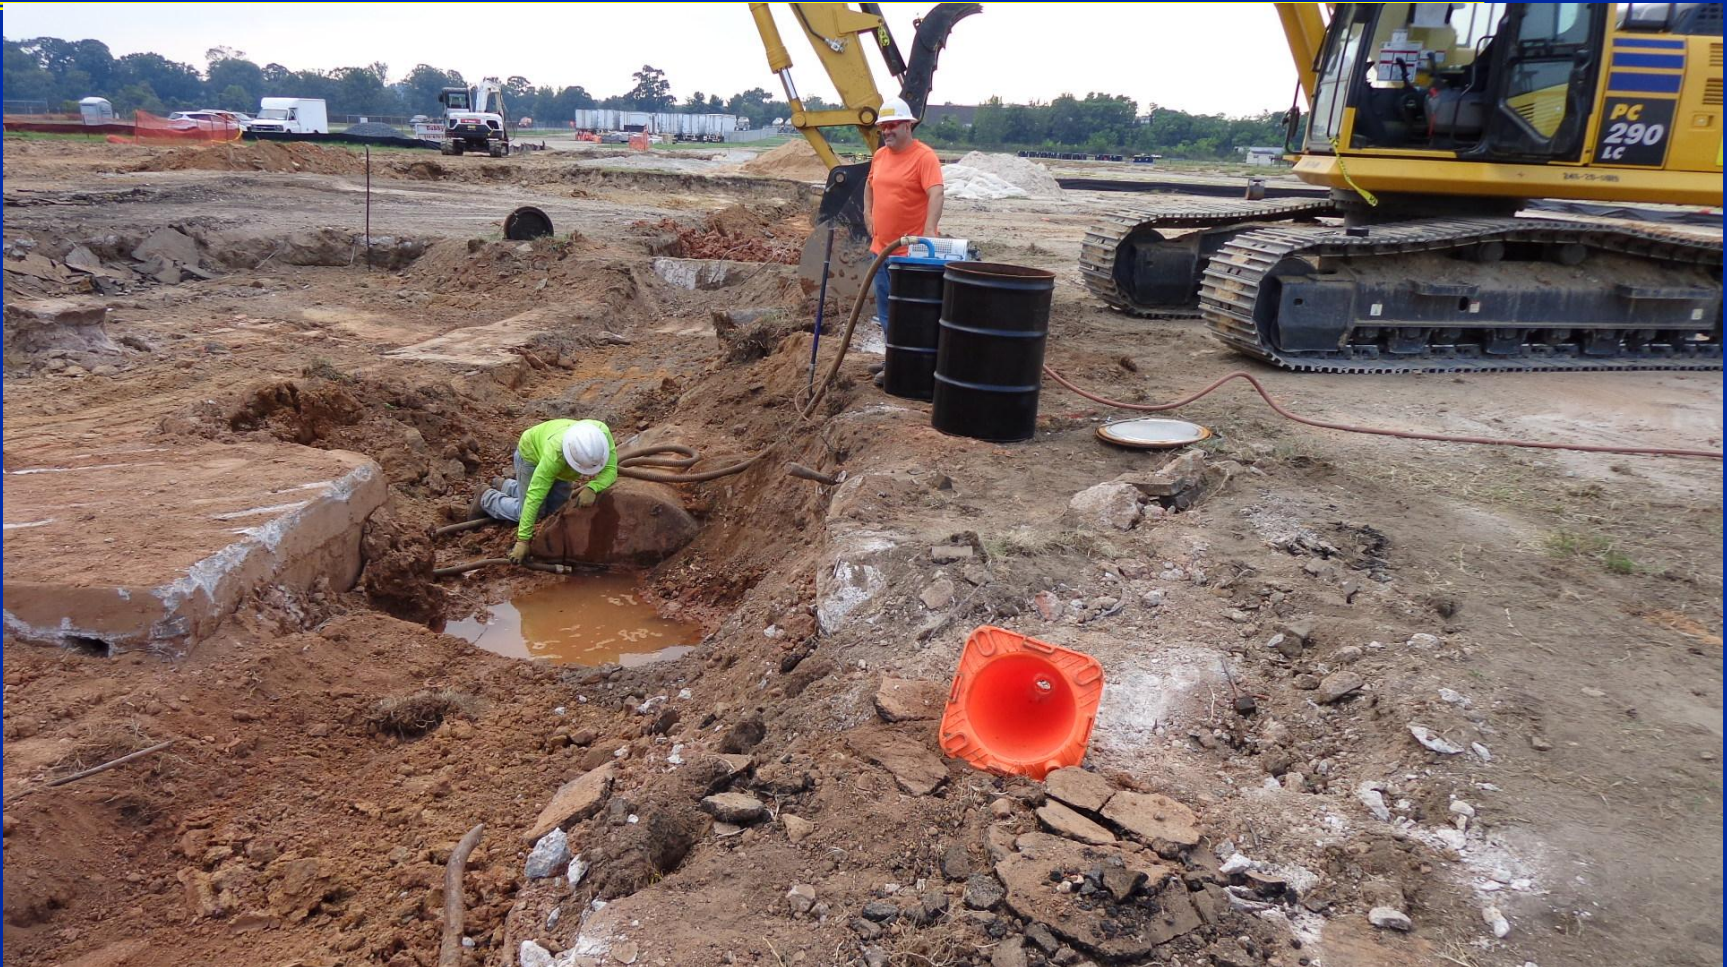
**Additional challenges came with the discovery of the first of two unexpected underground tanks.**

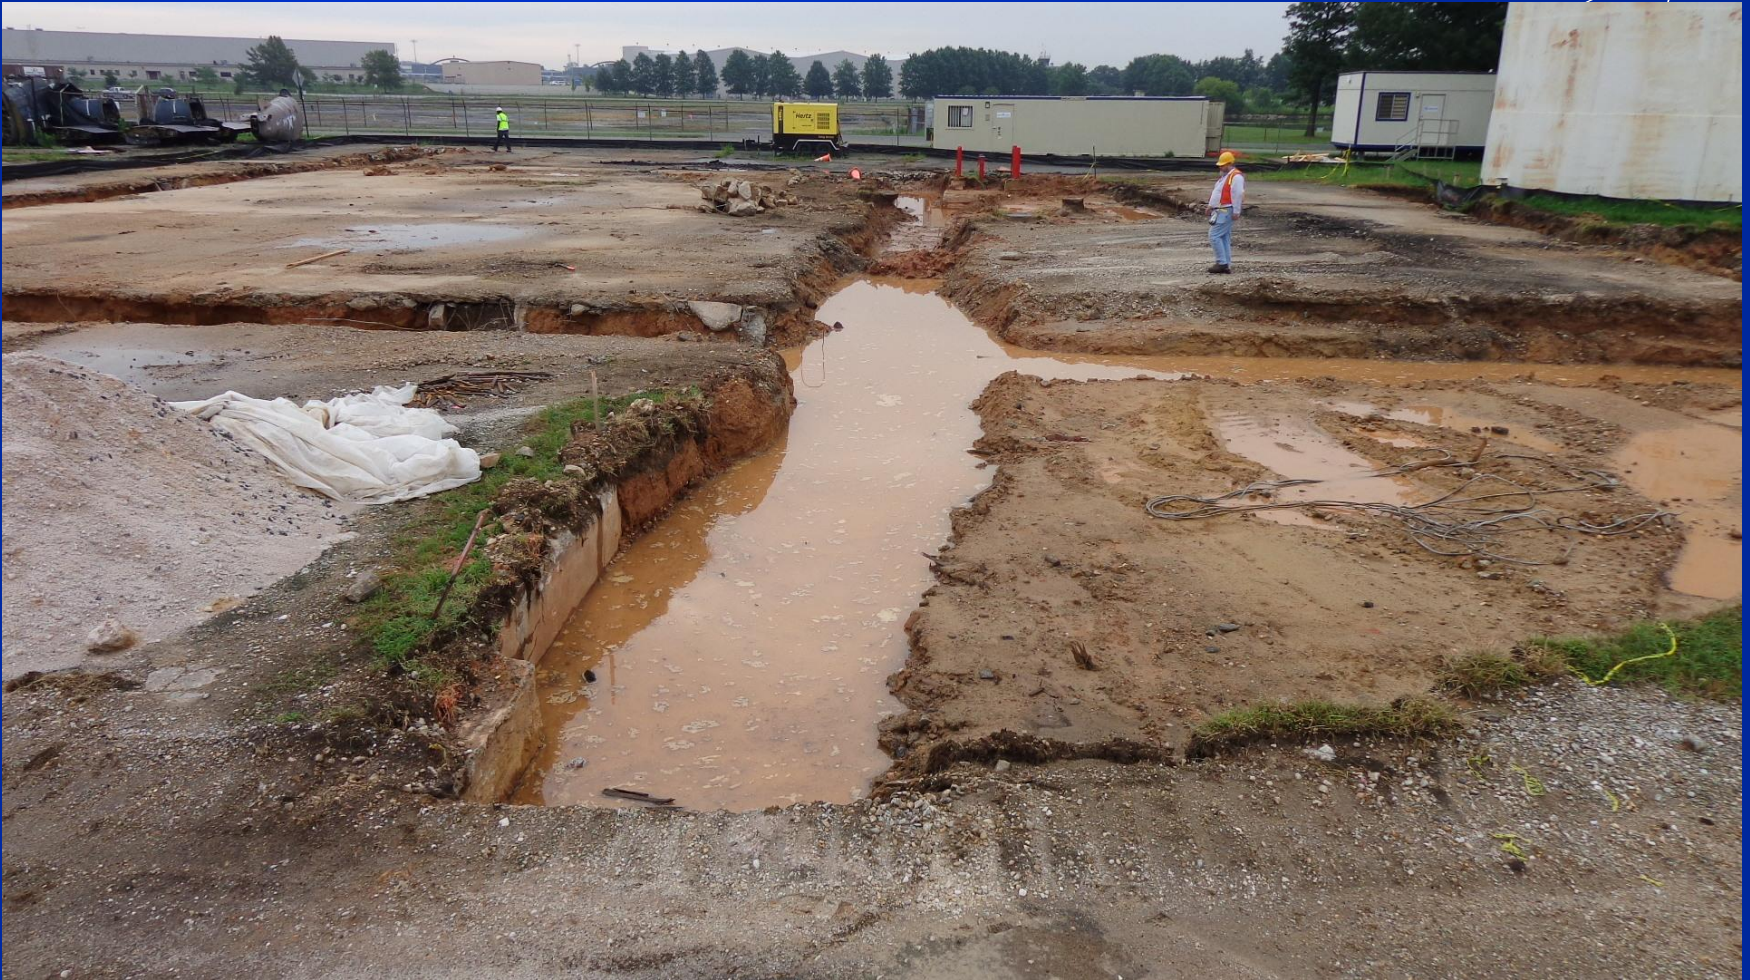
**The first unexpected underground storage tank held waste water and had stored petroleum/diesel. Contents were drained, drummed and tested for proper disposal.**

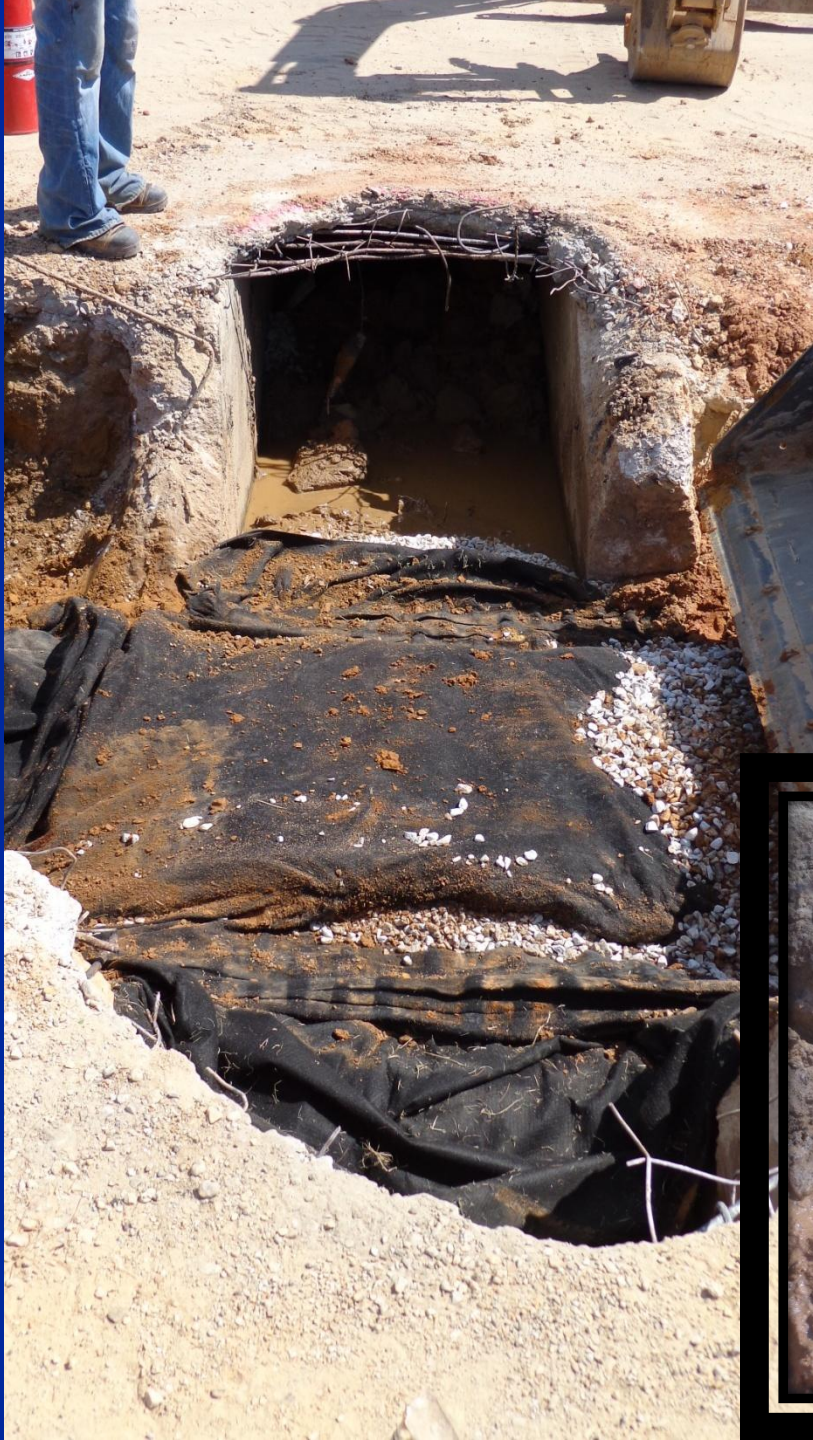
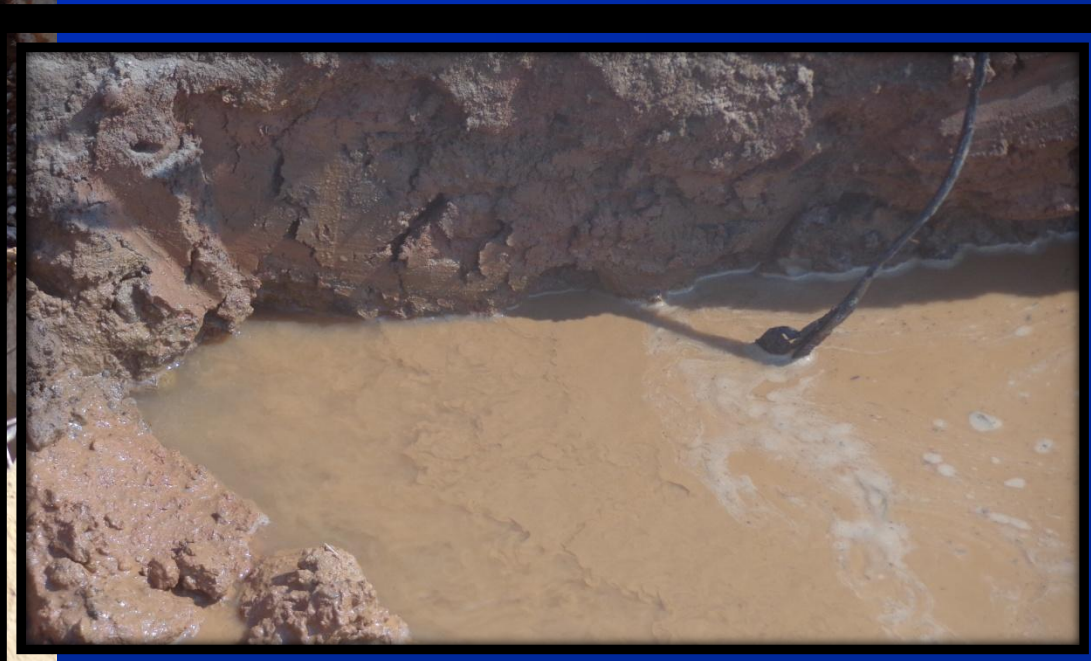
**Complications uncovered during construction included discovery of ventilation ducts (left), French drains (below), and other infrastructure located beneath former Building D, which unfortunately served to collect and drain rainwater.**

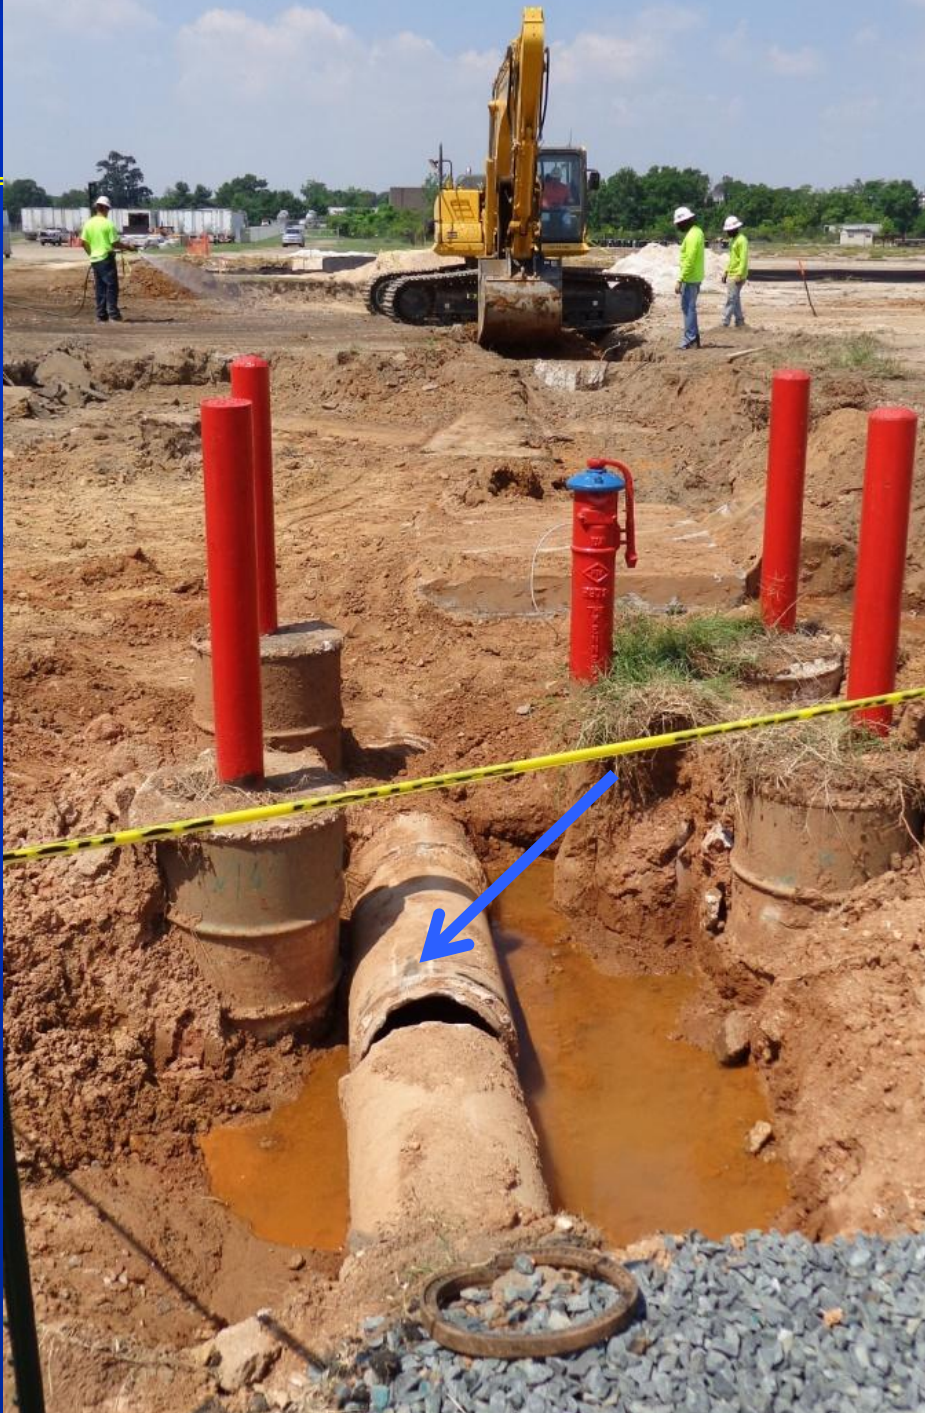
**A broken storm pipe is discovered and needed repair before being returned to use.**

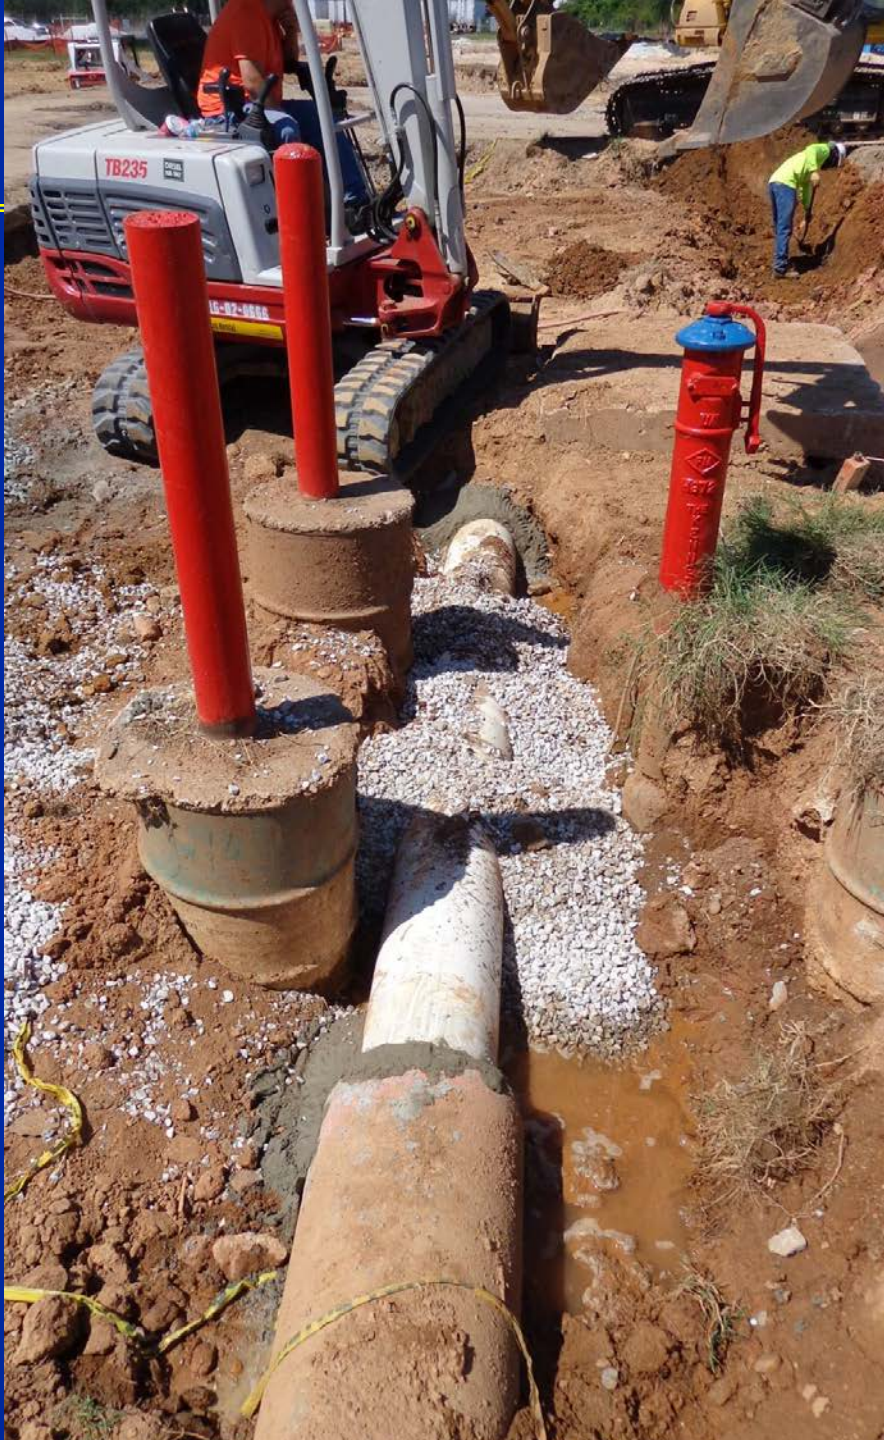
**The damaged storm pipe is repaired.**

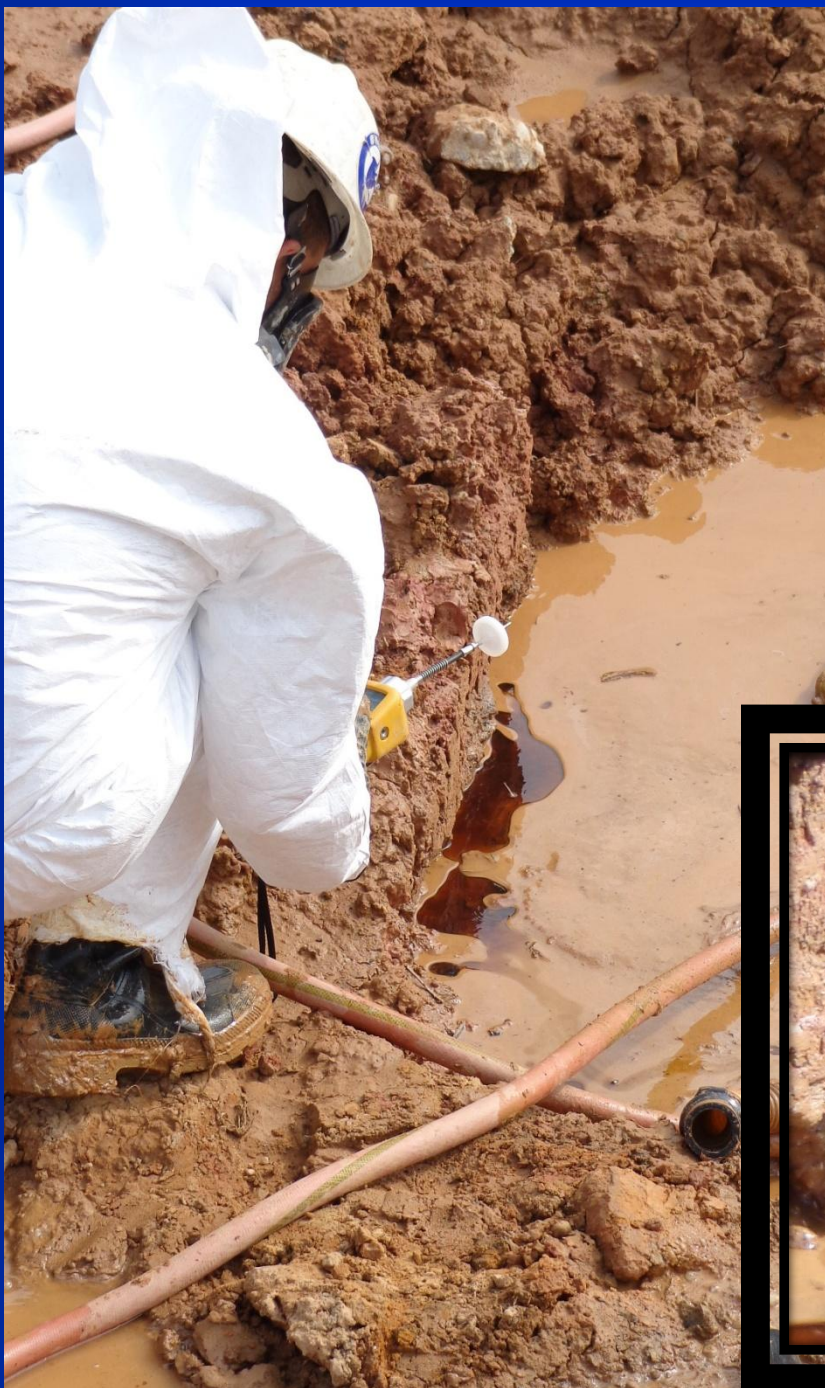
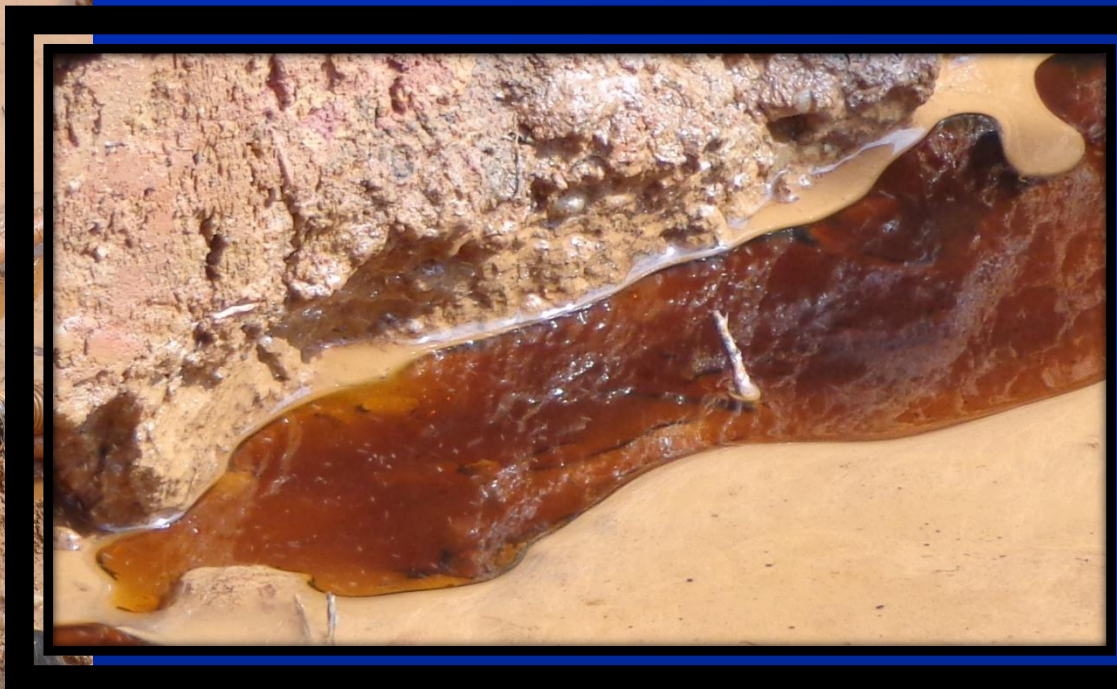
**A second unexpected underground storage tank contained trichloroethene (TCE), water and sediment, requiring additional worker protection measures be taken, and expanded air monitoring to help identify contaminants. The tank contents were drained and properly disposed.**

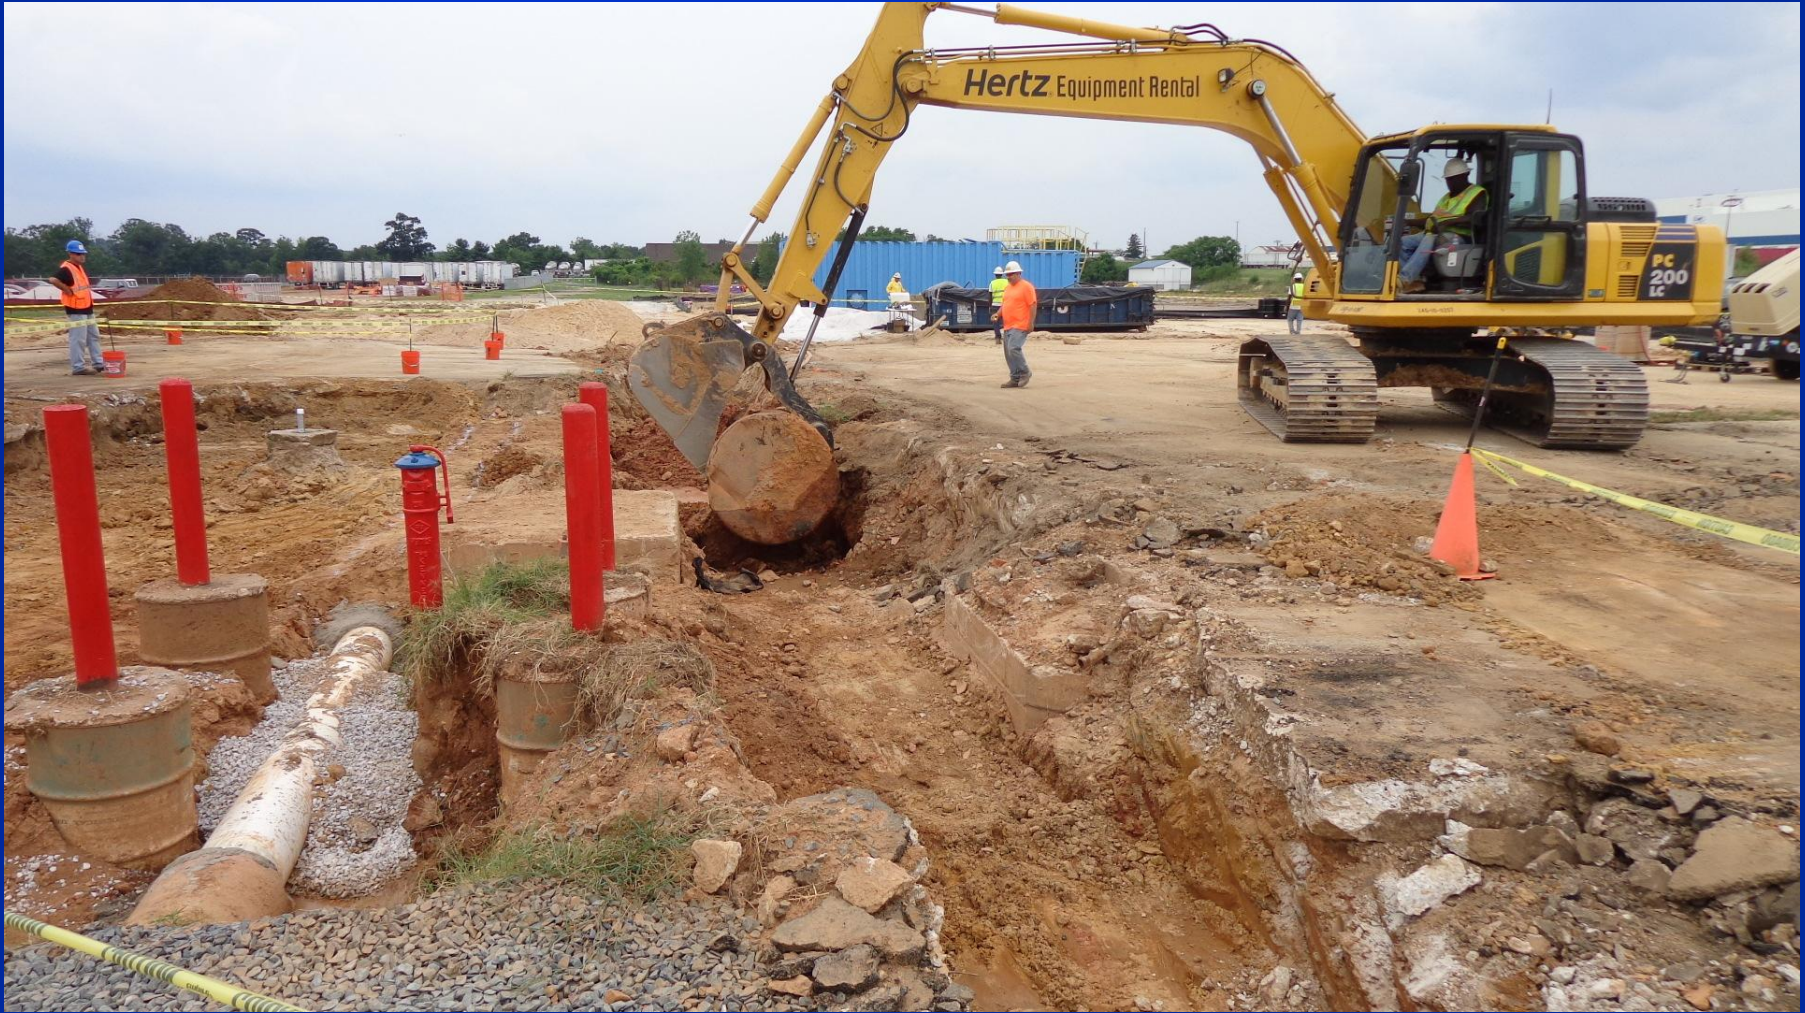
**The second unexpected underground storage tank, which had contained TCE, was removed for proper disposal.**
