**Lockheed Martin Corporation**  
**6801 Rockledge Drive MP: CCT-246**  
**Bethesda, MD 20817**  
**Telephone 301-548-2209**

**Subject: Building A Sub-Slab Depressurization-System Assessment and Indoor Air Quality Monitoring, Building A, Middle River Complex, Middle River, Maryland**

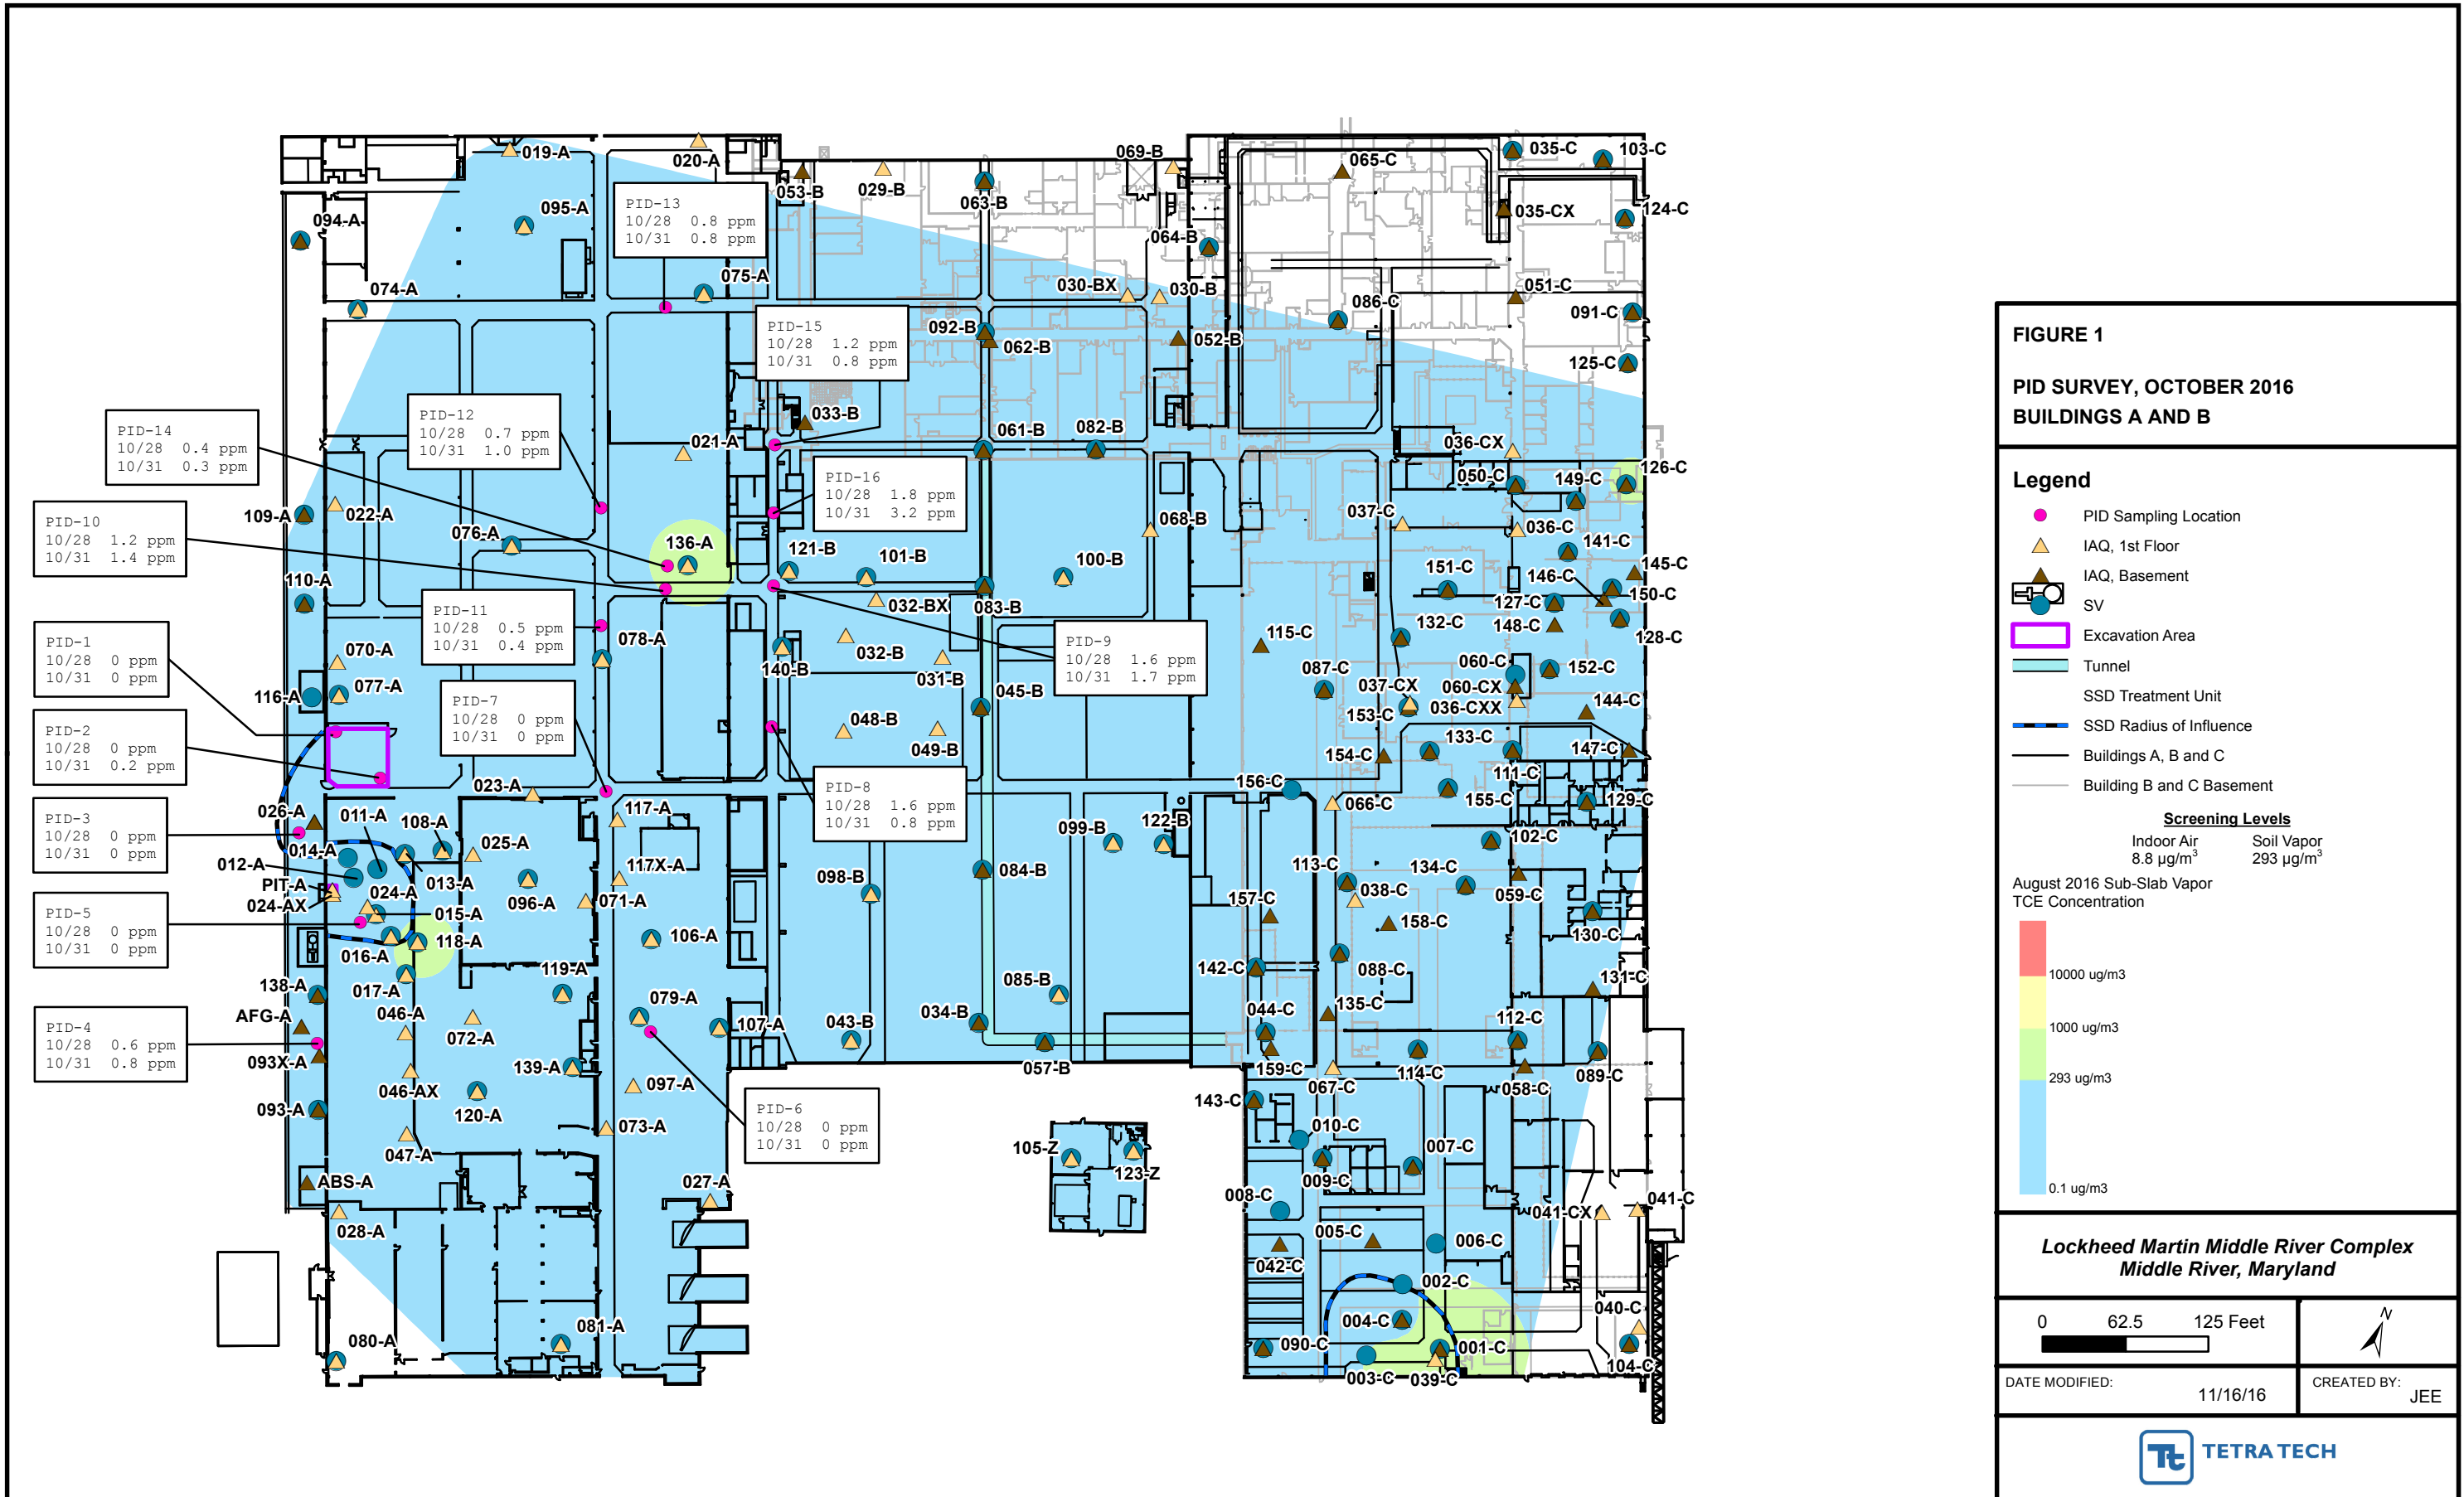
**FIGURE 1**  
**PID SURVEY, OCTOBER 2016**  
**BUILDINGS A AND B**

Concentrations ranging from zero ppm to 3.2 parts per million (ppm) were detected in areas surrounding SV-136-A. The highest PID reading detected during the two surveys was in an open walkway west of SV-136-A. This concentration was greater than the PID results (0.3 ppm and 0.4 ppm) detected immediately adjacent to SV-136-A. The PID measured no detectable readings (0 ppm) at the MRAS excavation area north of the former plating shop. Indoor air sampling locations and rationales are in Table 1. Sampling locations and PID survey results are shown on Figure 1.

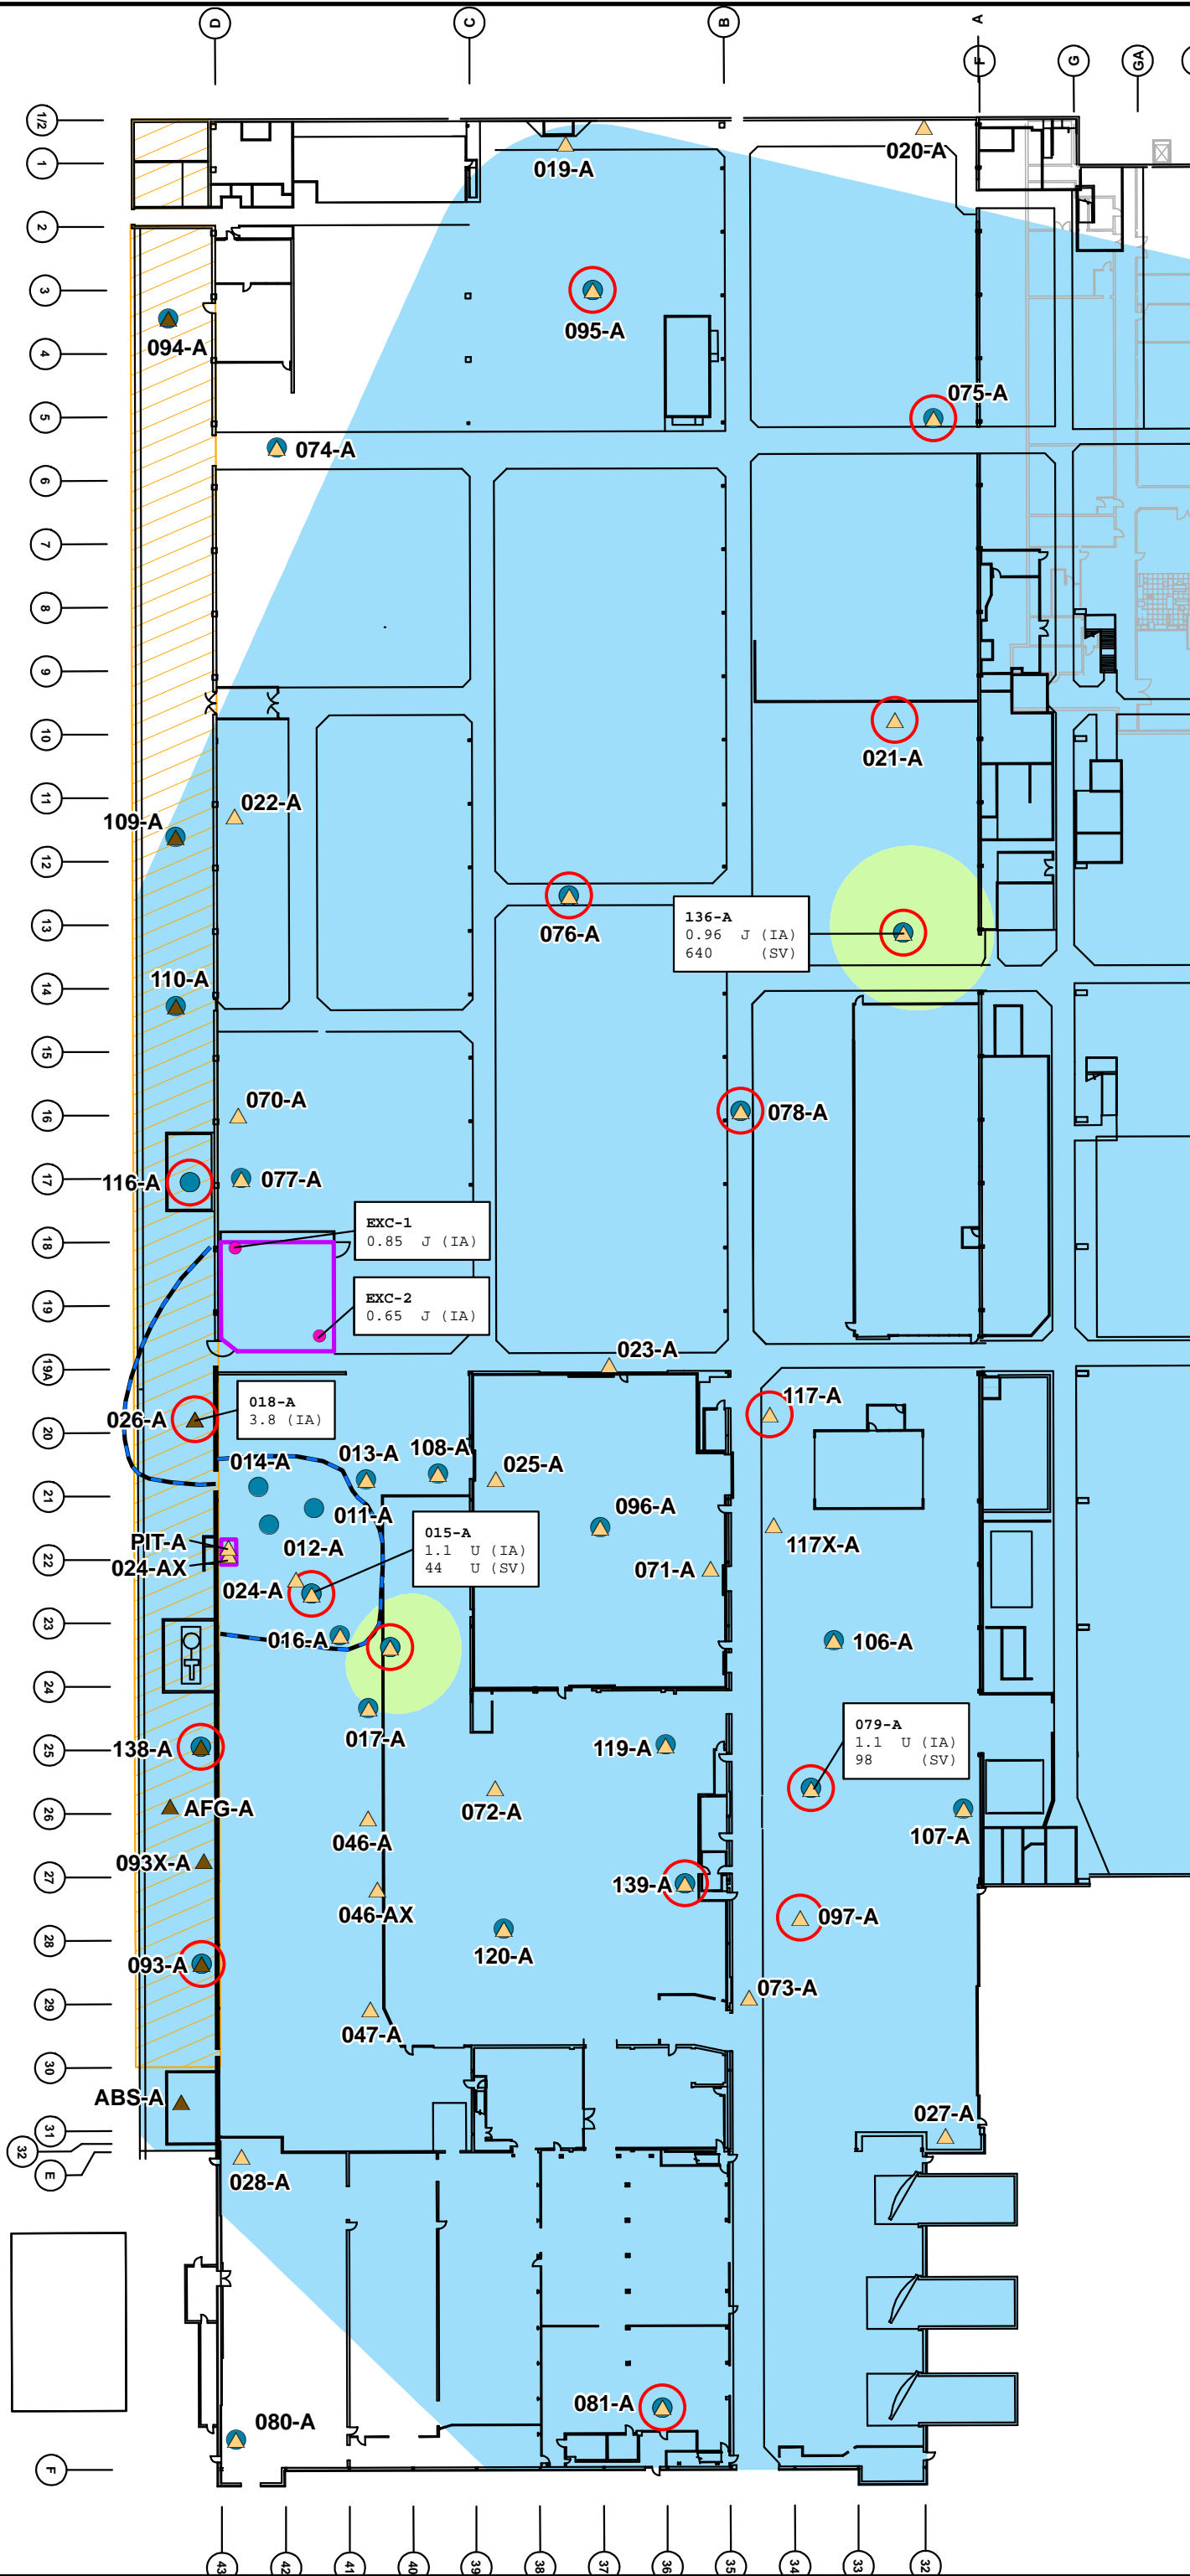
FIGURE 2

Table 2 compares TCE results from the Summa<sup>®</sup> canister sampling to PID survey results at each sampling location. Summa<sup>®</sup> canister sampling locations and results are shown on Figure 2. No exceedances of the indoor air screening level ( $8.8 \mu\text{g}/\text{m}^3$ ) were observed. One TCE exceedance ( $640 \mu\text{g}/\text{m}^3$ ) of the sub-slab screening level ( $293 \mu\text{g}/\text{m}^3$ ) was detected at location SV-136-A. This sub-slab exceedance does not affect human exposure.
