Subject: **Building C Air Sampling due to Recent Flooding**
 Sampling and Analysis Summary
 Middle River Complex, Middle River, Maryland

Table 1
Analytical Summary
Building C Basement Flooding Air Sampling
Middle River Complex
Middle River, Maryland

PHOTOGRAPHIC LOG

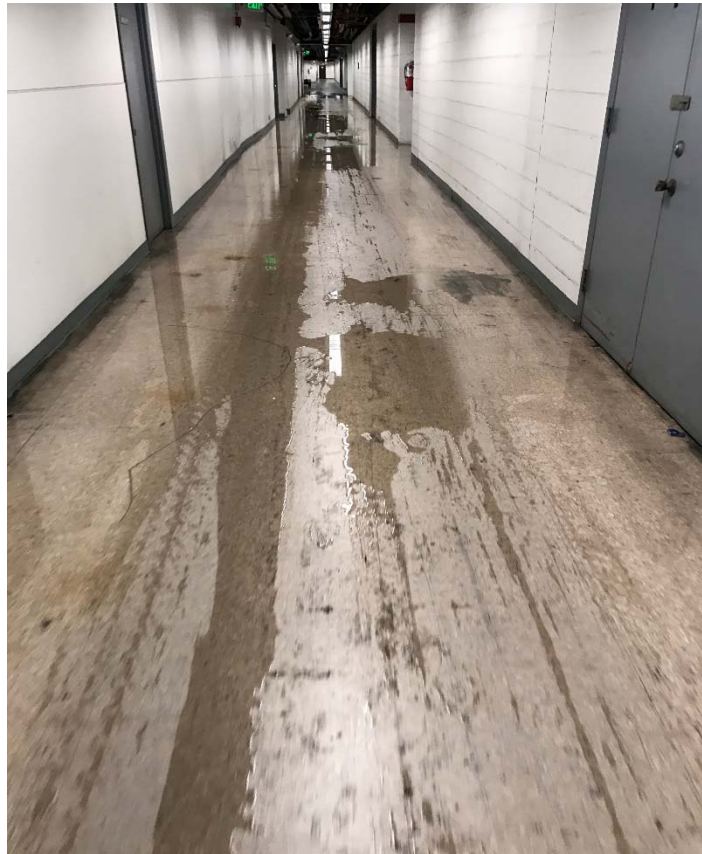
Flooding down hallway in northern portion of Building C basement
