Subject: Transmittal of the Bulkhead and Storm-Drain Assessment, Blocks D and F,  
Lockheed Martin Middle River Complex,  
2323 Eastern Boulevard  
Middle River, Maryland

# **Bulkhead and Storm-Drain Assessment, Blocks D and F, Lockheed Martin Middle River Complex 2323 Eastern Boulevard Middle River, Maryland**

Tetra Tech, Inc.

March 2016

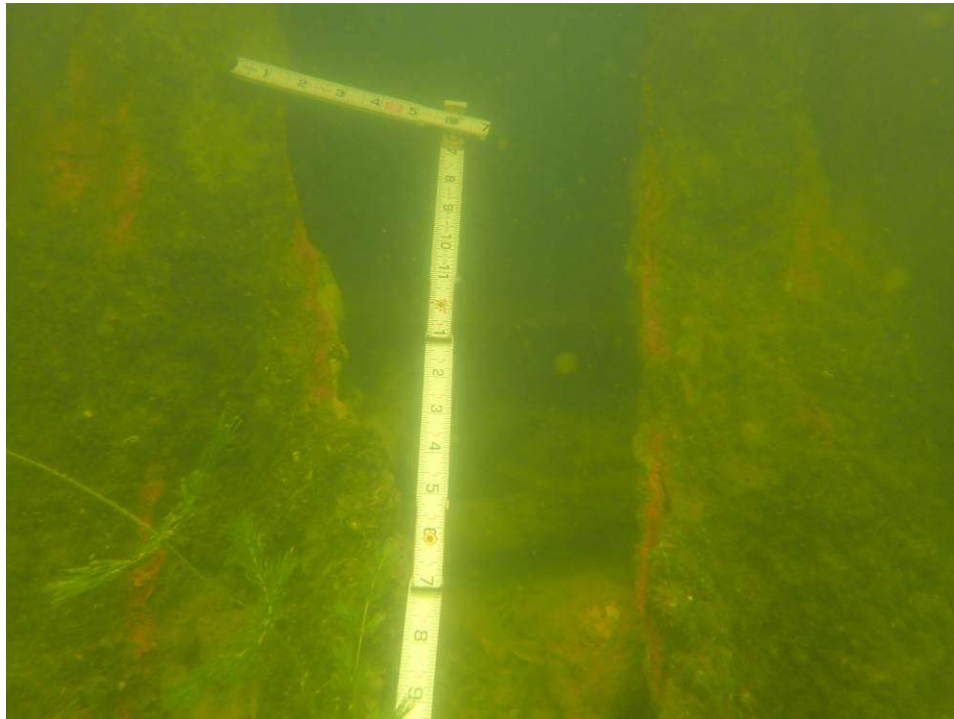
Photograph 9. Typical severe deterioration of steel sheet piling.

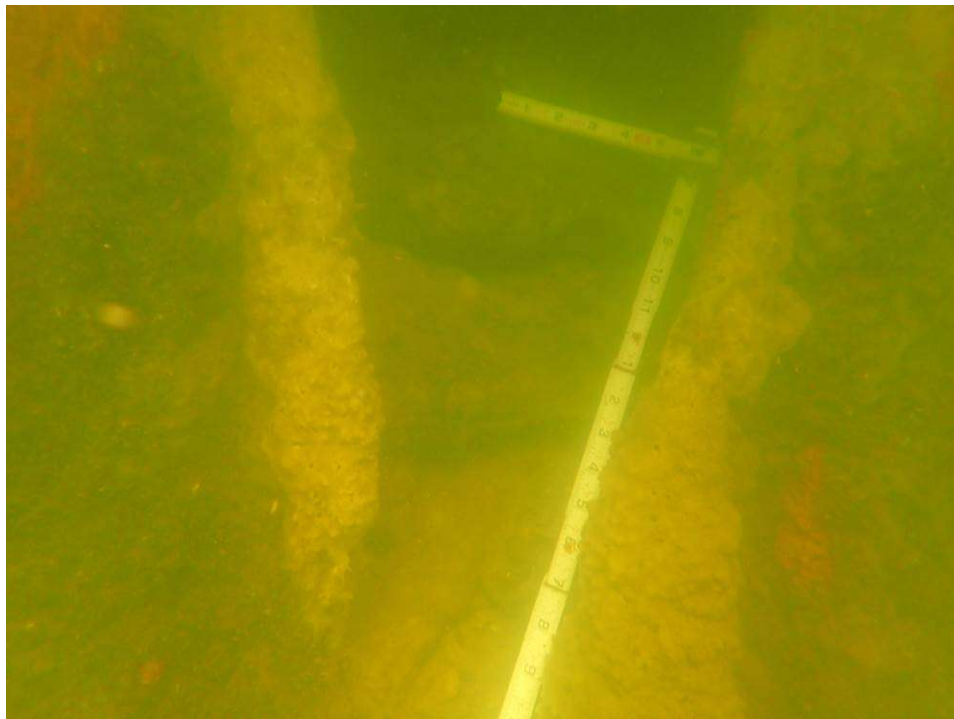
Photograph 10. Typical severe deterioration of steel sheet piling.

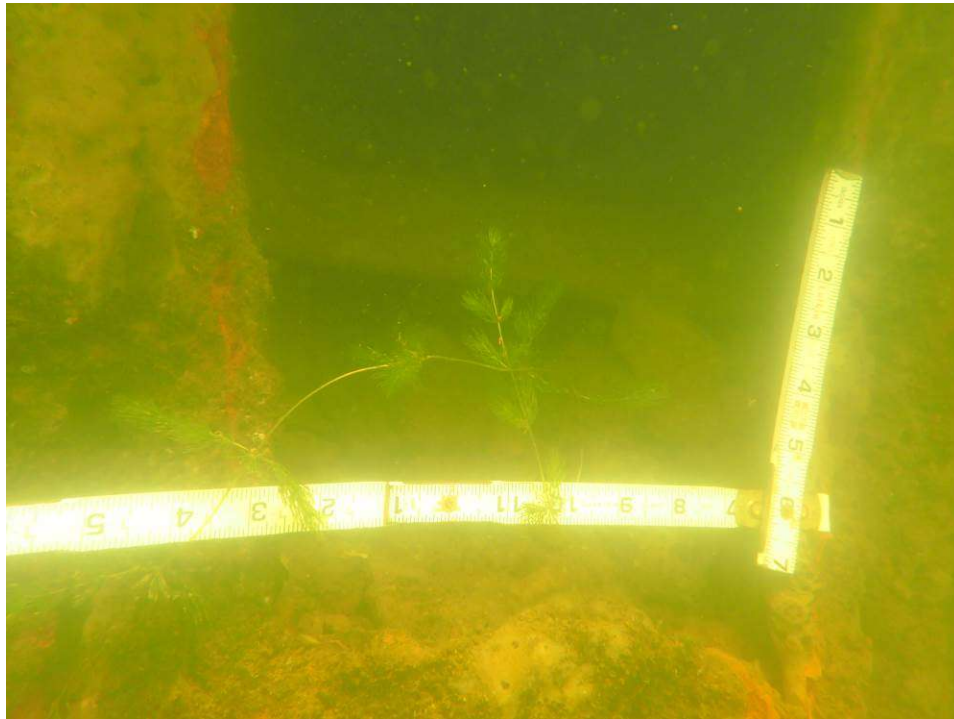
Photograph 11. Typical severe deterioration of steel sheet piling.

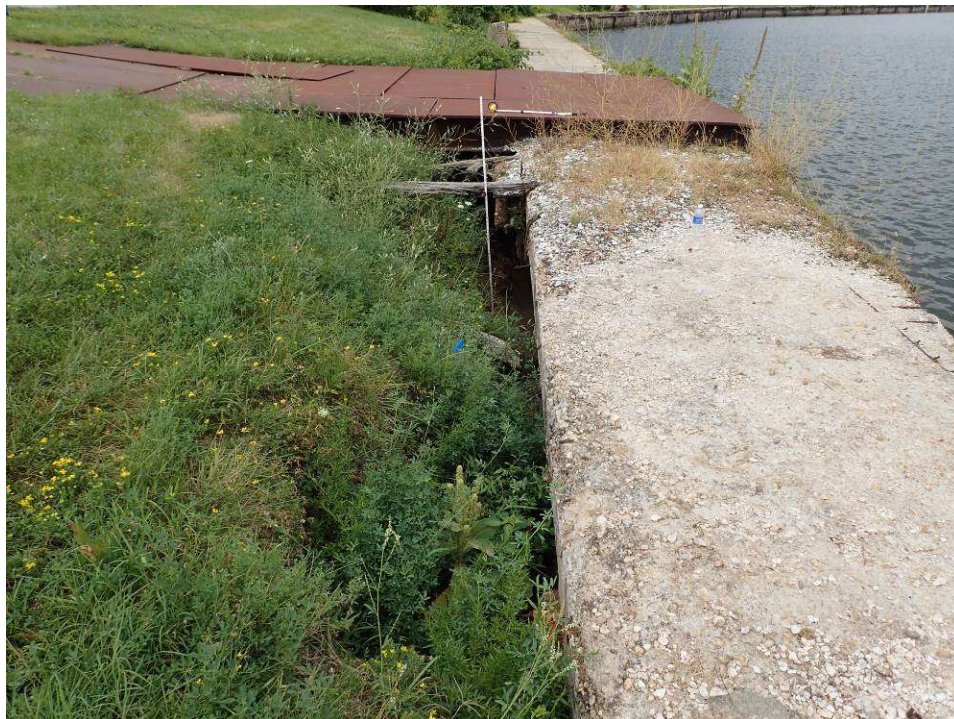
Photograph 12. Section “H”, typical embankment erosion behind seawall.

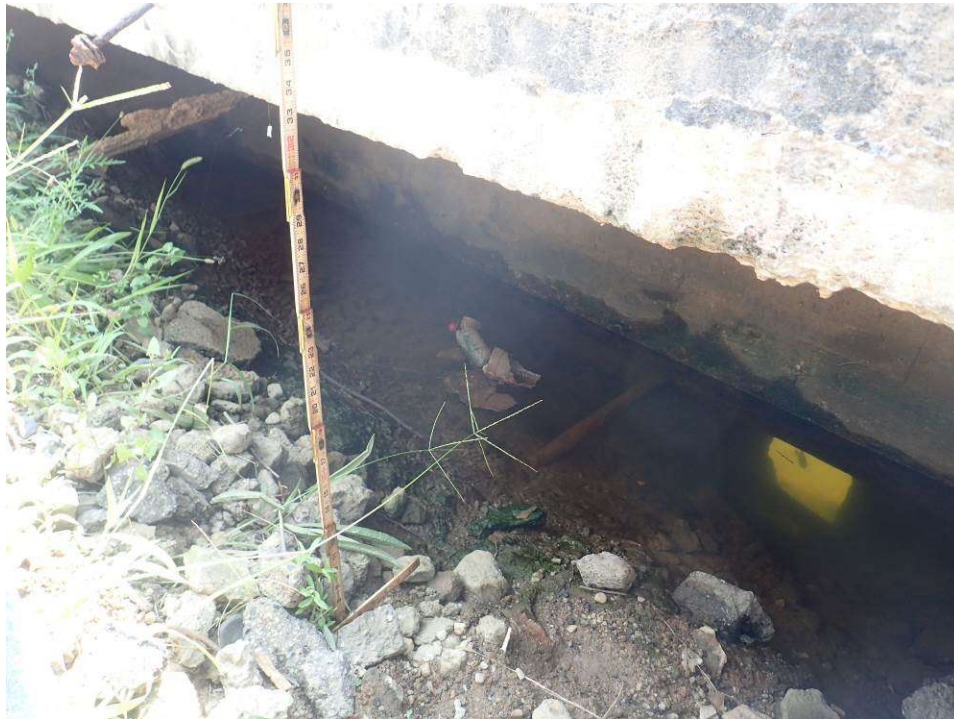
Photograph 13. Typical fill loss beneath concrete deck, showing area of 100% section loss in steel sheet pile at lower right.

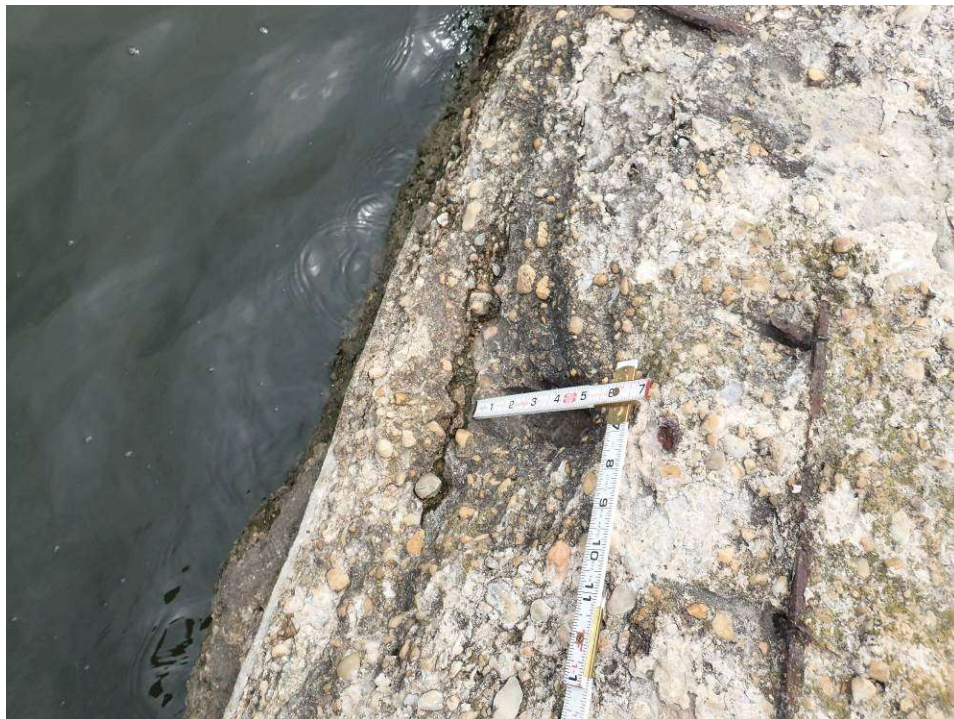
Photograph 14. Typical deterioration of concrete deck, showing spalling and exposed reinforcement.

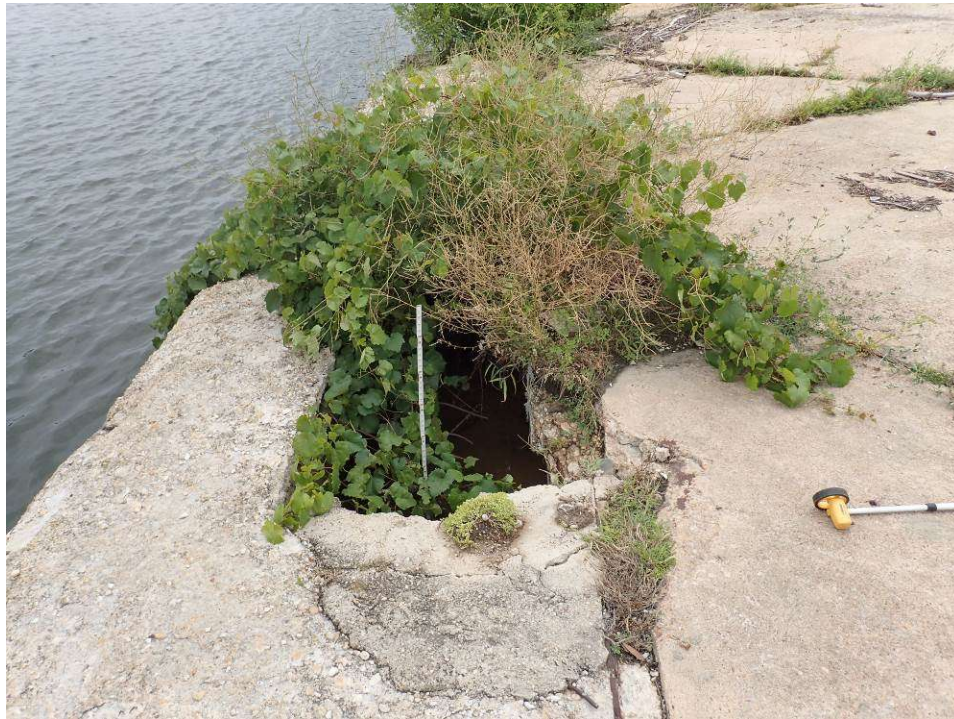
Photograph 15. Section “H”, failed area of concrete deck with backfill loss and vegetation growth.

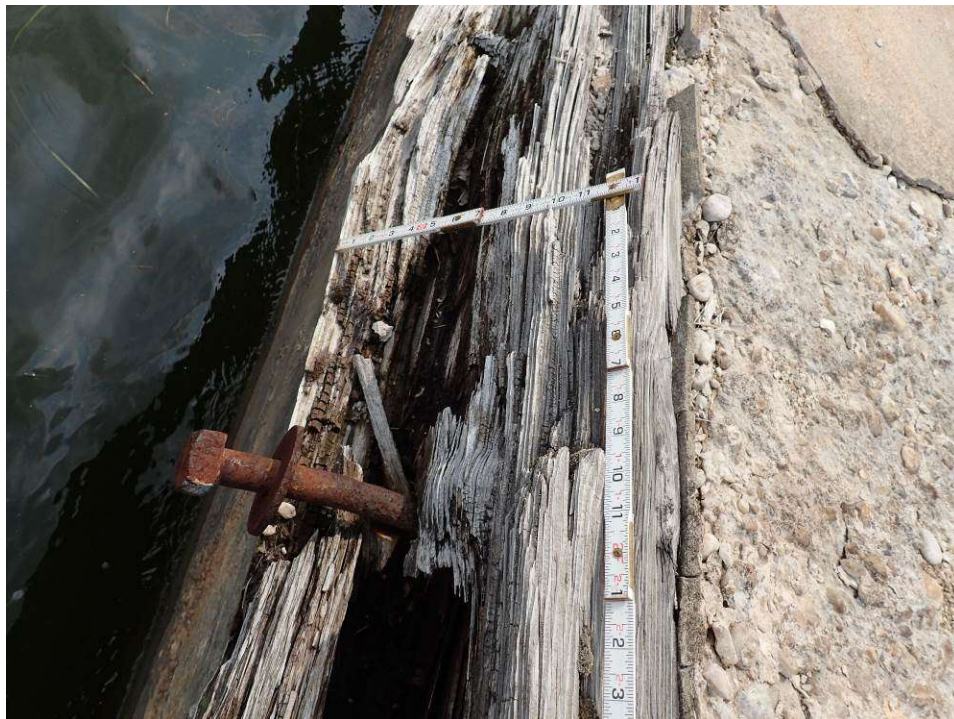
Photograph 16. Severe deterioration of timber fender at edge of concrete deck.

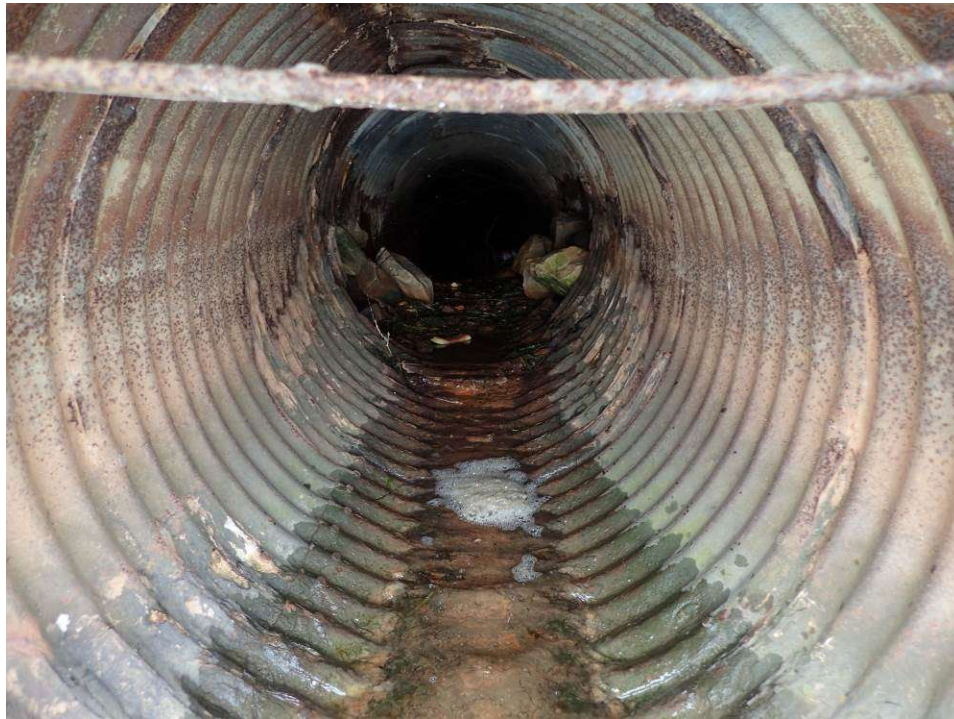
Photograph 17. Outfall pipe with areas of 100% section loss.

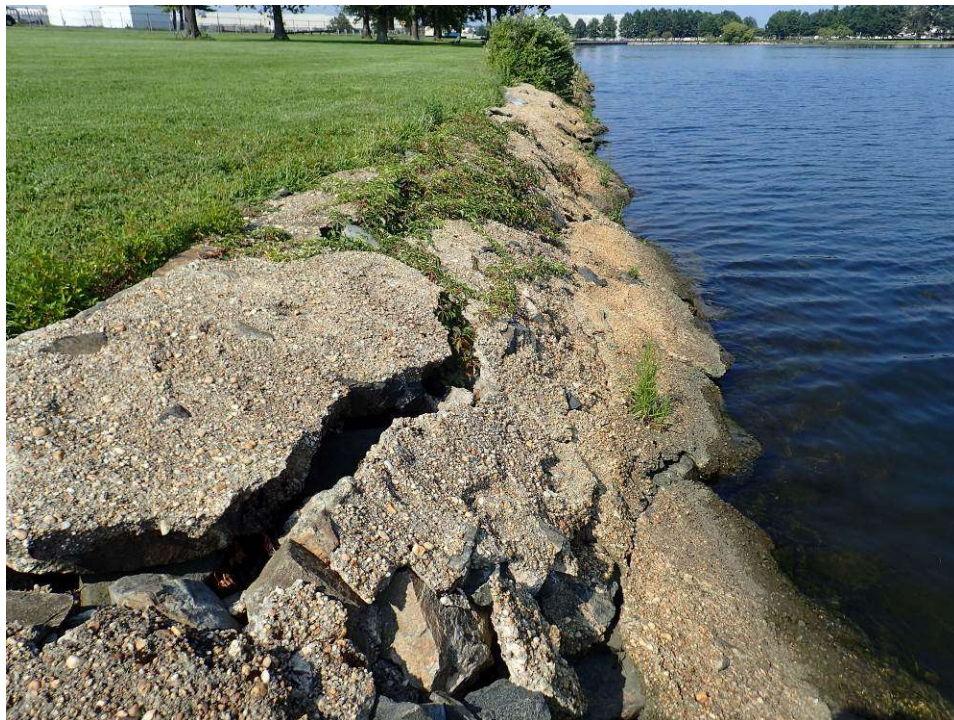
Photograph 18. Longitudinal cracking in upper concrete of stabilized riprap slope.

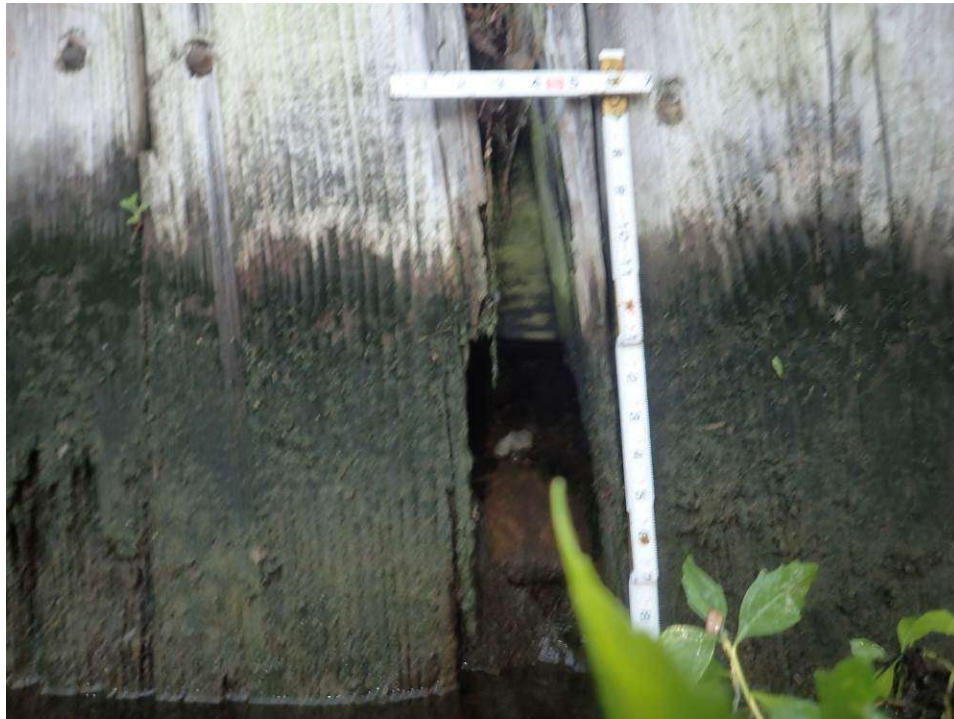
Photograph 19. Decay and 100% section loss of breastwall timbers in tidal zone.

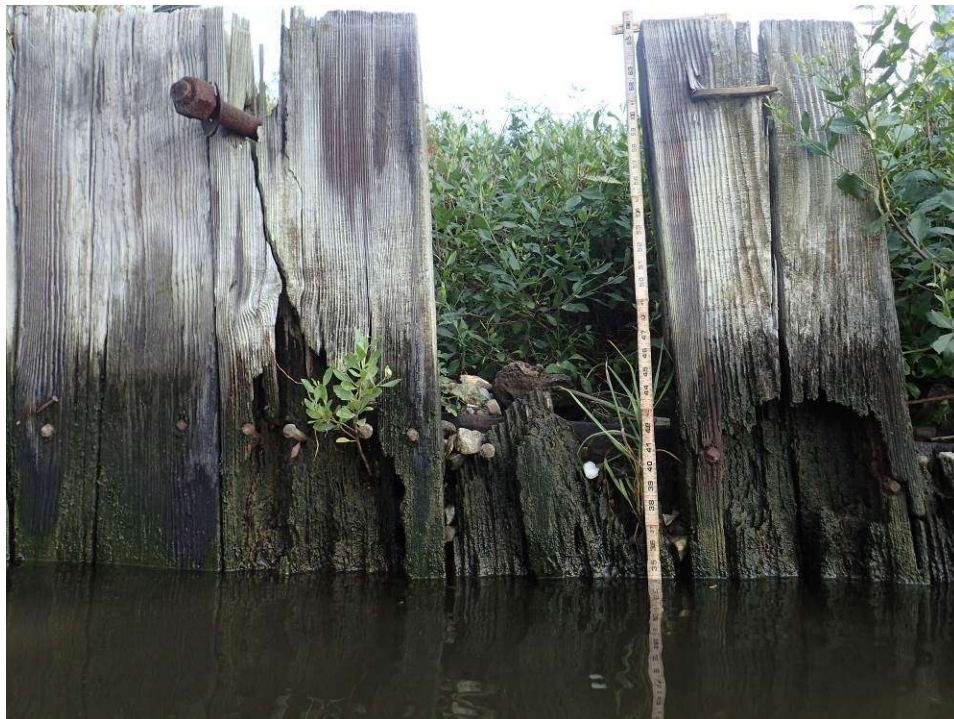
Photograph 20. Broken vertical timbers at waterline with associated fill loss.

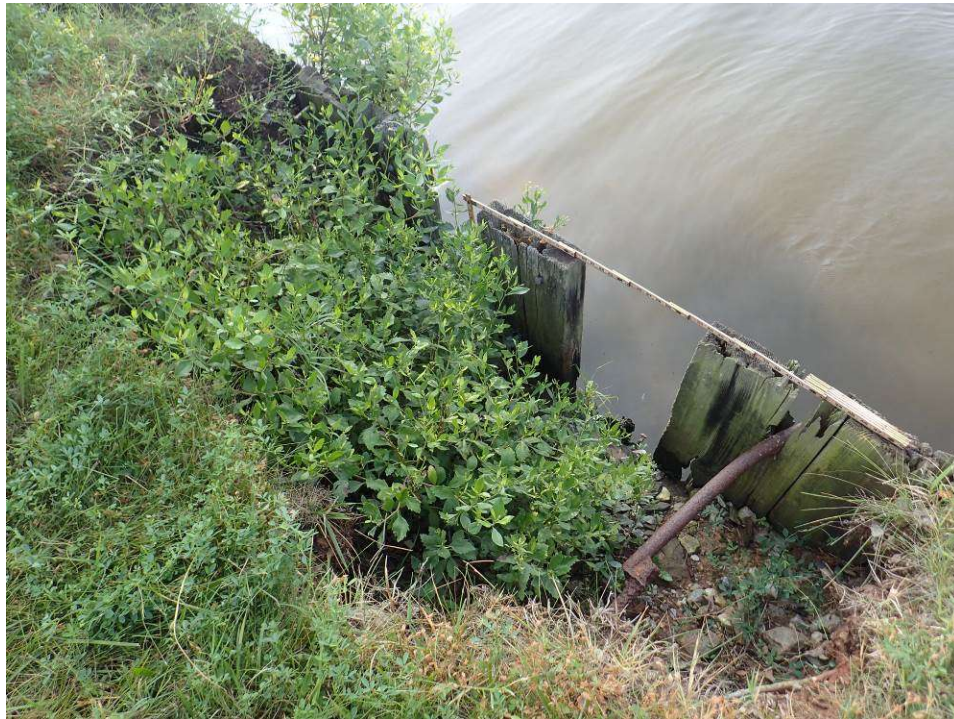
Photograph 21. Backfill loss and vegetation behind broken breastwall timbers.

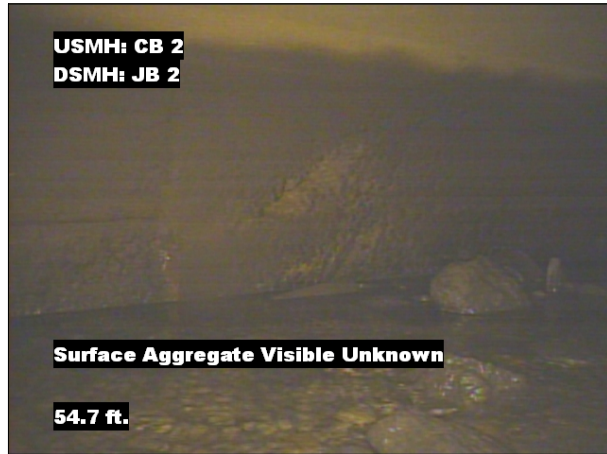
Photo: CB\_2\_JB\_2\_SAVZ\_54.7.jpg, VCR No.: 1  
54.7FT, Surface Aggregate Visible Unknown, at 09 o'clock,  
within 8 inches: NO

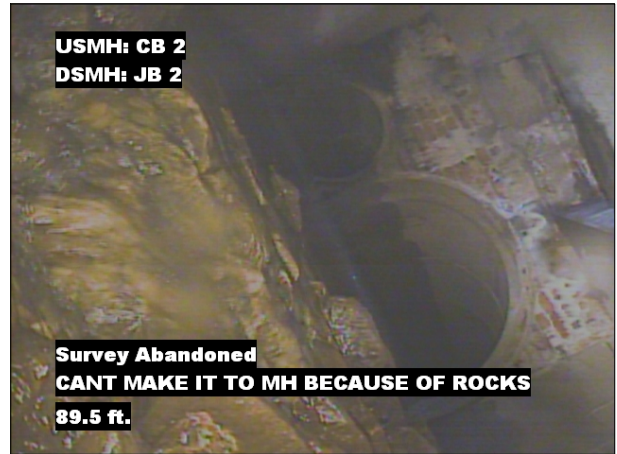
Photo: CB\_2\_JB\_2\_MSA\_89.5.jpg, VCR No.: 1  
89.5FT, Survey Abandoned, REMARK: CANT MAKE IT TO MH  
BECAUSE OF ROCKS

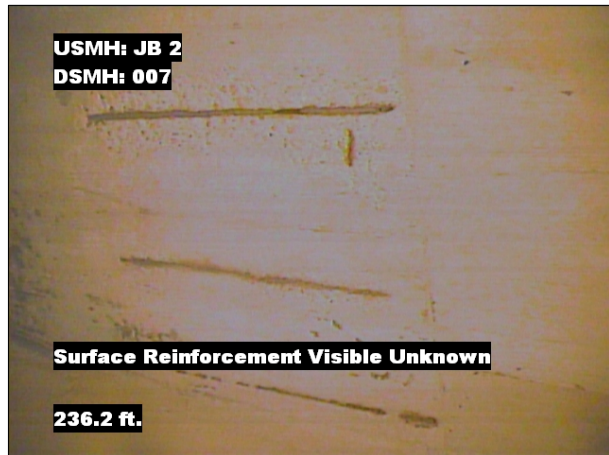
Photo: JB\_2\_007\_SRVZ\_236.2.jpg, VCR No.: 1  
236.2FT, Surface Reinforcement Visible Unknown, at 12 o'clock, within 8 inches: NO

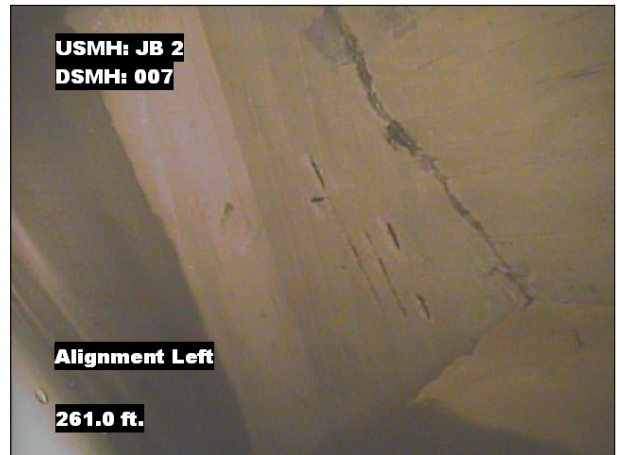
Photo: JB\_2\_007\_IL\_261.0.jpg, VCR No.: 1  
261FT, Alignment Left, 45%

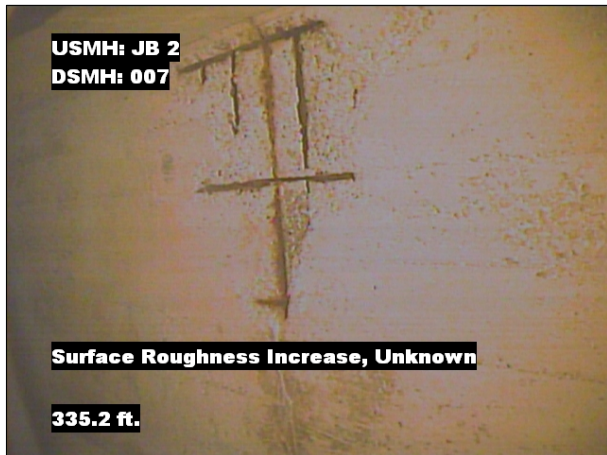
Photo: JB\_2\_007\_SRIZ\_335.2.jpg, VCR No.: 1  
335.2FT, Surface Roughness Increased Unknown, at 12 o'clock, within 8 inches: NO

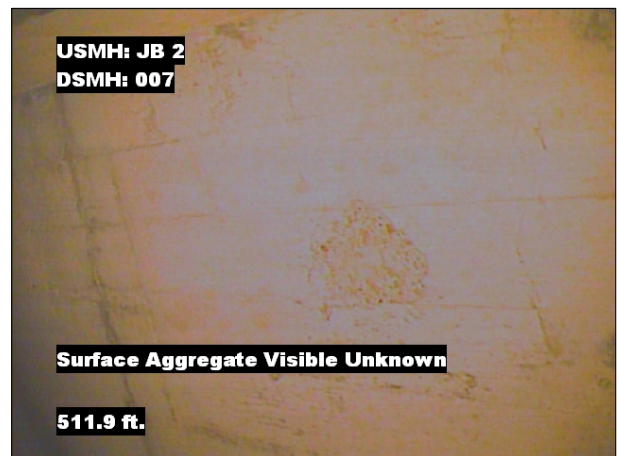
Photo: JB\_2\_007\_SAVZ\_511.9.jpg, VCR No.: 1  
511.9FT, Surface Aggregate Visible Unknown, at 12 o'clock, within 8 inches: NO

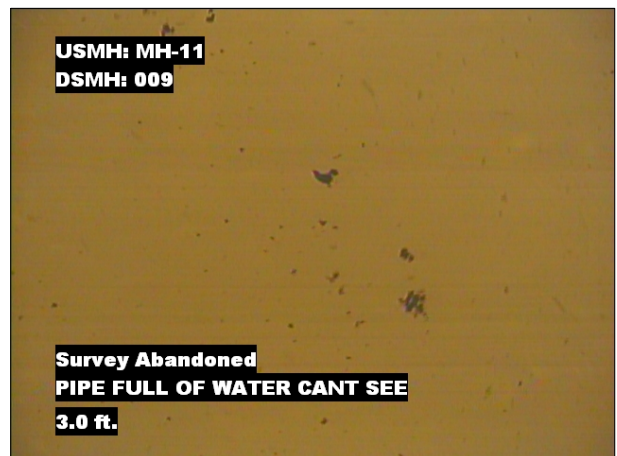
Photo: MH-11\_009\_MSA\_3.0.jpg, VCR No.: 1  
3FT, Survey Abandoned, REMARK: PIPE FULL OF WATER  
CANT SEE
