Subject: Transmittal of Bulkhead Outfall-Sealing Completion Report  
Lockheed Martin Corporation – Middle River Complex  
2323 Eastern Boulevard, Middle River, Baltimore County, Maryland

**BULKHEAD OUTFALL-SEALING  
COMPLETION REPORT  
MIDDLE RIVER COMPLEX  
2323 EASTERN BOULEVARD  
MIDDLE RIVER, MARYLAND**

Prepared by:  
Tetra Tech, Inc.

June 2021

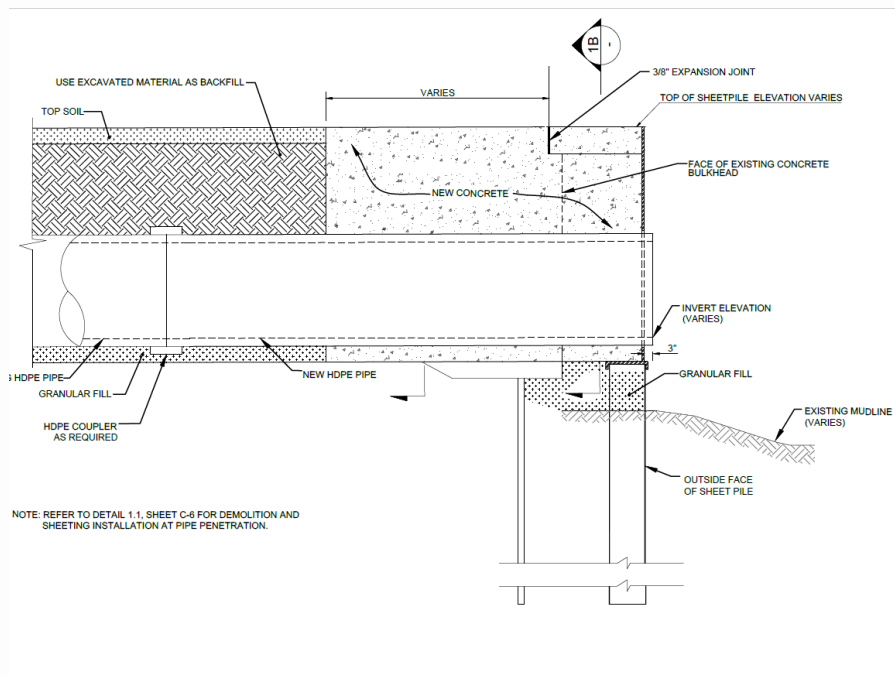
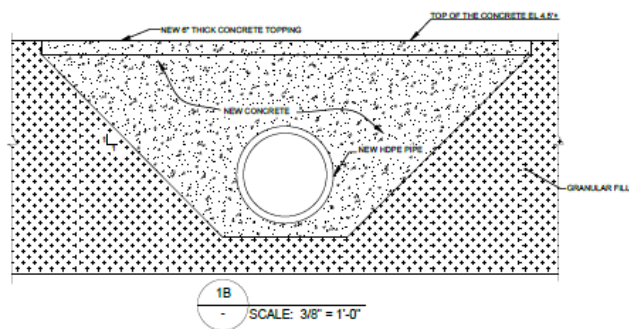
Figure 2: Transverse section of the outfall (Tetra Tech, 2018)

The two outfalls penetrate through the steel closure pieces in the sheet-pile bulkhead walls, as shown in Figure 2. The closure pieces are attached to the sheet pile walls with a steel sill plate. The area above the outfall pipe consists of concrete. The concrete surrounding the corrugated high-density polyethylene (HDPE) pipe appears to be displaced and cracked (Tetra Tech, 2019). Tidal action appears to have flushed granular fill through openings around the circumference of the outfall pipes and around the openings present on the steel plate. These openings are likely the result of concrete fracturing and displacement where it adjoins the steel wall components (i.e., at the concrete-steel interface).

The objective of this project was to immobilize granular fill around each outfall by injecting a urethane grout to cement the soil particles together and seal openings in the annular space surrounding the outfall pipe. After sealing, the granular fill along the entire length of the bulkhead was replenished.

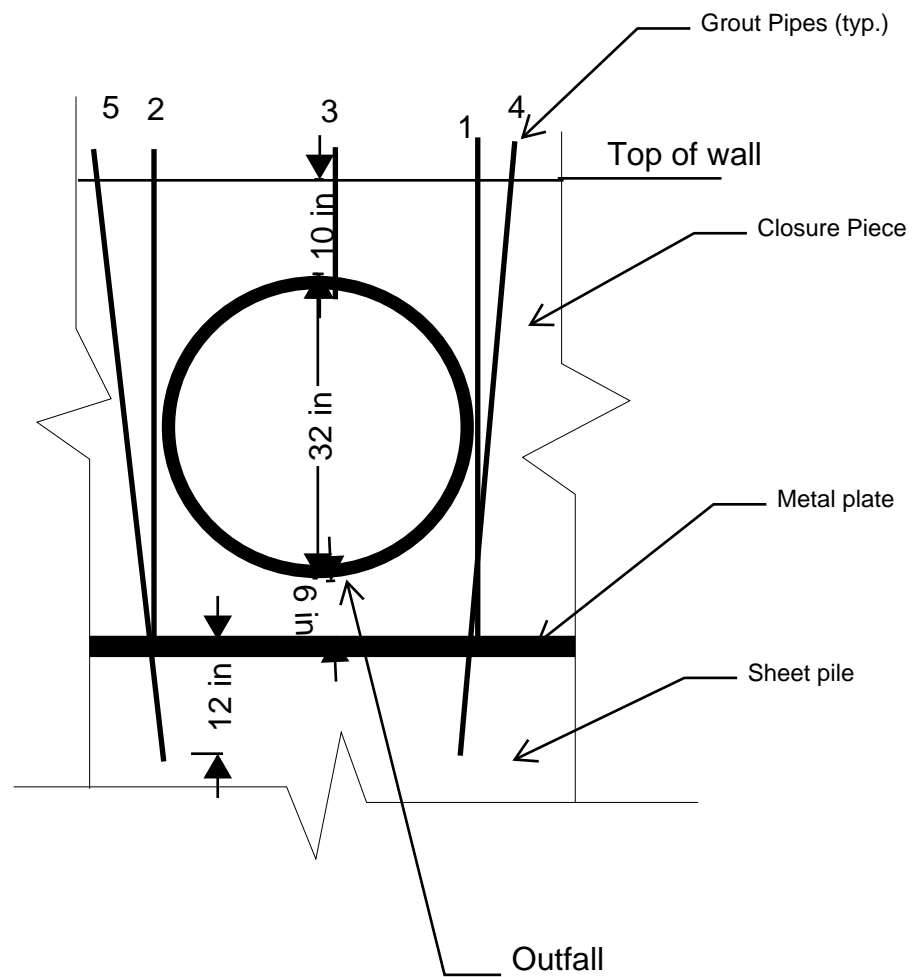
Figure 3: Profile View of Grout Pipe Location at OF-005-W, Block F (view towards the land)

Grout injection at outfall OF-0005W started on July 29, 2020 and was completed on the same day. Polyurethane grout was injected at five locations through the grout pipes inserted between the wall and concrete (see Figure 3). The initial grout injection (at locations 1 and 2) resulted in grout extrusion from the bottom sill plate that is located at the interface of the sheet pile wall and closure piece (see Figure 2 for an illustration of the closure piece). Extrusion at this location (beneath the sill plate) likely indicated an opening at the interface of the sheet pile wall and closure piece. In order to seal that opening, grout was also injected at locations 4 and 5, after injecting grout through locations 2 and 3 (Figure 3). The grout pipe was extended one foot below the level of the sill plate at locations 4 and 5.

Approximately 165 pounds of grout were injected through the five locations. Grouting at location 1 was terminated after grout extrusion through the bottom of the closure piece. Grout that was released into Dark Head Cove was contained through the use of a floating boom that was installed around the outfall prior to the start of grout injections. All grout that was released to Dark Head Cove was removed with a fishing net. Similarly, grouting at locations 2 and 3 was terminated after the grout extruded through the annular space between the pipe and closure piece, and into the gap between the concrete and the wall. The grouting at locations 4 and 5 was terminated after movement of the wall was observed. Grouting at these five locations is summarized in Table 1.

As stated earlier and indicated on Table 1, the initial grout injection at location 1 resulted in grout extrusion beneath the outfall at the level of the sill plate, which indicated that the grout sealed the openings on the sill plate. Subsequent grouting at location 2 resulted in extrusion through the annular space between the outfall and closure pieces at the top and bottom of the outfall, indicating

that the cavity at the bottom of the outfall was completely sealed, and the gap between the concrete and the closure piece was also completely sealed.

Similarly, while grouting at location 3, extrusion through the annular space between the outfall and the closure piece at the top of the outfall was observed. Subsequent grout injections at locations 4 and 5 resulted in sheet pile deflection toward the river after 30 seconds; grouting was then stopped, and the wall reverted to its original position. This wall movement indicated that the openings around the outfall were sealed, leaving no further outlet for the grout. Closure was also visually verified by observing extruded grout in the annulus during low tide on July 30, 2020.

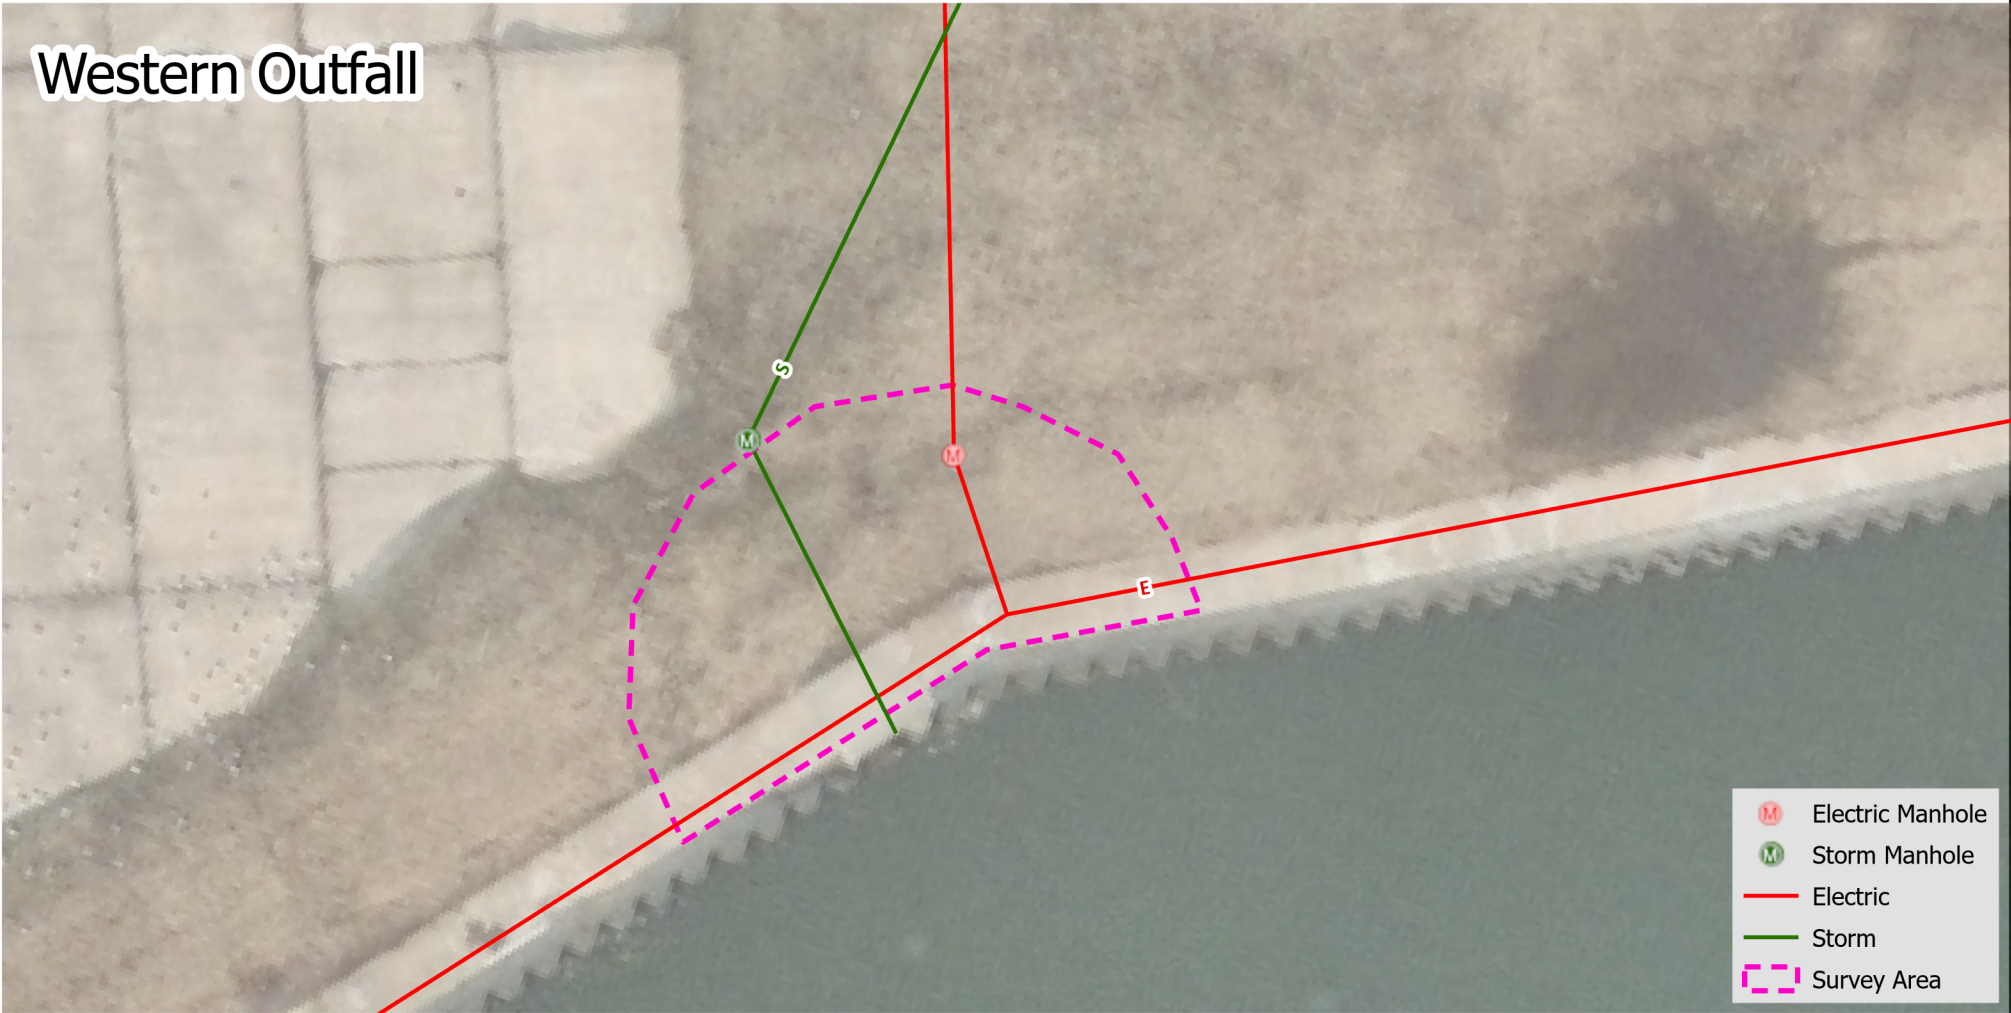
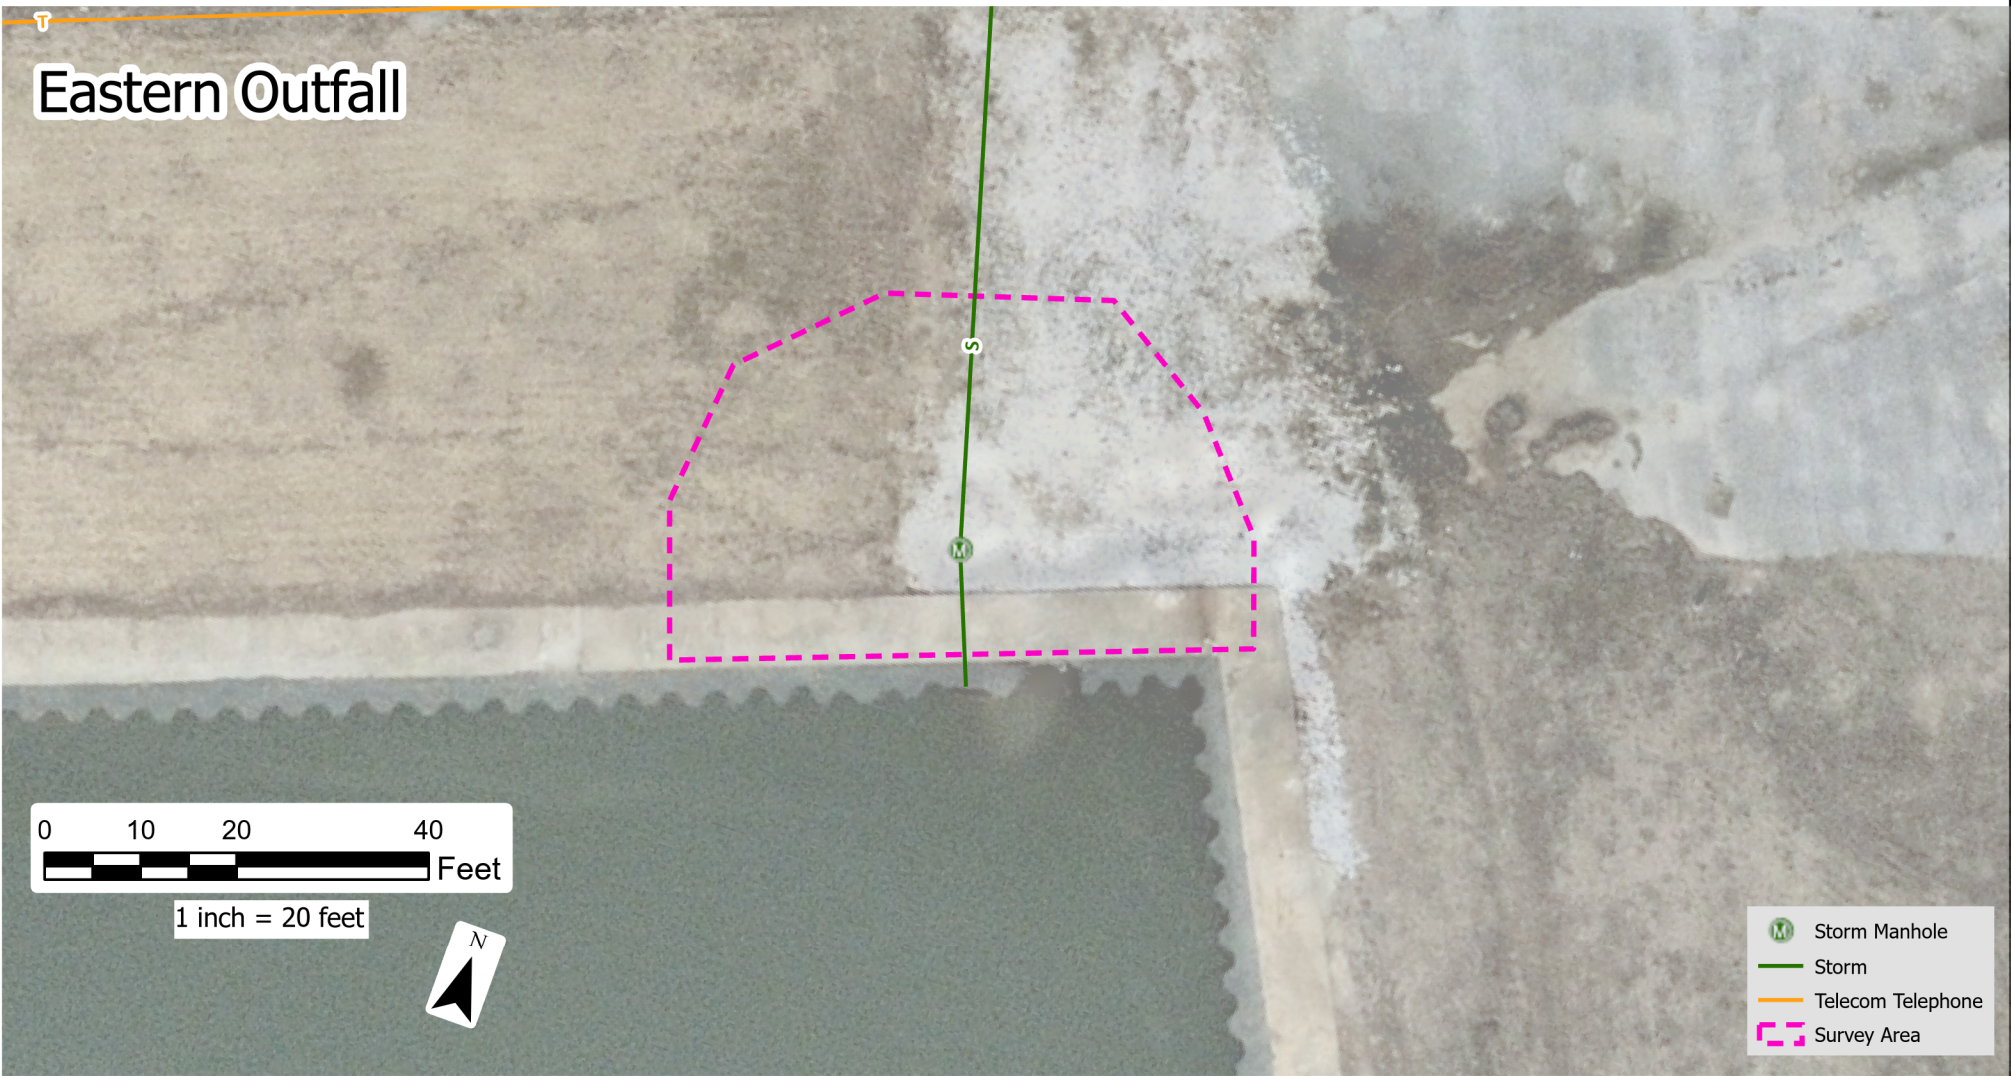
**Figure 1: Subsurface Utility Survey Results**  
**Storm Outfall Locations**  
Middle River Complex  
Middle River, MD

The utility survey by RETTEW indicated that an electric line is adjacent to Outfall OF-005-W. However, it was located outside of the proposed work area and did not prevent completion of the work. The subsurface utility engineering report prepared by RETTEW and the dig permit are in
