Subject: Transmittal of the Infrastructure Abandonment Report
Lockheed Martin Corporation; Middle River Complex
2323 Eastern Boulevard, Middle River, Baltimore County, Maryland

**INFRASTRUCTURE ABANDONMENT REPORT
LOCKHEED MARTIN MIDDLE RIVER COMPLEX
2323 EASTERN BOULEVARD
MIDDLE RIVER, MARYLAND**

Prepared by:
Tetra Tech, Inc.

September 2018

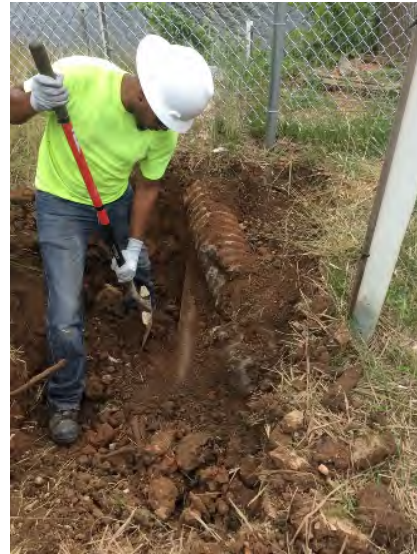
Work Completed

Eta north and south located via mini excavator and hand digging.

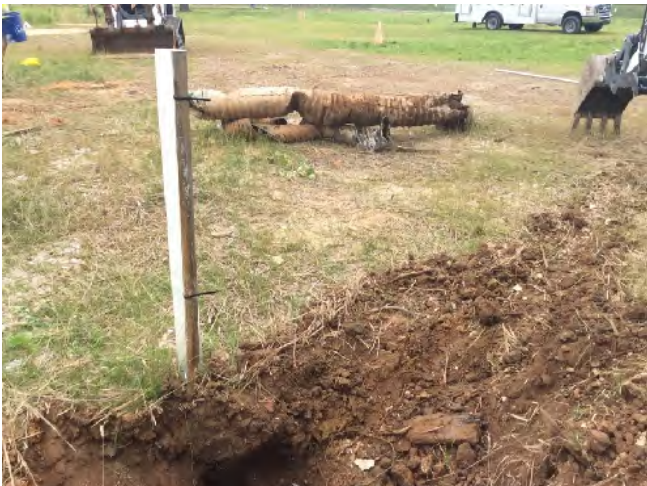
Eta piping removed from the bank

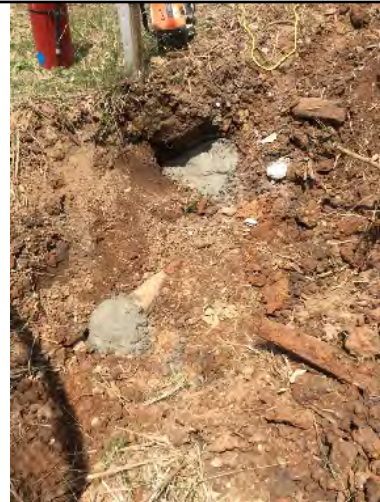
Eta north and south saw cut and filled with concrete.

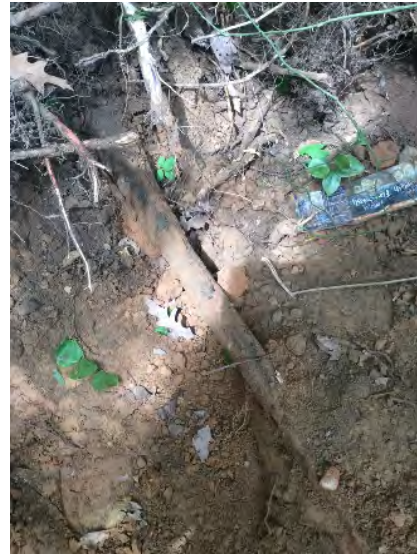
1.5" steel pipe located approx 1.5' bgs.

On June 20, 2018, a mini-excavator was used to dig a trench (approximately three feet by three feet by three feet) inside the Block F perimeter fence to locate Outfall Kappa. The 1.5-inch steel pipe was found approximately 1.5 feet bgs and was cut using a saw; the protruding piping was then removed from the bank. The protruding piece, approximately 21-feet-long, was cut into smaller three-foot sections and placed into a roll-off. The remaining pipe was abandoned in place by

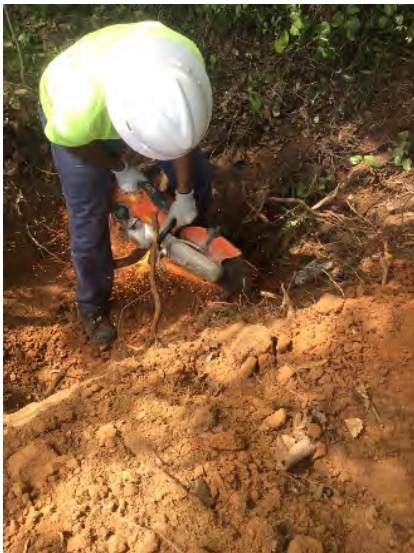
Steel pipe saw cut and removed.

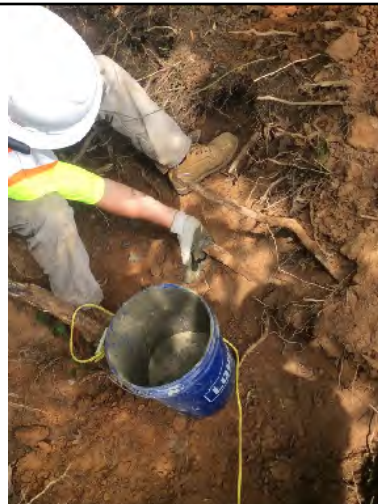
Non-shrink grout used to seal pipe prior to backfilling.

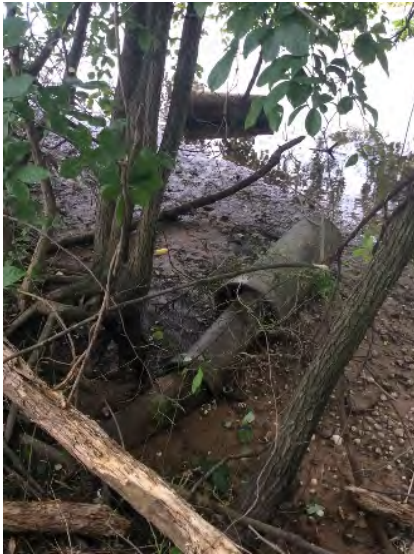
Bank after protruding terra cotta piping was removed

Low tide conditions were targeted for completion of this work. A mini excavator and skid steer were used to clear minimal brush. Four pieces of 3' long terra cotta piping were removed from the bank. A 2'x2'x2' trench was then dug to locate the pipe inside the perimeter fence. The pipe was located, cut, and sealed with non shrink grout. All terra cotta piping removed was placed in a rolloff with a skid steer. The disturbed soil area was restored with curl-x and grass seed. The fence was put back in place.

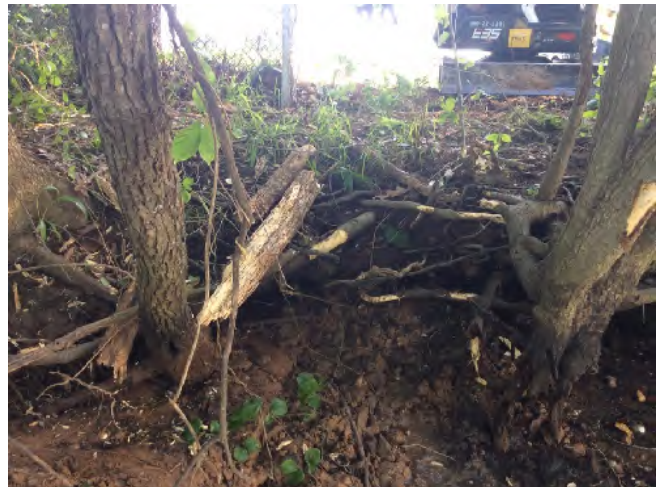
Terra cotta pipe located inside perimeter fence

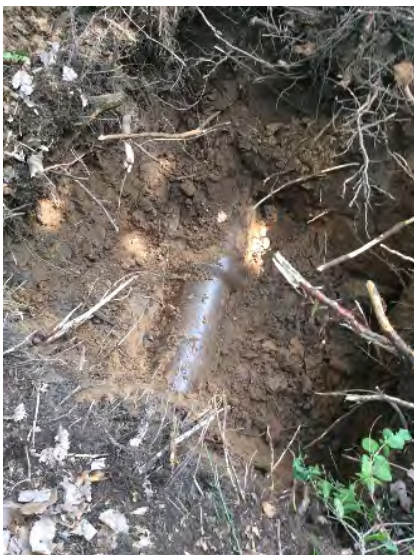
Pipe was broken, bank side removed, land side filled and sealed with concrete.

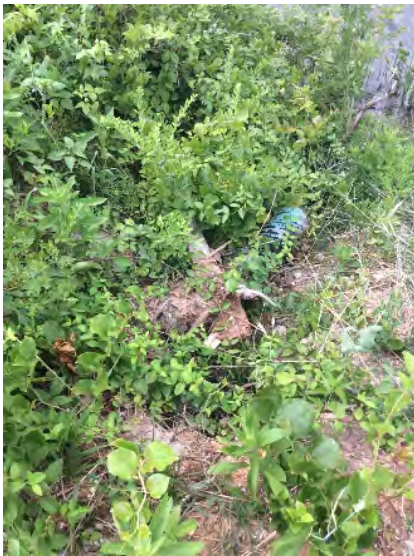
6" pipe located via mini excavator

The unidentified 6" CMP was located in the field and it was determined that the site fence needed to be cut to remove the pipe. Once the fence was cut a mini excavator dug an approximate 4ft long by 2ft wide by 3ft deep trench to locate the 6" CMP. The pipe was located and saw cut. The pipe protruding from the bank was removed and placed in a rolloff. The remaining pipe was sealed with non shrink grout and the area was then backfilled. Curl-x and grass seed was placed on the disturbed area and a new section of fencing was installed.

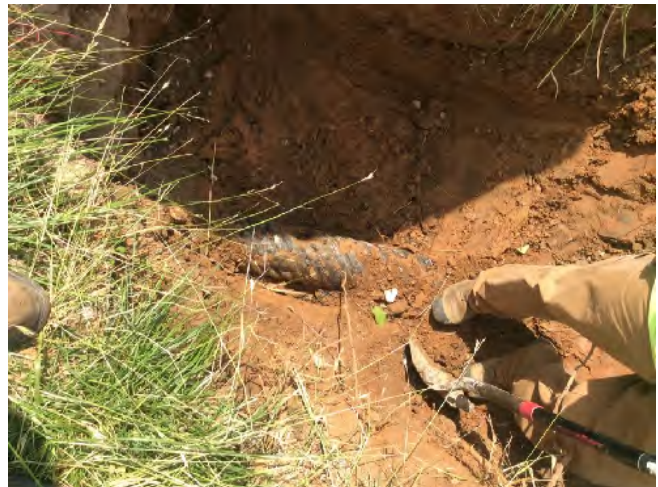
Elite personnel saw cutting 6" CMP

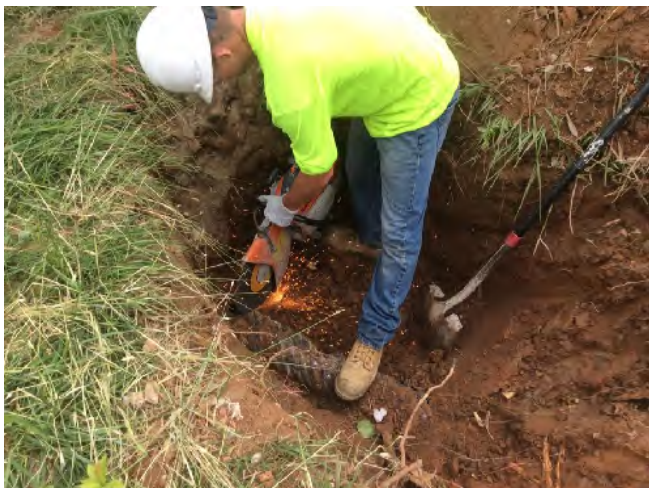
6" CMP sealed with concrete.

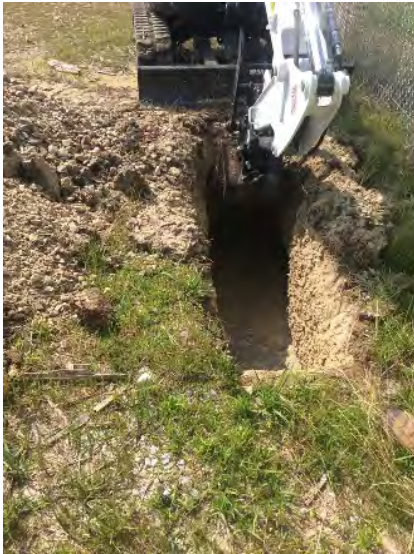
Disturbed area restored with curl-x and grass seed

A mini excavator was utilized to attempt to locate outfall Zeta. An approximate 4'x2'x5' deep trench was excavated, however, water was encountered at 3.5' and it was decided that the excavation would be unsuccessful if continued due to water infiltration. The excavation was backfilled and restored with curl-x and grass seed. Investigation resumed 6/21; a weed whacker cleared brush from the suspected area on the bank where a vertical pipe connected to zeta was located. Vertical pipe was indeed found and observed to be already filled with grout. A 1' hole was dug around the pipe and the pipe was broken apart with a sledgehammer so that nothing was visible from surface. Area was filled with soil and brush.

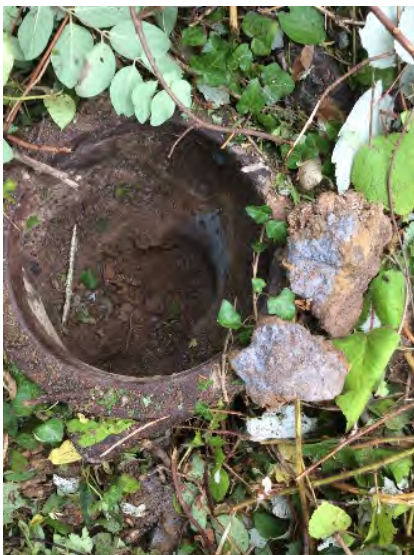
Surface vertical pipe dug down 1' and broken up with sledgehammer so that no pipe is visible from surface.

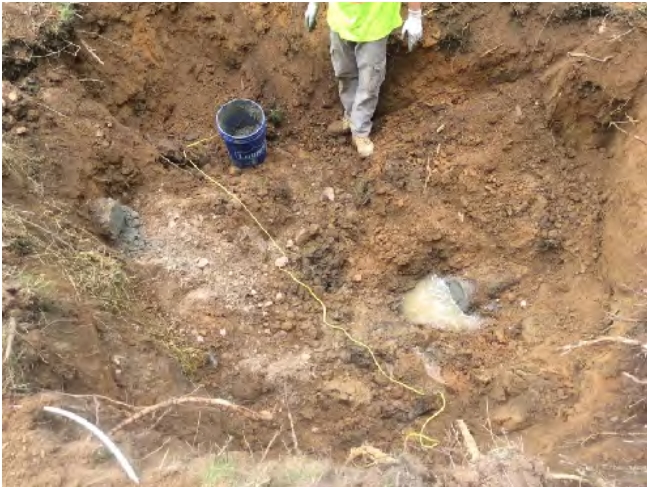
Influent and effluent pipes sealed with non-shrink grout on 6/20

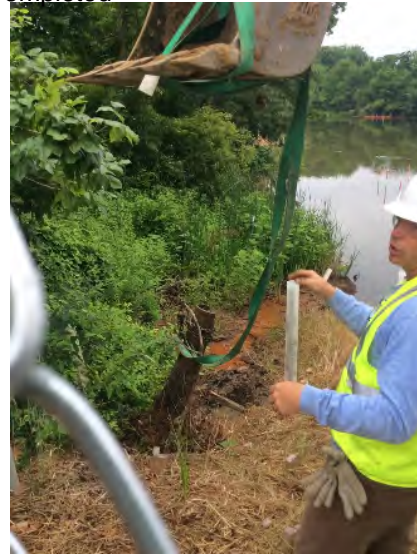
Bankside protruding pipe removed

A mini excavator was used to remove a 5' section of cast iron pipe from outfall Theta using straps and a chain to pull the pipe from the bank. The pipe was placed in a rolloff and the bank was restored with soil and straw. The fence was not disturbed for this portion of the work. The land side excavation was restored with curl-x and grass seed.

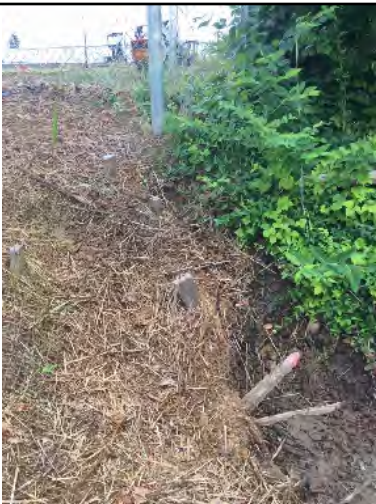
Pipe removed and bankside restored

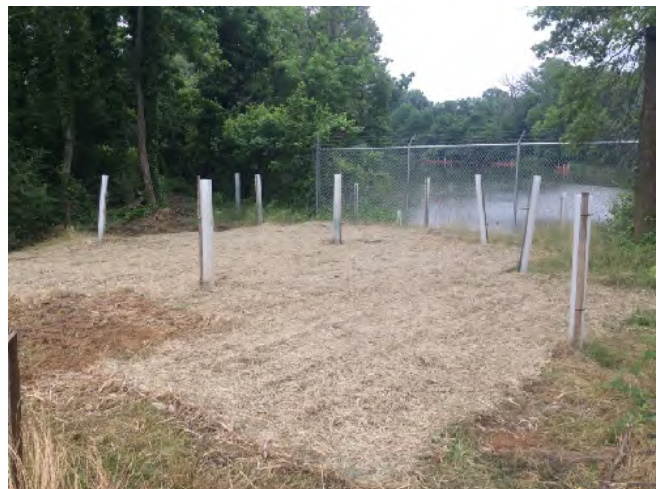
Disturbed area restored with curl-x and grass seed
