Subject: Protecting the Middle River Complex Sediment Remedy from PCBs in Storm Drains
Lockheed Martin Corporation; Middle River Complex
2323 Eastern Boulevard, Middle River, Baltimore County, Maryland

The purpose of this memo is to summarize the past, present, and upcoming storm drain sediment investigations, storm drain cleaning, sediment remedial actions, and periodic monitoring activities in Block E storm drains at the Lockheed Martin Corporation (Lockheed Martin) Middle River Complex (MRC). This memo focuses on the storm drains within the Outfall 006 and 008 pathways described above and shows that while a pathway between PCB contaminated storm drain sediments and Dark Head Cove exists, PCBs are not moving through the storm drains and discharging through Outfalls 008 and 006 at concentrations that may affect sediments complying with remediation goals.

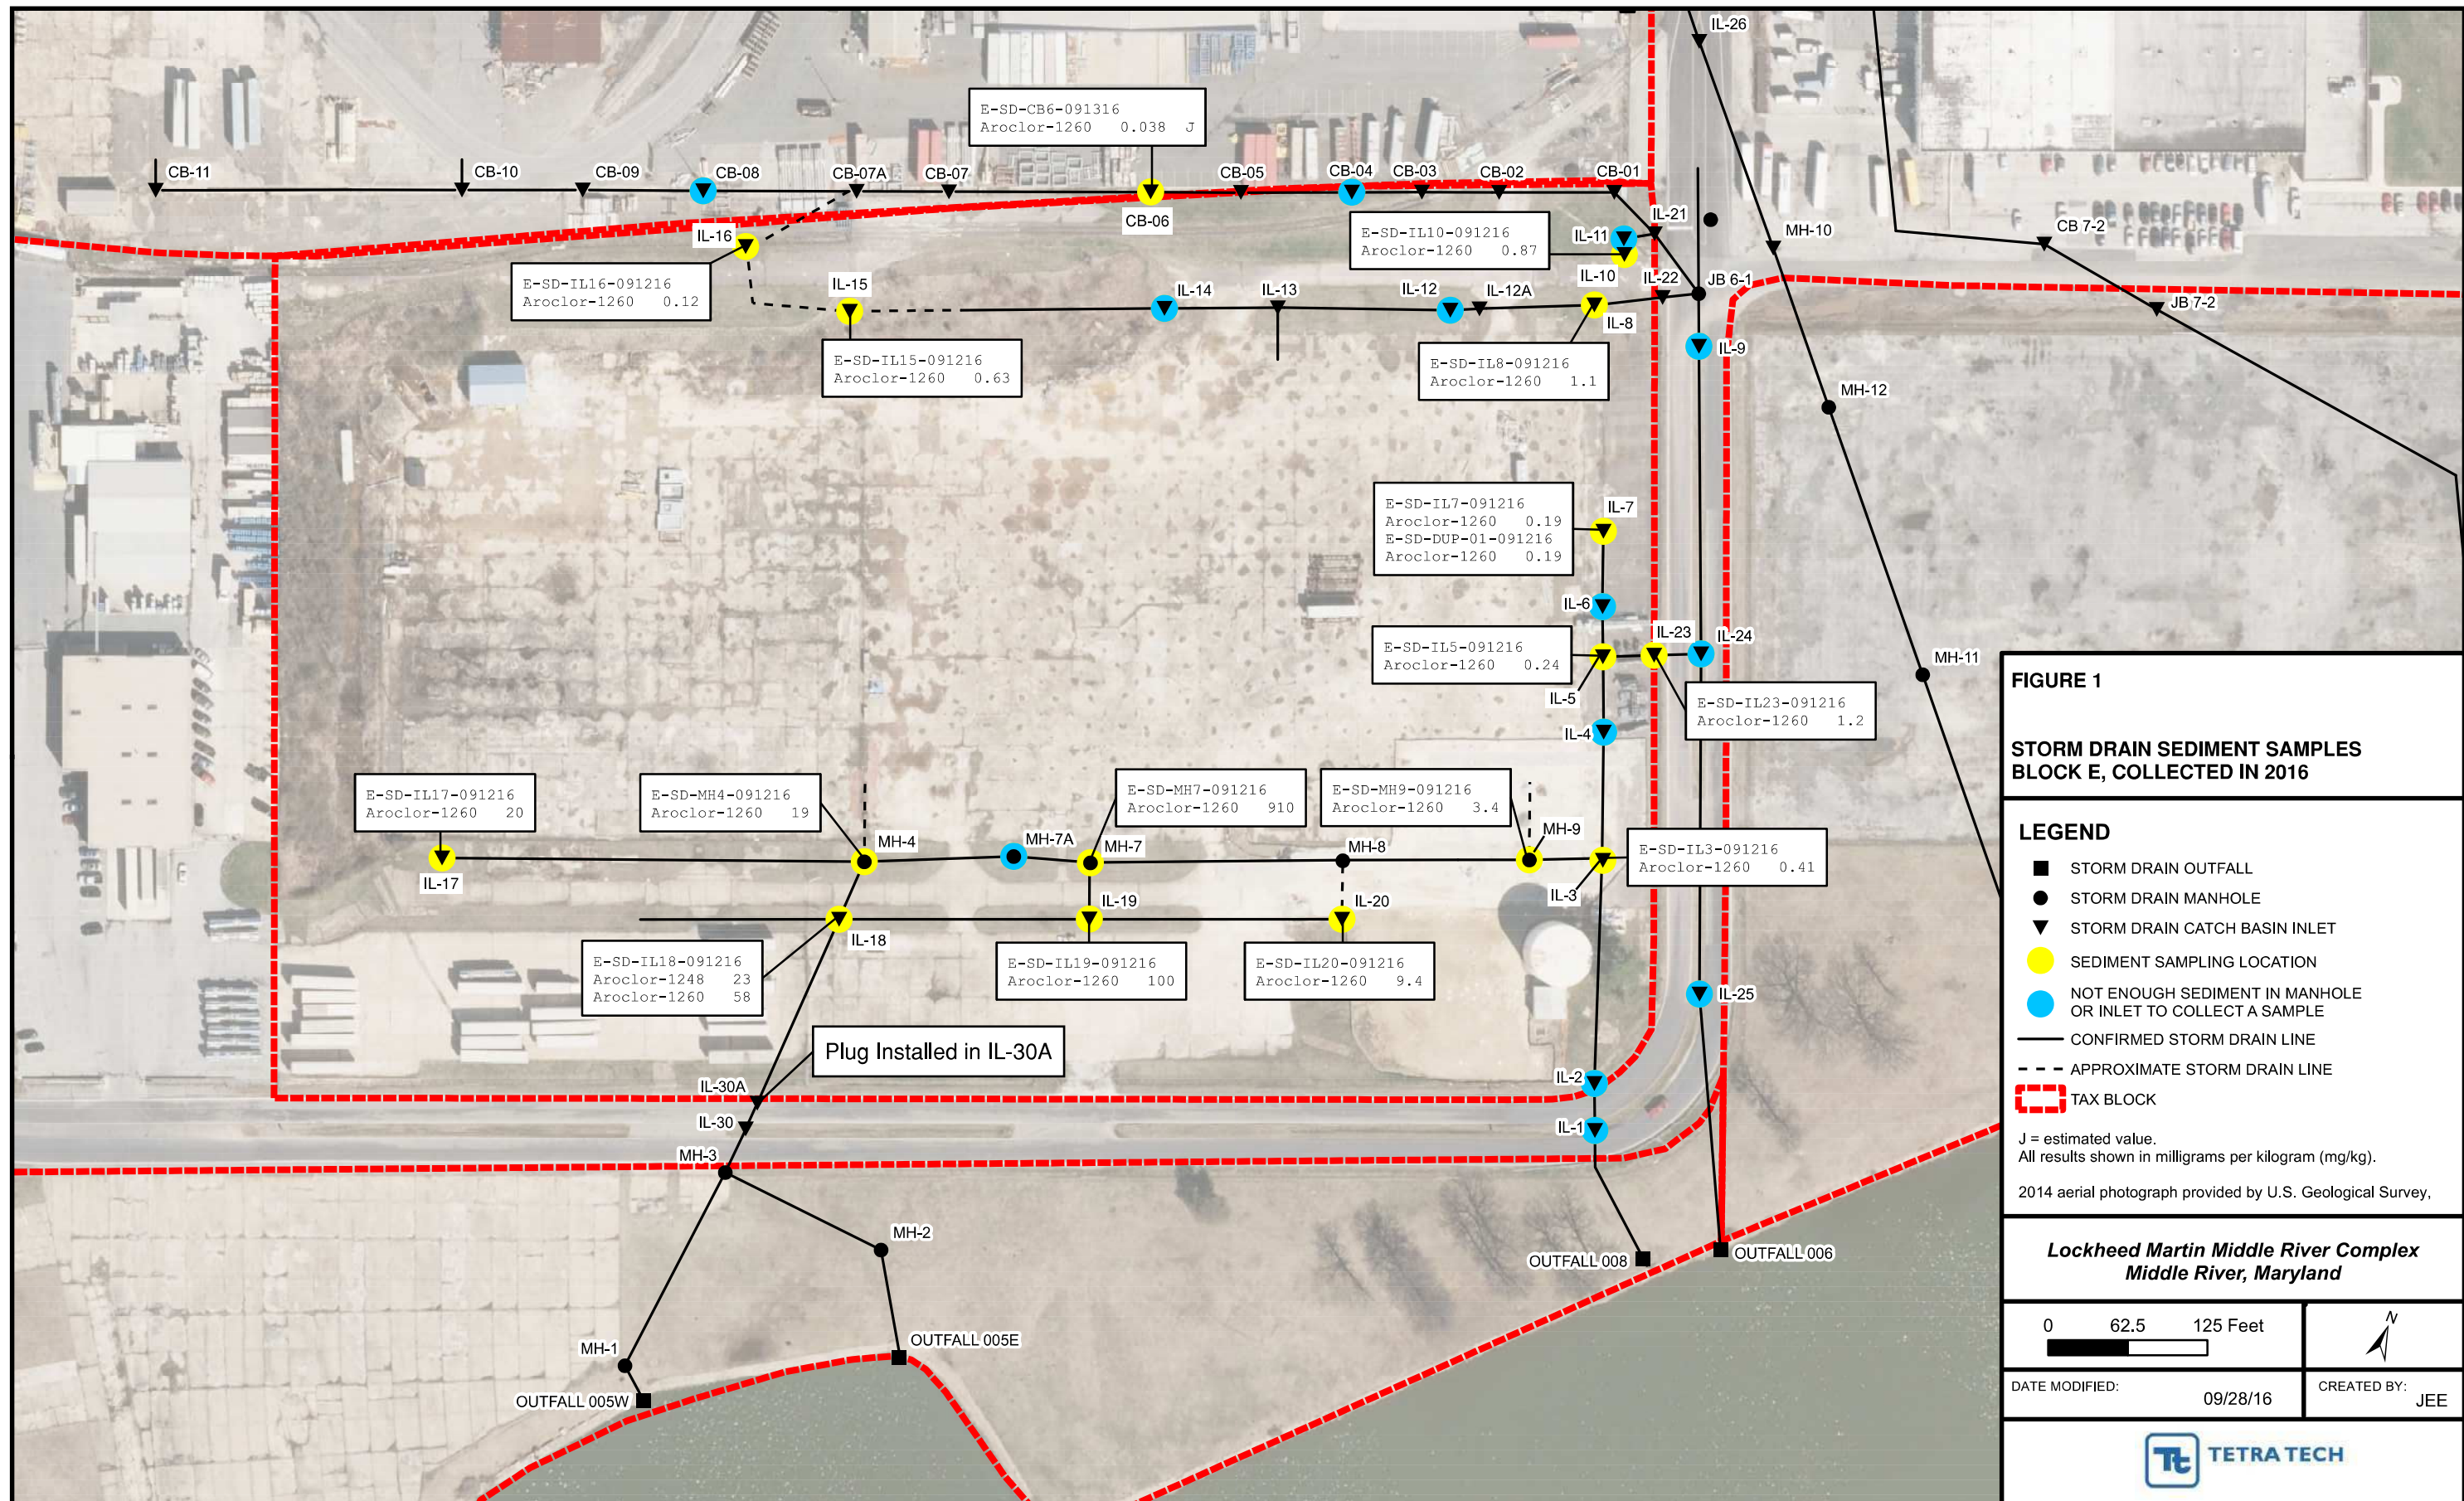
The attached figure, “Figure 1 – Storm Drain Sediment Samples Block E,” demonstrates that PCBs in sediments remain in the storm drains that could not be cleaned during the IRM. However, the concentration of PCBs (expressed as Aroclor-1260) decreases significantly while moving from MH-7 to Outfall 008. Additionally, field observations indicate that MH-9 marks a change in elevation for the storm drainage pipe. The upstream pipe is several feet lower than the downstream pipe, which may create a sediment trap hindering entrained sediments from reaching Dark Head Cove.

Sediment PCB concentrations decrease moving eastward from MH-7 (910 mg/kg) to IL-3 (0.41 mg/kg).

Field observations indicate that MH-9 marks a change in elevation for the storm drainage pipe since the upstream pipe is several feet lower than the downstream pipe. The depression of the upstream pipe creates a sediment trap, acting as a catch basin and preventing the sediments from reaching Dark Head Cove. Only an inch or two of sediment has been observed in MH-9 since it was partially cleaned in 2011.

Until the Block E soil remedial action begins, Lockheed Martin proposes to periodically monitor the amount of sediment collected in the new manhole installed just upstream of Outfall 008, IL-1, IL-2, IL-3 and MH-9. If sufficient sediment accumulates, a sample will be collected and analyzed for PCBs using Method 8082. If an increasing PCB concentration trend is detected, further cleaning will be conducted.

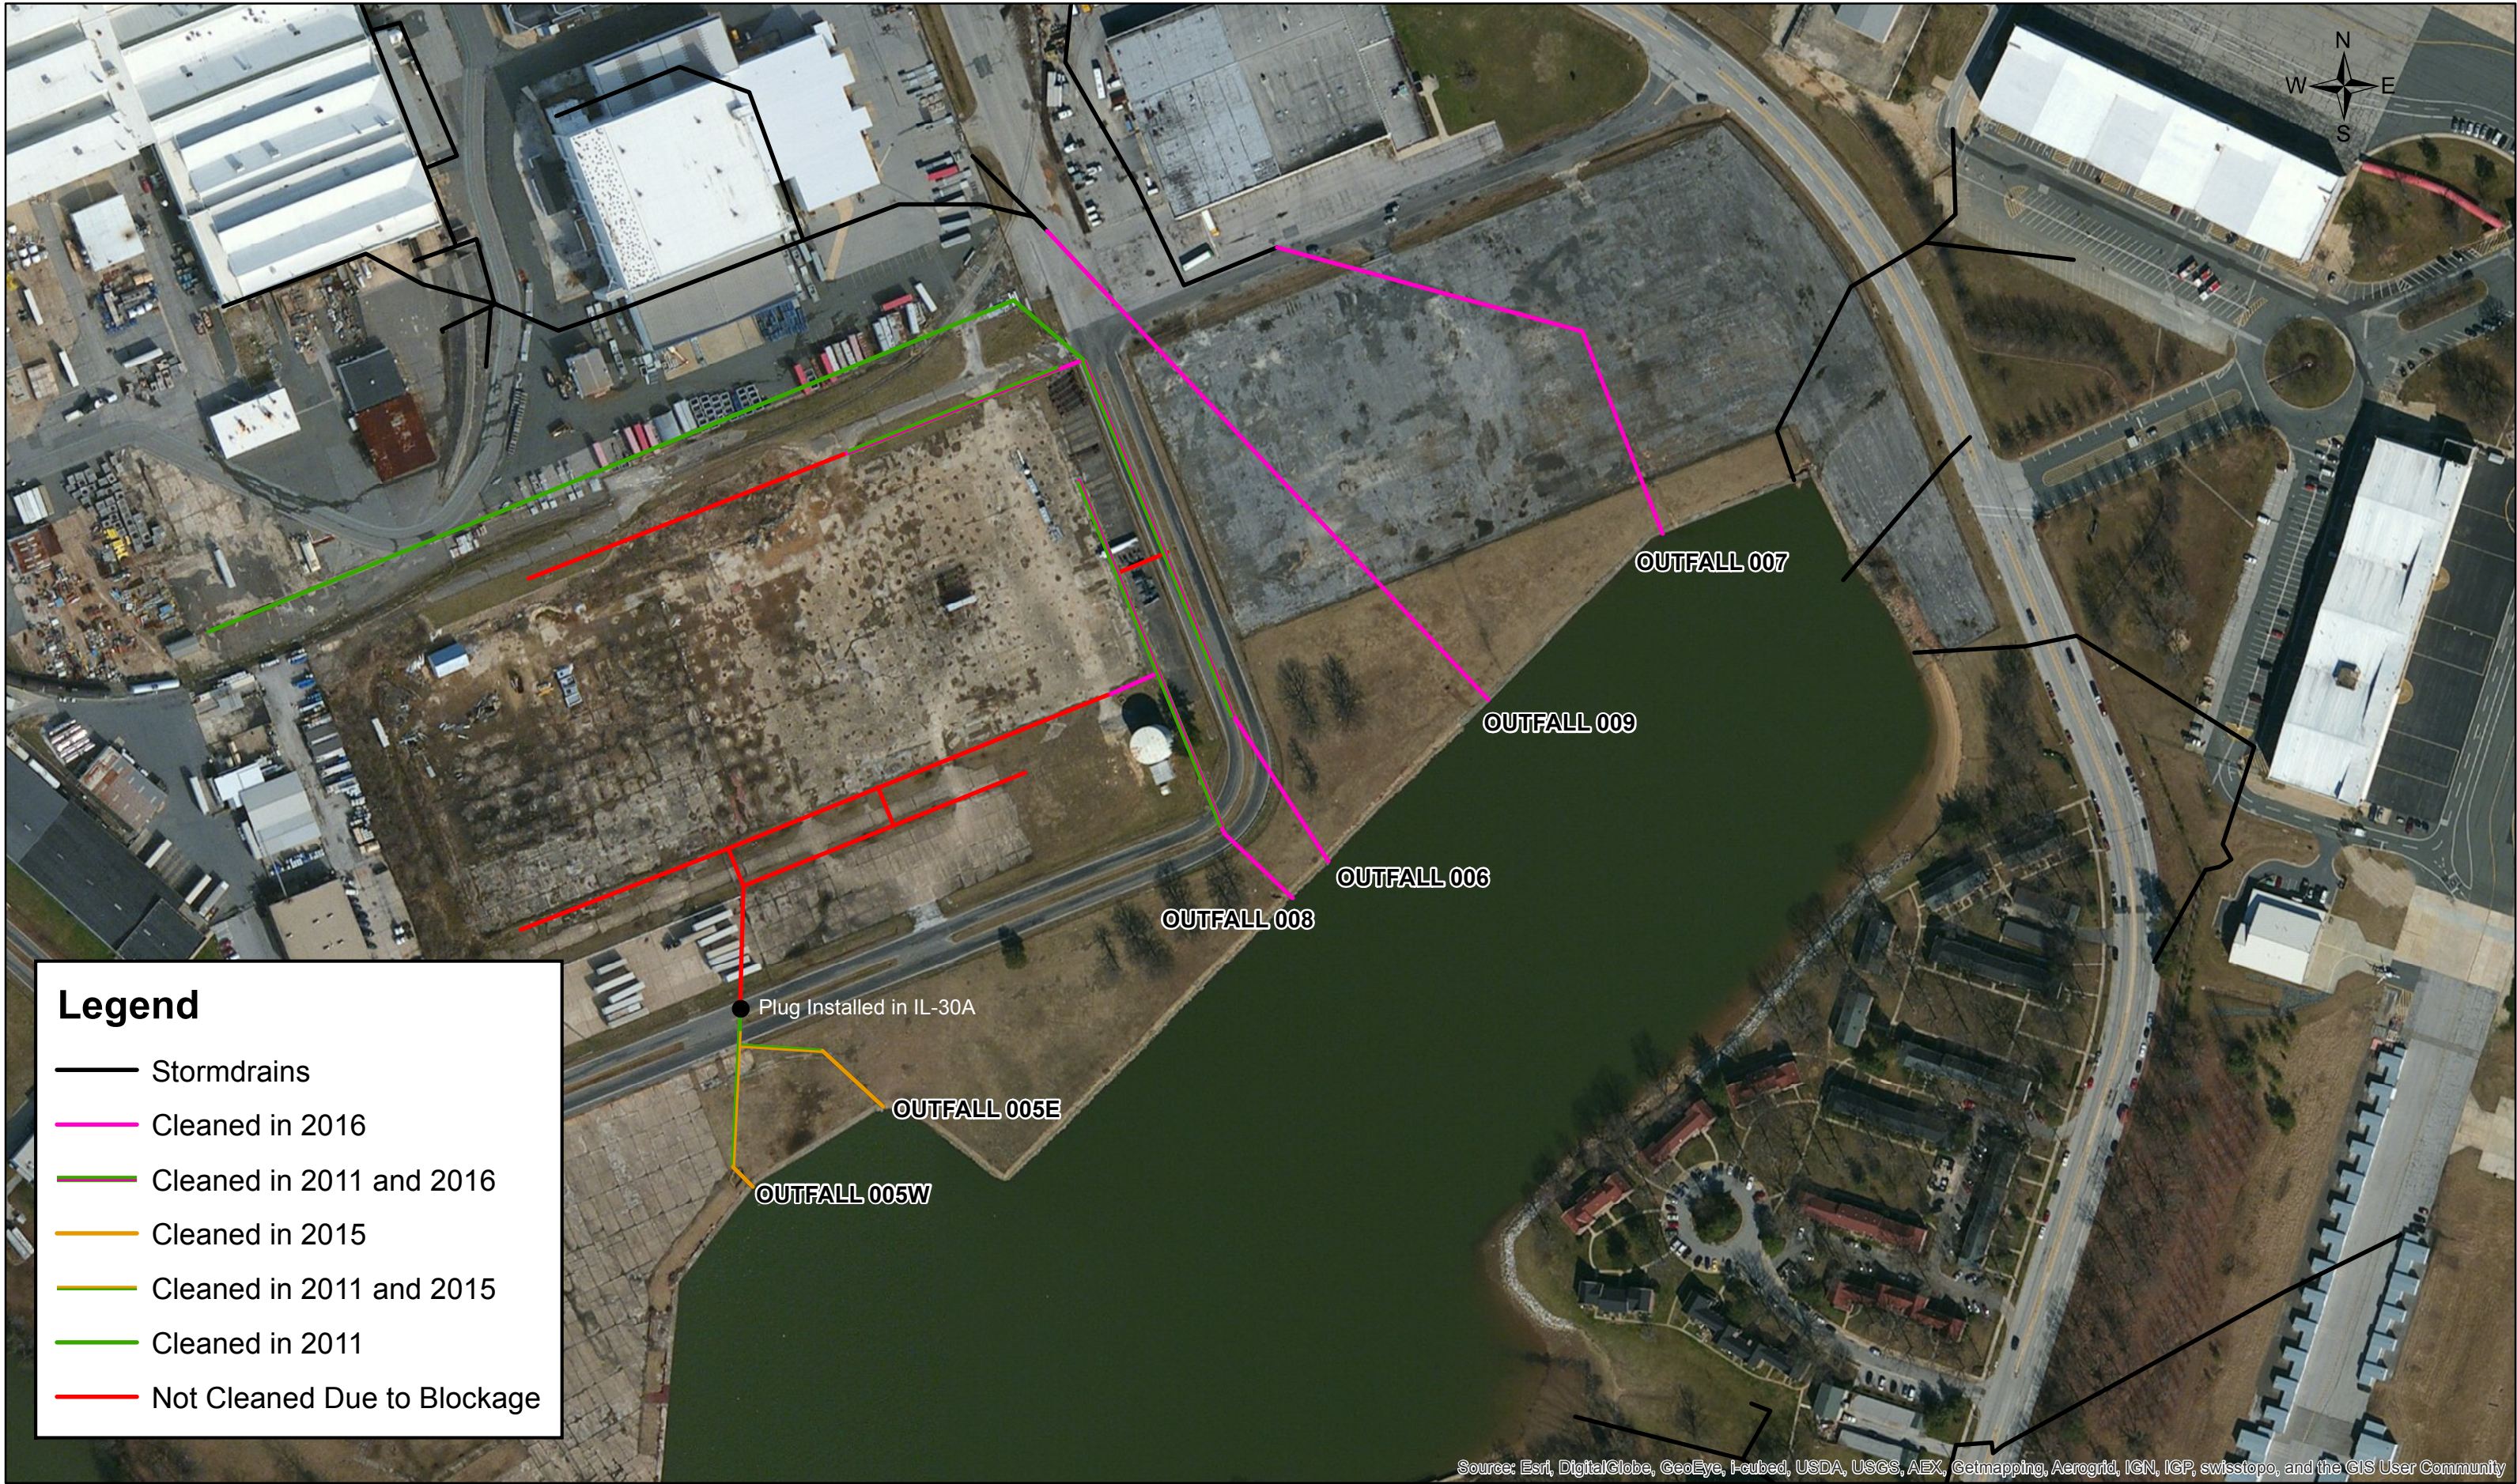
Lockheed Martin Midde River Project
FIGURE 2: STORM DRAIN CLEANING

2011 Cleaning. In 2011, interim remedial measures were completed to minimize the transport of contaminated sediments in the storm drain system to off-site locations and to improve Block E storm water drainage. These activities included: removing sediment and debris from system piping (Figure 2); implementing sediment controls such as silt fences; and repairing or replacing inlets and manholes where necessary. In general, storm sewer cleaning activities were successful, though blockages prevented cleaning in the northern portion of the Outfall 005 system and portions of the East-West lateral drains (Figure 2) (Tetra Tech, 2012b).

As part of the full sediment remedy for Cow Pen Creek and Dark Head Cove, portions of the Outfall 006 and 008 systems were cleaned in 2016 (Figures 1 and 2). Specifically, the Outfall 008 storm drain system was cleaned from Outfall 008 to MH-9 and IL-7 and the Outfall 006 storm drain system was cleaned from Outfall 006 to JB 6-1 to IL-14 (Figures 1 and 2). The lines were cleaned prior to dredging that occurred near the respective outfalls. Cleaning the pipes involved: installing temporary plugs to prevent movement of sediment or debris to the waterway; using jet lines to wash sediment in a downstream-to-upstream direction and into the vacuum line; and removal of the cleared debris from the storm line with a jet/vacuum truck. Following cleaning, a mobile CCTV truck conducted video inspections of the cleared portion of the drain lines. As during the IRM, it was infeasible to effectively clean the portion of storm drain systems 005 and 008 between IL-17 and MH-9 with the highest concentrations of PCBs due to the presence of debris.

New manholes were installed at Outfall 006 and 008 downstream of Block E. This will make cleaning the pipes easier in the future as the new manhole locations will be able to be utilized for plugging the storm drains. Additionally, a portion of pipe in Outfall 008 was replaced.
