Subject: Transmittal of the Technical Memorandum: Outfall Sealing East End of Blocks D and F  
Lockheed Martin Corporation – Middle River Complex  
2323 Eastern Boulevard, Middle River, Baltimore County, Maryland

**Subject:** Outfall Sealing East End of Blocks D and F

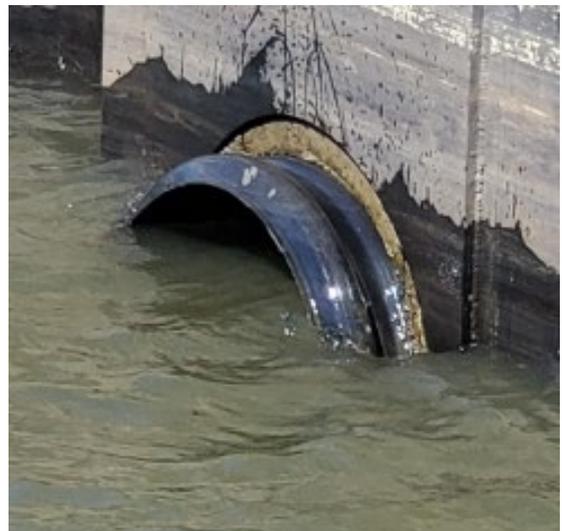
Observations of the outfall penetrations indicate that the concrete surrounding the corrugated HDPE pipe appears to be displaced and cracked. Probing in the cove adjacent these outlets indicates the presence of mounded granular soil that appears to be consistent with the volumes of material lost surrounding the culvert. Inspection of the invert of the pipes is not possible, since they are partially submerged, but it appears likely that the conditions observed for the exposed portions are representative of the full circumference of the pipe.

Based on these observations, it appears that tidal action is flushing granular fill through openings around the circumference of the pipes at the two outfalls. The openings appear to be the result of fracturing and displacement of the concrete where it adjoins the steel wall components. Because the area over the pipes consists of concrete cast to the sloping granular fill surface, the concrete is in a trapezoidal shape and the granular fill loss is occurring in an hour-glass fashion concentrated along the contact between the granular fill and the concrete. This results in the surface expression appearing as a sinkhole several feet off the centerline of each pipe.

Figure 1 - Recess in anular concrete at OF-00X

Based on the above discussion, the recommended approach is the Urethane Grouting Option, since it has the potential to provide an immediate repair. In order to complete this repair, it will be necessary to fill the existing openings prior to grouting to prevent the grout from flowing up the hole. The repair should be made by drilling holes through the existing HDPE pipes to intersect the gap between the concrete and steel wall structure. Grout should be injected at low pressure through multiple ports set in the wall of the pipe. Confirmation of successful sealing will be evidenced by grout appearance through openings in the annular concrete and from upper injection ports during injection at lower ports. The grout is expected to migrate upward, so grouting should begin at the invert of the pipe working toward the top.

If drilling through the pipe wall fails to intersect the gap/contact between the concrete and steel, an alternative approach would be to drill through the steel, tap the holes and install injection ports. The holes would be sealed with a marine sealant after the injection ports are removed. Grouting would be performed in the same sequence as for drilling through the pipe wall.

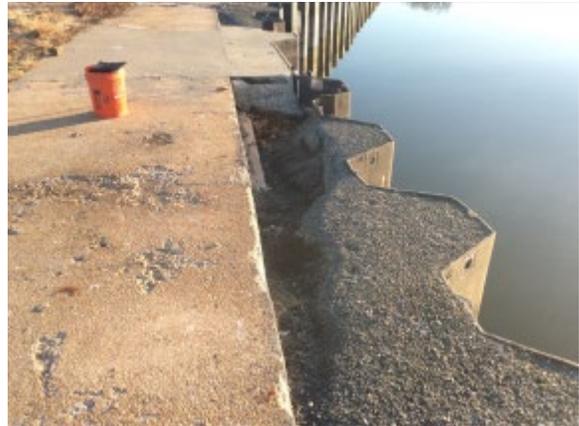
Since completion of the bulkhead walls along Dark Head Cove in Block D and Block F, settlement of the granular fill has been noted. This has primarily been attributed to loss of granular fill through openings in the original sheet piling. In the anticipation that these losses would stabilize as the existing voids became filled, it was decided to restore the settled areas with additional granular fill and restore the surface as needed with additional granular fill should settlements recur. For the majority of the walls, the settlement of the granular fill has been small, on the order of a few inches, except in the immediate areas surrounding Outfalls OF-0005W and OF-00X. Recent inspections in April 2019 after grade restoration in March 2019, indicate areas of granular fill loss to depths greater than 24-inches immediately adjacent to outfalls OF-0005W and OF-00X.

Figure 2 - Granular Fill loss at OF-005W
