**2016 Annual Site
Management Report**

**APPENDIX C:
Cover System
Performance Report**

**Former Lockheed Martin
French Road Facility
Utica, New York**

May 2017

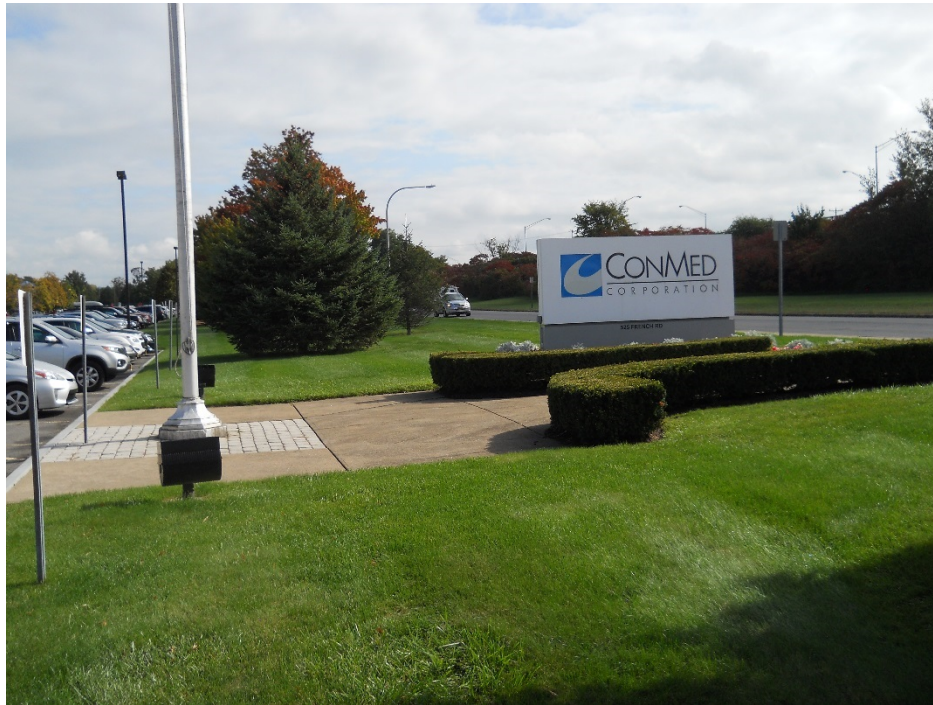
**Photo 1: South side opposite front entrance to building
- looking east.**

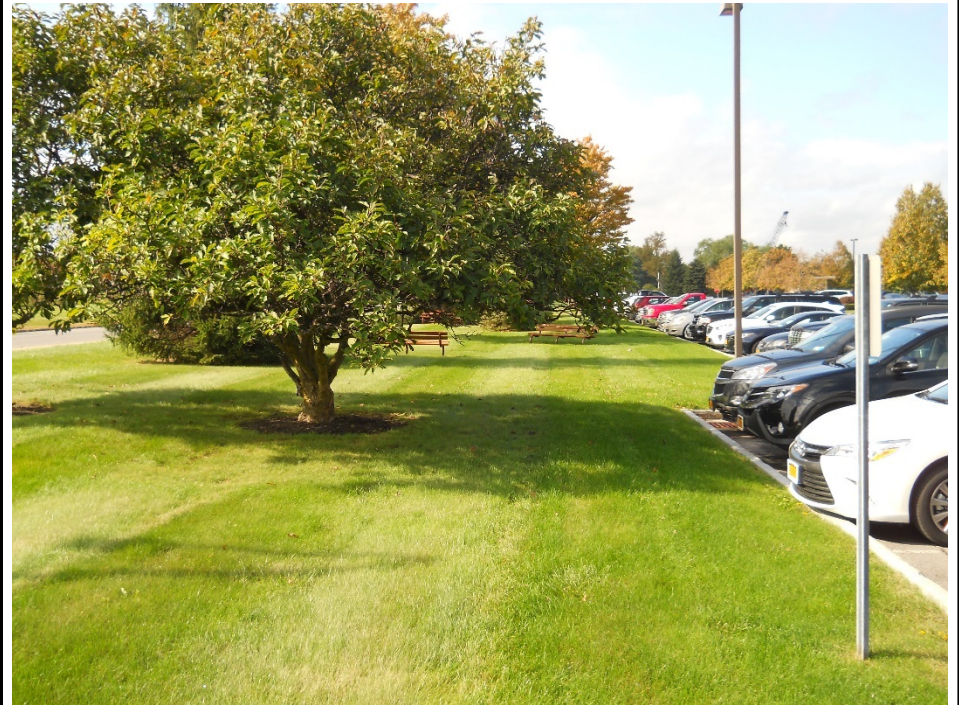
**Photo 2: South side opposite front entrance to building
- looking west.**

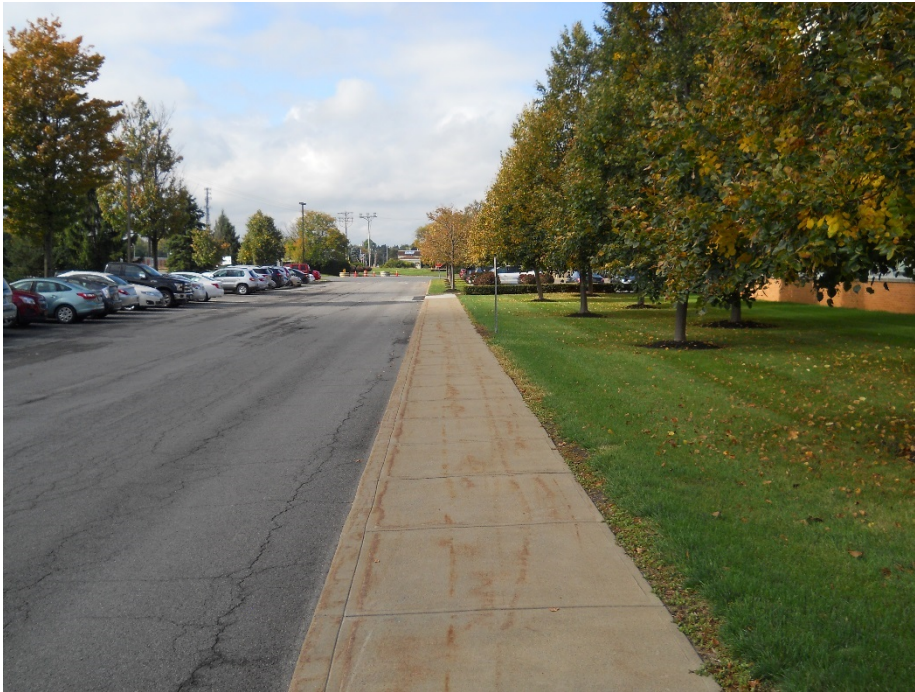
Photo 3: South side showing drive and landscaped area along front of building – looking west.

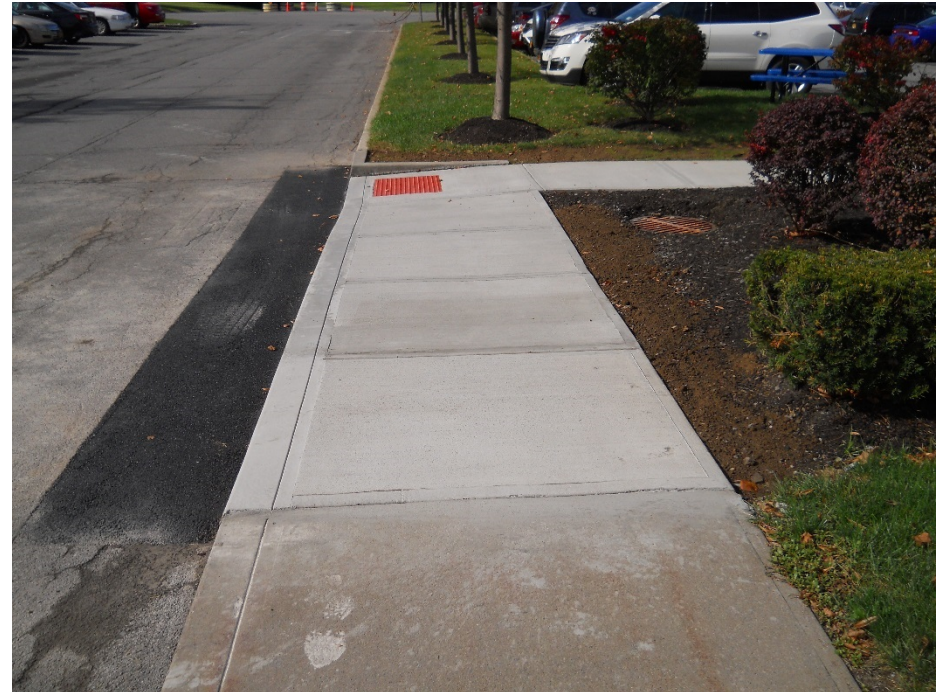
Photo 4a: South side west end showing new handicap ramp/sidewalk completed – looking west.

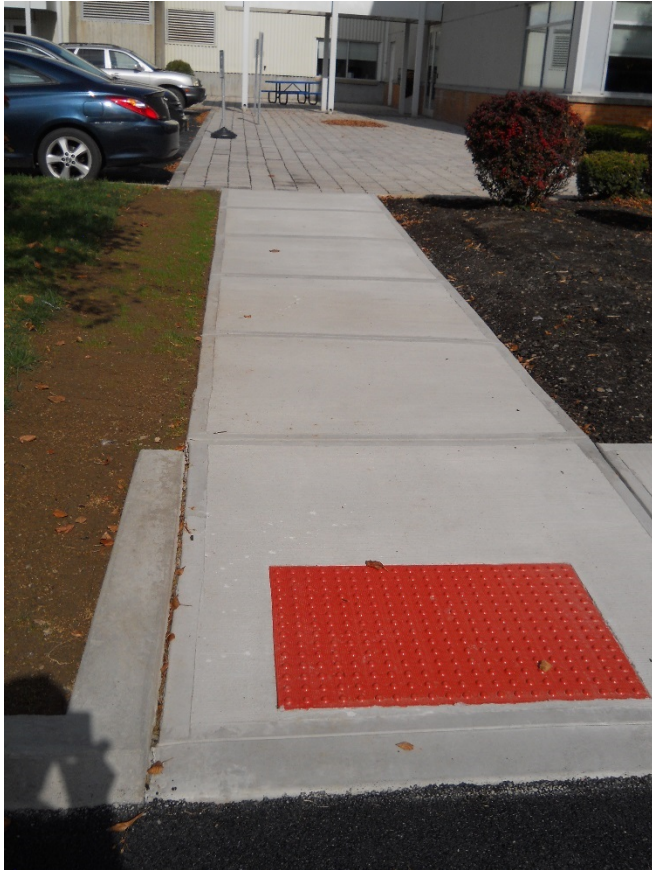
Photo 4b: South side – west end showing new handicap ramp/sidewalk completed – looking north.

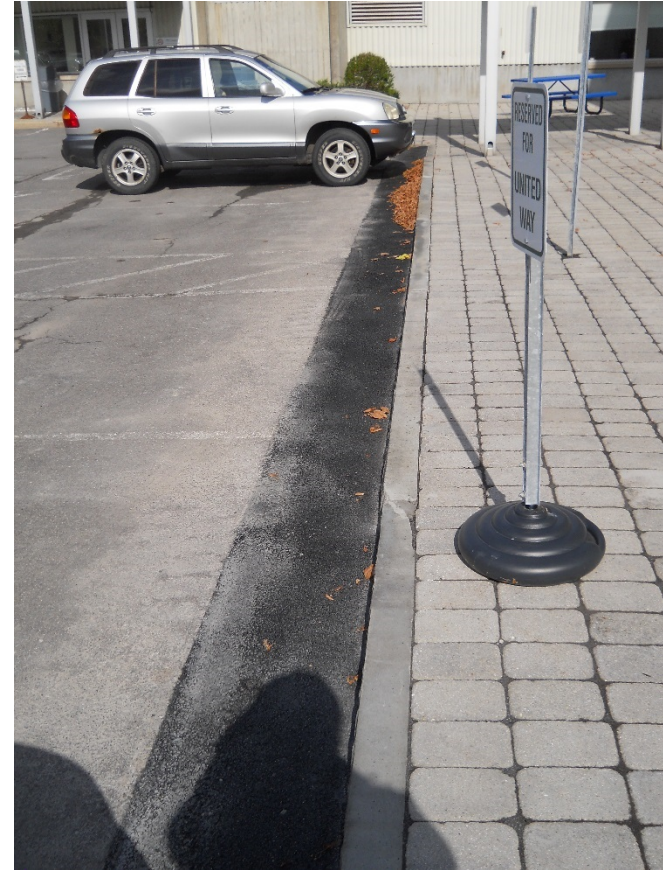
Photo 5: West side – curb replacement, completed along with ramp/sidewalk project – looking north.

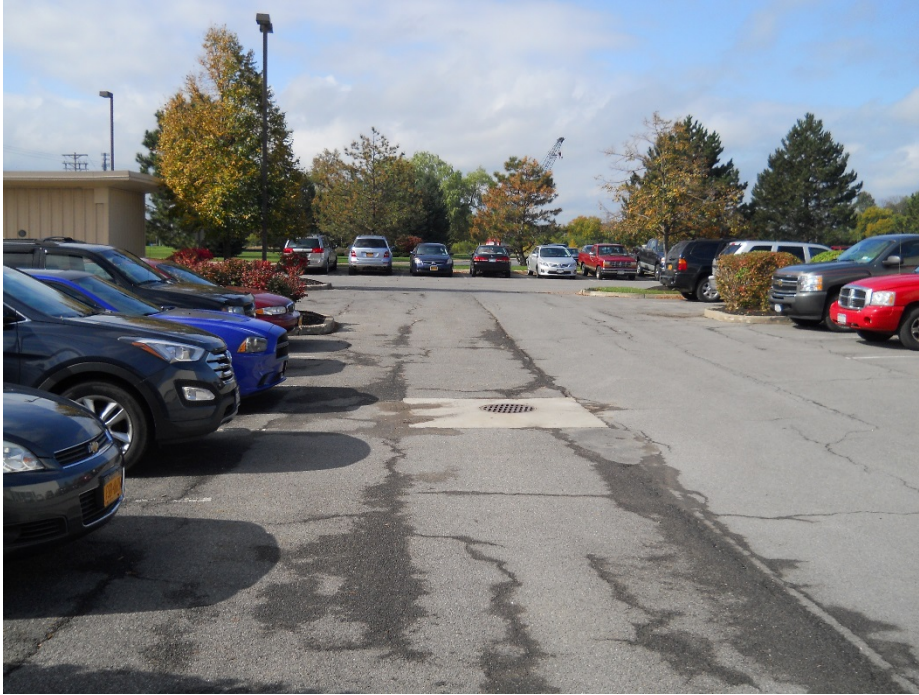
Photo 6: West side – typical parking area pavement – looking west.

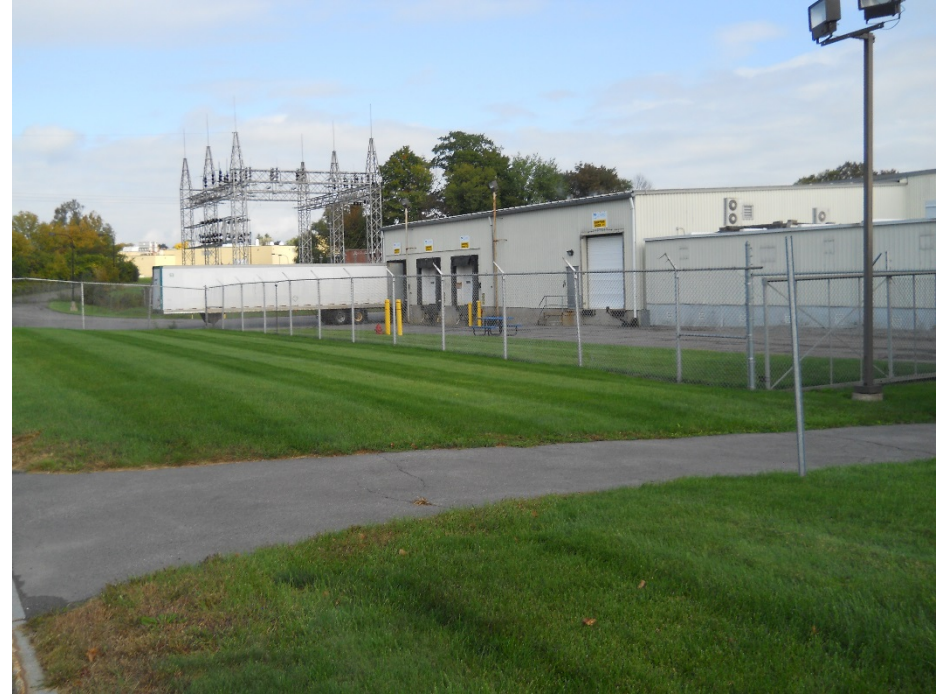
Photo 7: West side – typical landscaping at west side of site cover area – looking north

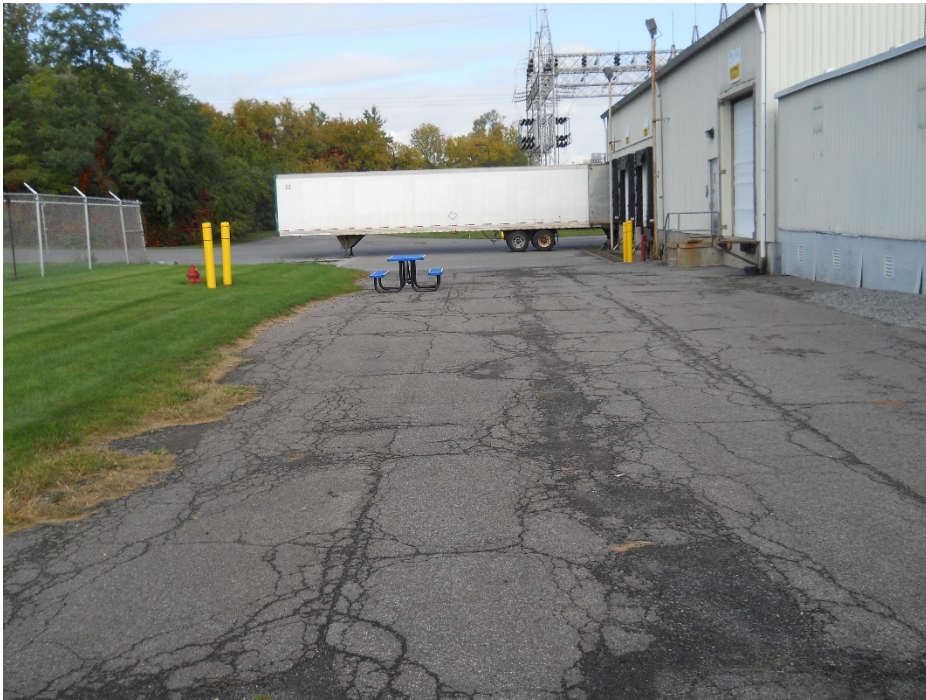
Photo 8: West side – paved area along building – looking north toward loading docks.

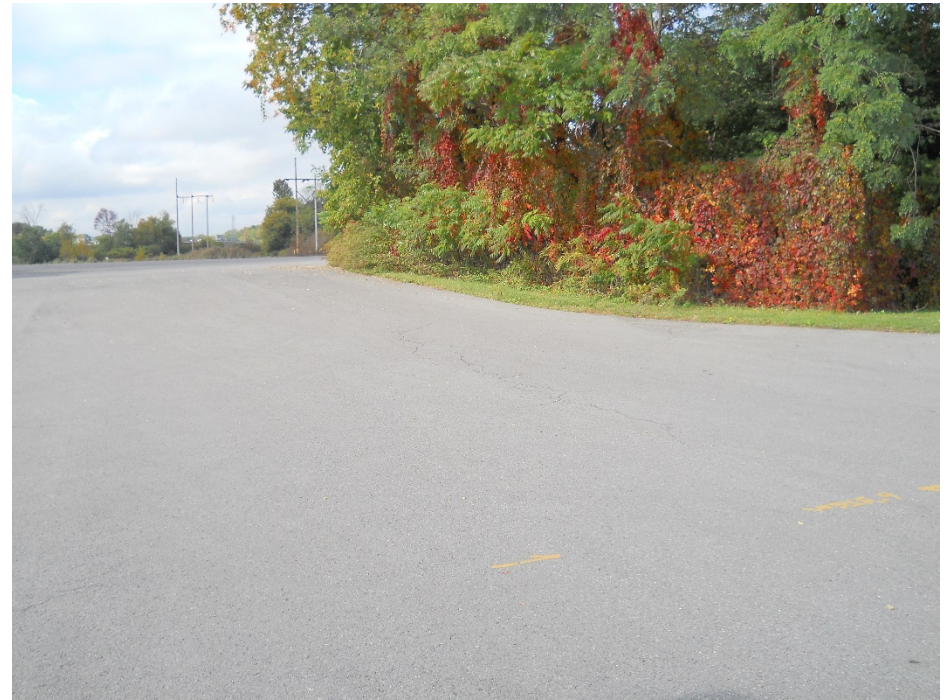
Photo 9: Northwest corner of site cover area – pavement and wooded area – looking west.

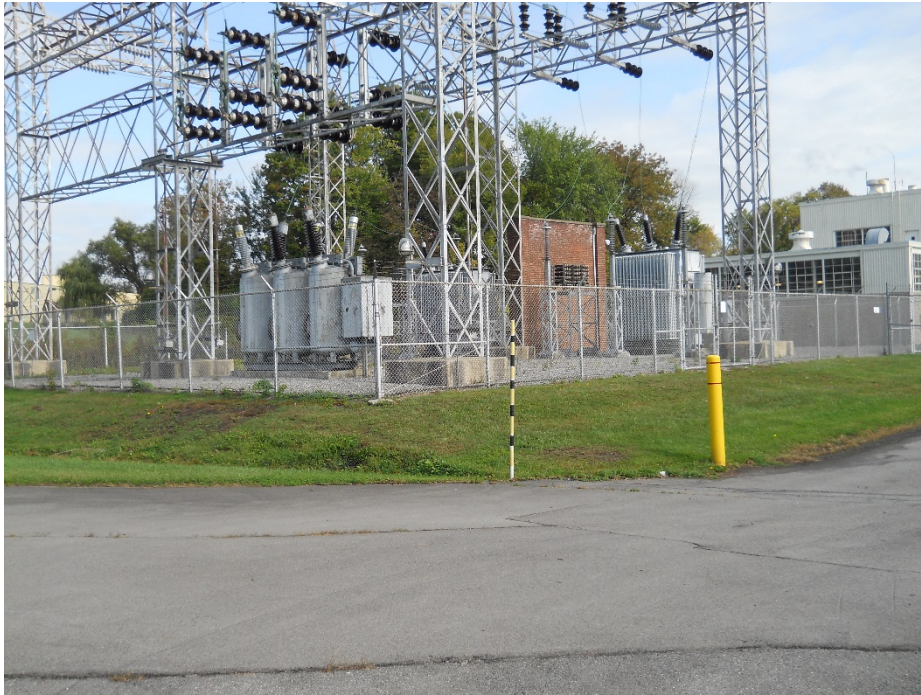
Photo 10: North side – west end showing electrical substation area.

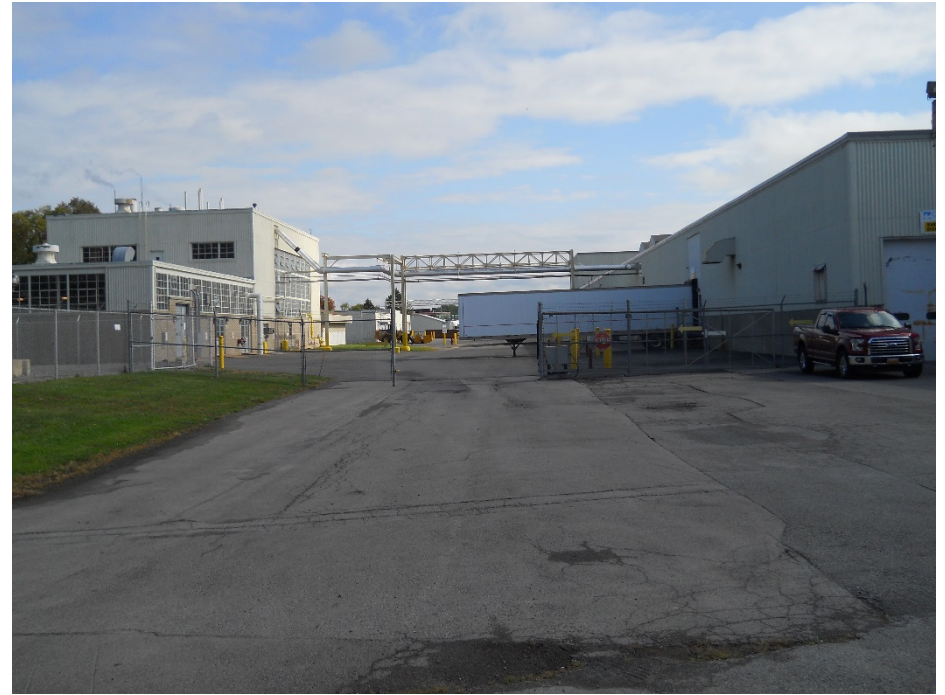
Photo 11: North side – west end, overview of paved access drive – looking east.

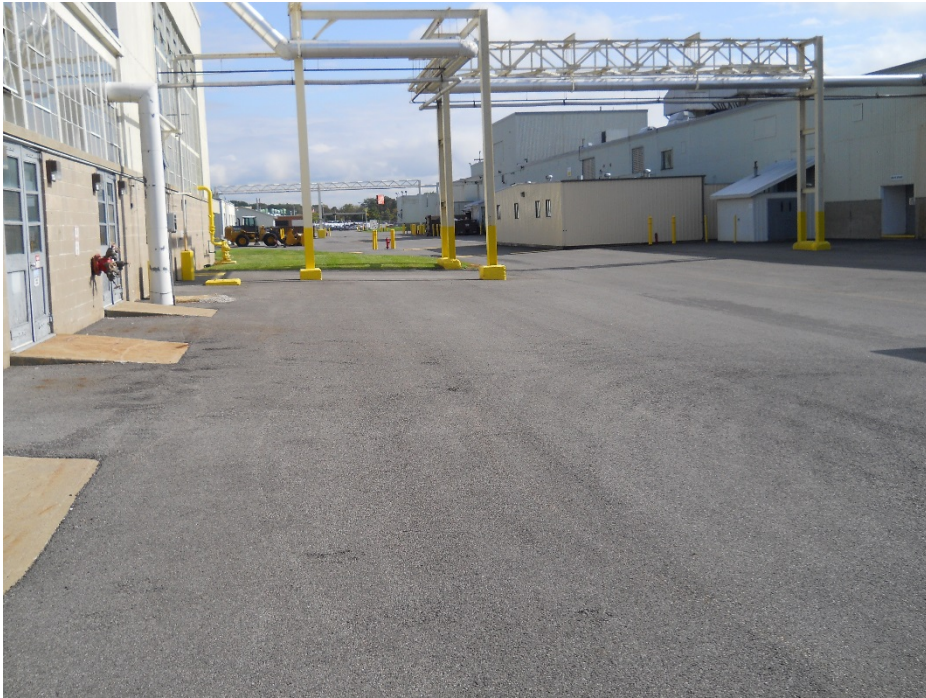
Photo 12: North side – west end, boiler house to left, overview of paved access drive – looking east.

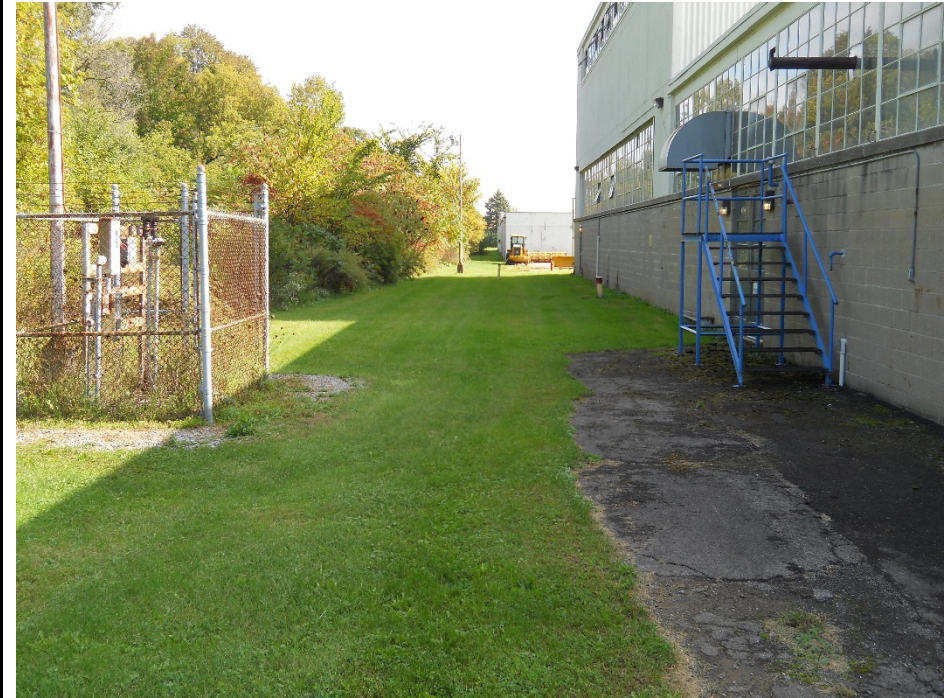
Photo 13: North side – landscaped area north of boiler house – looking east.

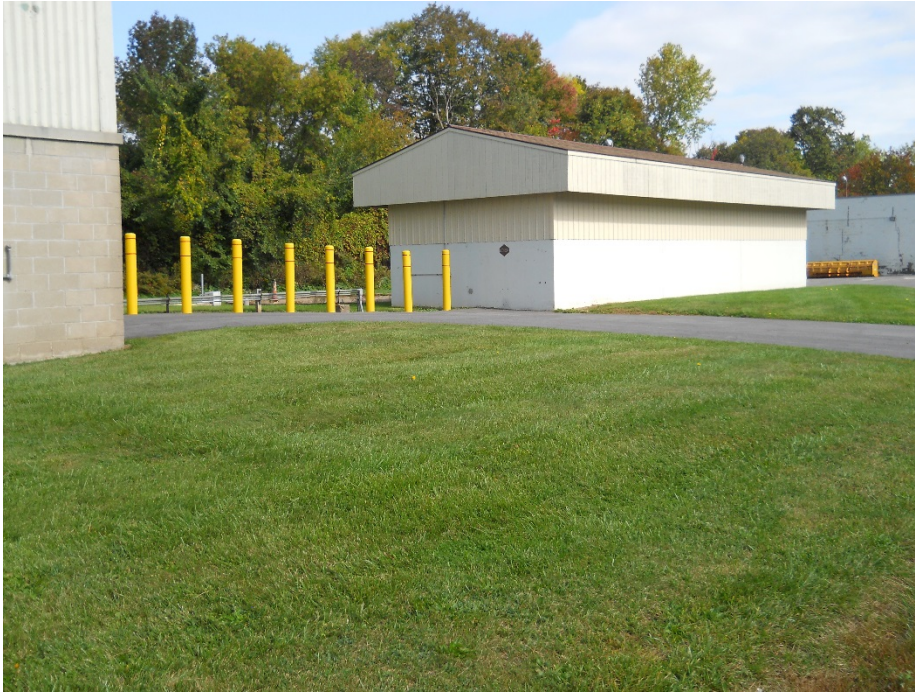
Photo 14: North side – showing area between boiler house and maintenance building.

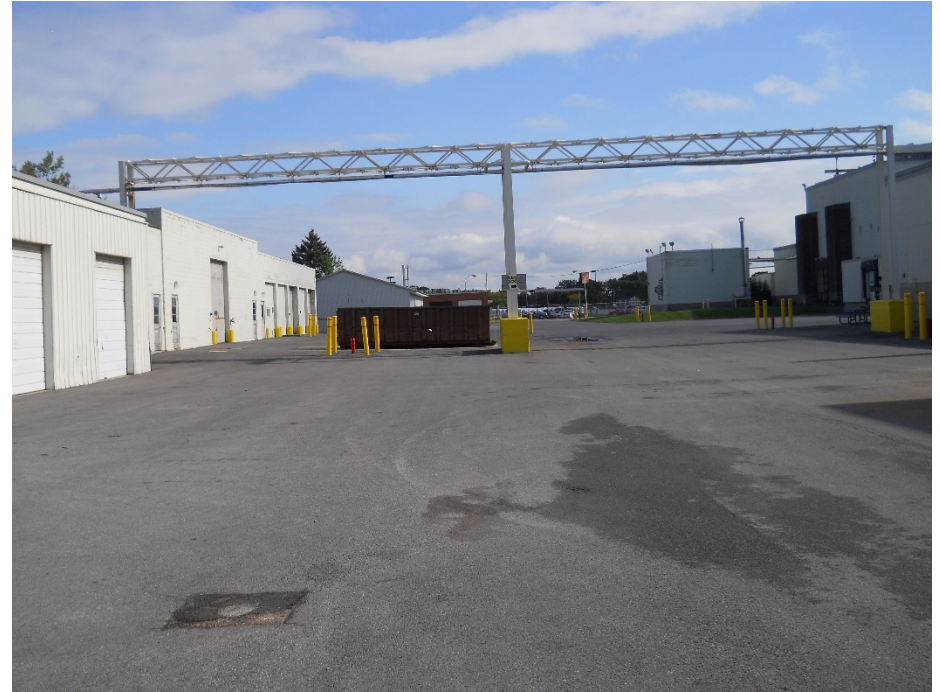
Photo 15: North side – central area, maintenance building to left – looking east.

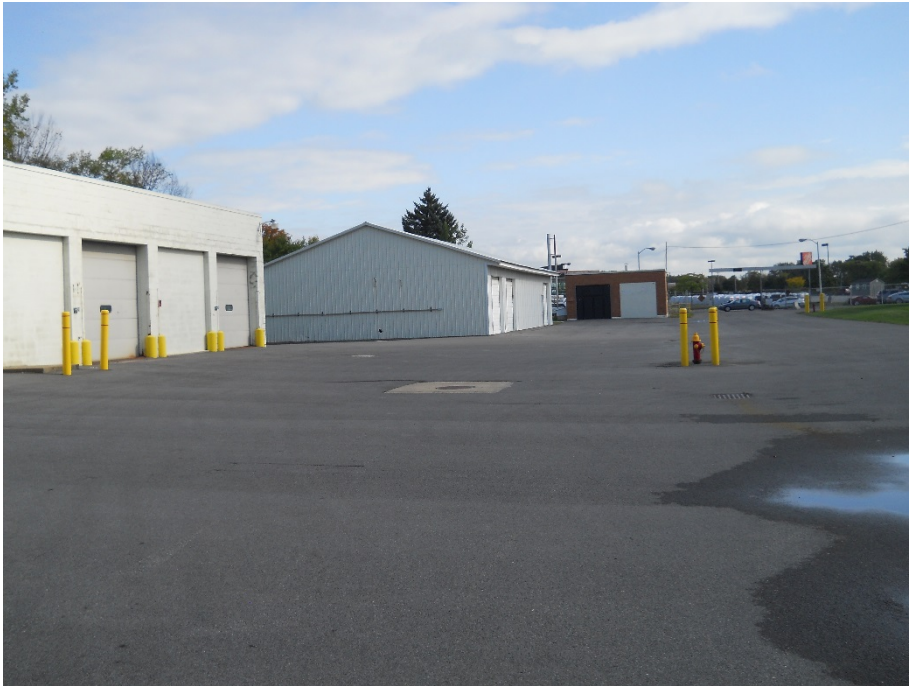
Photo 16: North side – central area showing pole barn in distance – looking east.

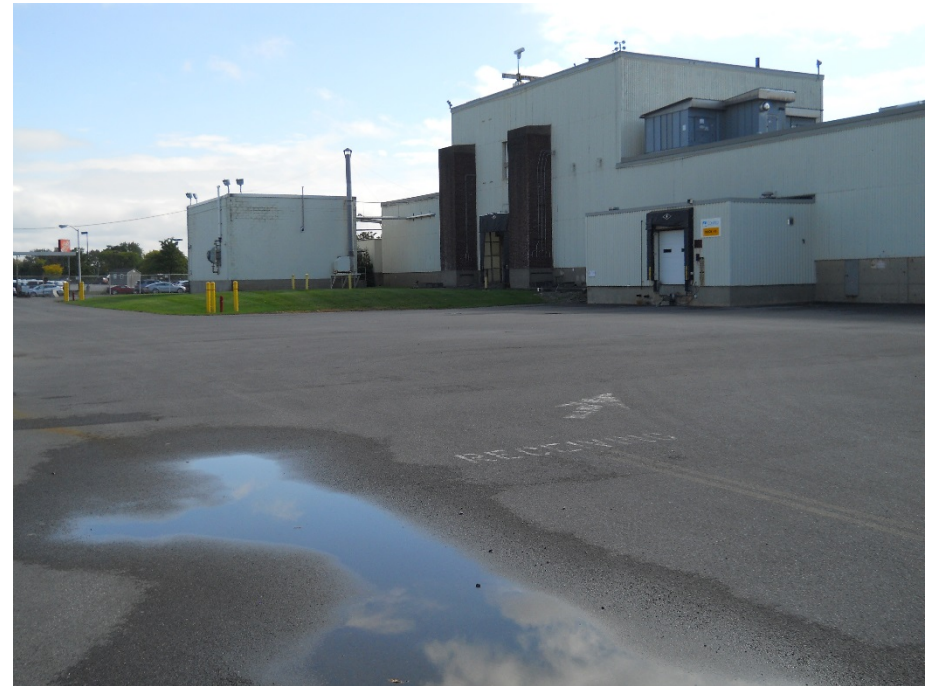
Photo 17: North side – eastern end showing pavement and main building – looking east.

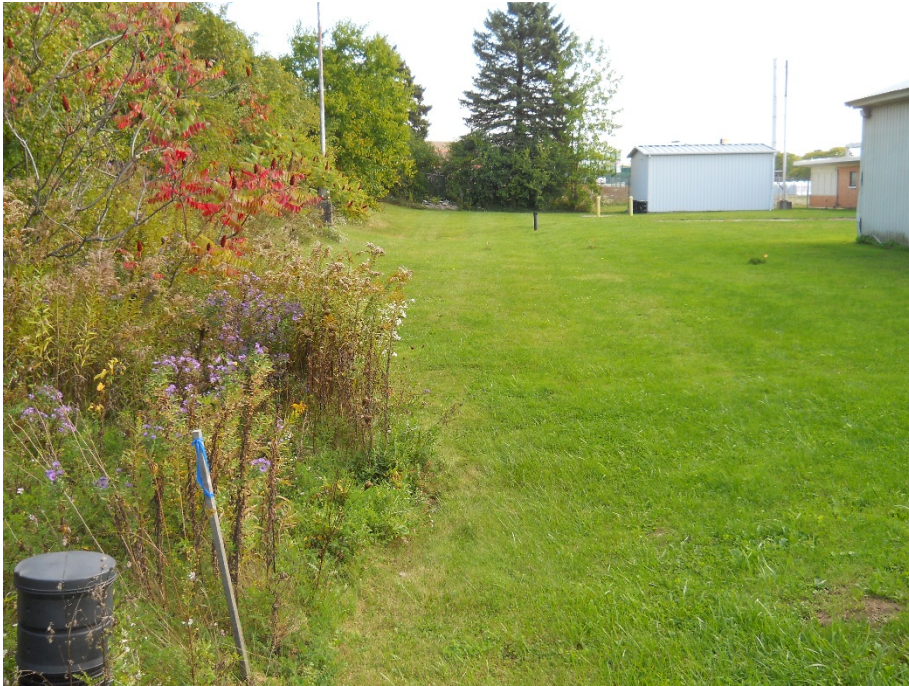
Photo 18: North side – area north of pole barn with GCTS in background – looking east.

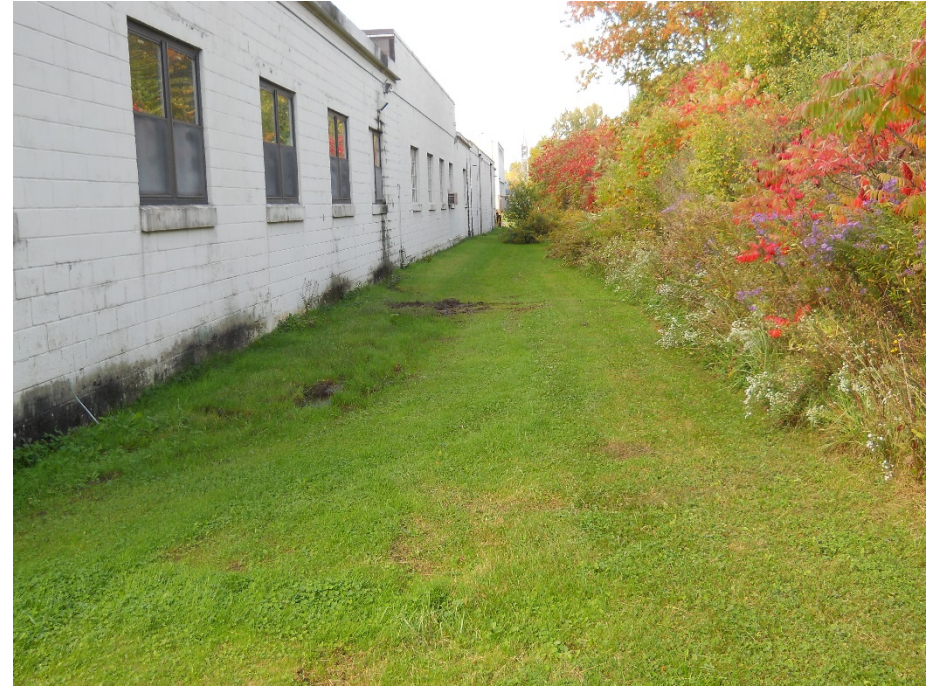
Photo 19: North side – area north of maintenance building, some minor rutting due to saturated ground – looking west.

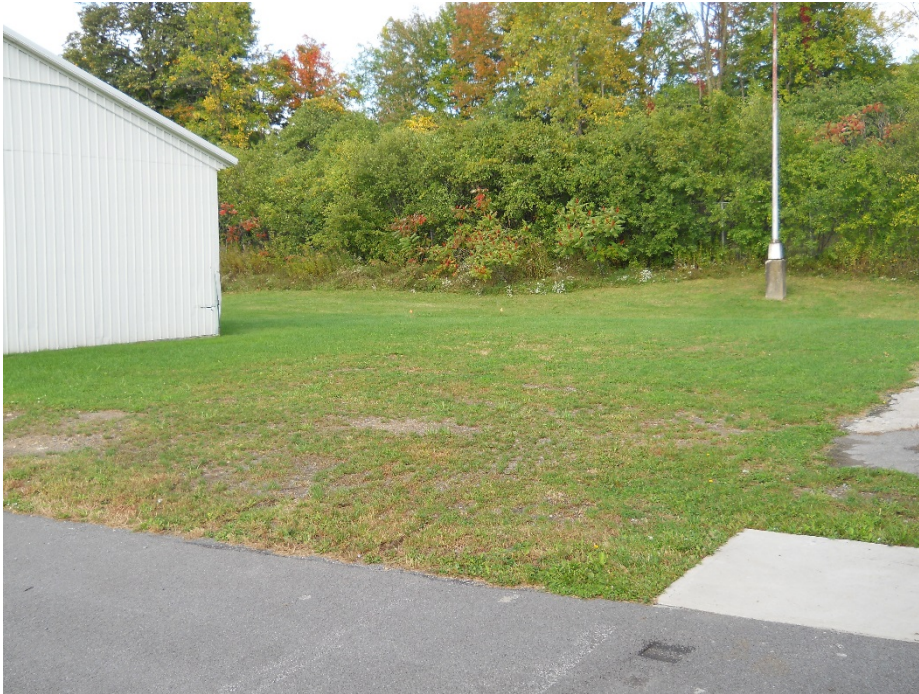
Photo 20: North side – showing east side of pole barn – looking north.

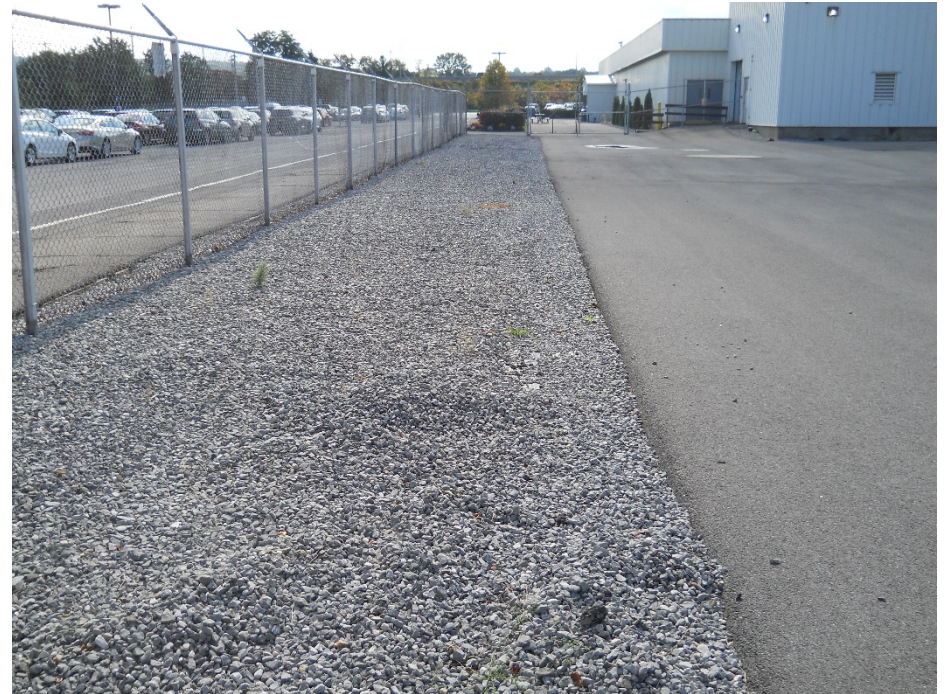
Photo 21: East side – gravel covered area along security fence line – looking south.

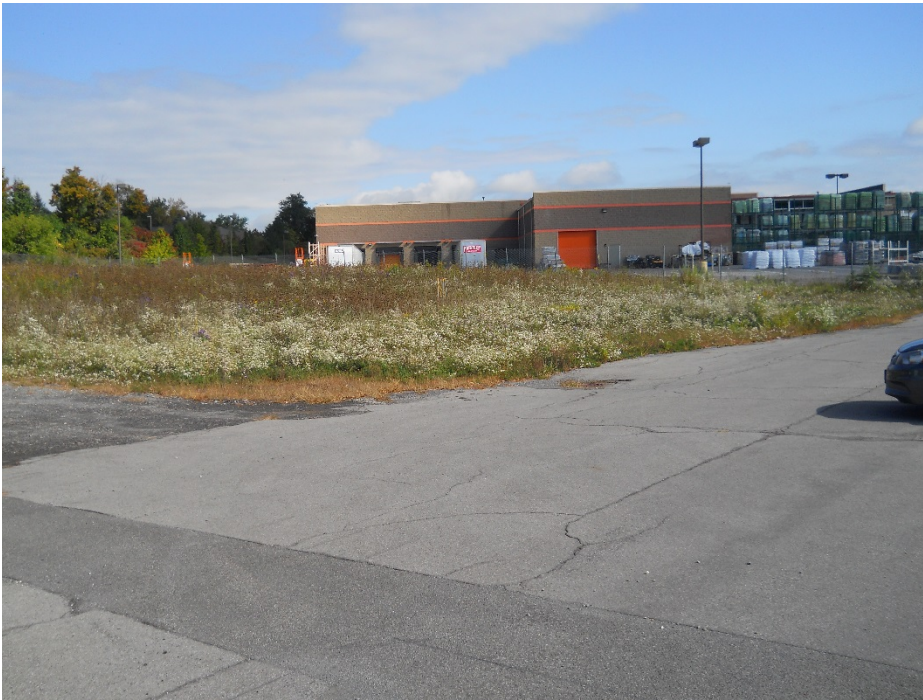
Photo 22: East side – Northeast corner showing grass covered area.

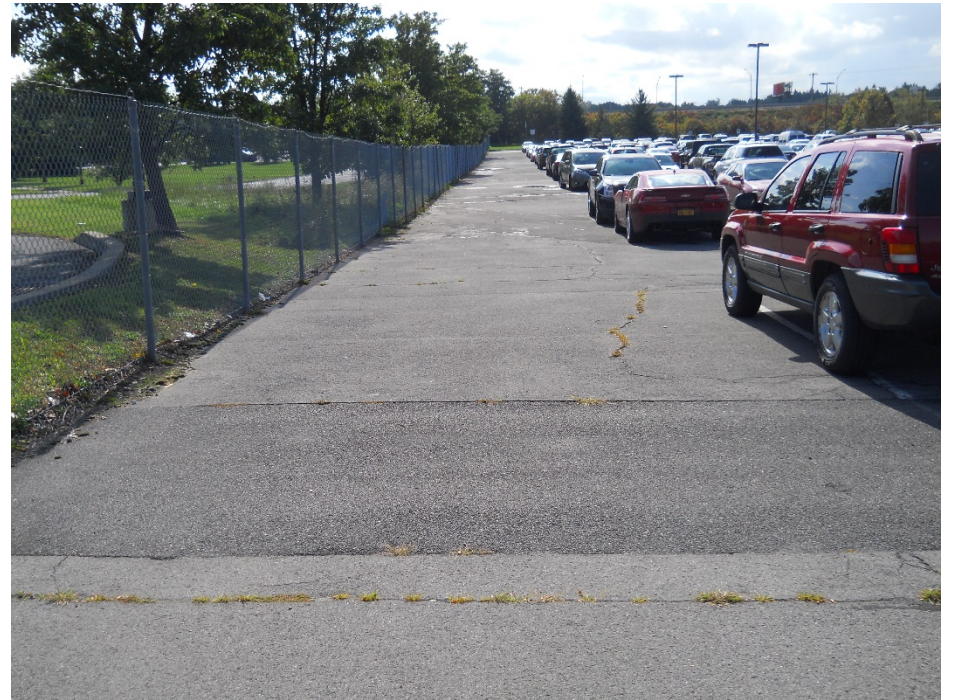
Photo 23: East side – showing parking/pavement area – looking south.

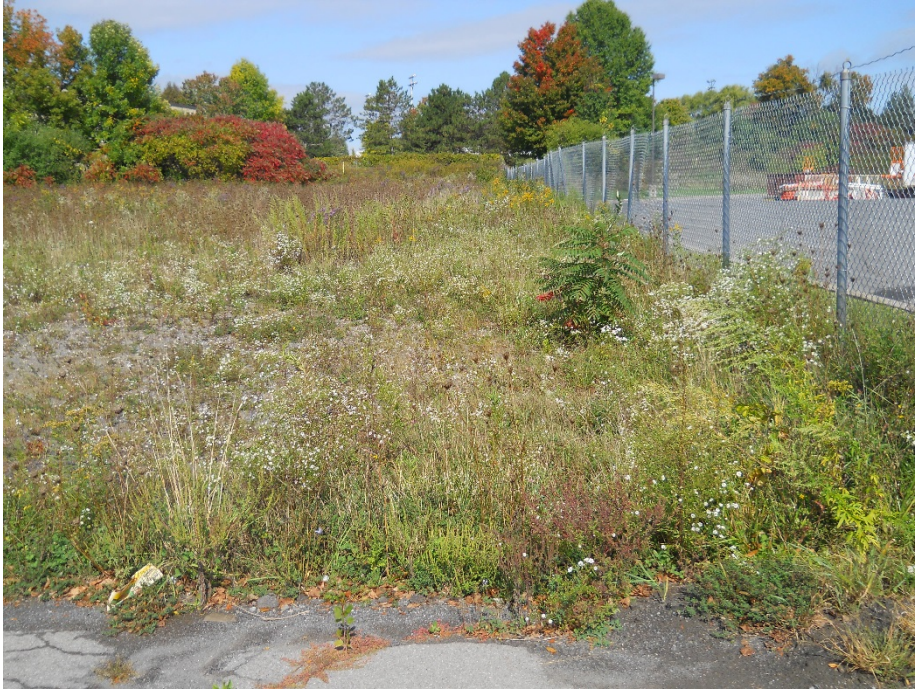
Photo 24: East side – Northeast corner showing grass covered area – looking north along eastern fence line.

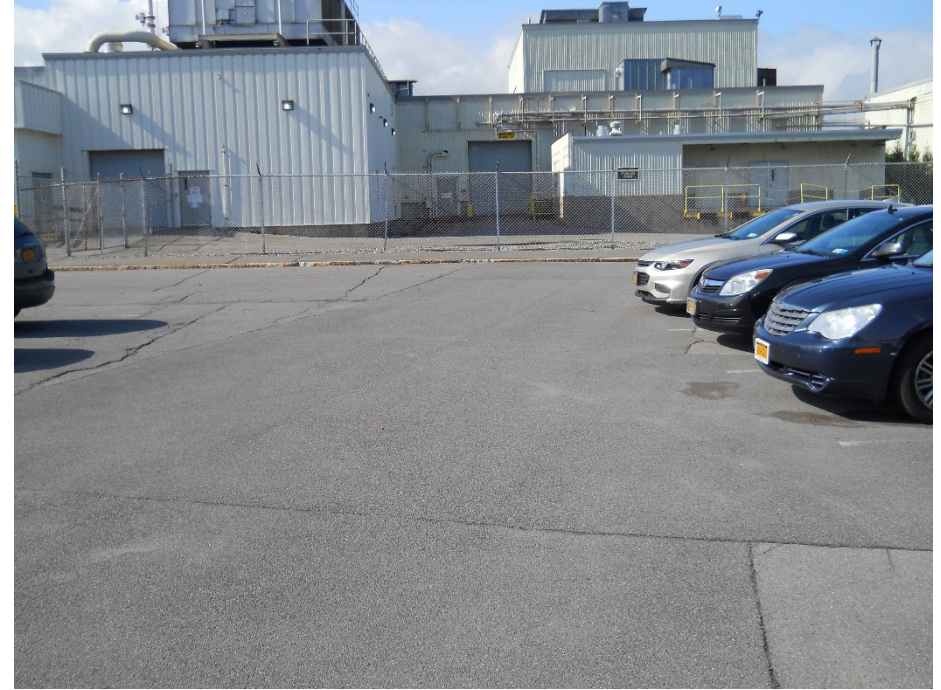
Photo 25: East side – showing parking/pavement area – looking west.

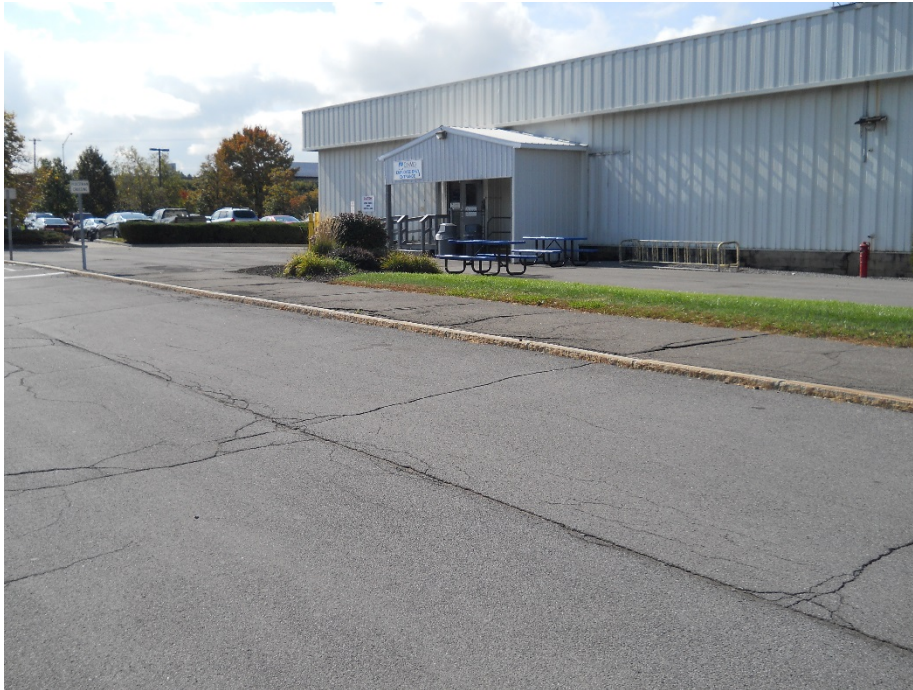
Photo 26: East side – showing parking/pavement area – looking west.

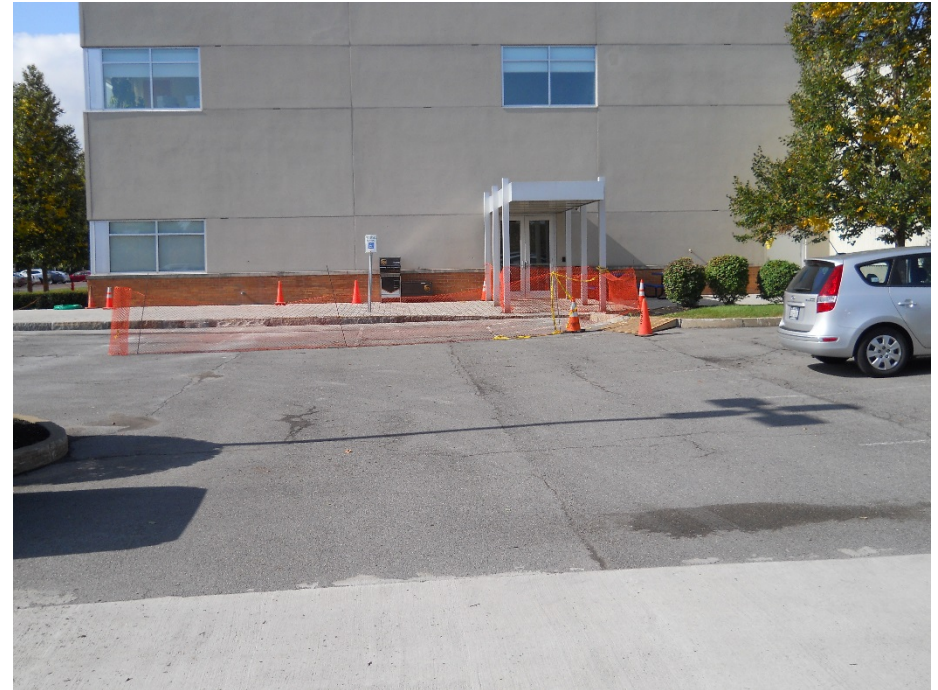
3. Firemain repair – On December 18, 2015 ConMed experienced a firemain leak in the parking area located near the southeast corner of the building (see Photo Log, locations 27 and 28). Excavation was required to repair the leak and due to the season and unavailability of asphalt, concrete was used to restore the pavement.

* One excavation was required in the
east parking area. A fire main repair
in Dec 18, 2015 was needed - no asphalt
available - so concrete was used.
(per Rich Zigentus - ConMed)

Photo 27: East side – showing parking/pavement area, note construction fencing for curb replacement sidewalk ramp project, and location of water main repair/concrete patch – looking west.

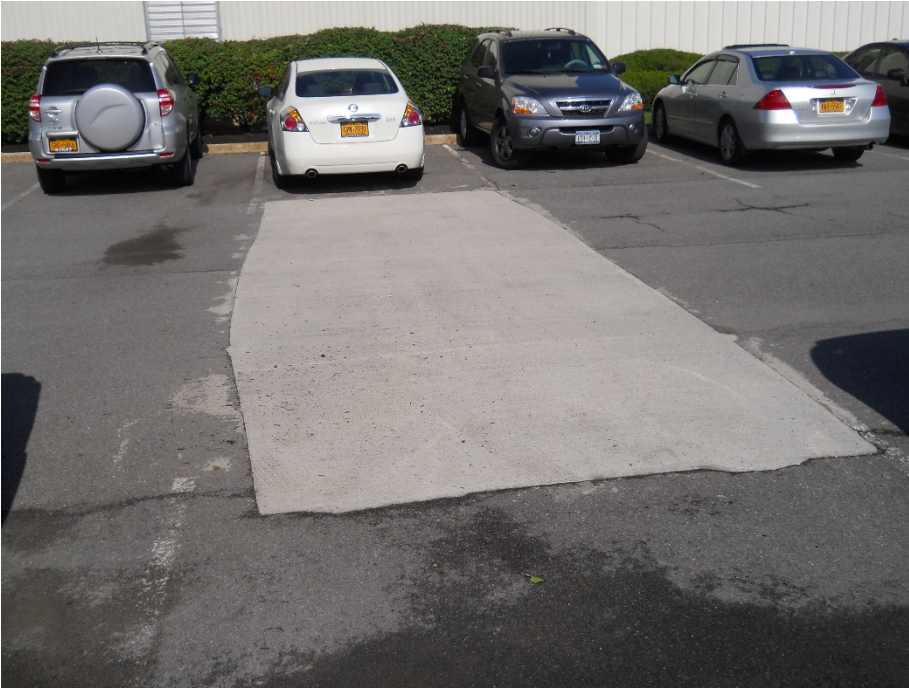
Yes - emergency watermain repair on 12/18/15, pavement replaced w/conc.

Photo 28: East side – showing water main repair/concrete patch – looking north.

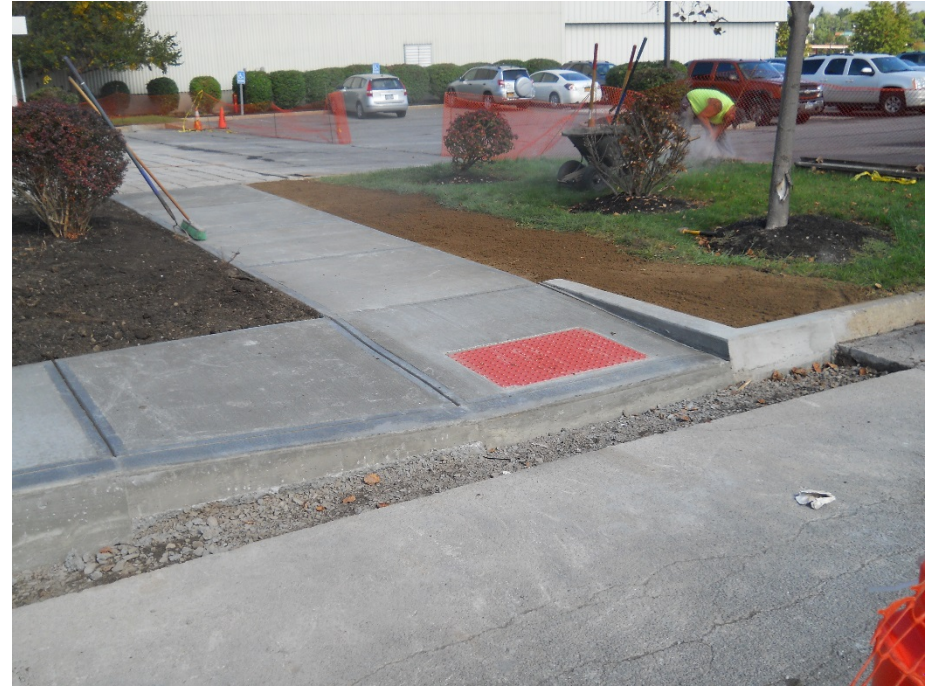
Photo 29: East side handicap ramp/sidewalk project nearing completion – looking northeast.

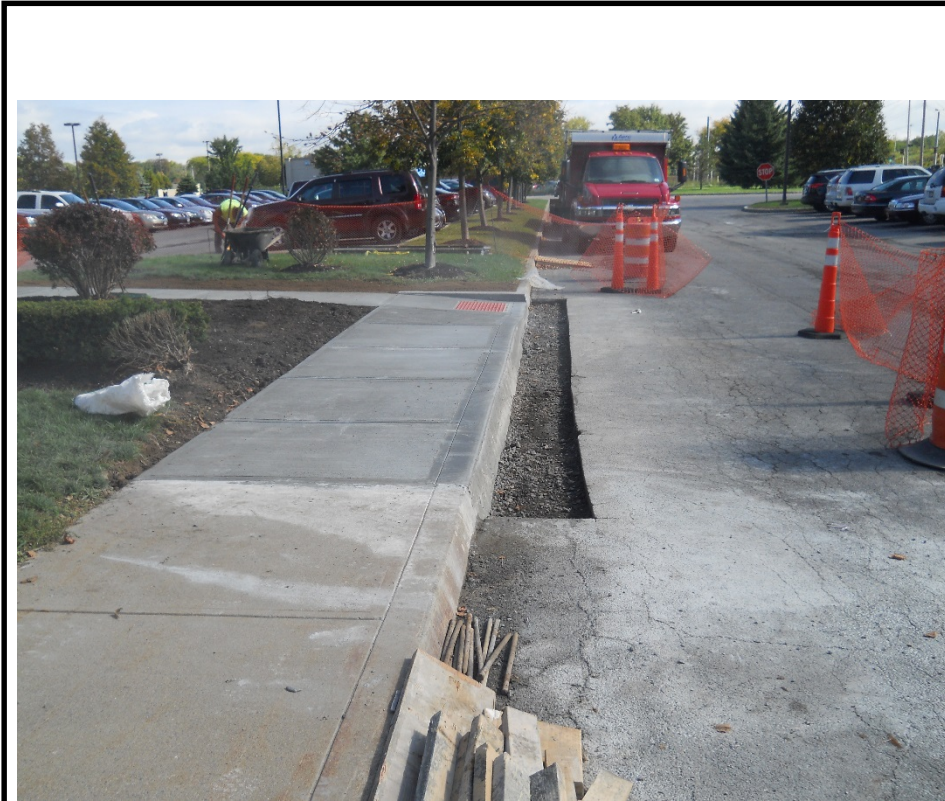
Photo 30: East side – handicap ramp/sidewalk project nearing completion – looking east.

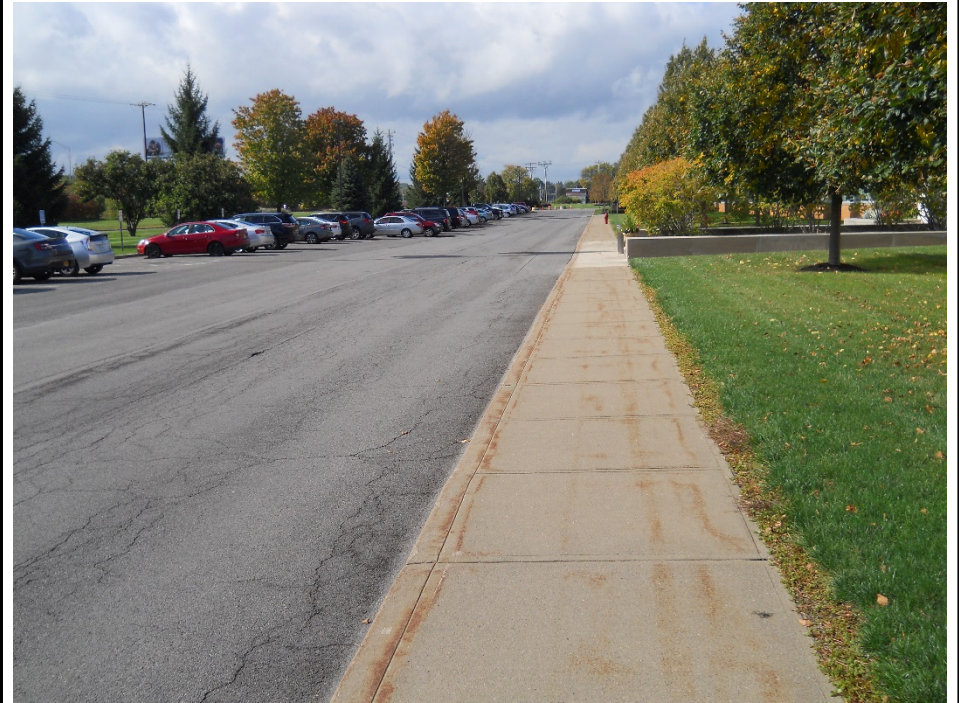
Photo 31: South side – east end showing typical pavement/landscaping – looking west.
