vvvv i P Monitoring Report N3001022.0001		
We are sending you:  ☑ Attached ☐ Under Separate Cover Via the Following Items:		
	☐ Change Order ☑ Reports	
Copies Date Description	Action*	
1 7/28/11 WWTP Monitoring Report, Former Lockheed Martin French Road Facilit New York.	ty, Utica, AS	
☐ AN Approved As Noted ☐ F File ☐ Ret	submit Copies turn Copies view and Comment	
	☐ FedEx 2-Day Delivery ☐ FedEx Economy	
Comments:

WWTP Monitoring Report
Former Lockheed Martin French Road Facility, Utica, New York

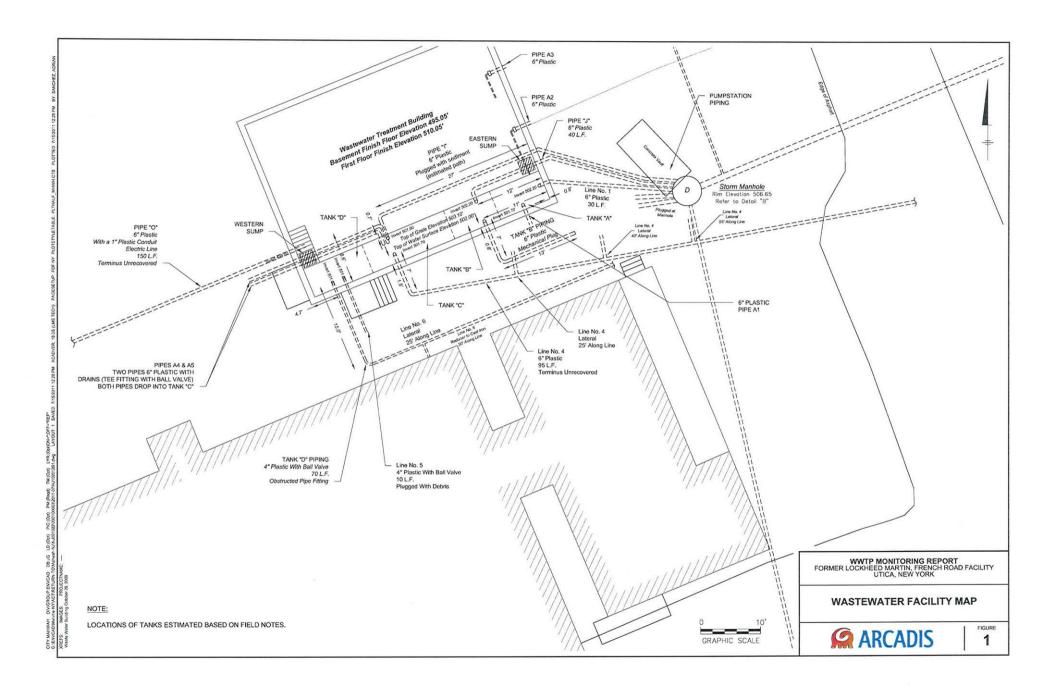
Several influent and effluent pipes, previously cut and capped as part of WWTP closure activities, were observed during the inspection period as leaking water. In each case, the source of the leak was identified as an insufficient or poorly installed cap or plug. On August 5, 2010, pipes A4 and A5 (as indicated on Figure 1) were closed and tightened. Pipe A4 (the northernmost pipe) appeared to continue dripping.

On two occasions (November 11, 2010 and February 9, 2011), ARCADIS made improvements to previously conducted plugging of WWTP piping. On November 11, 2010, threaded plugs with pipe dope and Teflon tape were replaced at pipes A4 and A5 (as shown on Figure 1). These activities successfully stopped the dripping previously noted at these locations. On February 9, 2011, a new plug was installed in

Pipe O (also shown on Figure 1). This replacement successfully stopped dripping water at this location.
