VOL. 8, No. 2, APRIL-JUNE 1981

*Lockheed*  
**SERVICE  
NEWS**

**3 Troubleshooting RPM Fluctuation**  
Understanding and troubleshooting  
the propeller control system.

## ***Troubleshooting RPM Fluctuation***

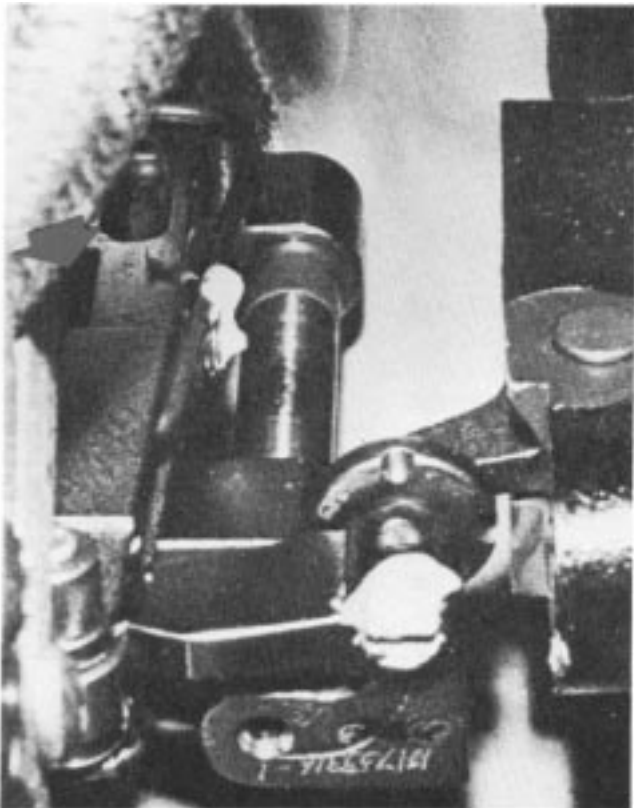
Figure 3. Insert screwdriver at point indicated by arrow to perform "NTS bracket check."

First, move the throttle to the flight idle position. Next, insert a wide, flat-bladed screwdriver between the NTS bracket lever and the forward end of the reduction gearbox (Figure 3). Position and hold the condition lever to AIR START so that the propeller auxiliary pump operates, providing pressure to change the propeller blade angle.

With the condition lever held to AIR START, twist the screwdriver until the NTS bracket roller moves forward and out of its curved saddle and onto the flat part of the cam. This causes the propeller blade angle to increase toward feather. Observe the propeller blades and allow them to travel at least 75 degrees toward feather, and then slowly release the twisting force on the screwdriver. Note whether or not the NTS bracket roller movement back to the saddle is smooth. If the roller movement is smooth, go to the next troubleshooting procedure. If the roller movement back to the saddle is not smooth, lubricate the NTS bracket. If lubricating the bracket does not result in smooth operation, remove and replace the NTS bracket.

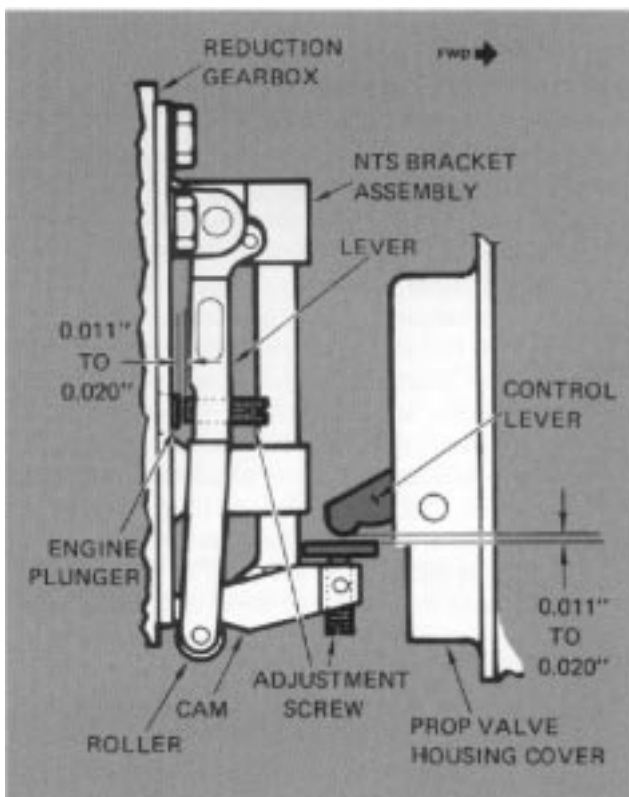
At this point, if the feather solenoid functioned properly, **check the two clearances** at the NTS bracket on the reduction gearbox to determine that each of the two clearances are between 0.011 and 0.020 inch (Figure 4).

Figure 4. NTS bracket: the clearance at the two adjustment screws should be between 0.011 and 0.020 inch.

If the clearances are not between 0.011 and 0.020 inch, adjust the NTS bracket by turning the two adjustment screws on the bracket as required to obtain the correct clearances. Prior to checking the NTS bracket clearances, make sure that the propeller control assembly is rotated clockwise (as viewed from the aft side) firmly against the propeller control drive bracket assembly. The drive bracket assembly is located on the forward side of the reduction gearbox at the 6 o'clock position.

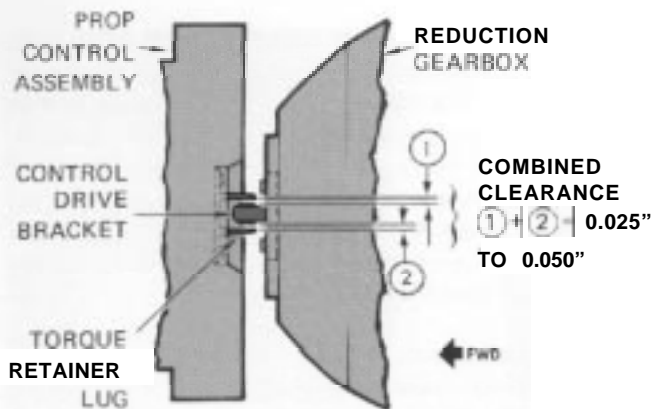
If the **NTS** clearances in the previous step were found to be satisfactory, check the prop control drive bracket assembly for security and proper clearance. The clearance to be checked is the clearance between the control drive bracket pads and the torque retainer lugs on the prop control assembly (Figure 5). The combined clearances between the drive bracket and the torque retainer lugs should be between 0.025 and 0.050 inch. If the combined clearances are not within proper limits, remove and replace the control drive bracket, which could have worn pads.

Figure 5. The combined value of the clearances between the control drive bracket and the torque retainer lugs should total 0.025 to 0.050 inch.

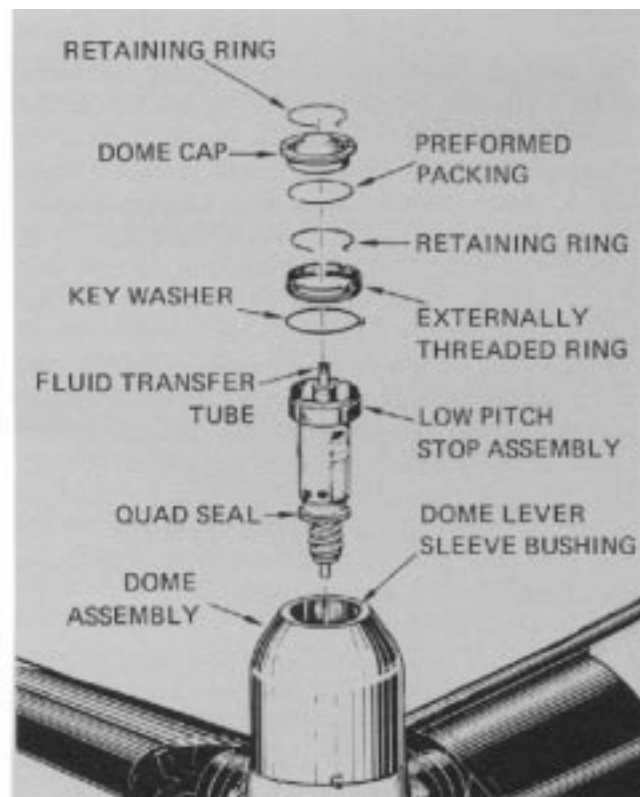
If RPM fluctuation still occurs after replacement of the propeller valve housing, there is a possibility that the low pitch stop quad seal located on the aft end of the low pitch stop assembly may be leaking (Figure 6).

Figure 6. Low pitch stop assembly. The quad seal is located on the aft end of the low pitch stop.

The quad seal can be replaced without removing the dome. Removal of the low pitch stop will provide the necessary access to the seal. Proceed as follows:

1. Remove the dome cap retaining ring, the dome cap, its preformed packing, and the fluid transfer tube.
2. Remove the low pitch stop retaining ring and the externally threaded ring.
3. Mark the groove of the dome lever sleeve bushing and the slot of the low pitch stop assembly which are in alignment for the tab of the key washer. Also, measure and record the depth from the top of the dome lever sleeve bushing to the top of the low pitch stop assembly. This step will ensure that the low pitch stop can be properly positioned during reinstallation after the quad seal has been replaced.
4. Remove the key washer and then the low pitch stop assembly.

After replacing the low pitch stop quad seal, the following procedure should be used to reinstall it:

1. Using petrolatum or hydraulic fluid, lubricate the quad seal and the mating inside surface of the piston sleeve in the dome.
2. Insert the low pitch stop assembly in the dome, making sure the stop levers do not drag along the threads in the lever sleeve bushing. Make sure that the quad seal enters the piston sleeve properly before the thread engagement is reached.
3. Using the appropriate spanner wrench, screw in the low pitch stop assembly until it reaches the previously measured depth and the previously marked slot and groove are aligned.
4. Install the key washer, the externally threaded ring, and its retaining ring.
5. Lubricate the dome cap preformed packing and the outside of the fluid transfer tube.
6. Install the dome cap, its packing, and the fluid transfer tube. Tighten the dome cap and install its retaining ring.

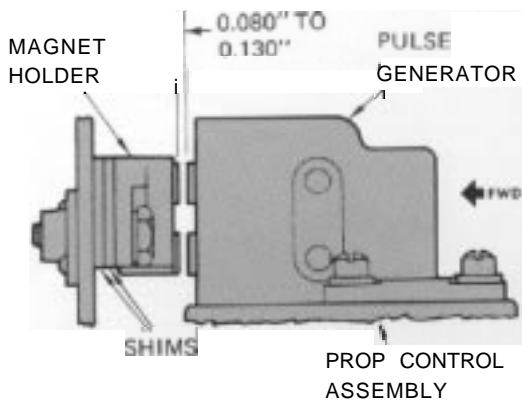
Figure 7. Ensure that the pulse generator clearance is between 0.080 and 0.130 inch.

If the RPM is not stable after indexing the propellers, check the pulse generator clearance of the affected engine. The pulse generator clearance should be between 0.080 and 0.130 inch (Figure 7). If it is not, adjust it to these limits by adding or subtracting shims.

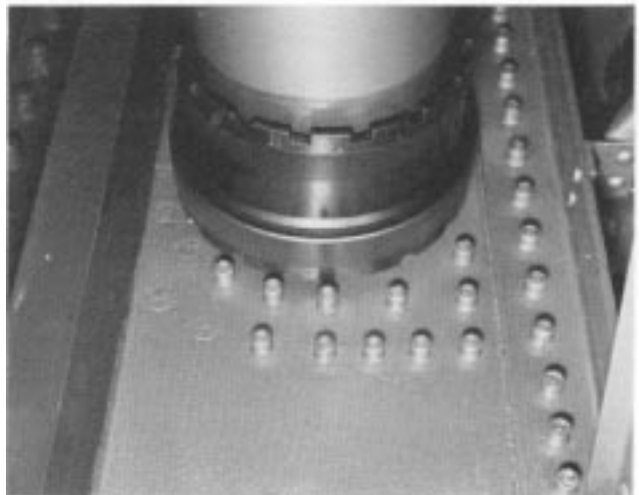
When the right wheel well upper refueling tube, P/N 373611-6, is removed for repair or replacement, difficulty is often encountered when it comes time to reinstall the new or repaired tube. The main problem comes when an attempt is made **to secure** the top end of the assembly. Interference from structural components in this area can make torquing the fitting to the proper values something of a challenge.

**Figure 1. Top end of upper refueling tube. Note that working space is restricted by Huck bolts protruding from adjacent structure.**

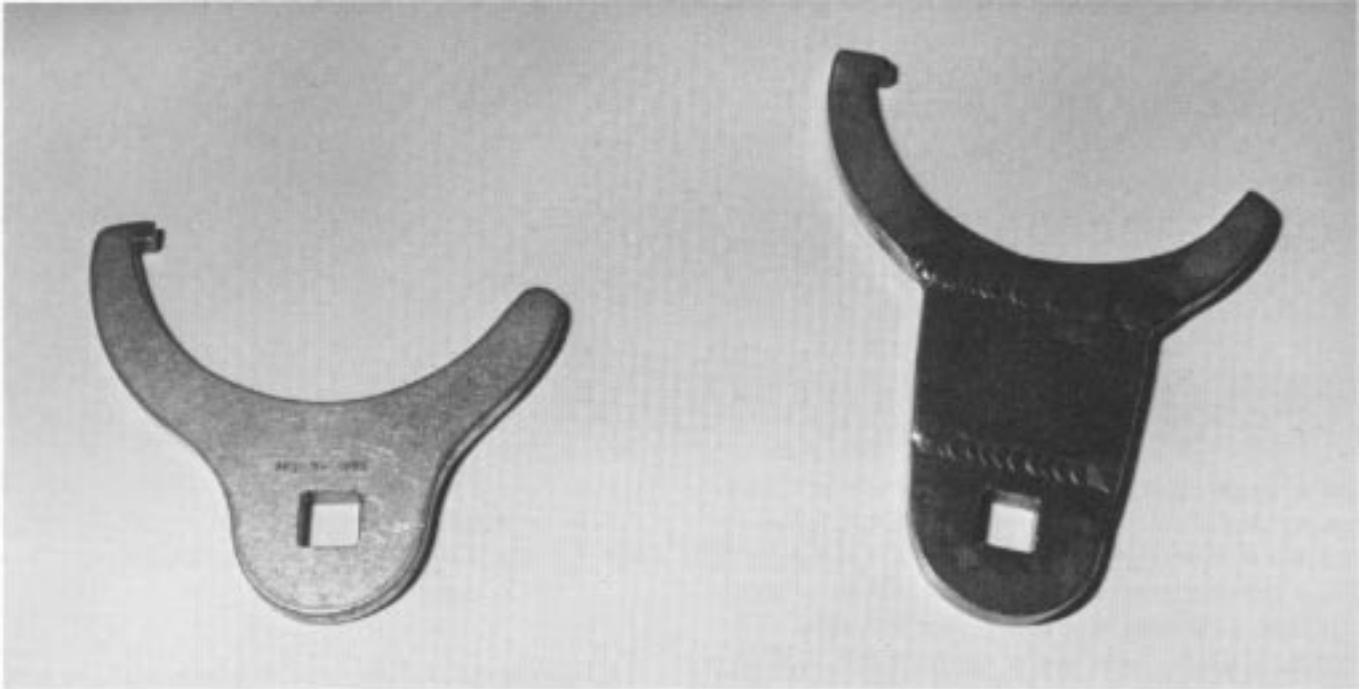
Figure 2. Unmodified (left) and modified 3600.48DH spanner wrench.

5. Torque the male fitting at the top end of the upper refueling tube to 800 (+/- 17) inch-pounds with the modified 3600.48DH spanner wrench.
6. Torque the female coupling at the bottom end of the upper refueling tube to 940 (+/-20) inch-pounds with a P/N 3600-56DH spanner wrench.

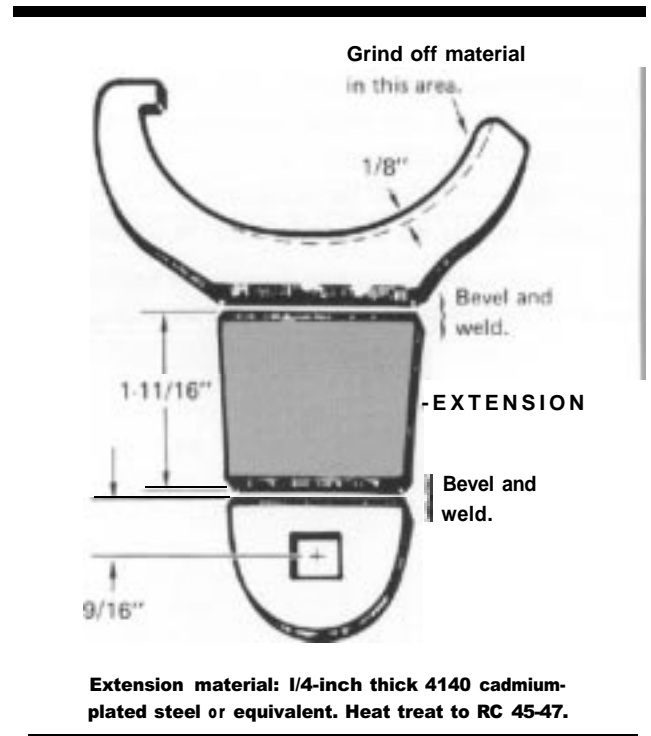
Figure 3. Fabrication details of the modified spanner wrench.
