SERVICE NEWS

Vol. 8, No. 4, October - December 1981

Troubleshooting Pressurization Problems

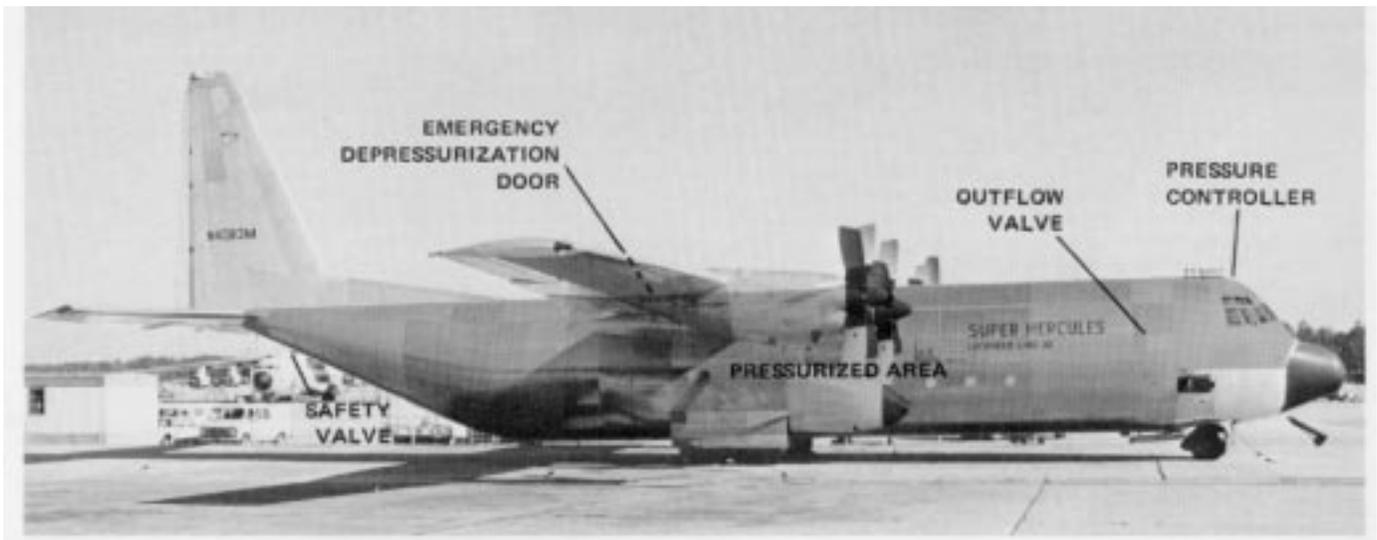
Figure 1. Pressurization system component locations.

One of the first questions to ask is: Can pressurization be obtained in the MANUAL mode but not in the AUTO mode? If the answer is yes, the problem is trouble in the cabin pressure control equipment, not an inadequate air supply. The following troubleshooting procedure may be used to help you isolate a defective pressure controller or outflow valve (Figure 1).

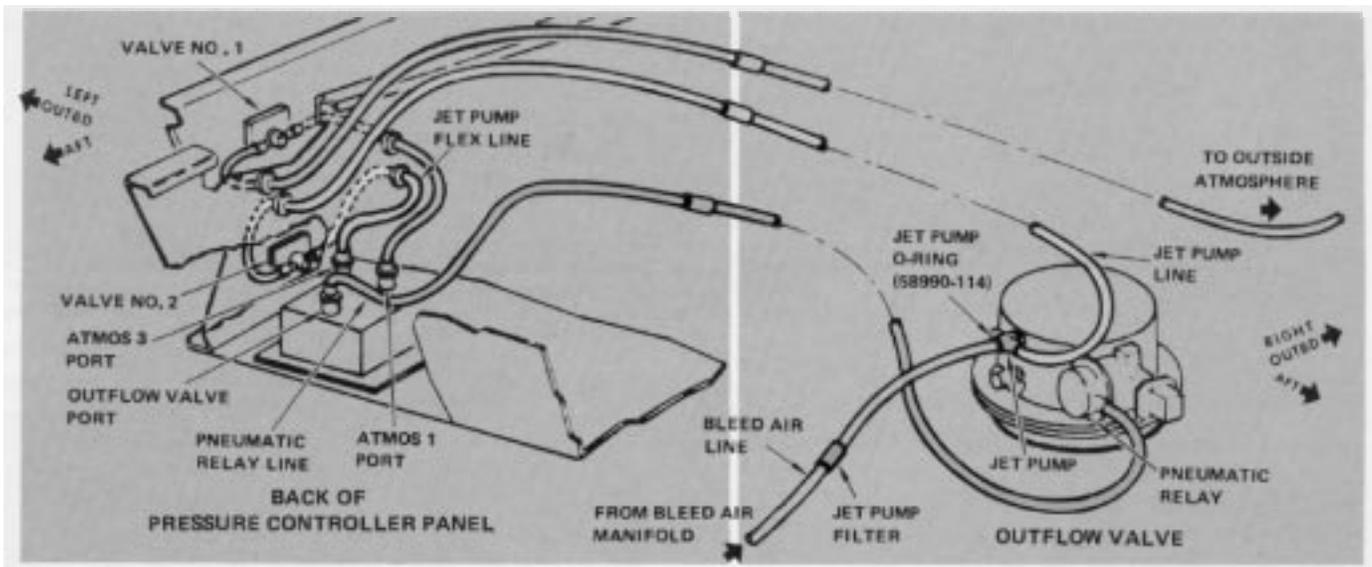
Figure 2. Cabin pressurization control components.

7. Disconnect the pneumatic relay line from the OUTFLOW VALVE port at the back of the pressure controller and attach the vacuum gage to the OUTFLOW VALVE fitting on the pressure controller (Figure 2).

9. Check the vacuum gage. If the gage indicates 0.4 in. Hg or less, proceed to Step 10. If the gage indicates 0.5 in. Hg or greater, replace the pressure controller.

10. Move the cabin altitude selector knob to 8000 feet and the rate knob to MAX. Check the vacuum indication on the gage. If the pressure is less than 1 in. Hg, replace the pressure controller. If the pressure is greater than 1 in. Hg, reconnect the pneumatic relay line to the OUTFLOW VALVE port on the pressure controller and then check the position of the outflow valve.

a. If the outflow valve is open, move the cabin altitude selector knob to minus 1000 feet; the valve should soon close. If the valve closes, the system is satisfactory. If the valve remains open, clean the pneumatic relay and repeat this step. If the valve still fails to close, replace the outflow valve.

b. If the valve is closed, clean the pneumatic relay and repeat Step 10. If the valve remains closed, replace the outflow valve.

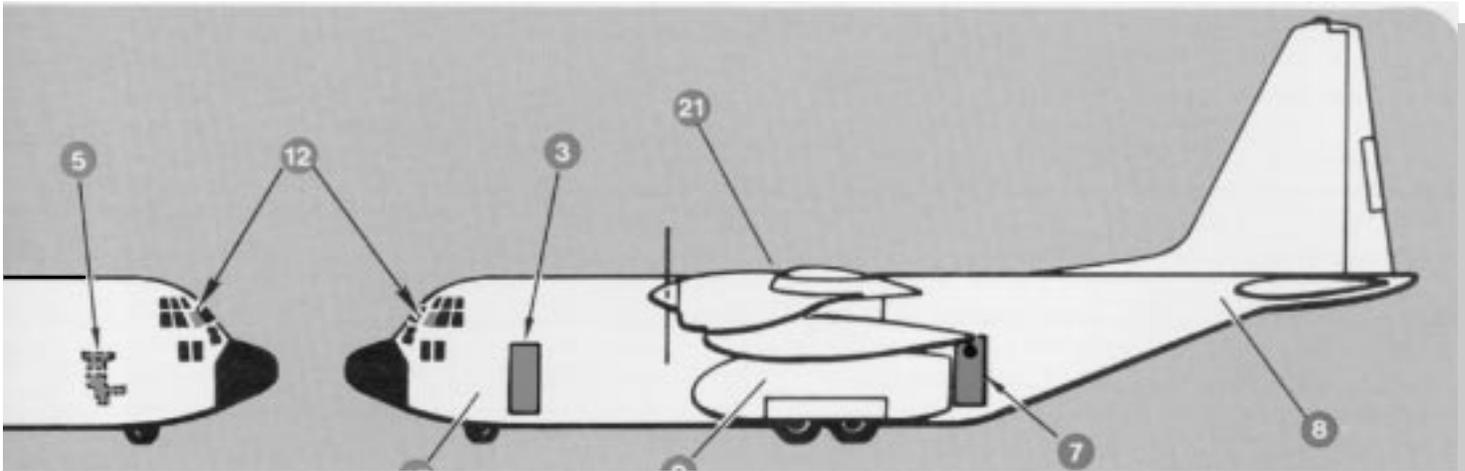
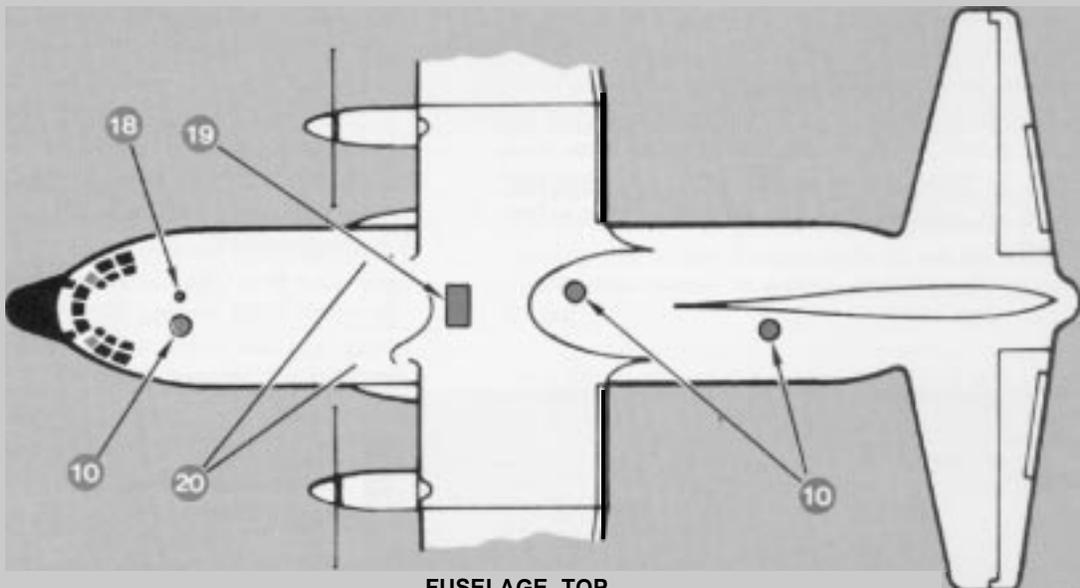
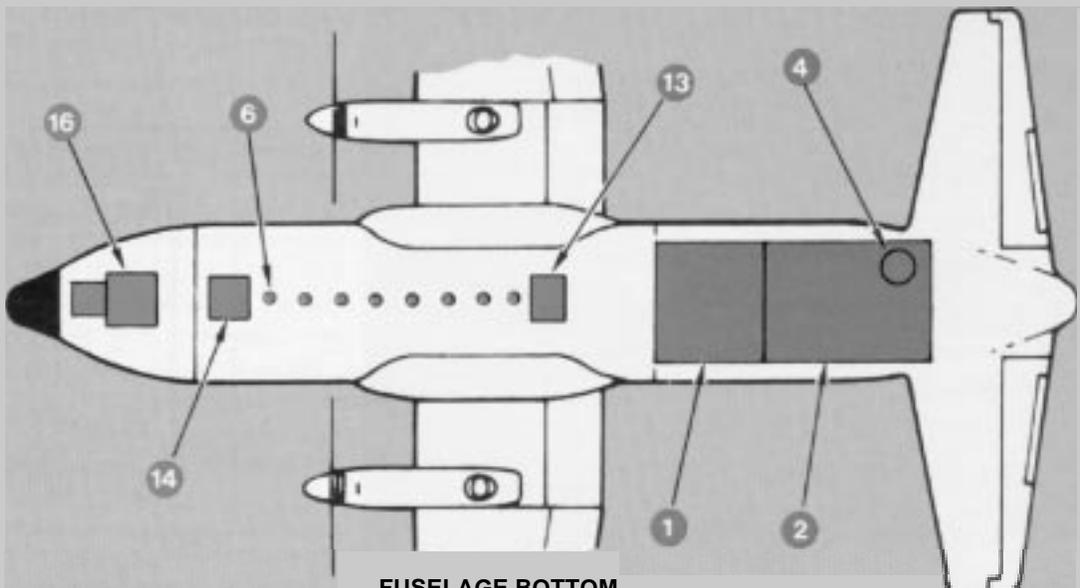
Figure 4. Pressurization Leak Locator Chart.

If the timed pressure decay leakage test is unsatisfactory, the cabin is leaking excessively. To find where the leaks are, pressurize the aircraft to 2 to 3 in. Hg (0.98 to 1.47 psi) and inspect the fuselage door seals, exterior surfaces, and joints. Leaks can be located by feel or by using an approved liquid leak detector or soapy solution. Figure 4 shows those areas of the Hercules aircraft which tend to leak most often. In the table, these areas are listed in the approximate order of their susceptibility to the kinds of wear and damage that can result in pressure leakage problems. A systematic approach to finding a pressure leak in an unknown location would be simply to start at the top of the list and work down.

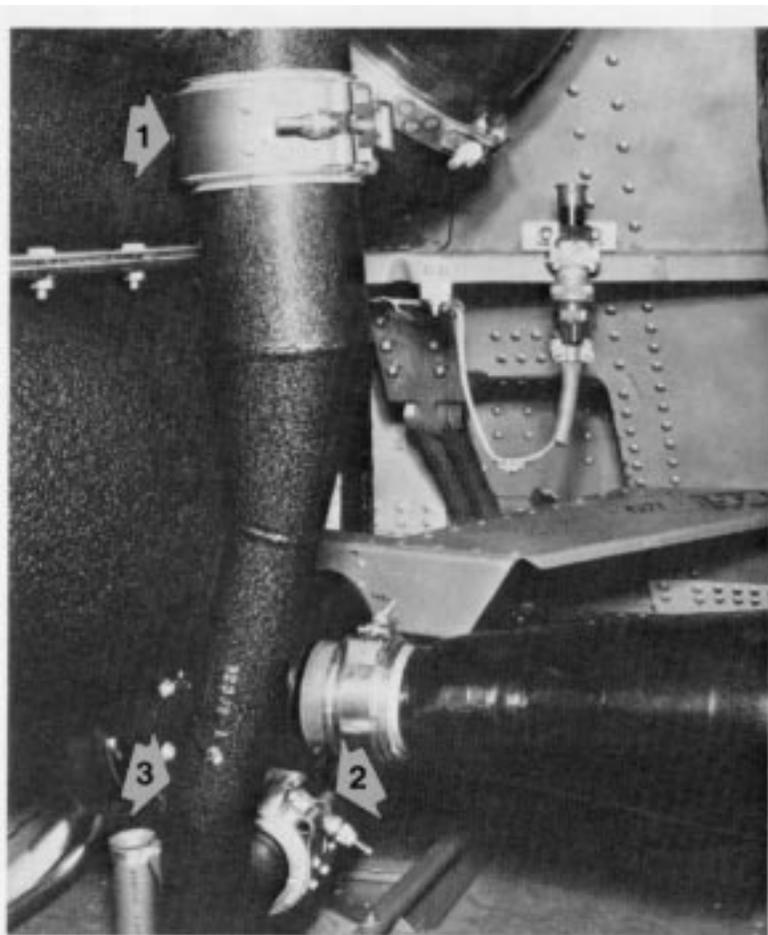
Figure 5 Heat exchanger leak check: (1) Loosen upper clamp. (2) Disconnect lower clamp. (3) Rotate duct 180 degrees to install leak test fitting. Figure 6 (below). Heat exchanger leak test fitting.

1. Disconnect the duct between the heat exchanger and the turbine and cap the end of the duct from the heat exchanger (Figure 5), using a locally manufactured leak test fitting (Figure 6).
2. Start the GTC or APU, or an MA-IA compressor (or equivalent) and turn on the air conditioning system being checked. Drive the temperature control valve to the full cold position.
3. Check for leaks by feeling for the presence of escaping hot air in the air intake scoop or exhaust. Leaks are very evident when they exist. Replace the heat exchanger if leaking is evident.

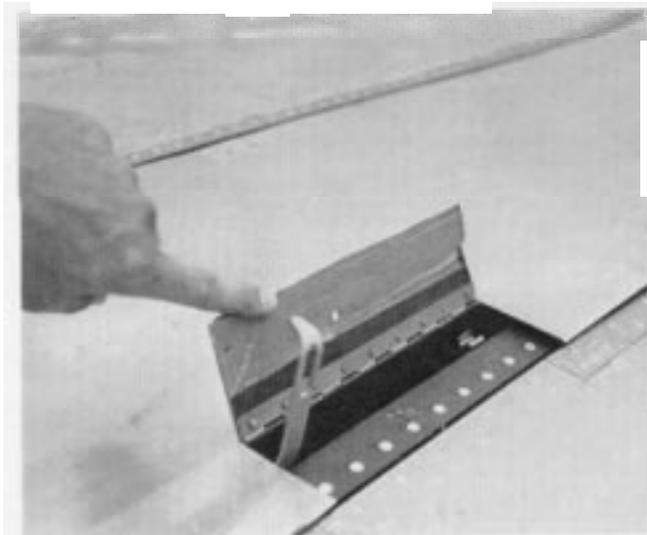
Latch release handle access door and handle.

The springs on the latch release handle access door assembly can become weakened through vibration, corrosion, and age. The same factors can also affect the door hinges. As the springs weaken, the access door acquires a tendency to flutter, especially during propeller reversal. With weak or broken springs and excessive hinge corrosion, the suction created by propeller reversing could conceivably pull the access door loose.

1. Gain access to the former beneath the latch release handle access door and locate the position of the hole to be drilled in the former. The correct position is 3.50 inches aft of the forward edge of the access door and 0.40 inch from the inboard edge of the former. The OAO-inch measurement is critical, so measure it carefully,
2. Drill a 0.201- to 0.204-inch diameter hole in the former at the previously marked location, using a No. 8 (0.1990.inch) drill bit.

3. With the access door in place, locate the hole to be drilled in the door by back locating it with a hole locator.

4. Drill a 0.193- to 0.199-inch diameter hole in the access door, using a No. 10 (0.1935-inch) drill bit at the previously marked location. Countersink the hole for an NAS517-3-3 low-degree flathead machine screw.

6. Mount the nut plate, using two MS20426AD3 rivets.

7. Secure the access door closed by installing the NAS517-3-3 screw.

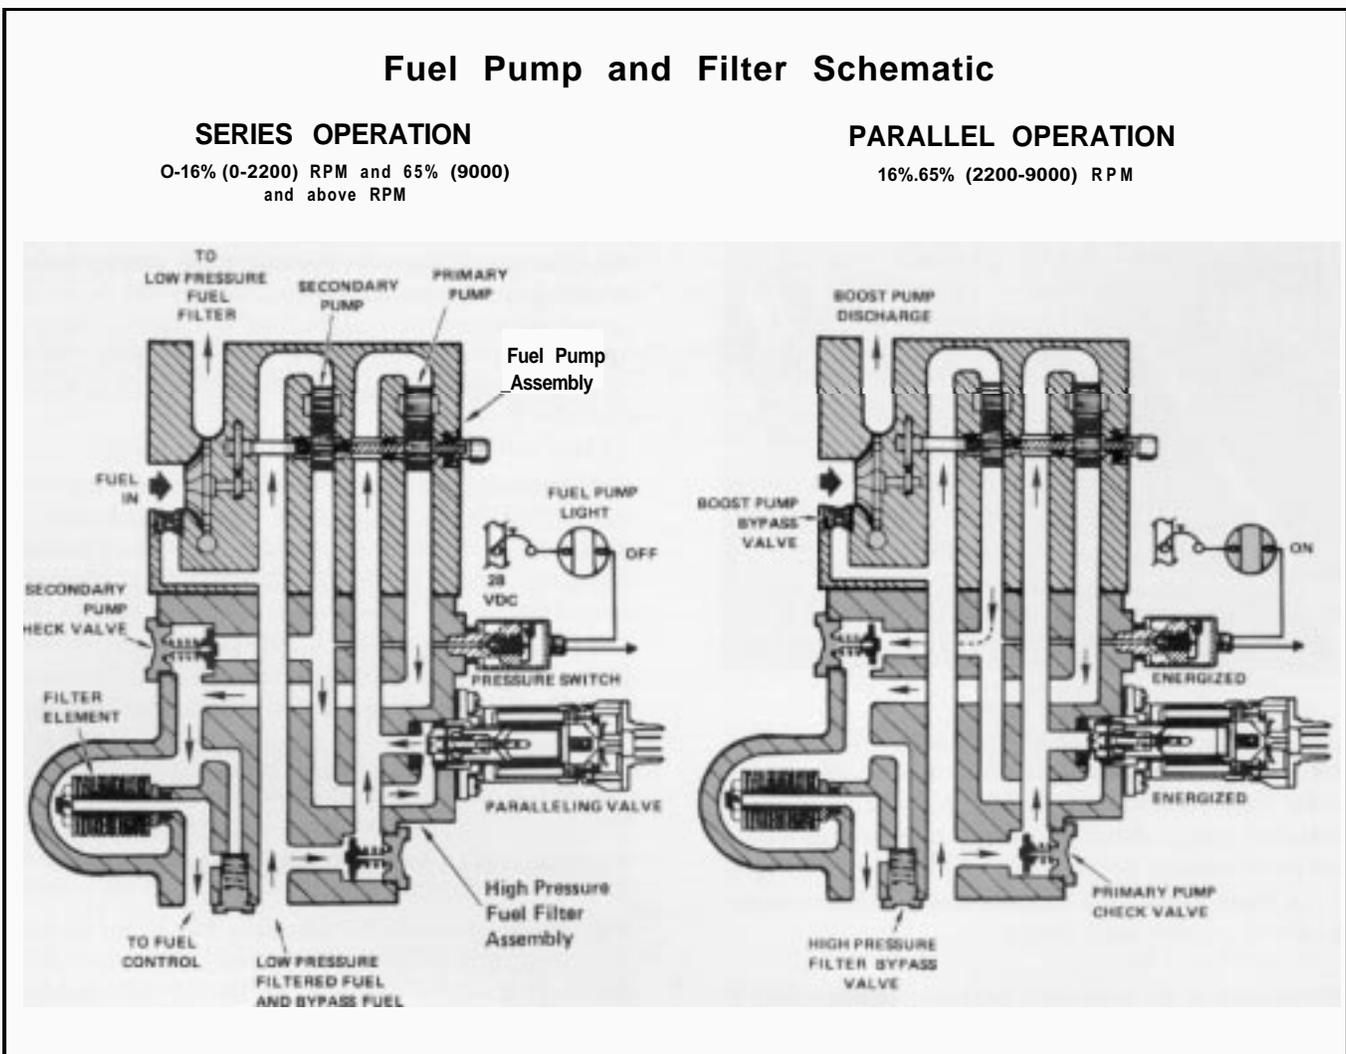
Fuel pump and high pressure filter schematic, showing series and parallel modes of operation.

If, in addition to the relatively high pressures caused by crossfeed operation, some other condition is present within the pump which tends to raise the pressure in the secondary circuit still more, the point may be reached where the total pressure in the body of the fuel pump rises high enough to cause the secondary fuel pump pressure light to illuminate. Such a situation can arise as a result of the failure of the paralleling valve to open completely after the starting sequence.

The reason that the paralleling valve fails to open completely is usually binding caused by scored valve plunger and seat surfaces. Since the valve does not open completely, secondary pump output is restricted, which increases the pressure in the secondary pump outlet circuit. During crossfeed operation, the pressure increase caused by a malfunctioning paralleling valve may be sufficient to raise the total pressure sensed by the pressure switch to the 150 (+ 10) psi value needed to close it. If the light extinguishes or stops flickering when the fuel feed is switched

The scoring of the valve parts is usually caused by uneven and/or excessive torquing of the four screws that secure the paralleling valve during installation. To correct the problem, remove the paralleling valve and polish any scored contact areas between the plunger valve and the seat with crocus cloth. Replace the two O-rings that are installed on the valve seat and then reinstall the valve.

Use extreme care during valve installation. The four mounting screws must be tightened alternately in 5-inch-pound increments, to a total of 15 inch-pounds. If these screws are overtightened or tightened unequally, the paralleling valve will probably bind and cause the secondary fuel pump pressure light to illuminate. Note that when the valve is properly installed, there will be an obvious gap between the valve retainer plate and filter body.
