SERVICE NEWS

VOL. 9, NO. 3, JULY-SEPTEMBER 1982

3 Thermocouples and TIT

Understanding thermocouples and their relationship to engine overtemperature conditions.

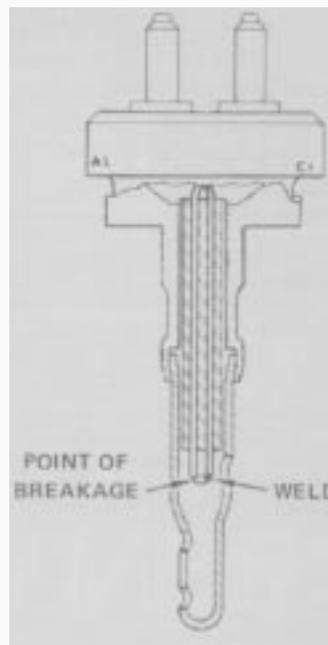
The failure of a thermocouple is an event that has the potential for initiating a whole series of further events, none of them good. Let us first look at what can happen when one or more thermocouples have open circuits. When a thermocouple develops an open circuit, it generally occurs adjacent to the weld point of the two platinel alloys in the sensing element (Figure 4). For the purposes of the following discussion, we shall assume that this has occurred and that both circuits in a thermocouple have failed simultaneously.

Let us also assume that the malfunctioning thermocouple was damaged because of a hot spot in the engine. This implies that the thermocouple that has become inoperable is the one that is located in the hottest part of the engine. The loss of a thermocouple in the hottest part of an engine causes the average temperature signal

Figure 4. Thermocouple (non-air-cooled) with an open sensing element.

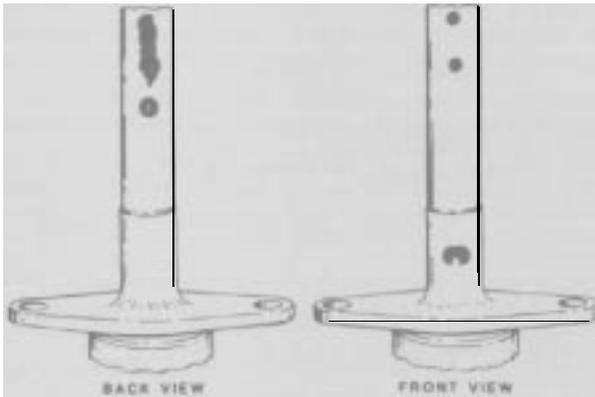
eroded in the downstream side of the thermocouple probe tip (Figure 5). but the two sensing elements remain intact. This kind of damage destroys the ability of the thermocouple to measure the temperature of the gas stream accurately. The result is an erroneous signal that will be averaged into the temperature readings being passed along to the TD amplifier and the flight station TIT indicator.

Figure 5. Front and rear view of an air-cooled thermocouple with probe tip aft wall erosion.

Each thermocouple damaged in this way will cause the signal to be approximately 7.5 degrees too low. Since

the TIT signal will now be below the reference signal, the TD amplifier will initiate an increase in the fuel flow to raise the average TIT signal to satisfy the reference signal. When the system stabilizes, the real TIT will be 7.5 degrees C above the indicated value. Again we have an overtemperature condition, but in this case one of greater magnitude. Multiple failures of this type will compound the problem.

When the probe tip aft wall is eroded away, the gas-sampling function of the probe is upset. The combustion gases are not properly mixed and are not directed over the sensor elements before they escape through the downstream side of the thermocouple. This yields a temperature signal that is lower than normal.

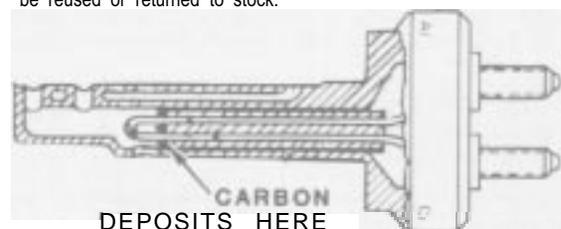
Analysis at Allison's facilities in Indianapolis determined that carbon had deposited between the thermocouple wires where they emerge from the insulator (see accompanying illustration). These deposits caused the low ohmmeter readings observed. It was found that carbon deposits can form in this area when the engine is operated in the taxi range at a TIT below about 700 degrees C for periods of 5 to 10 minutes or more. The carbon discovered in the thermocouples the field representative returned to the factory had evidently been deposited when the aircraft taxied slowly from the runway to the maintenance area after flight. This phenomenon had not been observed during engine tests at Allison previously because virtually all engine testing is done above 700 degrees C TIT. The carbon deposits quickly burn away when an engine is operated at temperatures above 700 degrees C TIT.

- 1 Prior to checking thermocouples, run the engine above 850 degrees C TIT for 5 minutes. Shut the engine down normally, but attempt to minimize the operating time at 700 degrees C TIT or below. This procedure should burn off the offending carbon that might interfere with a proper thermocouple resistance check.
- 2 Thermocouples that have been rejected for low resistance can sometimes be salvaged. Try heating the thermocouples in a Jet-Cal tester for a minimum of 3 minutes at 1400 degrees F. If a Jet-Cal unit is not available, heat the junction ends to a cherry-red glow with a propane torch and maintain this heat for 3 minutes. Be sure to protect the terminal ends of each thermocouple — and yourself — from the heat of the torch. Thermocouples that test good after this treatment may be reused or returned to stock.

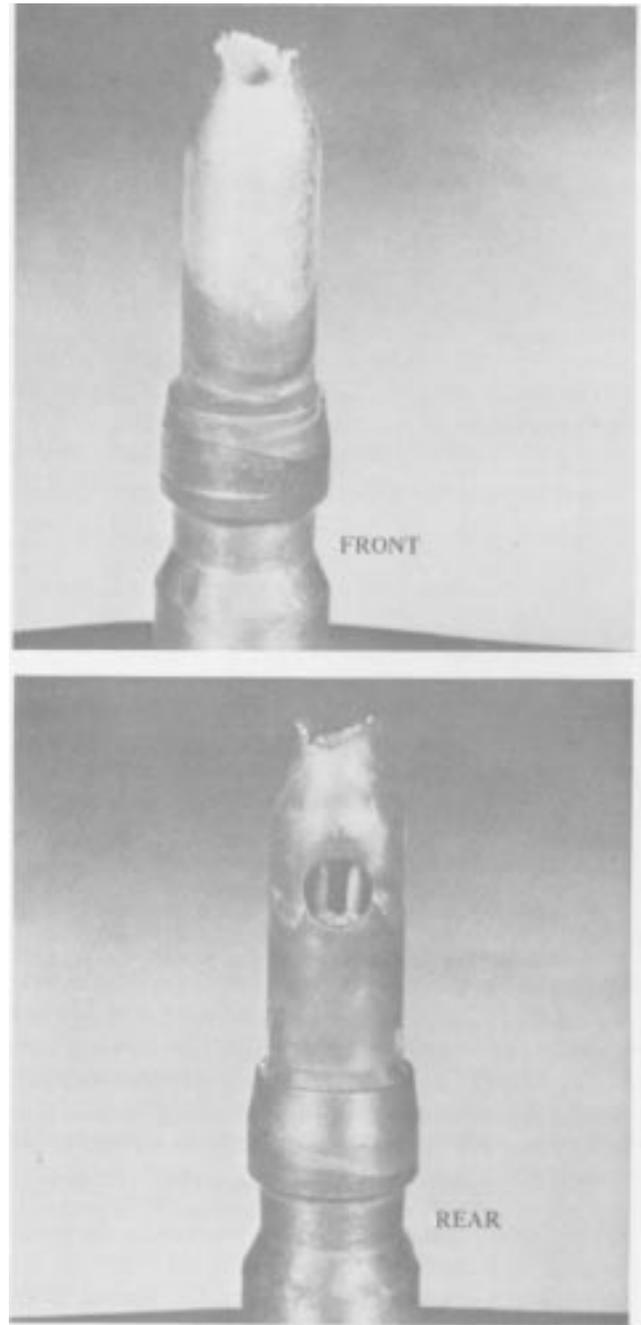
The last thermocouple problem we shall discuss in this presentation concerns non-air-cooled thermocouples with missing probe tips. This is potentially the most serious condition of all from the standpoint of the possible effects on the TD control system. In this case, the probe tip is completely missing from the affected thermocouple, but again, the two sensing elements remain intact (Figure 7).

In addition to whatever foreign object damage the separated probe tip may inflict on its way through the turbine, the presence in the system of a thermocouple without a probe tip has a marked effect on the average temperature signal being received by the TD amplifier and the TIT indicator. Each missing probe tip will cause the average temperature reading to be about 22 degrees C too low. Here again, since the TIT signal will then be below the reference signal, the TD amplifier will call for additional fuel to raise the average TIT signal to match the value of the reference signal. The result is a severe overtemperature condition, one much worse than any of those previously described.

When a thermocouple probe tip is missing, the ability of the probe to perform its vital gas-sampling function is completely lost. The gas sample cannot be obtained from deep within the gas flow where the temperatures are highest. Instead, the sensing elements are exposed to the relatively cool environment at the periphery of the combustion gas path. This means that the affected thermocouple will introduce an excessively low gas temperature signal into the system, with serious consequences for the operation of the engine.

Figure 7. Front and rear view of a non-air-cooled thermocouple with probe tip missing.

couple with a missing tip introduces an error that results in the average TIT signal being 22 degrees C below the true temperature. Since the error is cumulative and there are three thermocouples with missing tips, the indicated TIT for this engine is going to be approximately 66 degrees C below the real value. Figure 8 shows the correlation between the indicated and actual TIT of an engine that has one or more thermocouple probe tips missing. This means that at an indicated takeoff TIT of 971 degrees C, the actual TIT would be 1037 degrees C. Even at the maximum continuous permissible TIT of 932 degrees C indicated, the true TIT would exceed that of takeoff TIT, which is

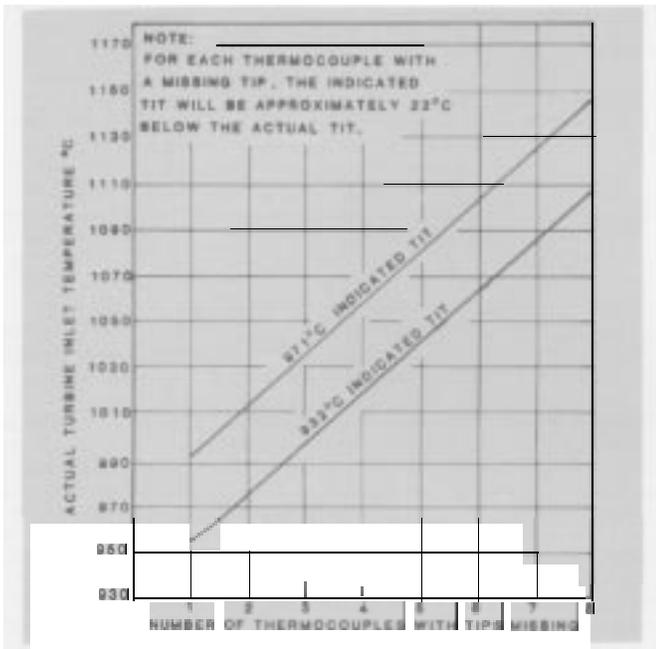
To gain an appreciation of just how serious the impact of lost thermocouple probe tips can be, let us assume that we are operating a T56-A-7 engine that is performing properly except that three of its thermocouples have missing probe tips. Remember that each thermo-

Figure 8. Indicated and actual TIT in a 501 -D22/T56-A-7 engine with one or more thermocouple probe tips missing.
