SERVICE NEWS

A Service Publication of Lockheed Aeronautical Systems Company

Vol.1 7, No.3, July-September 1990

FEDC Valve Installation

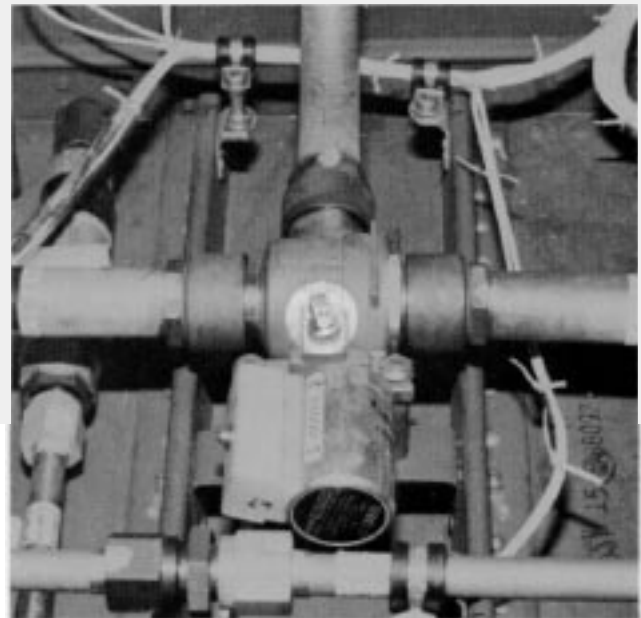
Figure 1. The GTC/APU FEDC valve is located below the fire extinguisher bottles above the left main wheel well.

GTC/APU FEDC Valve: Access to this valve involves standing on top of the left forward main landing gear tire. Reach through the opening for the screwjack assembly and toward the rear of the aircraft. Locate the line coming down from the fire bottle and follow it until you come to the valve, all by feel. The valve indicator lever will point inboard, and you should be able to rotate it clockwise against the spring tension, toward the tail of the airplane. Viewed from outside the airplane and above the valve, this would be to the right

(see Figures 1 and 2). If the lever moves as described, the valve is installed properly.

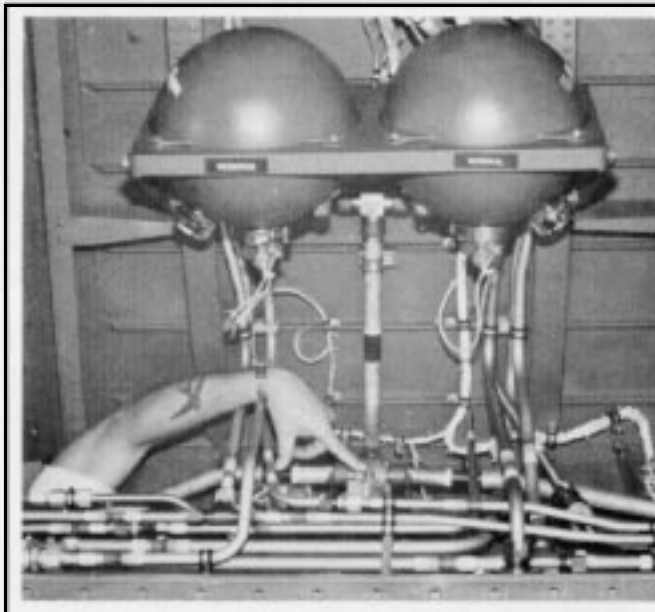
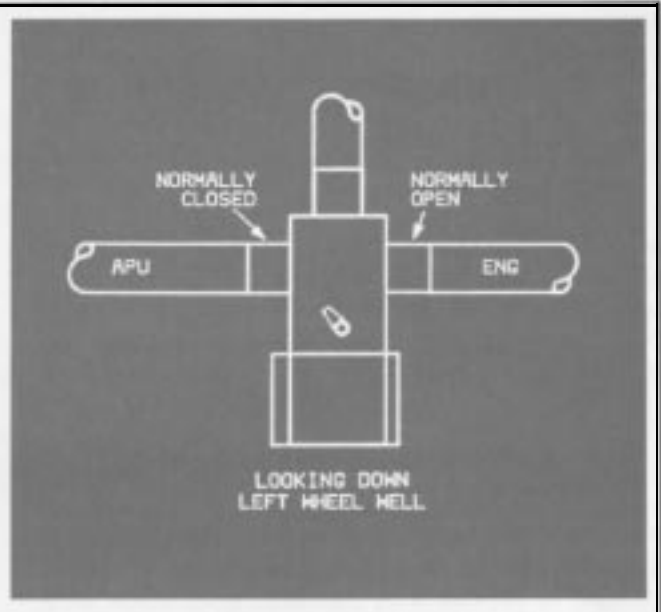
Figure 2. Showing a dexterous (and decorated) arm, the author demonstrates the proper technique for reaching the GTC/APU FEDC valve. The correct valve lever position is shown in the diagram at the right.

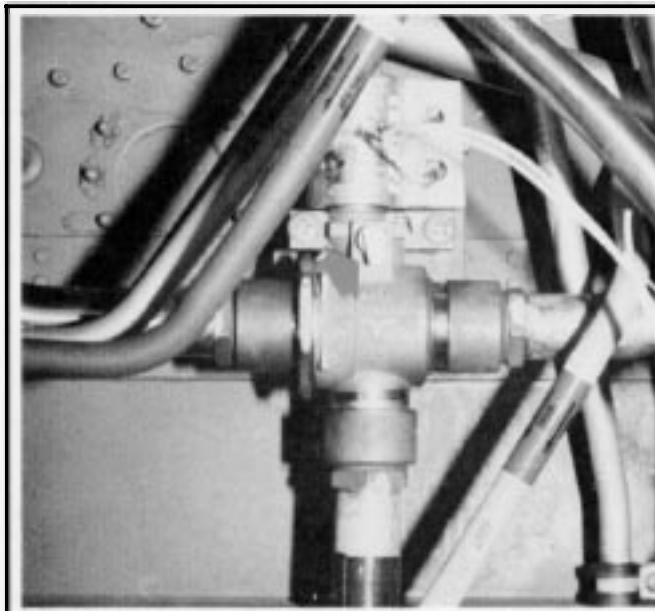
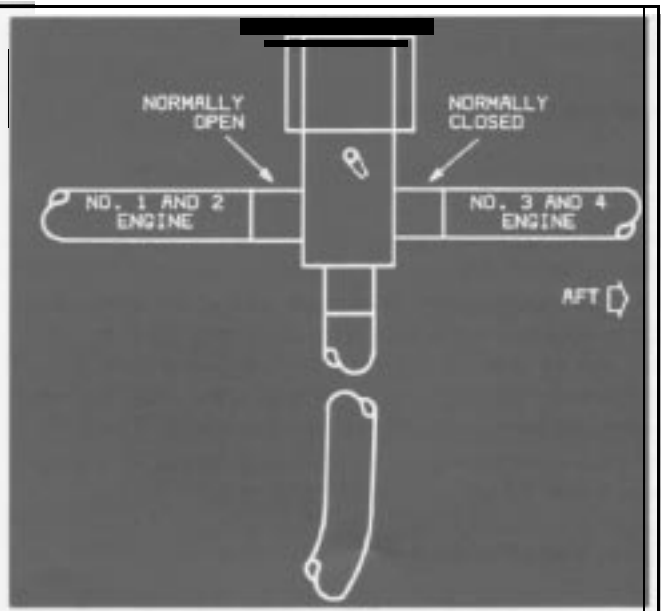
Figure 3. Under normal conditions, the center wing FEDC valve can only be checked visually. Compare the photo above with the idealized representation at the right for the actual appearance of indicator lever.

Center Wing FEDC Valve: Access to the center wing FEDC valve is by sight only unless the exterior access panel above and behind the left aft main landing gear is removed. Stand on the left aft MLG tire and shine a flashlight upward through the slot at the forward outboard corner of the mudguard mounted just aft of the vertical beam. See that the valve indicator lever points toward the right as you face inboard (Figure 3). The indicator will appear to point downward and slightly aft of the vertical position.

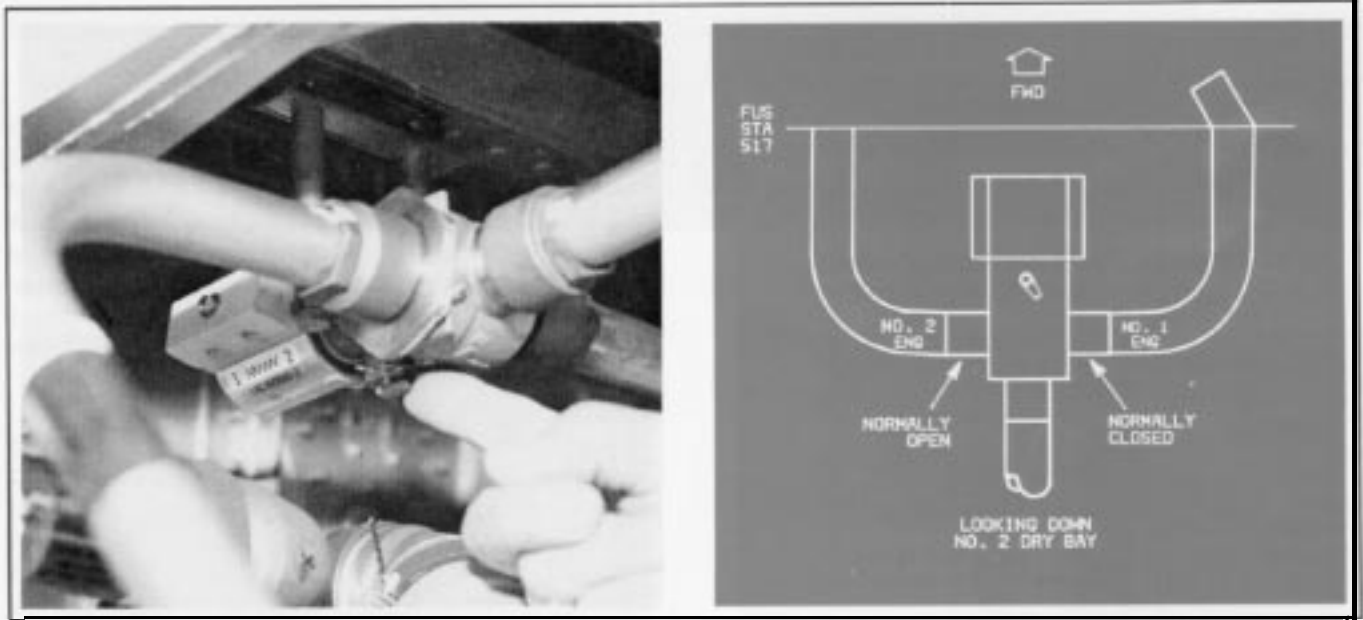
Figure 4. The No. 2 dry bay FEDC valve can be reached through the dry bay access panel. Note on the drawing the apparent-but only apparent-discrepancy in the tubing to the engines in this dry bay.

No. 2 Dry Bay FEDC Valve: To check the No. 2 dry bay FEDC valve, you will first need to open the dry bay access panel. Then, facing forward, lie down on the wing and reach with your left hand through the access panel opening toward the leading edge to locate the valve lever (Figure 4). Check the valve movement as indicated on the diagram. The lever will be spring-loaded toward the right (in a counter-clockwise direction), and you should be able to move it toward the left (clockwise) with your fingers.

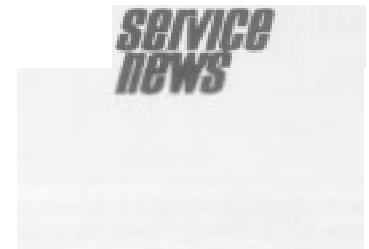
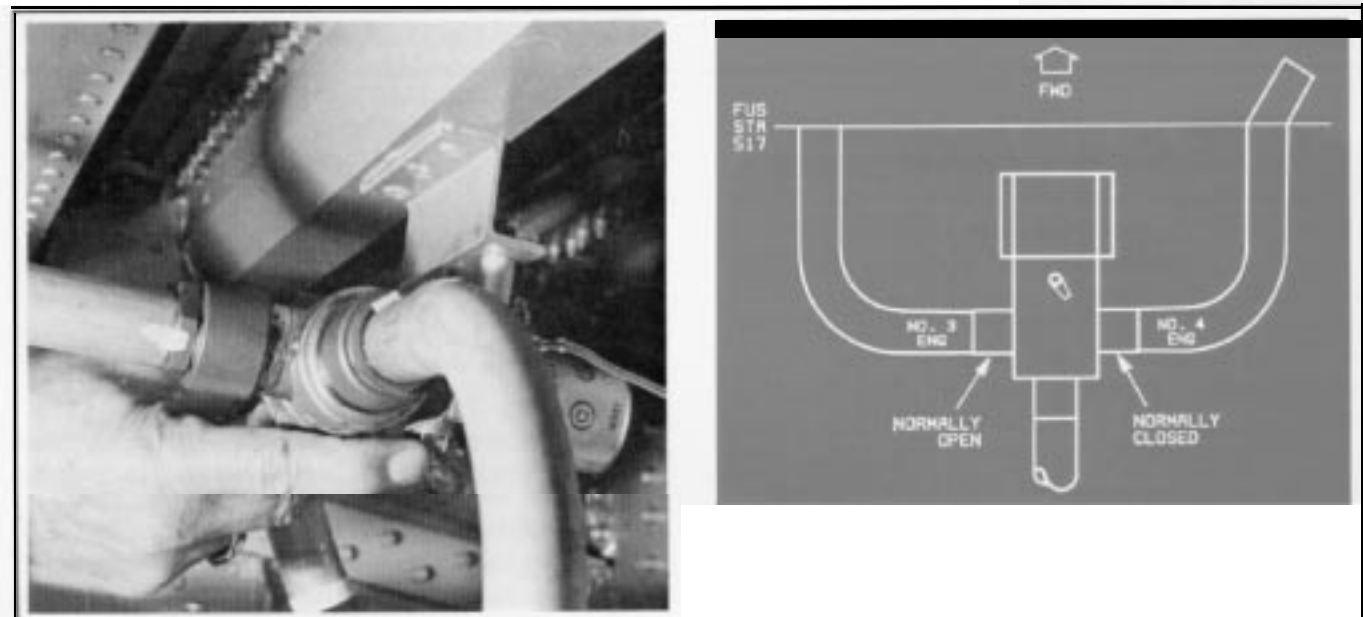
Figure 5. The procedure for checking the FEDC valve in the No. 3 dry bay is similar to that for No. 2 dry bay. The diagram at the right shows correct lever position in a good installation.

except in this case it is more convenient to use your right hand (Figure 5). Here again, the indicator lever will be spring-loaded toward the right (counterclockwise), and in a correct installation you should be able to rotate it to the left (clockwise) against the spring tension.

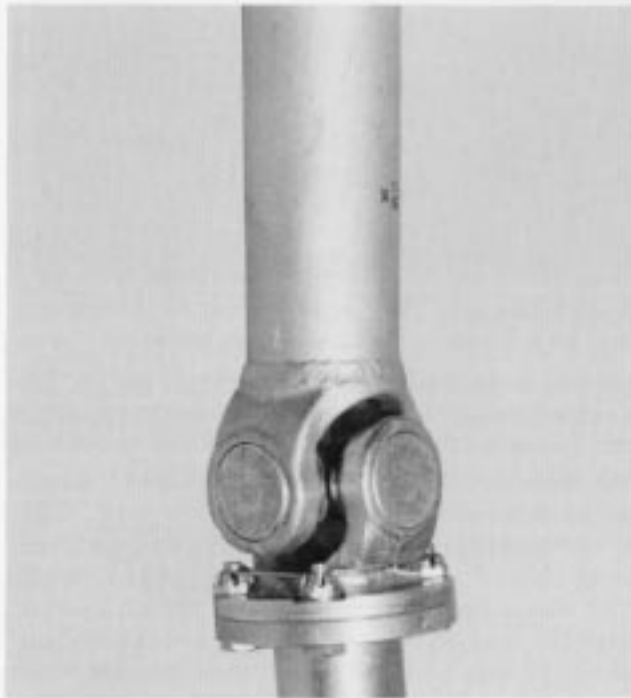
MLG torque shaft lower universal joint, typical of airplanes built prior to LAC 5162. Note the bolted coupling.

Aircraft built prior to Lockheed serial number LAC 5162 were equipped with PN 8372-MI, PN 8372, PN 69757943, or similar MLG vertical torque shafts. In these designs, the universal joint companion flanges are connected

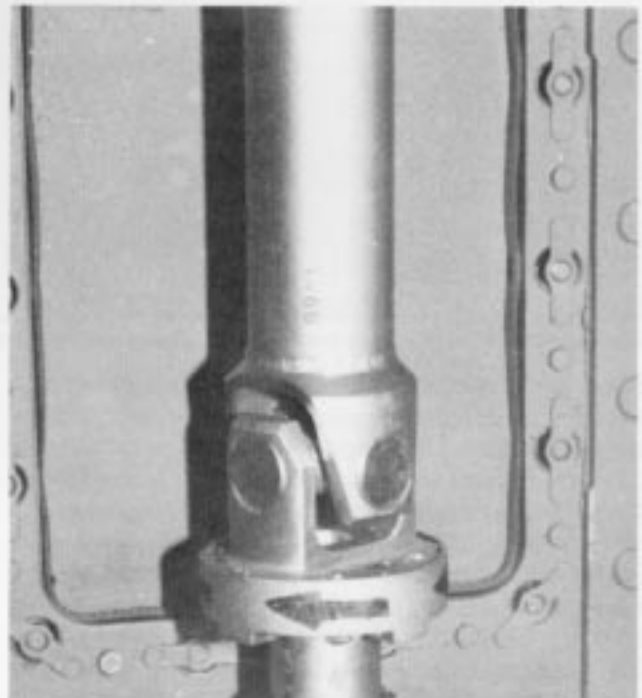
LAC 5162 end subsequent Hercules aircraft are equipped with quick-disconnect couplings at these locations.

by four bolts. LAC 5162 and subsequent aircraft use PN 8372442 at these locations. The vertical torque shaft lower companion flanges in this case are connected by a single, knurled, quick-disconnect coupling.

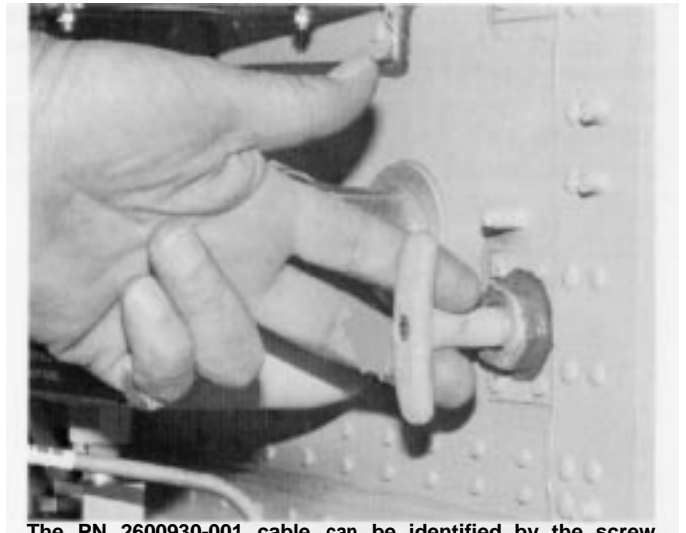
All three of cable assemblies are completely interchangeable, but there is an important difference to note in the operation of the new cable. The operational instructions given in some of the flight manuals specify that the T-handle be rotated counterclockwise before being pulled all the way out. This should not be attempted in the case of the new cable because the T-handle will not rotate until it is extended to its full length. It is important to bear this in mind. The PN 2600930401 MLG disconnect cable assembly is of sturdy construction, but attempting to force the T-handle to rotate before extending it fully could cause the cable to jam, or damage the T-handle's locking mechanism.

The PN 2600930-001 cable can be identified by the screw placed in the center of the T-handle.

A service bulletin will be issued requiring replacement of the old emergency procedure decals for the vertical torque

shaft and the MLG emergency extension engaging cable. The replacement decals will cover the procedures for both the old and the new designs of the torque shaft and engaging cable.
