***T56 Oil System
Maintenance***

Lockheed SERVICE NEWS

Vol. 18, No. 3, July-September 1981

A Guide to Oil Loss Prevention

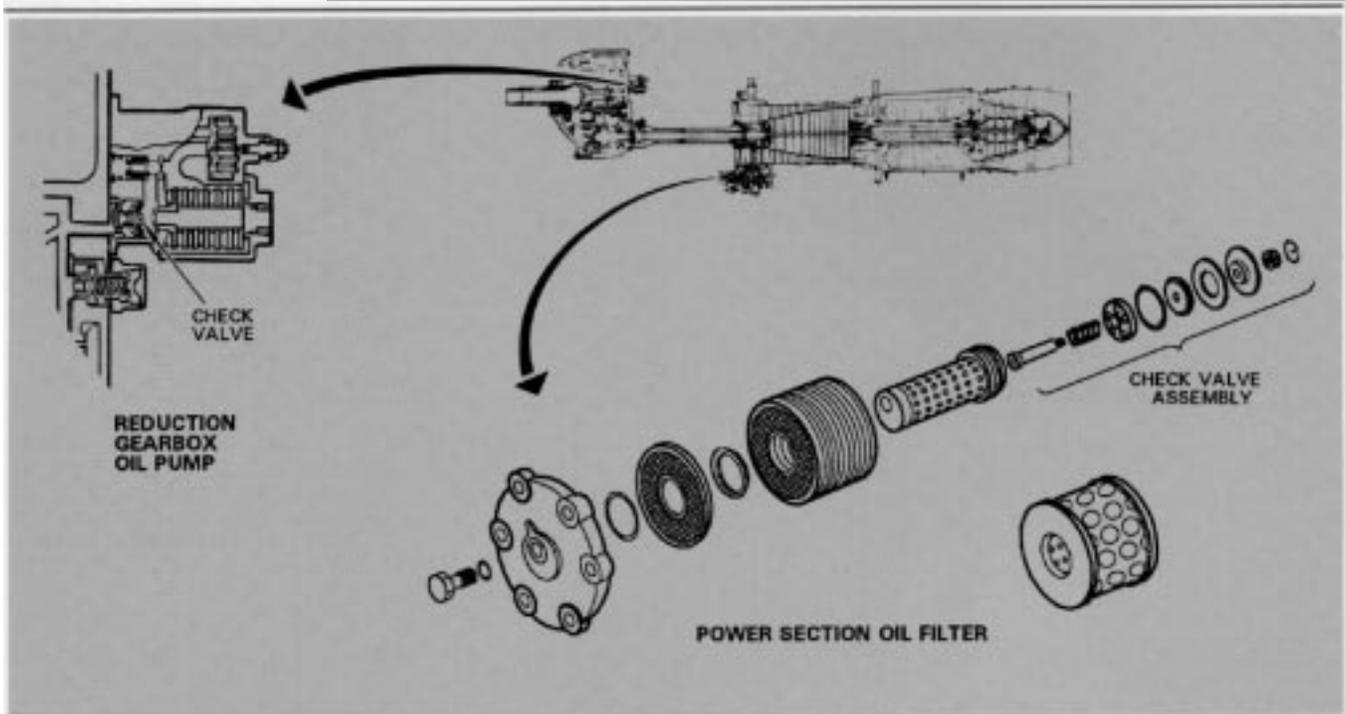
The most common cause of static leakage, also called gravitational flooding, is an improperly functioning oil retention check valve. This may occur either in the power section oil filter assembly or in the reduction gearbox oil pump assembly (Fig. 2).

Figure 2. Improperly functioning oil retention check valves are a common cause of static oil leakage.

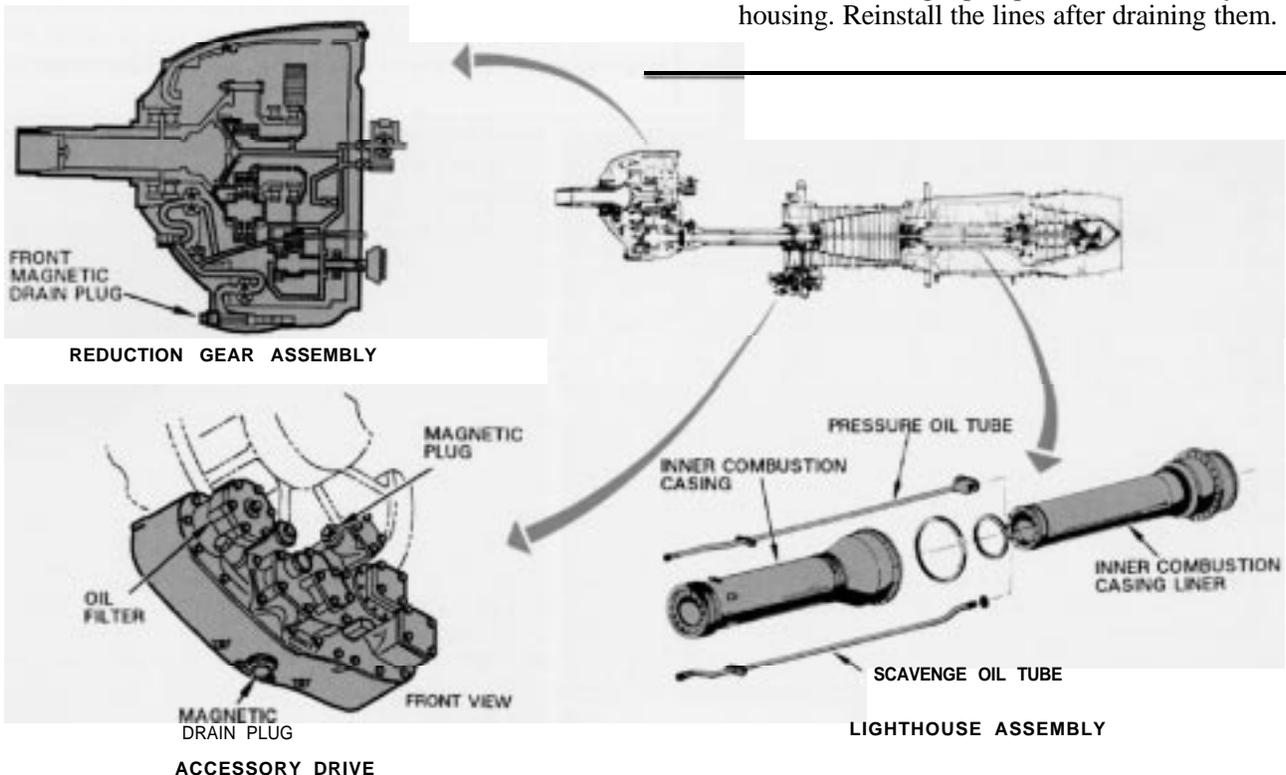
Figure 3. Accumulated oil will often collect in one or more of three major areas.

system. When an engine consumes or dumps oil, it will often do so after accumulating oil in one or more of three major areas: (1) the combustion assembly inner casing-the “lighthouse” assembly, (2) the reduction gear assembly, and (3) the accessory drive housing (Fig. 3).

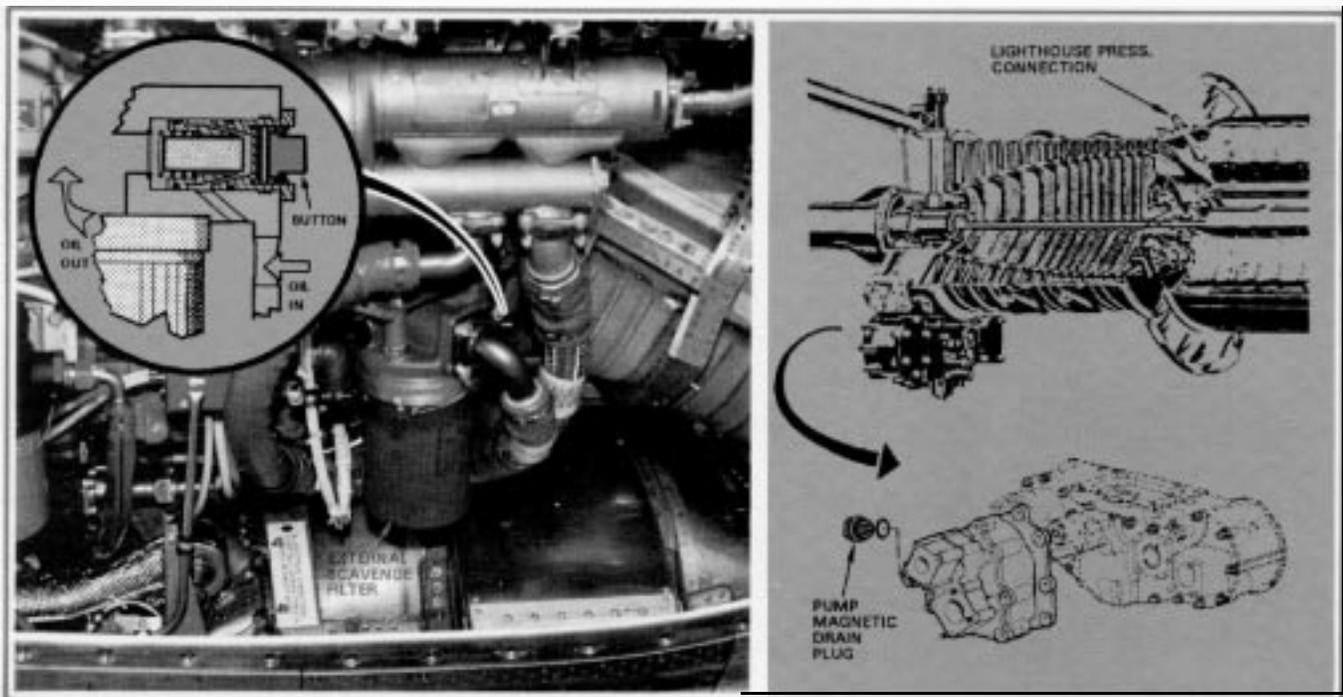
Figure 4. Determine "pump out" pressure at the main oil pump magnetic plug or the external oil filter "in" point, and lighthouse pressure at the pressure connection on the diffuser case.

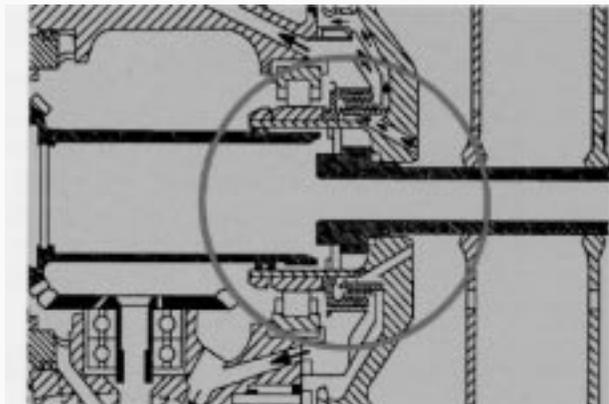
There are several locations where internal leakage most often occurs, all of which are in the power section. Worn or deteriorated O-ring seals, or a worn or damaged compressor front bearing labyrinth seal in the compressor front bearing and extension shaft area can cause internal leakage (Fig. 5).

Figure 5 Compressor front bearing labyrinth seal.

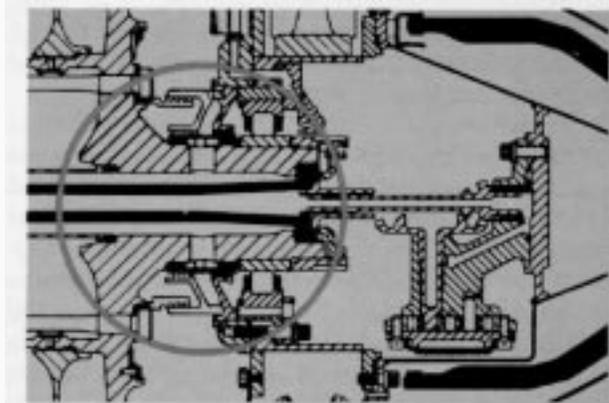
The lighthouse area can experience internal leakage from either end caused by damaged crush gaskets, worn or damaged labyrinth air or oil seals, or even a crack in one of the combustion chamber inner liners. The turbine rear bearing sump area can suffer leakage because of ineffective crush gaskets, turbine rear scavenge pump failure, or a worn or damaged turbine rear bearing labyrinth seal (Fig. 6).

Figure 6. Turbine rear bearing labyrinth seal.

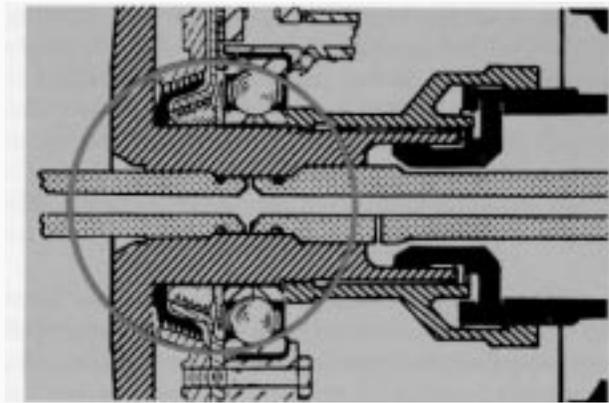
Figure 7. Compressor rear bearing labyrinth seal.

For example, if the **lighthouse pressure** is over 11 in. Hg, coupled with evidence of oil loss, the most probable cause is an ineffective compressor rear bearing labyrinth air seal (Fig. 7). This is due to the lighthouse being overpressurized by compressor discharge air flowing over the worn or damaged labyrinth air seal.

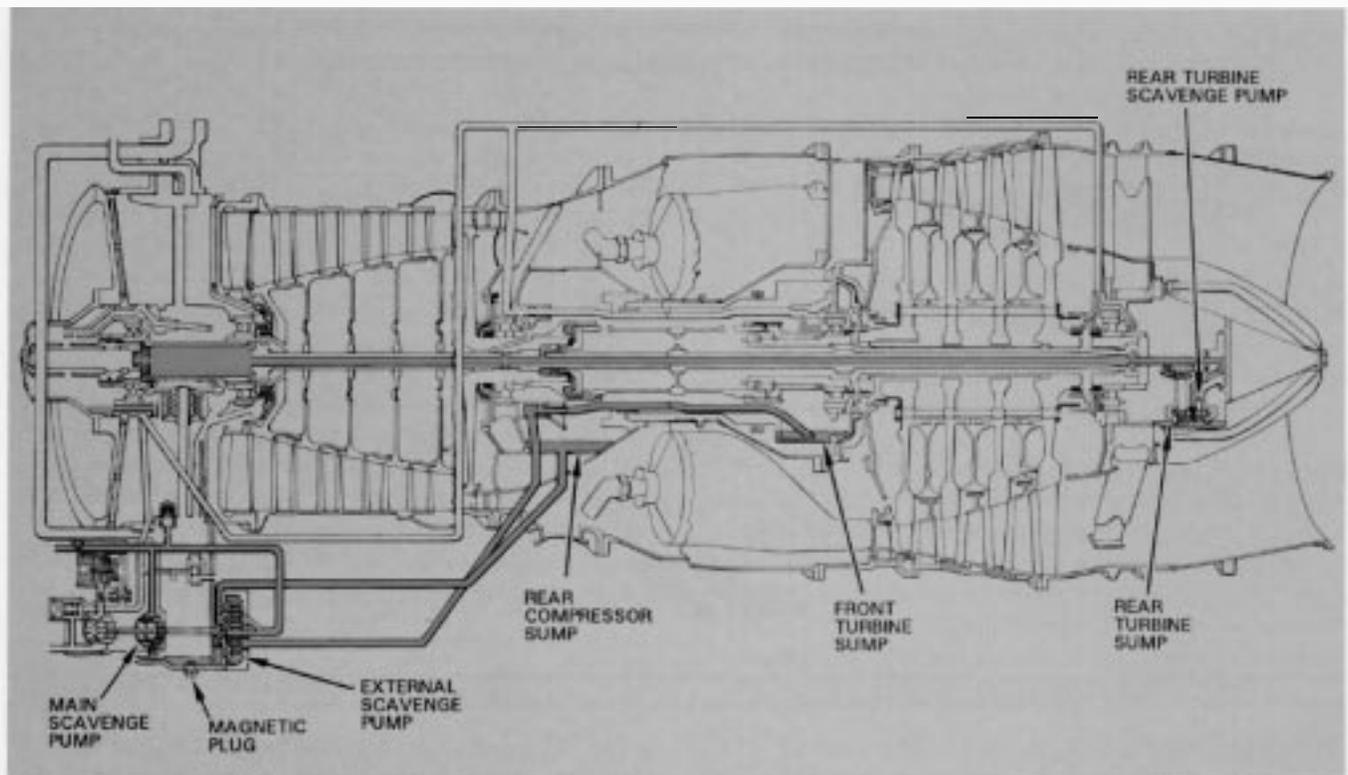
Figure 8. Power section scavenge problems can often be traced to ineffective pumps, leaking seals, and restricted scavenge oil tubes.

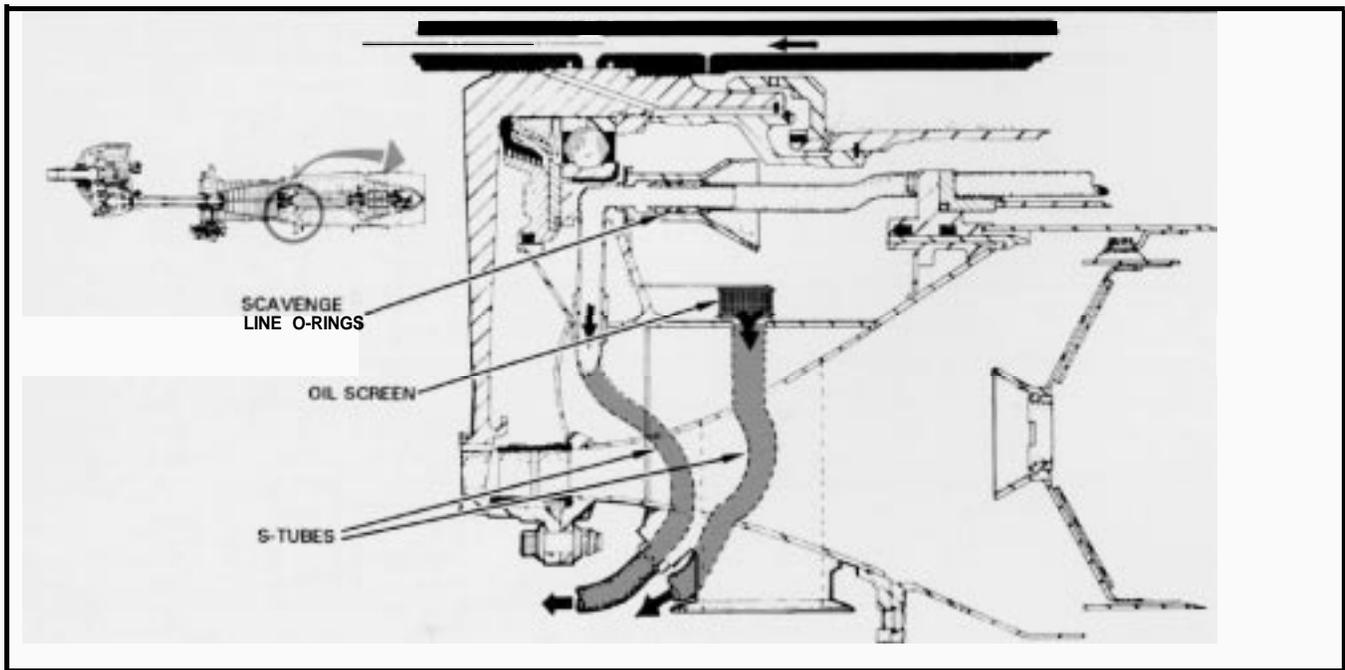
Figure 9. Good seals, unobstructed lines, and undamaged S-tubes are critical to proper scavenge oil flow.

The other cause for restricted oil tubes is air. Air is not really a restriction, but it can act to inhibit flow. Leaking scavenge line packings at the diffuser port connection allows lighthouse pressure to enter the oil tube. This breaks the suction to the turbine front bearing sump. There are two O-rings installed on the return scavenge line to help prevent this from happening.

Another place air can enter the system is at the diffuser S-tubes. These tubes are located inside the diffuser 5 o'clock and 7 o'clock struts. They serve as oil passageways to transfer the oil from the lighthouse area through the compressor air stream to the pump. If one of these tubes becomes cracked, compressor discharge air can enter the tube. The air pressure acts to break the suction and thus inhibits the free flow of oil to the pump.

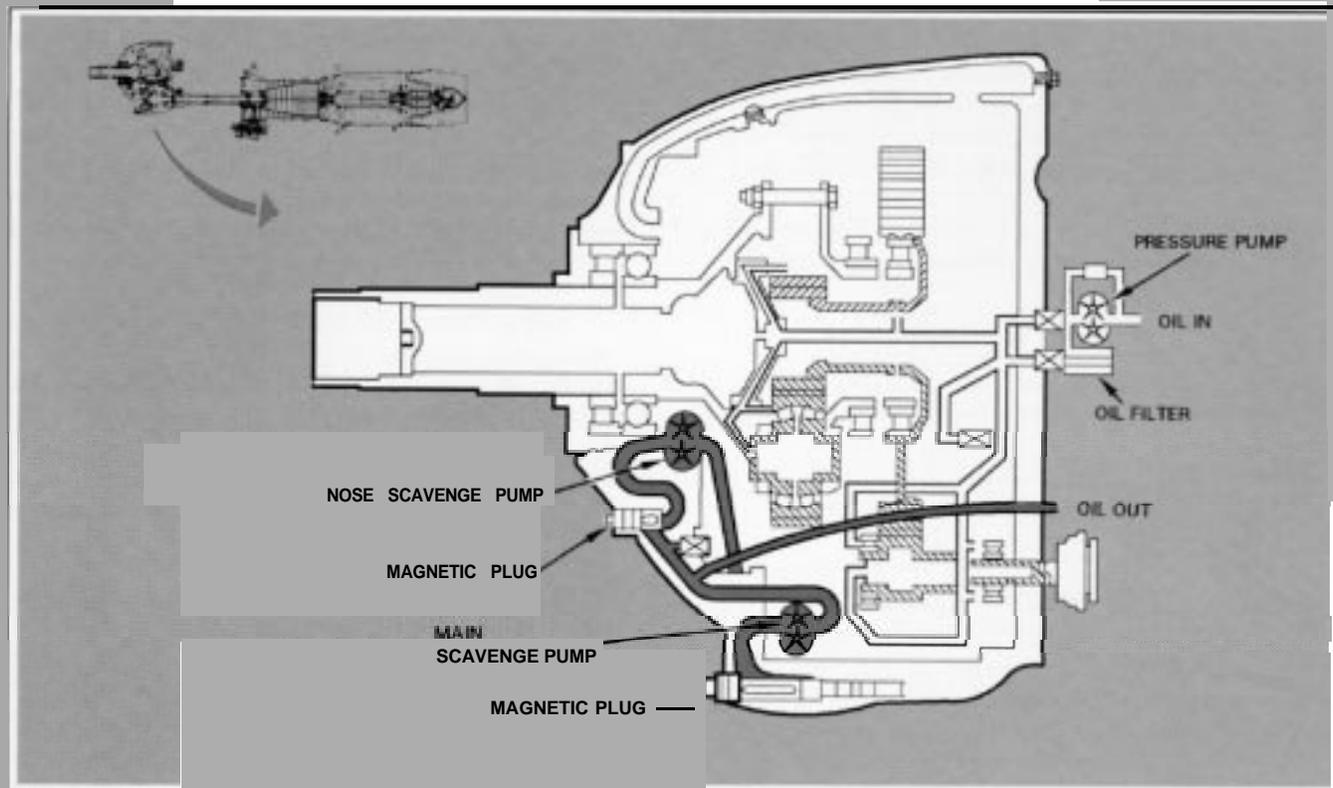
Figure 70. Effective reduction gearbox scavenging at altitude depends on efficient operation of both nose and main scavenge pumps.

This occurs because one pump cannot keep up with the oil flow at altitude and oil accumulates. The single good pump may be able to prevent further accumulation at lower altitudes, but it does not have enough capacity to completely recover the oil that has been accumulated at altitude. The oil simply stops accumulating.

One symptom which is unique to reduction gearbox main scavenge pump failure is that the engine dumps oil or indicates a reduction of oil quantity only when the aircraft is in a nose-up attitude or during rapid acceleration. It is under these conditions that oil normally scavenged by the nose scavenge pump flows to the rear of the reduction gear assembly.

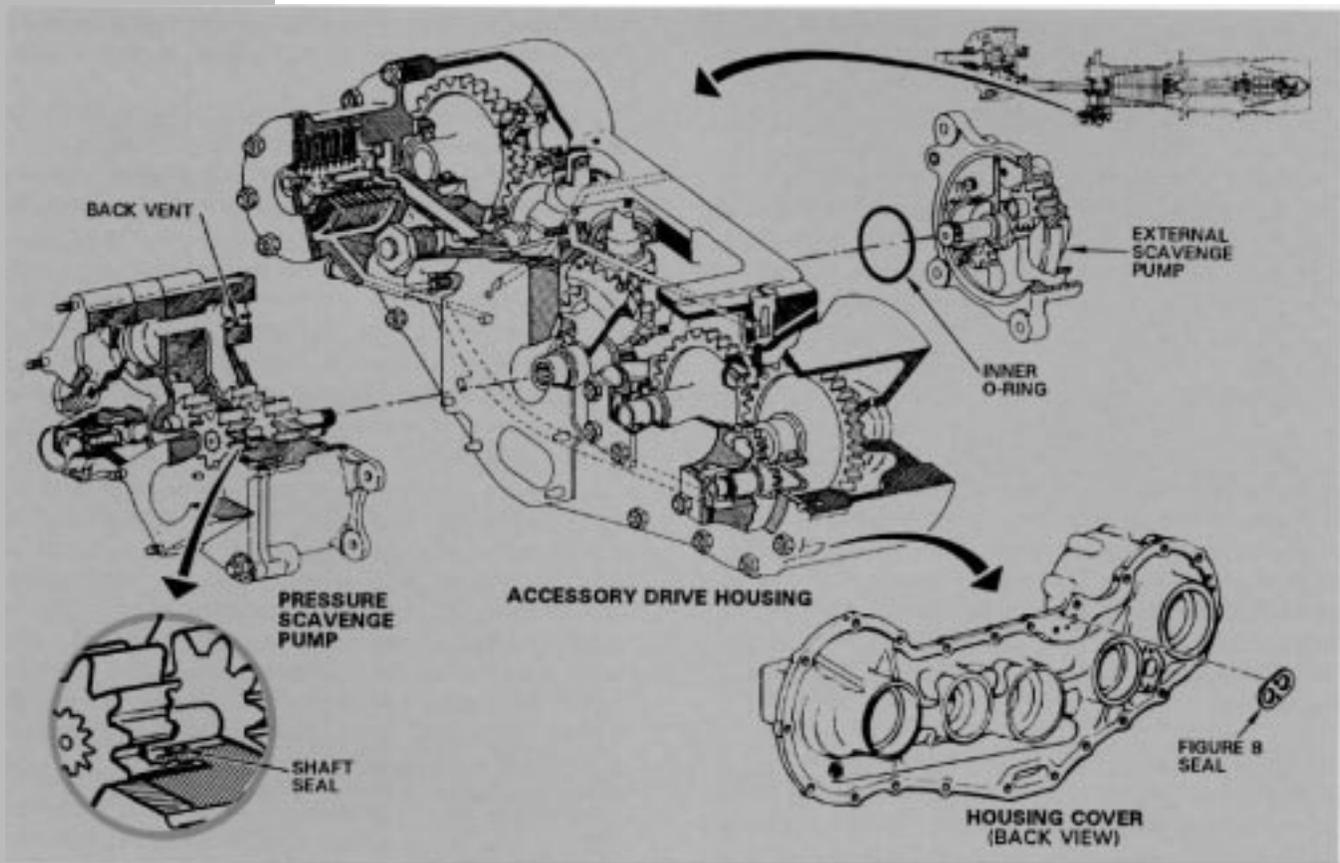
All too often, an external scavenge pump is replaced because it is thought to be worn, when in fact it only has a leaking O-ring. The inner O-ring on the pump cover, if leaking, can cause one element of the pump to cavitate. This causes the pump to lose its efficiency (see Fig. 11 on page 15).

Figure 11. Accessory drive housing oil accumulation is often caused by wear, obstructions, or seal problems affecting the main pressure scavenge pump.

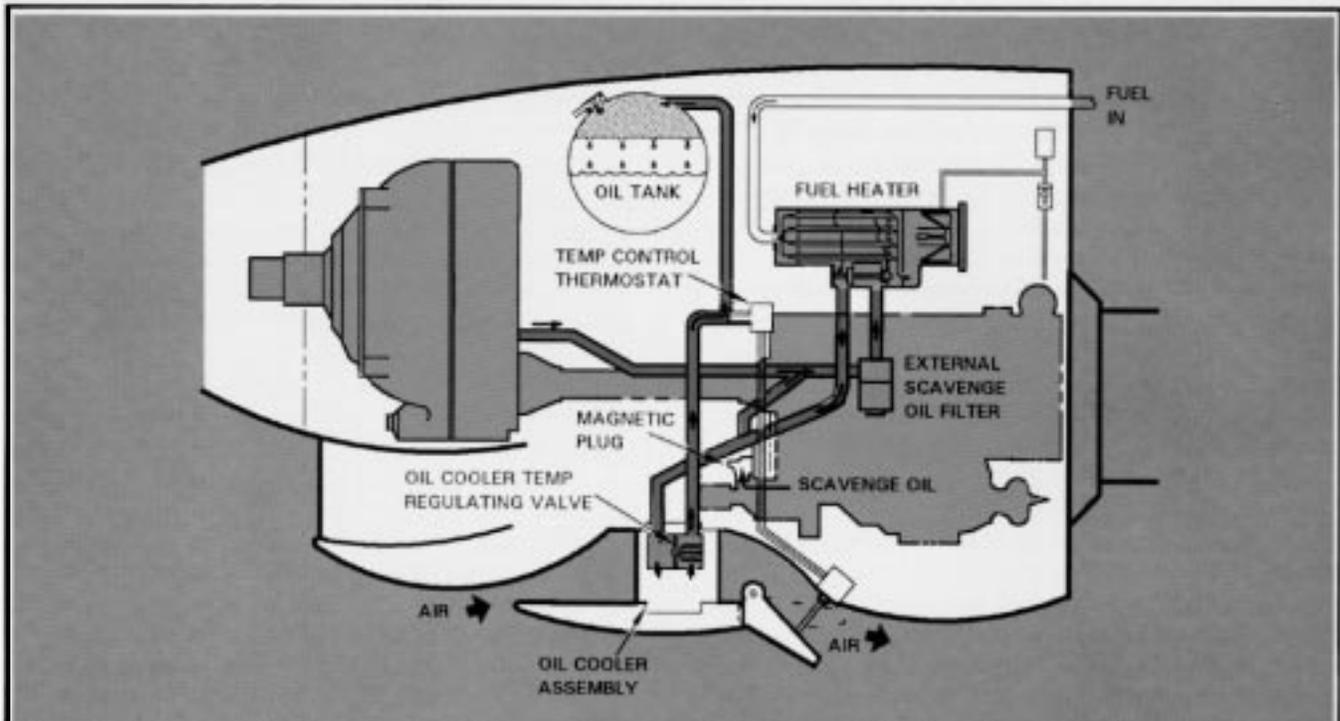
Figure 12. Nacelle-mounted oil system components such as the oil cooler, fuel heater, and external scavenge oil filter are important contributors to scavenge system back pressure.

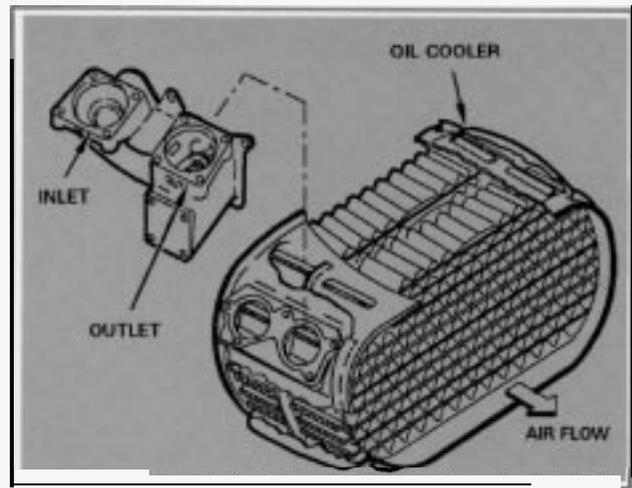
Figure 73. Even in full operation at 80°C, the AP of the oil cooler should not be more than 9 psi.

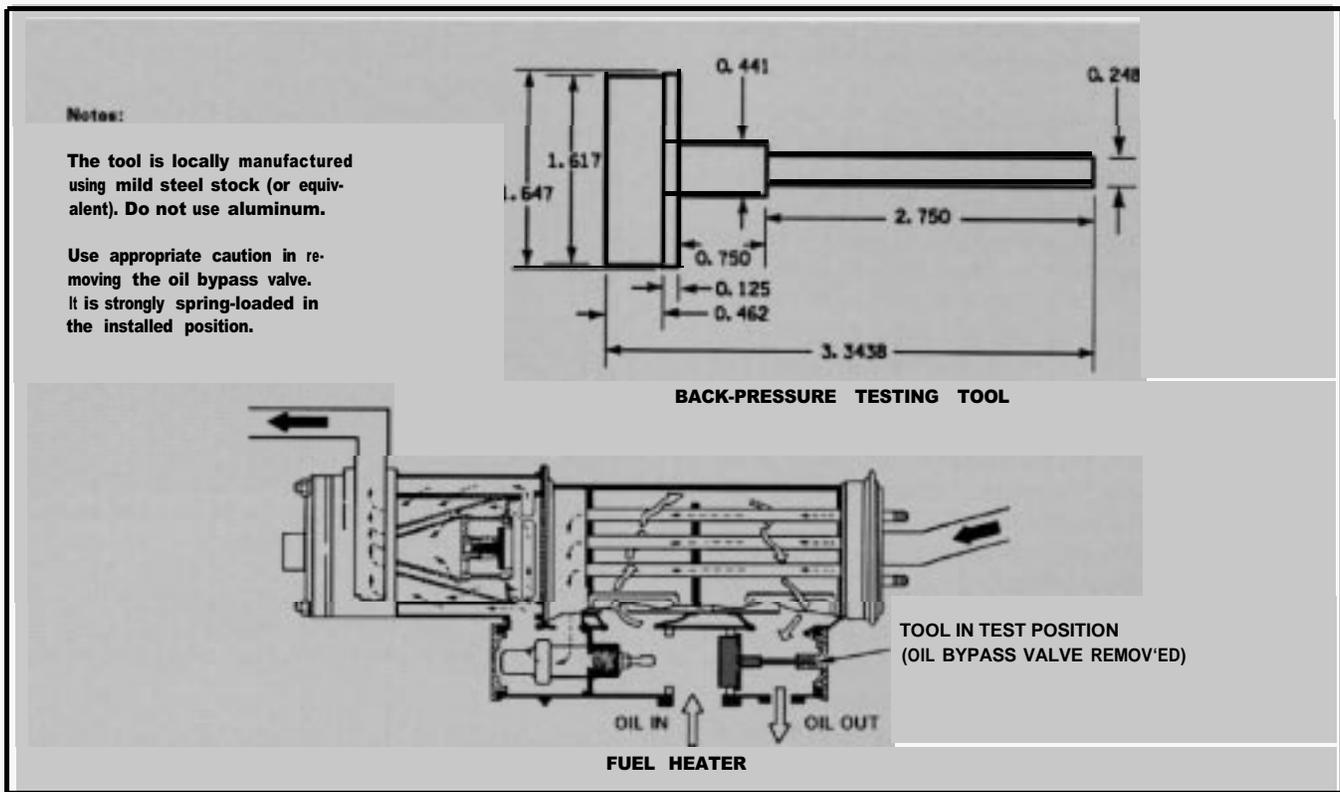
Figure 14. Installed in the fuel heater, this locally manufactured tool will allow the unit's maximum back pressure to be measured.
