THE HERCULES: SYMBOL OF HOPE

SERVICE NEWS

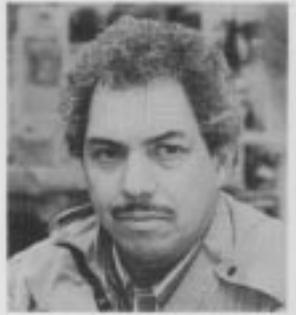
The Hercules: Symbol of Hope

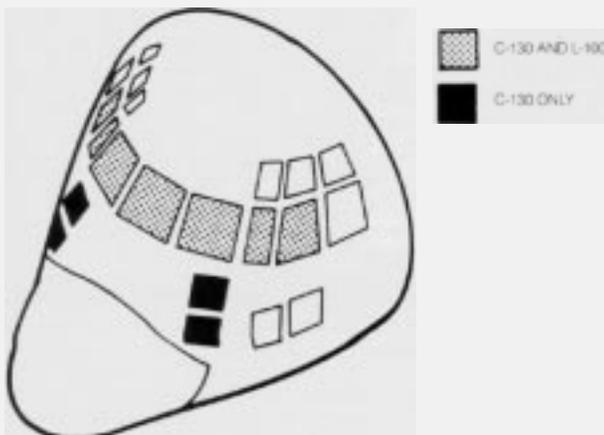
The NESA windows on Hercules aircraft are of either five-layer or three-layer construction (Figure 2). In the case of five-layer panels, a central structural glass layer is sandwiched between two vinyl layers, which in turn are enclosed between two layers of glass.

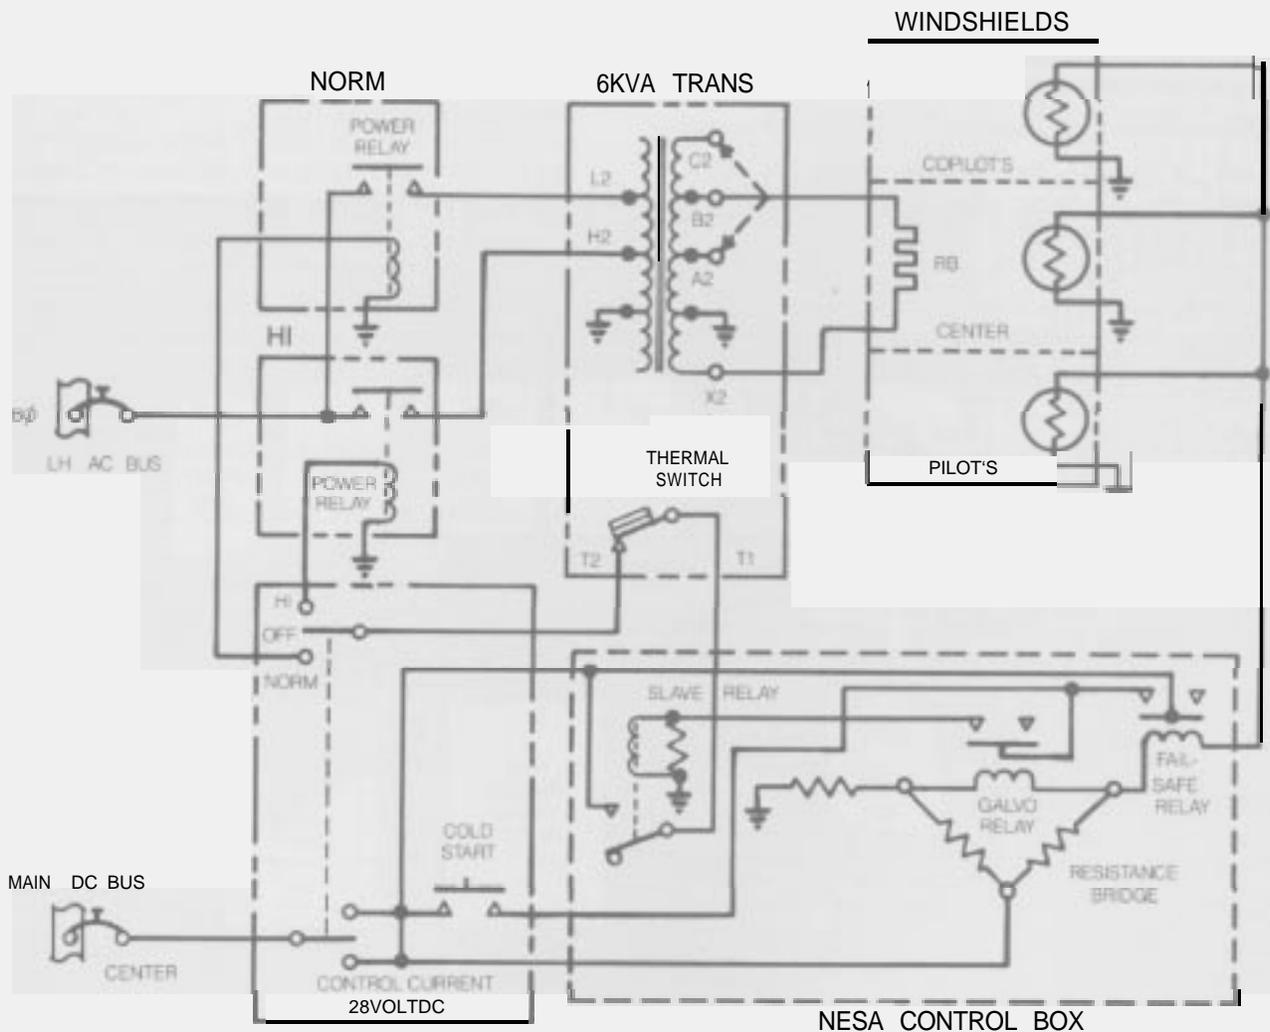
figure 7. NESA windshield conventional control system (simplified).

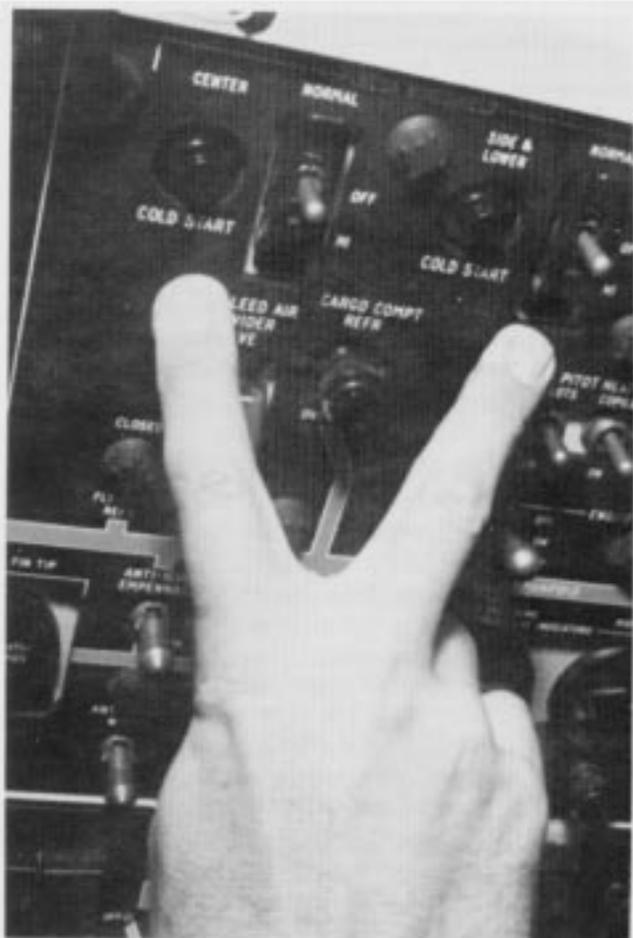
Temperature Control - Solid-State

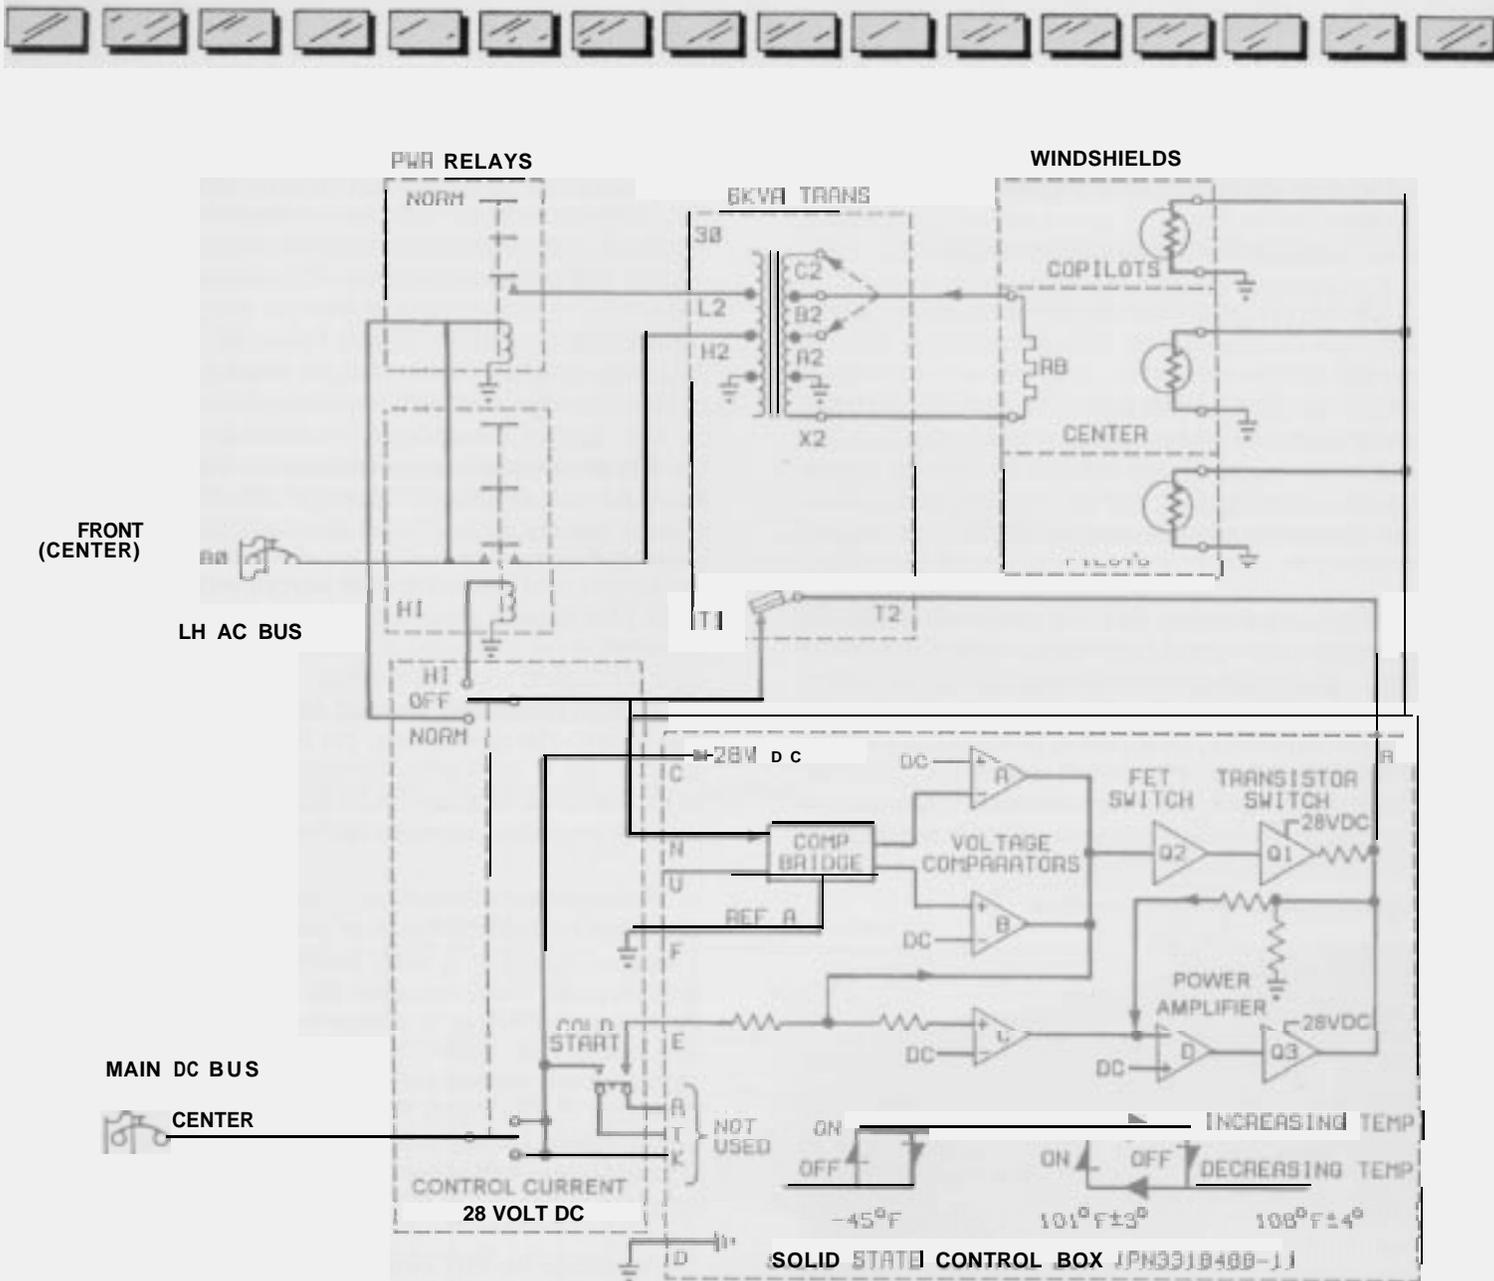
figure 9. NESA windshield solid-state control system (simplified).

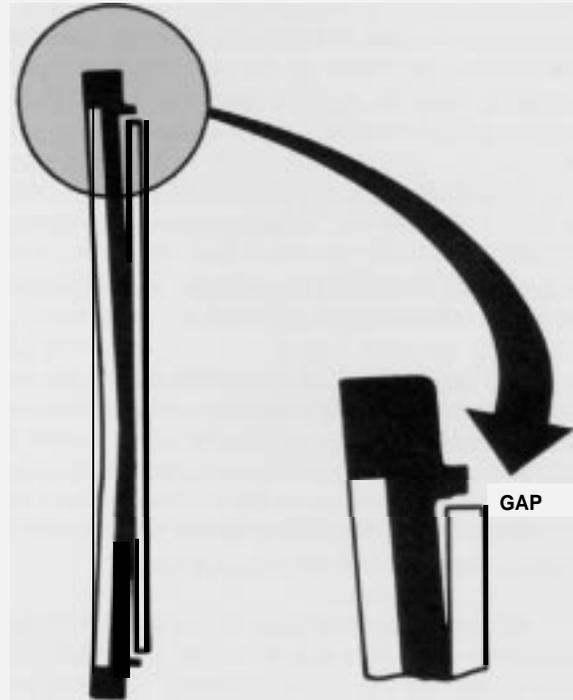
Figure 70. Gap development caused by pressurization cycles and vinyl shrinkage.

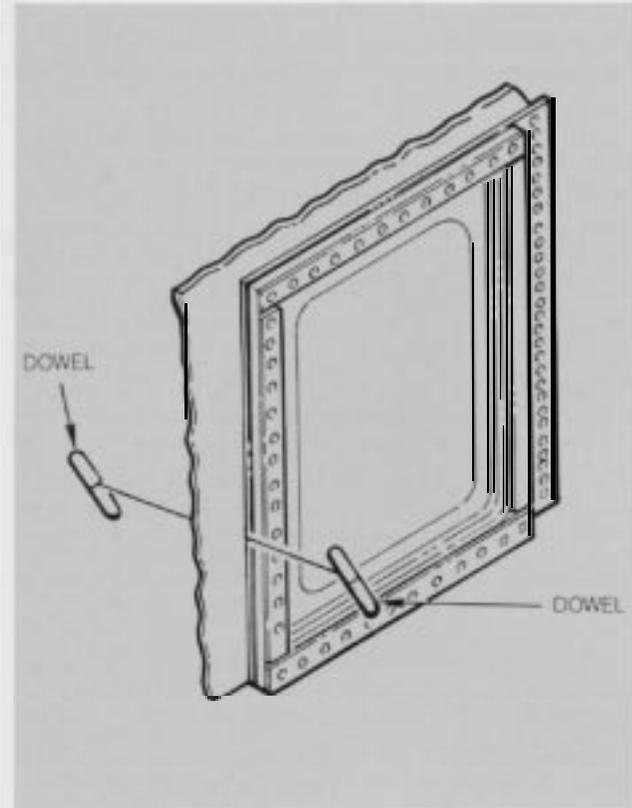
Figure 17. Window removal tool (locally manufactured).

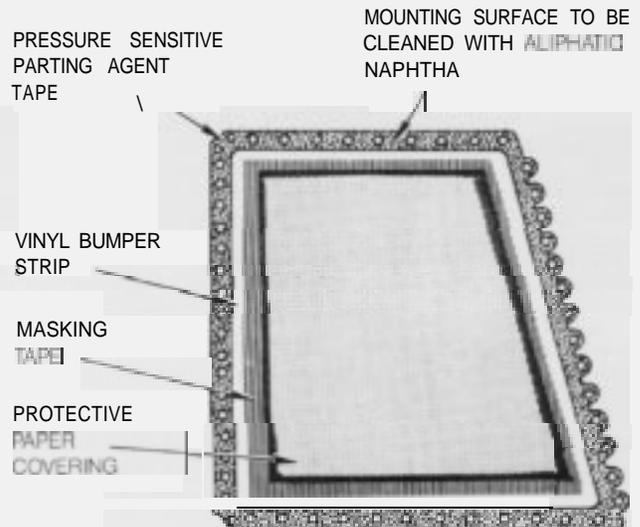
Figure 72. Preparing a windshield panel for installation.

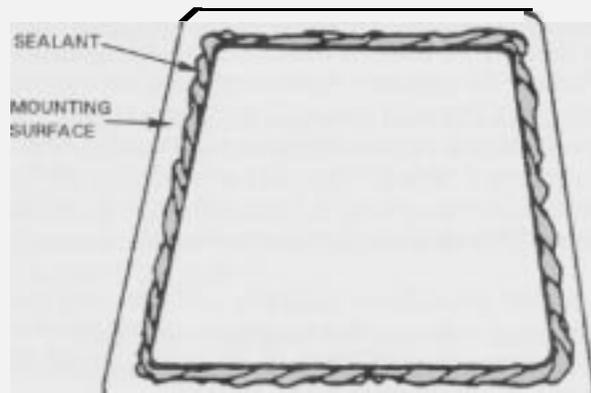
manually with a spatula. Use a sufficiently thick layer of the sealant to form a complete seal between the mounting surfaces of the windshield and the airframe.

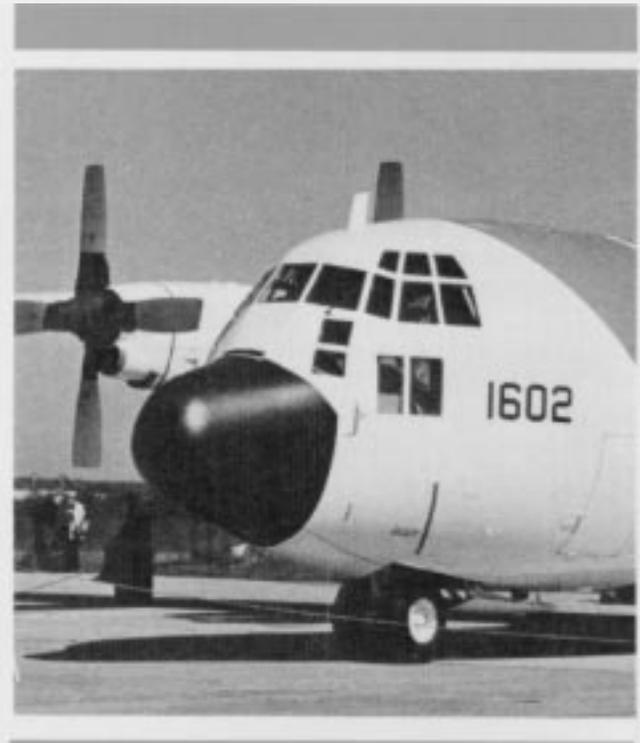
After the sealant has fully cured, open the clear-vision panel. Trim all excess sealant. The formed-in-place seal should have a smooth and continuous surface. Fill any voids in the sealant to a flush condition and allow to cure.
