# ***SERVICE NEWS***

A SERVICE PUBLICATION OF  
LOCKHEED AERONAUTICAL  
SYSTEMS COMPANY

Vol 21, No.3, July-September 1994

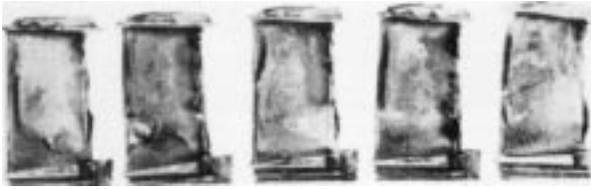
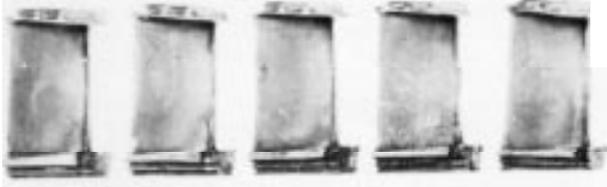
Turbine blades and vanes are subject to gradual deterioration as engine operating hours accumulate. The process is commonly referred to as sulfidation. Turbine sulfidation is caused by the accelerated oxidation of metals in the presence of sulfur ions, in particular sulfides and sulfates. The oxidized metal goes out the tailpipe, leaving eroded blade and vane surfaces behind.

**First stage turbine blades after a service test.**  
**Top row: uncoated alloy.**  
**Bottom row: the same alloy protected with Alpak.**

To help prevent such damage to the metal surfaces and extend the service life of the turbine section components most often affected by sulfidation, diffused coatings of aluminum or aluminum and chromium (often referred to as Alpak and AEP, respectively) are applied to new turbine blade and vane surfaces.

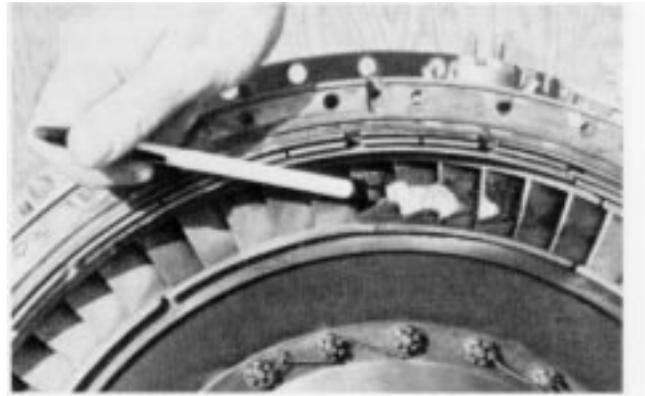
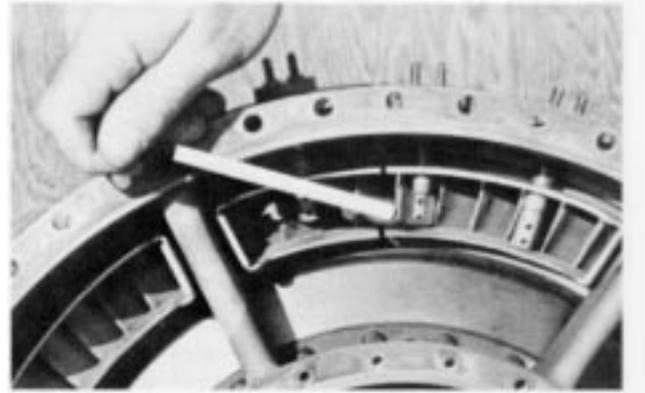
**This turbine wane burn-through was caused by the use of thermocouples of the incorrect type.**

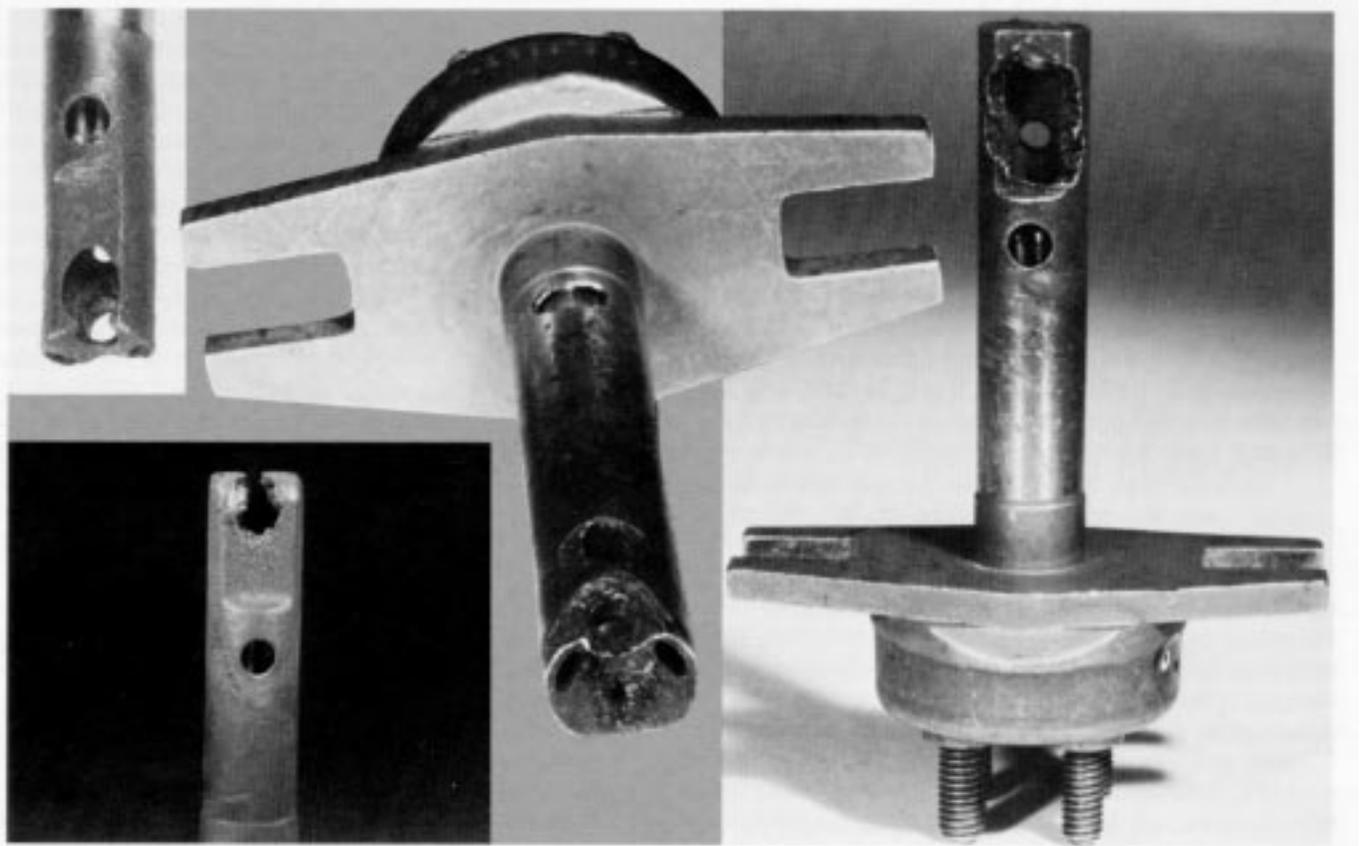
Eroded or defective thermocouples that are still producing current can also cause temperature control errors, although for a different reason. In fact, the temperature error in these cases can be even more severe than when a thermocouple has dropped completely off line. One thermocouple with the aft wall of the probe tip eroded, for example, can cause the true operating TIT to increase by as much as 7.5°C.

**All of these thermocouples were damaged by exposure to overtemperature conditions.**

A sequence of failures involving five thermocouples with probe tip aft wall erosion can therefore raise the actual operating temperature of the engine by over 35 °C at every power setting above crossover. Such exposure to excessive operating temperatures is very destructive to engine components and will result in significantly shortened engine life.

One of the most important things to remember about thermocouple inspections is to do it often enough. Finding more than three defective thermocouples in one engine at inspection time is a good indication that the period between inspections needs to be shortened.

When thermocouples are removed for examination, be sure to tag them as they are removed and keep a record of the positions where they were located. The condition of individual thermocouples often provides valuable clues about underlying problems involving other components. For example, thermocouples with badly burned probe tips or unusual carbon deposits suggest malfunctioning fuel nozzles or defective combustion liners, as does repeated thermocouple failures at the same location.
