# *Service News*

Volume 29, No. 1 2004

# PREVENTING AIRCRAFT CORROSION

# SERVICE BULLETIN UPDATES (CONTINUED)

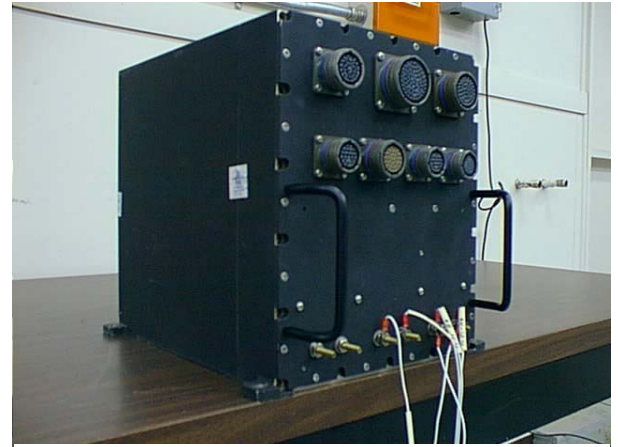
Lighting Control Unit (LCU)

The TSP is used to send and receive trim, channel, and fault information from the LCUs. From the TSP, the desired lighting levels can be set by two different methods. The first is manually using the knobs and switches on the face of the TSP. Once new settings are made, they can be saved utilizing the SAVE TRIM switch. The second method uses a laptop computer and ALCS software input through a nine pin RS-232 connector that is connected to the face of the TSP. The maintenance person can program the lighting to desired levels and save the changes for later when replacing an LCU.

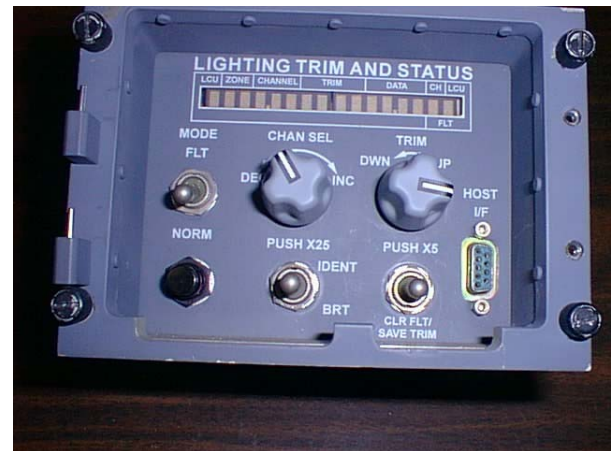
Trim and Status Panel (STP)

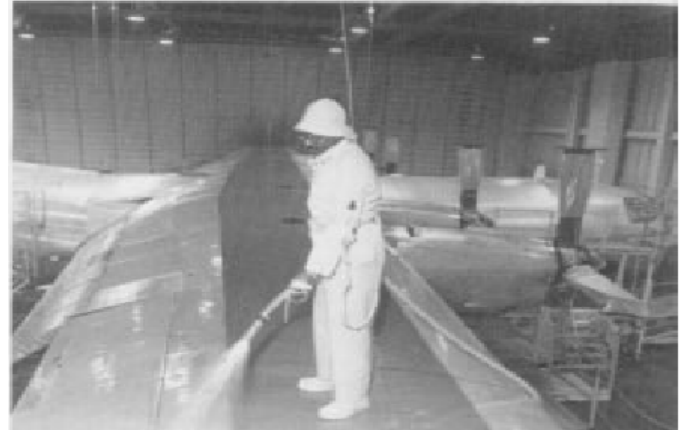
**Wash rack workers need the protection of safety harnesses when working on the upper surfaces of the aircraft.**

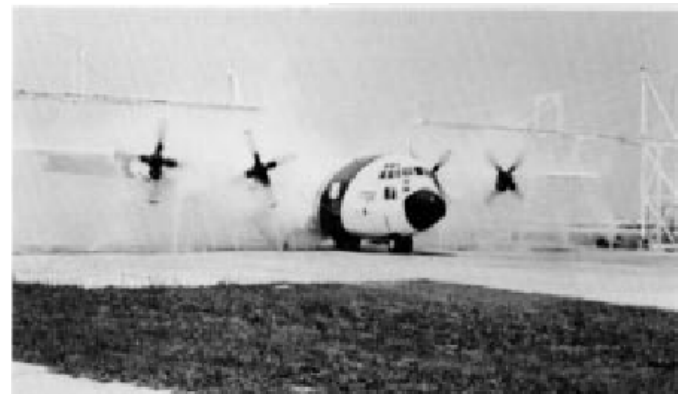
**An automated outdoor rinsing facility helps protect Coast Guard aircraft from the corrosive effects of salt spray.**

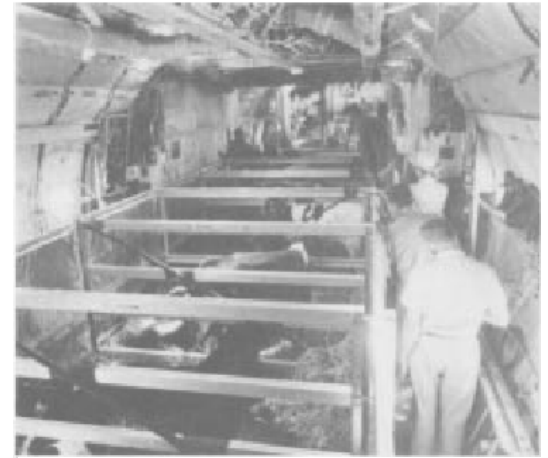
**Aircraft interiors must be cleaned thoroughly after each mission involving the transportation of animals.**

Most fire extinguishing agents are corrosive and can very quickly produce severe corrosion on airplane structure. Bromochloromethane and foam type agents are the most notable offenders in this regard. Some of the more commonly used dry powder type agents, such as potassium bicarbonate (PKP), are only mildly corrosive. However, after exposure to heat, the residue may convert to potassium hydroxide, which is very corrosive indeed.

As if that were not already bad enough, both of these potassium salts are hygroscopic and will absorb moisture, creating a corrosive poultice on airplane surfaces. The soot generated by an airplane fire is carbon contaminated by a variety of combustion byproducts, depending upon what is being burned. Like the agents in dry powder extinguishers, soot is both corrosive and hygroscopic. Airplanes contaminated with fire extinguishing chemicals and soot must be cleaned and neutralized as soon as possible after exposure. Regardless of the type fire extinguishing agent used, it is recommended that the affected areas be water rinsed and/or neutralized as soon as possible to minimize corrosive attack.

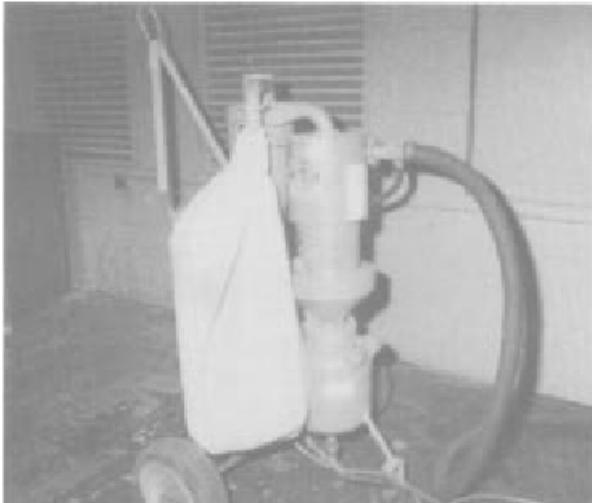
**Most corrosion must be removed mechanically. In many cases an abrasive blaster can speed up the cleaning chore.**

Most corrosion problems have to be attacked mechanically, and there are a number of methods by which this can be done. These include everything from the use of sandpaper to complex methods involving abrasive blasting. The method of selection will depend upon the type of metal, the location and accessibility of the corroded area, the degree of damage, and the type of corrosion involved.

- Protect the area surrounding the corroded area from damage during the corrosion repair.
- Clean the affected area of dirt, grease, etc.
- Remove the corrosion. To avoid stress risers (crack starting points), be sure the corrosion removal surface is left in the shape of a saucer, with no sharp angles. Also ensure that all corrosion is removed and the affected area is polished smooth.

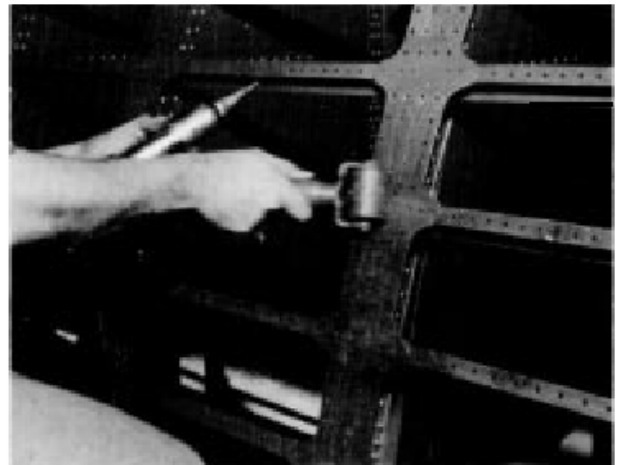
**The use of sealants during aircraft manufacture has proved an effective and versatile weapon against corrosion.**

Sealant may be the most versatile and effective weapon in preventing aircraft corrosion ever introduced. It is used to exclude moisture and water and to separate joined metals. Exterior joints and gaps are filled with sealants to prevent water and chemicals from entering. In addition to environmental sealing, sealant is also used for wet-installation of fasteners, pressure sealing, and aerodynamic smoothness.

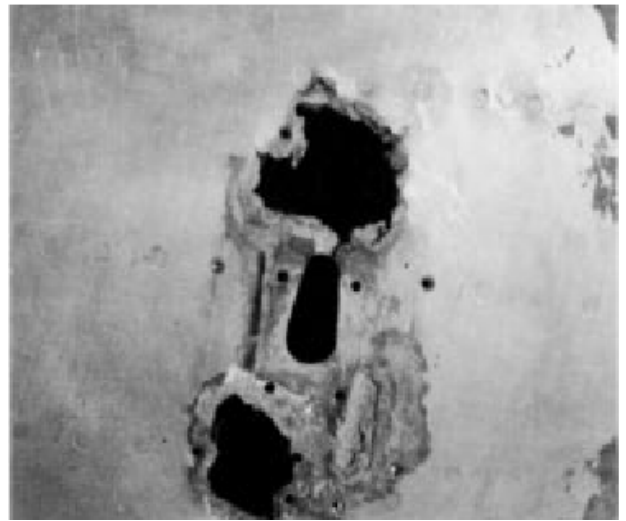
**Structure under antennas is a common site for corrosion, particularly where the antenna is not sealed, or gaskets have been damaged.**

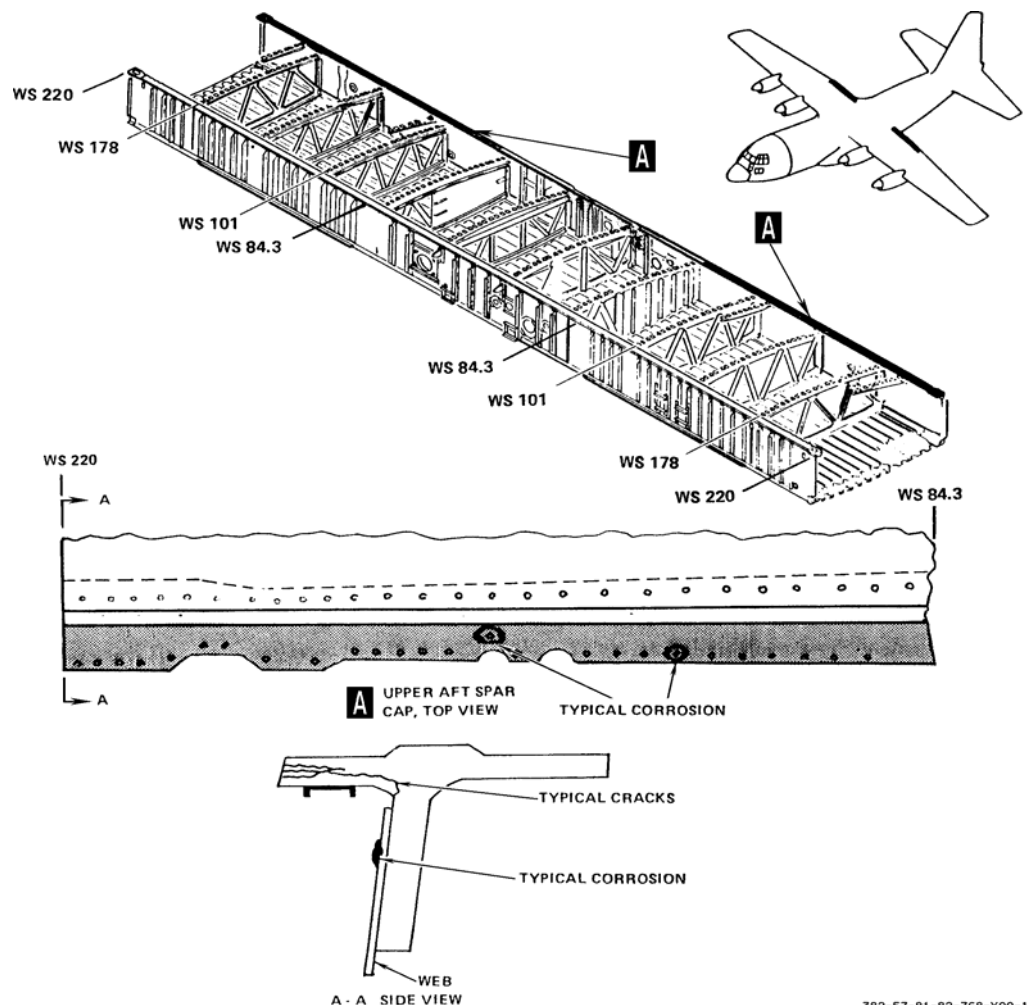
**Figure 1. Inspection of Center Wing Beam Caps**

Hercules operators have reported finding exfoliation and pitting corrosion in the center wing beam caps made from 7075-T6 Aluminum Alloy. Lockheed Martin Aeronautics Company recommends that the inspection/modification specified herein be accomplished at the next convenient maintenance period, but not to exceed 360 days after receipt of this Service Bulletin. Lockheed Martin Aeronautics Company also recommends repeating this inspection every five years.

This service bulletin consists of an eddy current conductivity testing of four center wing beam caps made from 7075 Aluminum Alloy to determine alloy heat treatment for identification purposes. If the center wing beam caps are manufactured from 7075-T6 material, clean for visual inspection for corrosion, cracks, and other defects.
