VOL. 16, NO. 3, JULY-SEPTEMBER 1989

SERVICE NEWS

A SERVICE PUBLICATION OF LOCKHEED AERONAUTICAL SYSTEMS COMPANY—GEORGIA

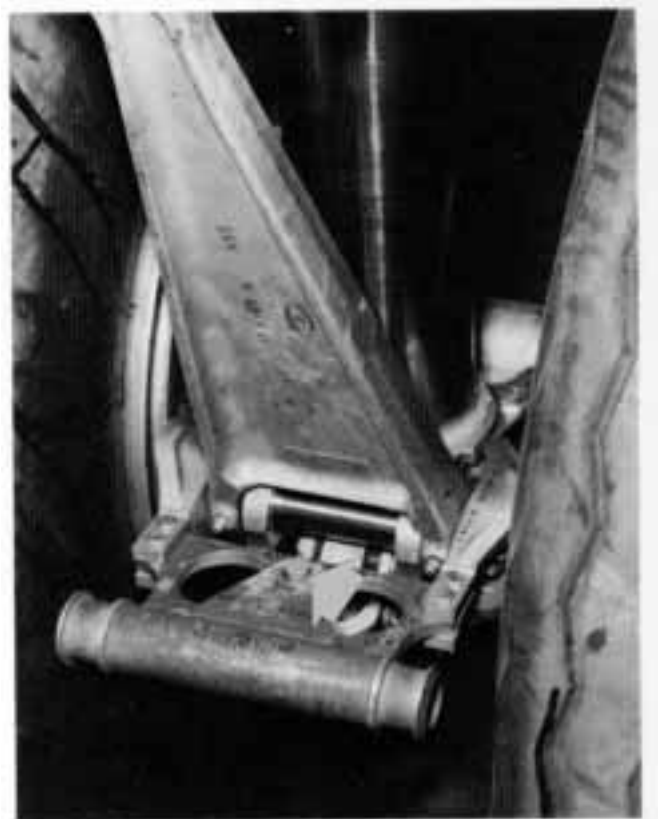
This safety shear bolt is designed to shear only when excessive pulling force is applied.

It should be remembered that the AN6 safety shear bolt installed in the aircraft nose landing gear crossbar and tow fitting (see illustration) is designed to shear only with a pulling force. If the Hercules aircraft is being pushed backward, the nose landing gear tow fitting will bottom out against the crossbar and the crossbar bolt will not shear, leaving only the AN6 bolts in the towbar to provide the safety shear function.

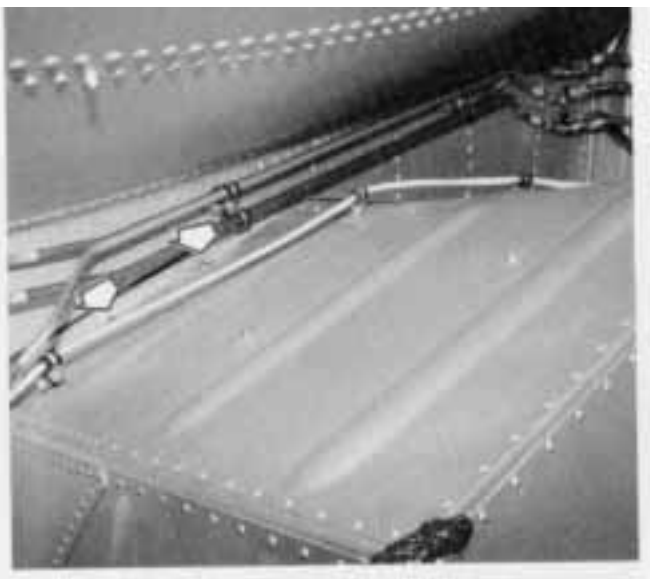
Two of the five rigid fasteners that can be replaced with NAS 1298 shoulders screws and spring washers are visible in this photograph.

Engineering analysis has determined that the problem does not present a safety of flight concern, but a change has been proposed that will eliminate the possibility of unwanted noises from this source in future production aircraft. The change replaces the rigid fasteners at the battery box attaching flange with spring washers and NAS 1298 shoulder screws. The new arrangement will allow a small amount of movement between the components during pressurization without the accompanying sound effects.

This same modification could also be accomplished on in-service aircraft subject to battery box noises. If any of your organization's Hercules aircraft have recorded this complaint and you wish to correct the problem, please contact the C-130/Hercules Service Department at the address below and request full information, including print No. 339275, Box Installation-Battery and External Recep. (note in particular reference

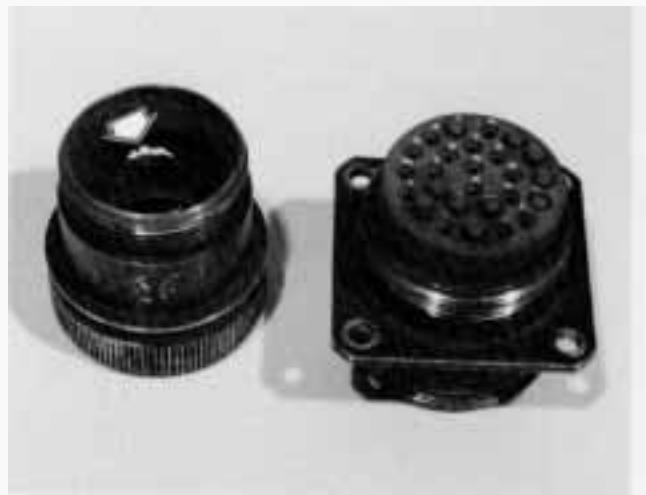
Corrosion has penetrated all the way through the metal structure of this connector body.

When corroded pins and sockets are found and the connectors are considered salvageable, the following process is recommended to restore conductivity, and provide protection for the conducting surfaces in the future.
