# *SERVICE NEWS*

A SERVICE PUBLICATION OF LOCKHEED-GEORGIA COMPANY, A DIVISION OF LOCKHEED CORPORATION

Vol. 5, No. 4, October – December 1978

*Better service from*  
**Bendix**  
*Starters*

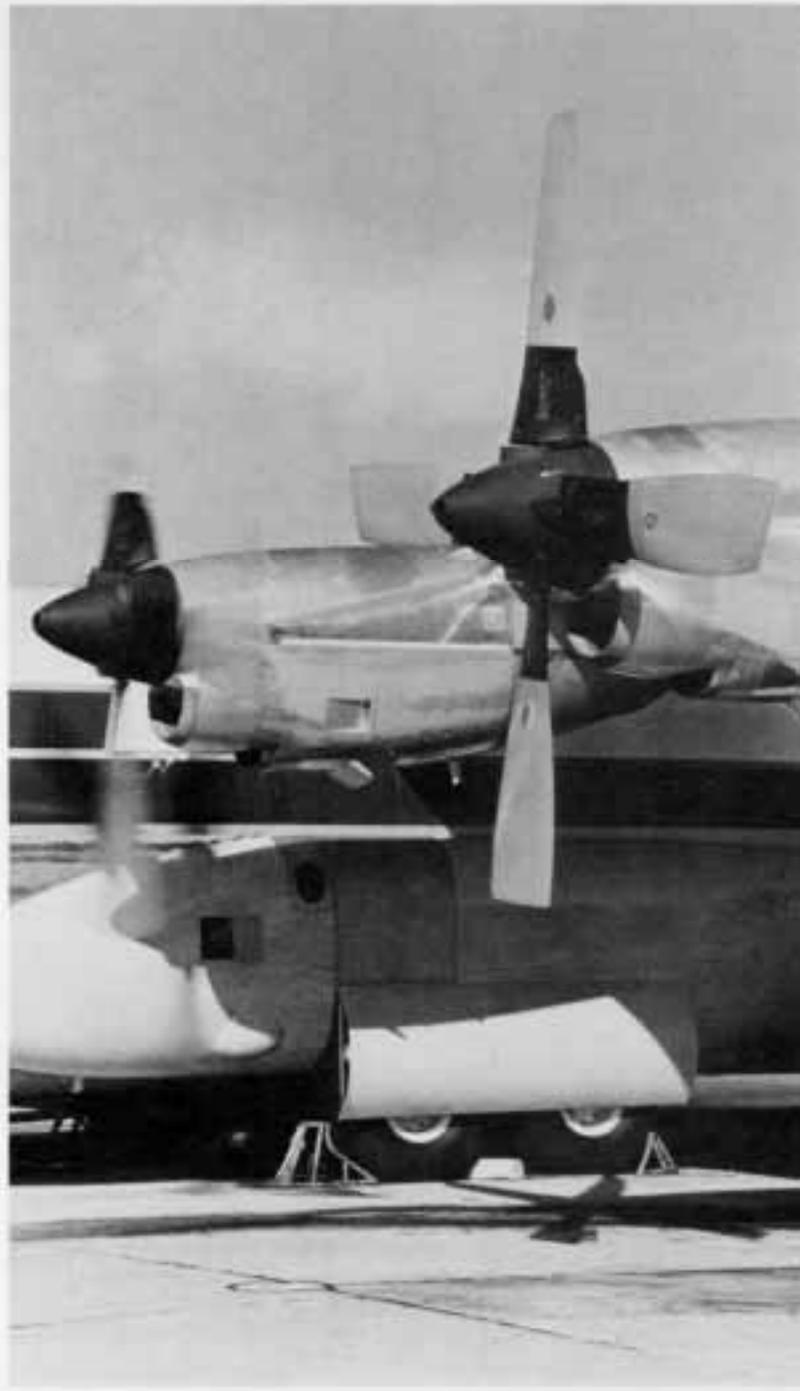
Bendix starters have been standard equipment on Hercules aircraft since mid-1972, beginning with aircraft serial LAC 45 15. The starters were originally supplied in two basic versions, model 36E84-16QA, which incorporates an automatic cutout switch and is used in aircraft equipped with push button starter controls, and model 36E84-18QA, which does not have the automatic cutout switch and is installed on aircraft equipped with toggle switch starter controls.

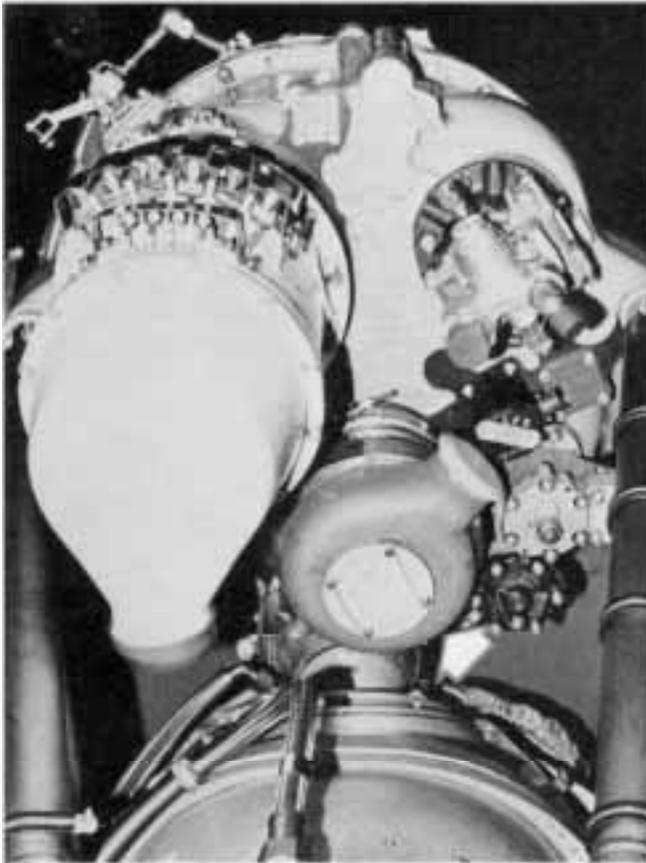
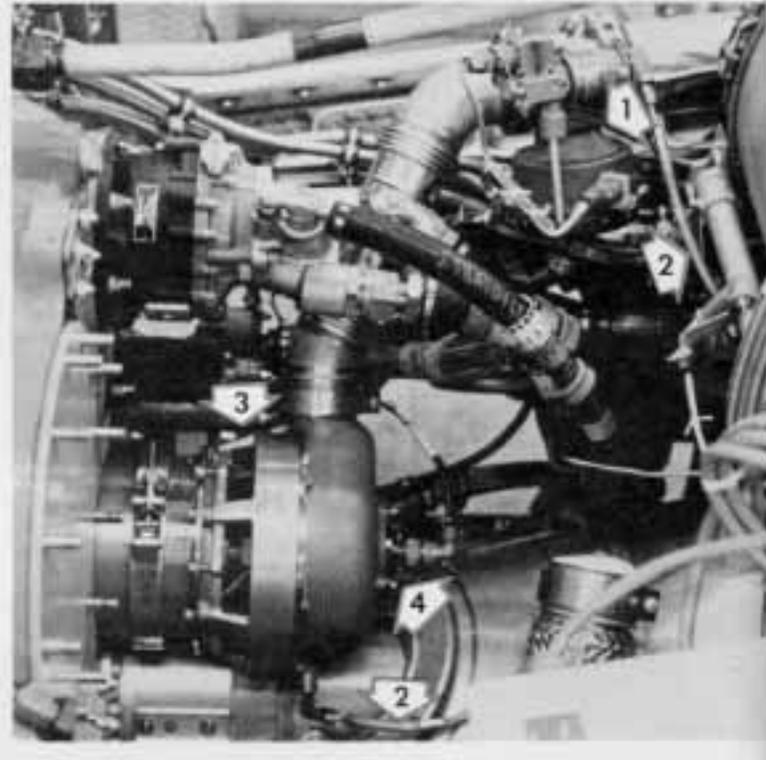
Left: Pneumatic starter location on back of engine reduction gearbox. Above: Starting system components – (1) air control valve (2) pressure sensing line (3) starter (4) speed switch assembly (push button starter controls only).

Essentially, the Bendix pneumatic starter is a specialized type of air turbine motor. Its major components are an inlet assembly, a turbine, reduction gearing, a slip clutch, and an engaging mechanism.

The starter turbine has a titanium wheel which is splined to a steel shaft. It is used to convert air flow from an APU/GTC, an operating engine, or an external air source into torque. A reduction gearing system consisting of a single set of planetary gears is used to convert the high speed and low torque at the turbine to low speed and high torque at the output drive. The overall reduction ratio is 5.41:1.

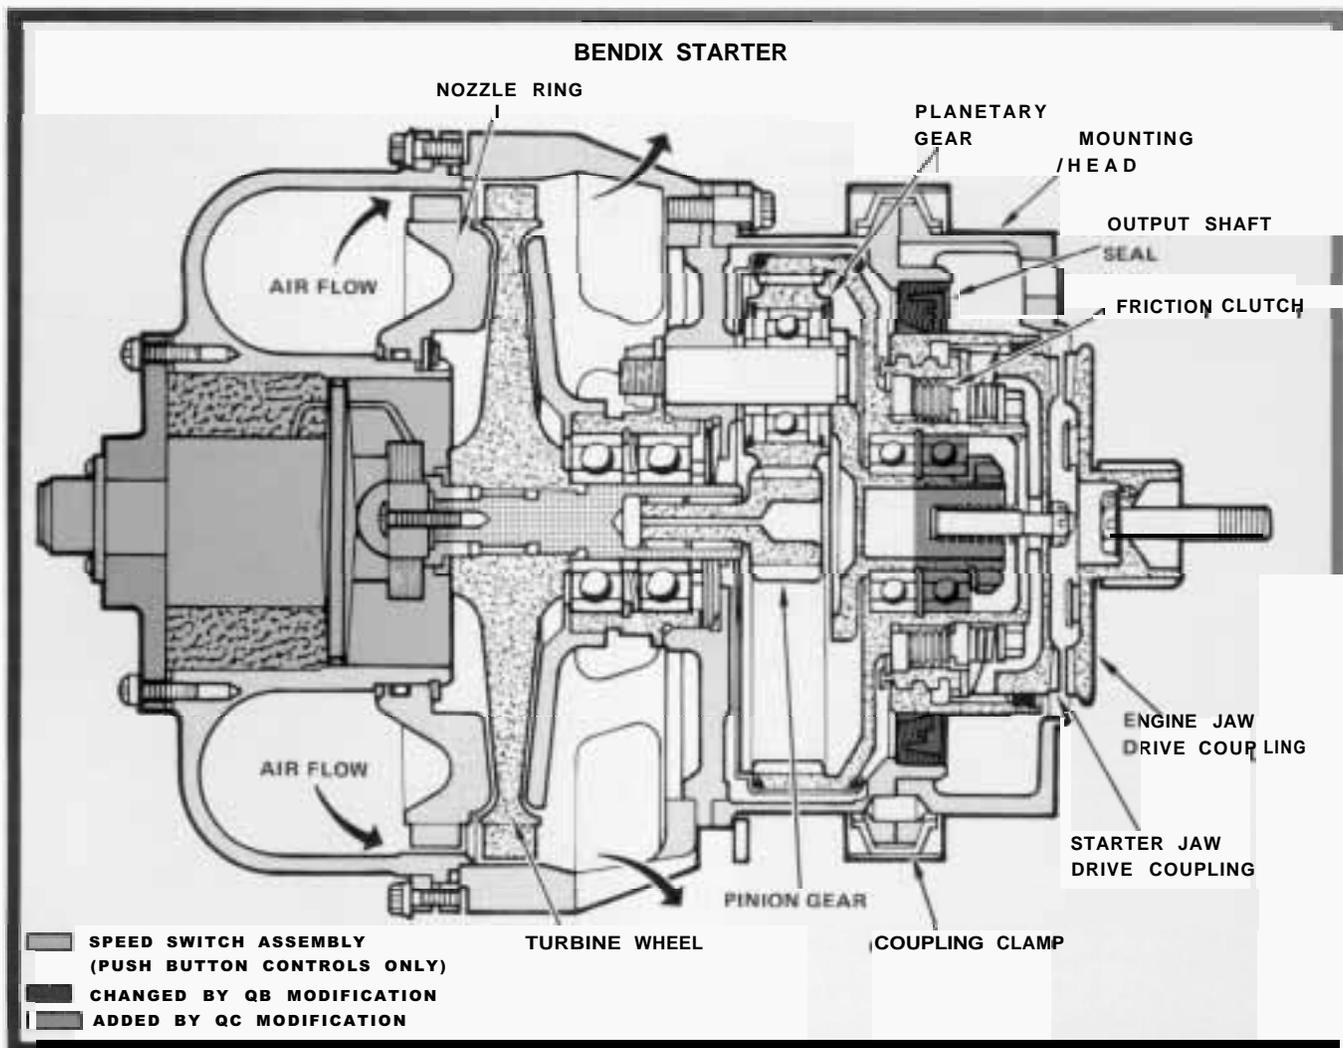
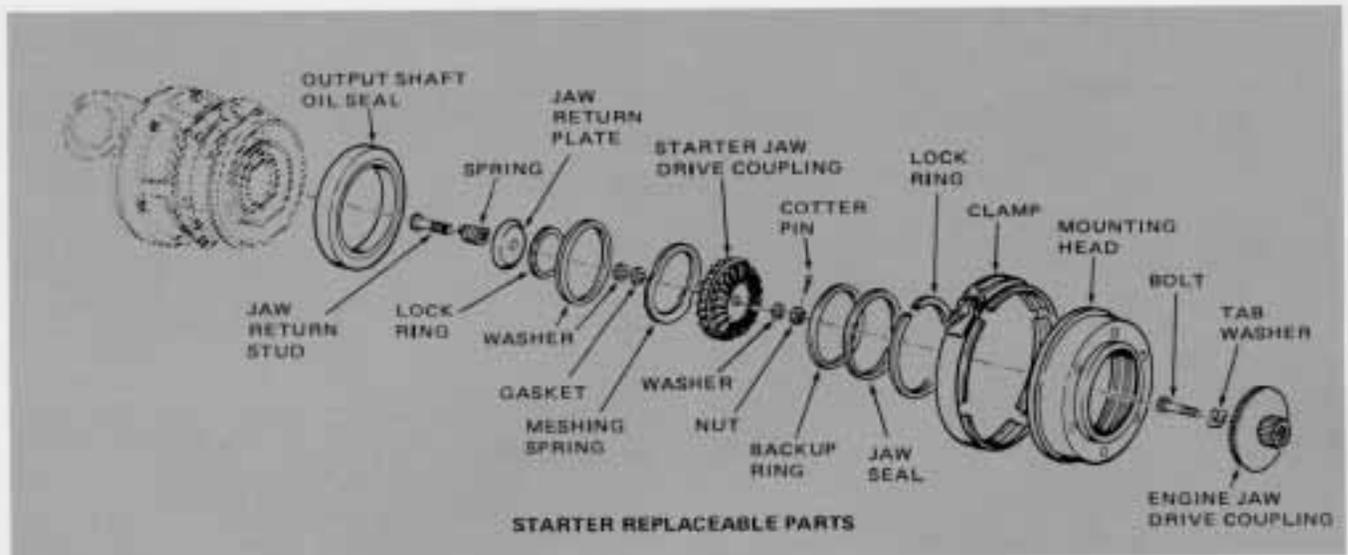
While tests under controlled conditions had shown that the seal would usually last for at least 1200 starts, it became evident from field experience that the serviceability of this seal was the main factor tending to limit the potential operating life of the starter. If the wear resistance of the oil seal could be upgraded, it seemed likely that the service life and dependability of the unit could be significantly improved.

The answer to the problem was found in a new seal material called Viton. When output shaft oil seals composed of Viton were tested, it was found that not only would the seals on the average remain serviceable for more starts than those made of the original material, but their performance was much more reliable. Bendix immediately began installing seals made of the new material in new production starters and supplied the Viton seals (P/N 2492193) to the field at no cost for retrofit in existing equipment. All units in which the new seals were installed received the QB designation.

The investigations which led to the development of the new seal material subsequently also pointed the way to another improvement which has the potential to extend the service life of Bendix starters still further. In the QA and QB models, the engage-disengage mechanism is supported by a single bearing. At starter cutoff speed, when separation of the starter and engine jaws occurs, the mechanism is fully advanced and rotating at approximately 8500 RPM. When disengagement occurs, it takes about 10 to 20 seconds for the starter to decelerate to rest. The single bearing support allows some degree of eccentric rotation of the engaging mechanism before it comes to a stop. While the eccentric running does not impose unmanageable loads on the bearing, it does tend to cause additional wear on the output shaft oil seal. The new Viton seals are much more resistant to this type of wear than were seals made of the old material, but the cumulative effect can still be significant.

Engineers at Bendix determined that the addition of a second set of ball bearings in the engage-disengage mechanism stabilizes the rotational characteristics of the shaft on which the oil seal rides and significantly reduces the wear it receives. Starters equipped with both the Viton seal and two-bearing support for the engage-disengage mechanism have completed more than 3500 starting cycles before seal replacement was required.

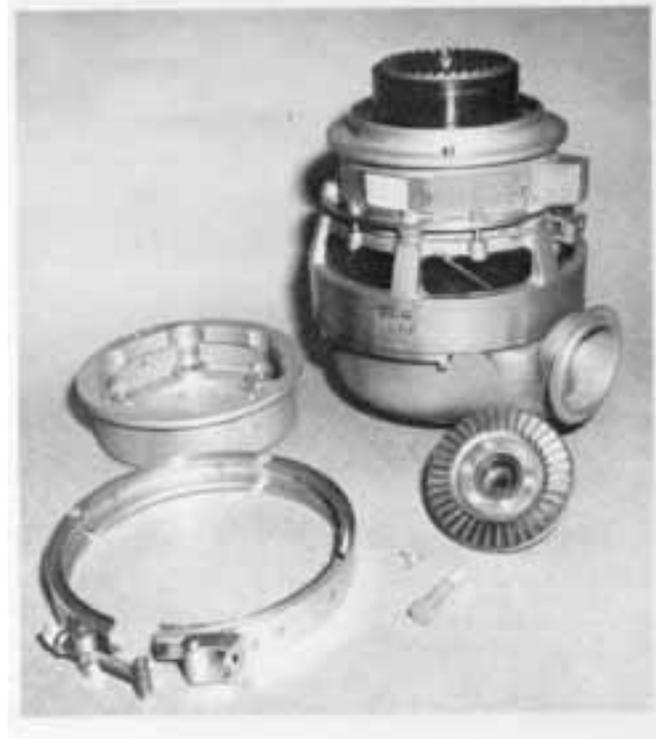
Bendix starter with engine jaw coupling and mounting hardware.

It is worth noting here that the engine jaw drive coupling, together with its attachment hardware, must ordinarily be replaced each time a starter is changed on an engine. An exception is allowed if the engine jaw coupling is to be used again with the same starter and starter jaw coupling. Always use a new locking tab washer under the attachment bolt, but before reinstalling a used engine jaw coupling, inspect it carefully for cracks, broken teeth, or other damage, and measure the jaw for wear (see diagram, page 7). Couplings measuring less than 0.255 inch are to be scrapped.

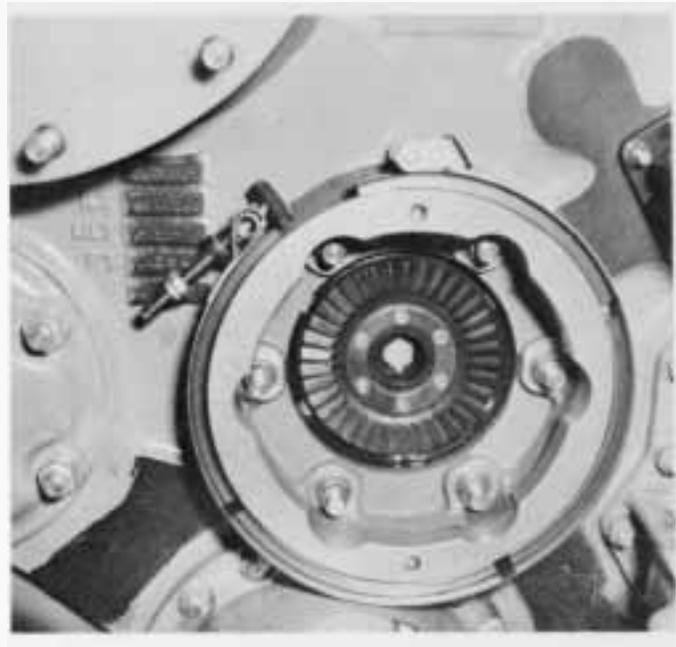
Engine jaw coupling, installed.

A particularly troublesome point has been failure to properly secure the bolt which attaches the engine jaw drive coupling to the gearbox shaft. During installation, the lock tab of the tab washer must be set into the hole on the engine drive coupling. Bend the other two tabs slightly so that a tool can be inserted to bend the tabs up to the locking position after the bolt has been tightened down.

The bolt should be torqued to between 70 and 7.5 inch-pounds. Be careful to stay within these values while

securing the bolt. Too little torque may allow the bolt to loosen, and too much could rotate the washer and pull the lock tab out of the hole in the engine drive coupling or cause the washer to fracture, which would ultimately produce the same result.

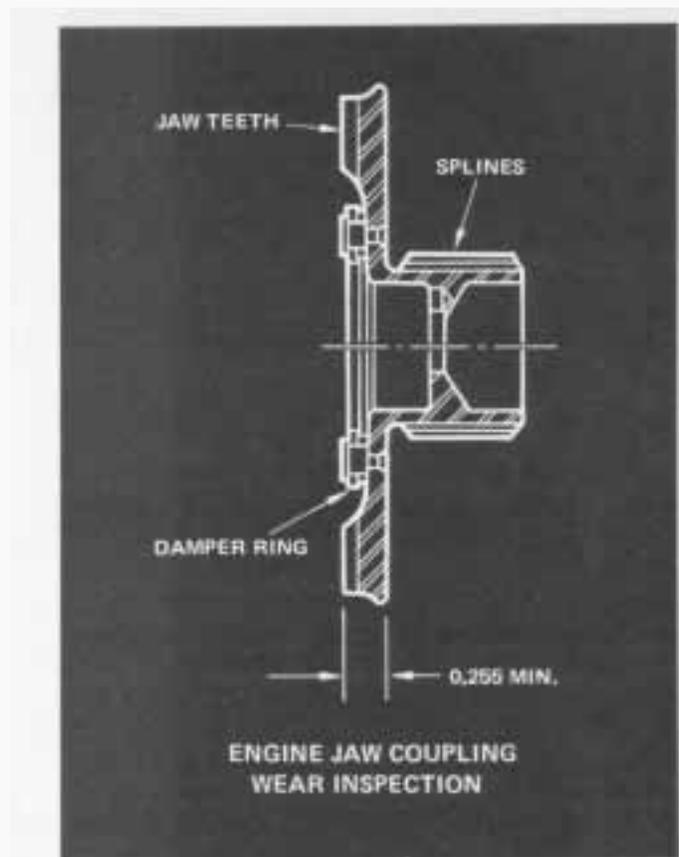
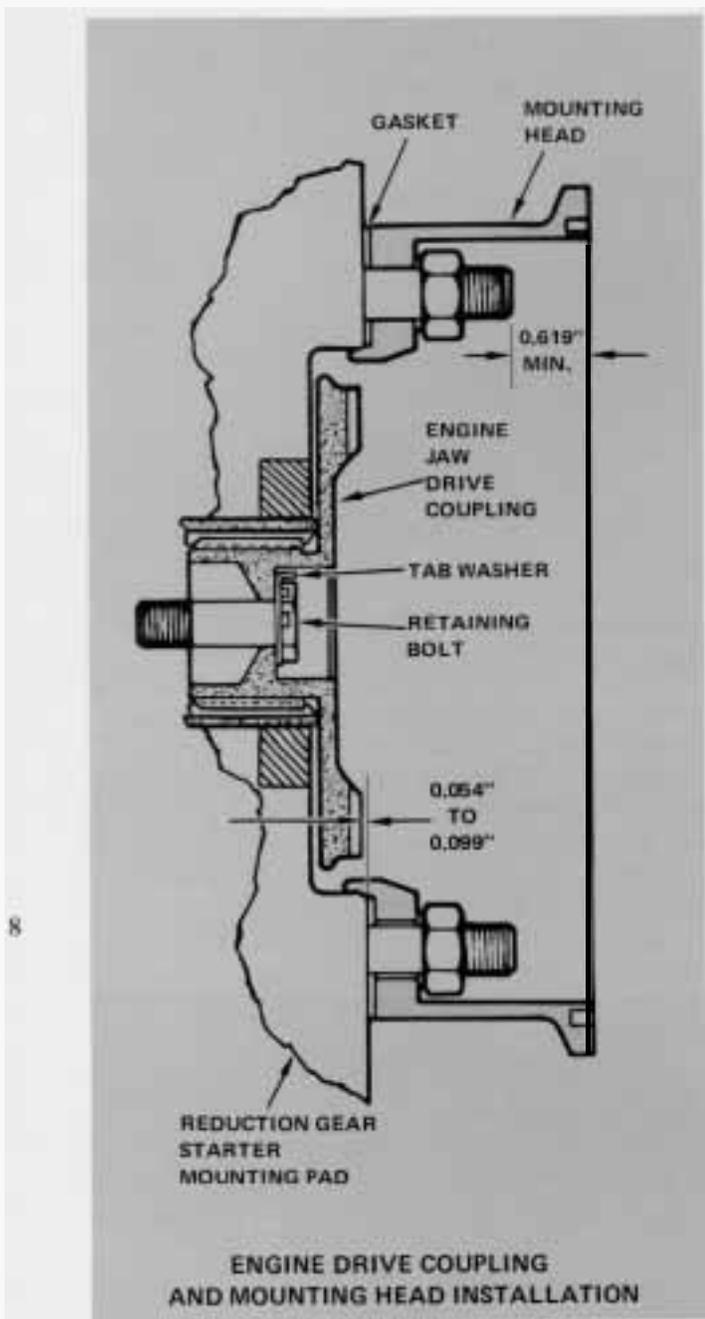
lock washer so that they are positioned securely against the flats of the bolt head.

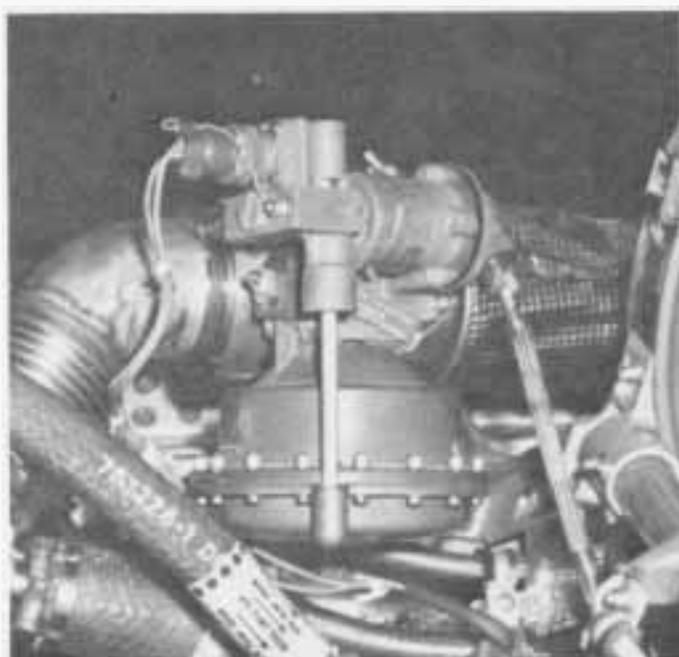
Starter (air) control valve with pressure sensing line.

Not all engagement problems originate in the starter or in starter mounting procedures. Sometimes faulty starter control valve operation will impose stresses on the starter which set the stage for failures that really should not be blamed on the starter at all.

One other potential cause of abnormal starter jaw wear which should be considered is leakage from the pressure sensing line that connects the starter scroll with the starter control valve. The main function of this line is to supply a reference pressure from the starter turbine to the regulator of the control valve. The control valve adjusts the air flow delivered to the starter turbine in response to the pressure applied at the regulator through this line.

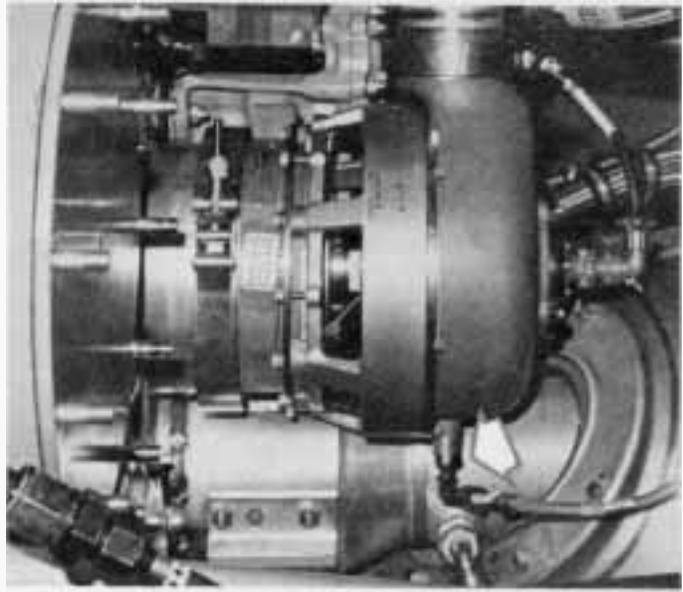
Operating pressure can be checked at port on starter scroll.

Bendix suggests that operators tee in a direct reading gage and measure the starter control valve pressure at the “B” check (200 hours of aircraft time), especially if starter problems have been experienced. The tee should be installed at the pressure sensing line port of the starter scroll so that accurate readings of actual starter operating pressures may be obtained.

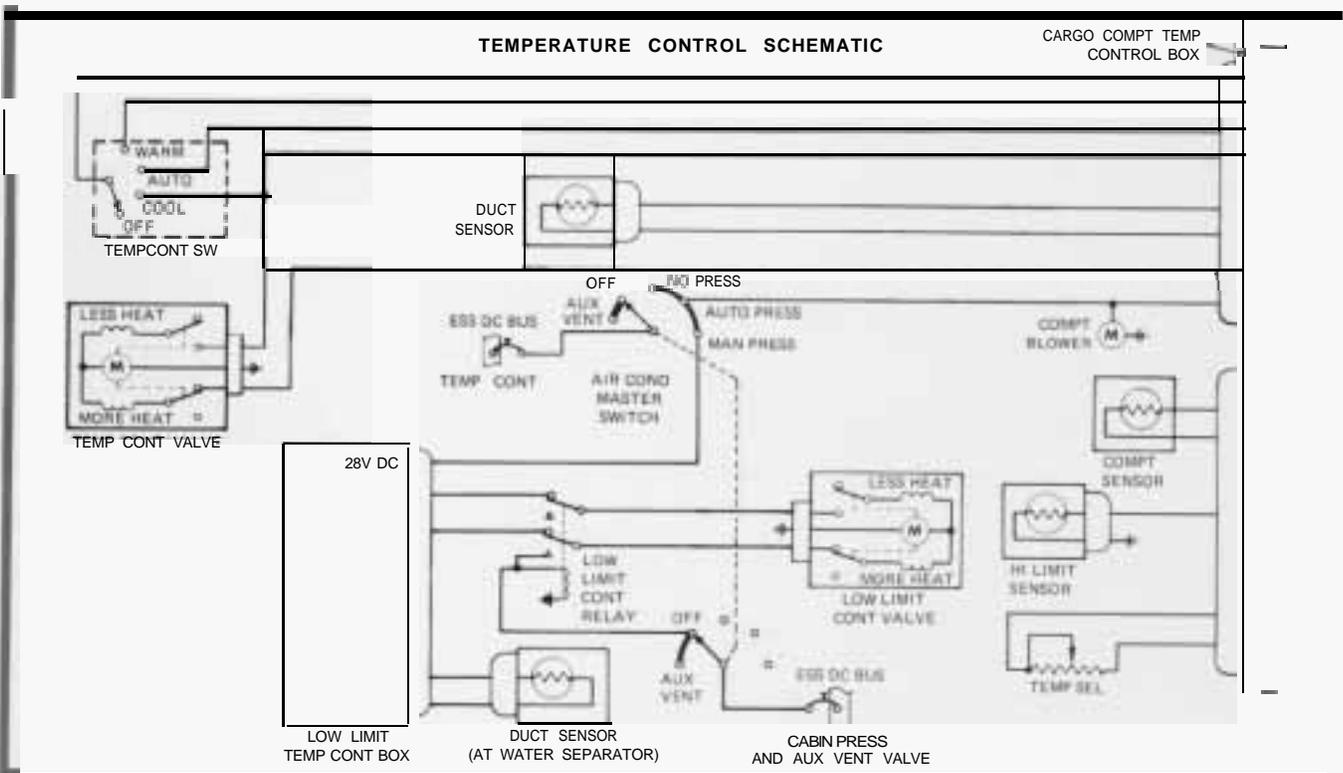
A simplified schematic of the wiring for the temperature control components is provided for reference. All switches and valves are shown in the OFF position. You will have to interpolate and visualize the various switch and valve positions as you proceed through the troubleshooting steps.
