SERVICE NEWS

INTEGRAL FUEL TANKS

Vol. 9, No. 4, October-December 1982

3 Maintenance of Integral Fuel Tanks

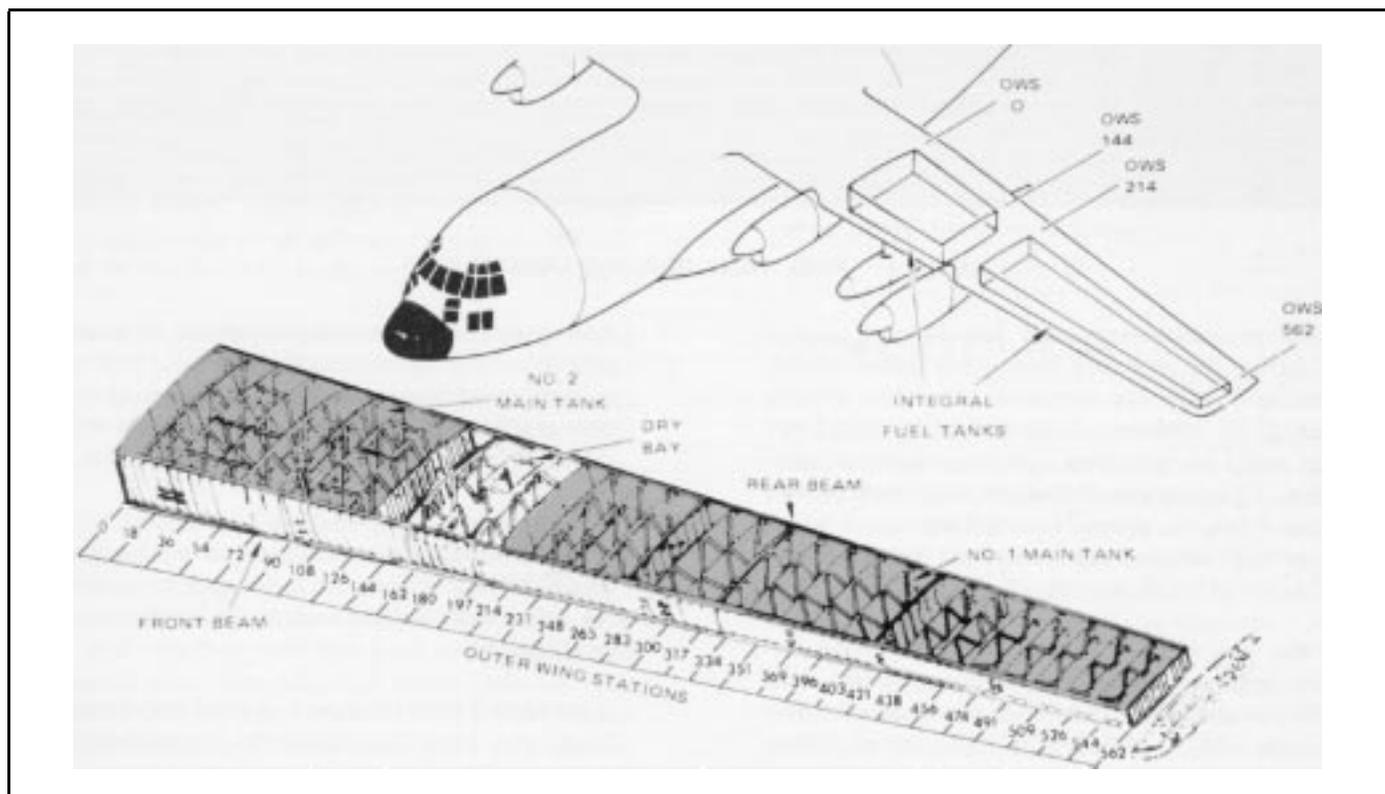
Figure 1. integral fuel tank locations – left wing.

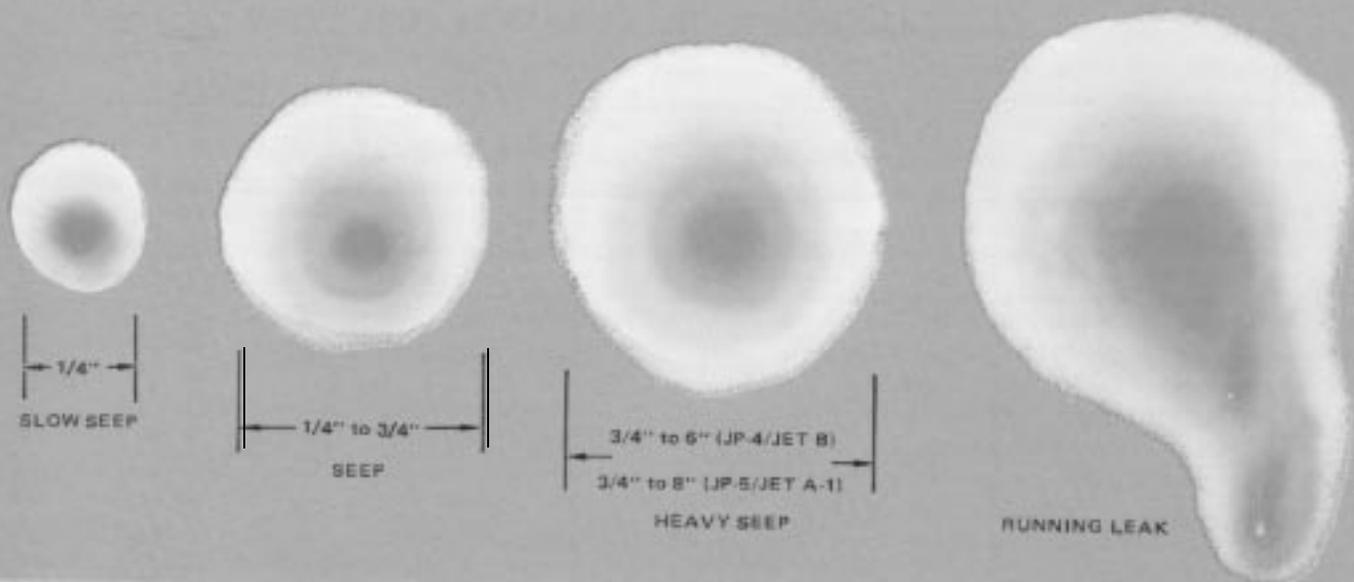
Figure 2. Classification of leaks by size of wetted area

Fuel tank leaks are classified as belonging in one of four categories, depending on the size of the wetted area around the leak. They are, in order of increasing severity, slow seep, seep, heavy seep, and running leak. Both the type of leak and its location have a bearing on whether immediate remedial action is required or repair can be delayed until a convenient opportunity presents itself.

The wet area around a leak is a fairly reliable measure of its severity. To evaluate the size of this area accurately, dry the area around the leak exit point with a clean, absorbent cloth and then apply red-dyed talcum powder (Semco PR-491 or the equivalent). After waiting 6 minutes, examine the affected area again and evaluate the leak according to the following criteria (see also Figure 2 and Table 2). These guidelines reflect updated information scheduled for publication in a forthcoming revision of T.O. 1-1-3, Inspection and Repair of Aircraft Integral Tanks and Fuel Cells.

A slow seep is a leak where fuel does not reappear immediately after being wiped away, and does not wet an area more than 1/4 inch wide in a 6-minute period when it does reappear. This applies to all approved Hercules aircraft fuels.

A ‘heavy seep’ is a leak where fuel reappears immediately after being wiped away and continues to spread slowly. JP-4 or Jet B leaking from a heavy seep does not wet an area greater than 6 inches in diameter in 6 minutes and does not run, flow, or drip. JP-5, JP-8, Jet A, or Jet A-1 leaking from a heavy seep does not wet an area greater than 8 inches in diameter in 6 minutes and does not run or flow. These fuels may, however, drip up to 4 drops per minute from a heavy seep.

A running leak is a leak in which fuel wets an area greater than that specified for a heavy seep or, as the name implies, runs, flows, or drips from the aircraft structure. Any leak where JP-4 or Jet B drips from the structure is regarded as a running leak. When kerosene-type fuels like JP-5, JP-8, Jet A, or Jet A-1 drip more than 4 drops per minute, the leak must also be placed in this category.

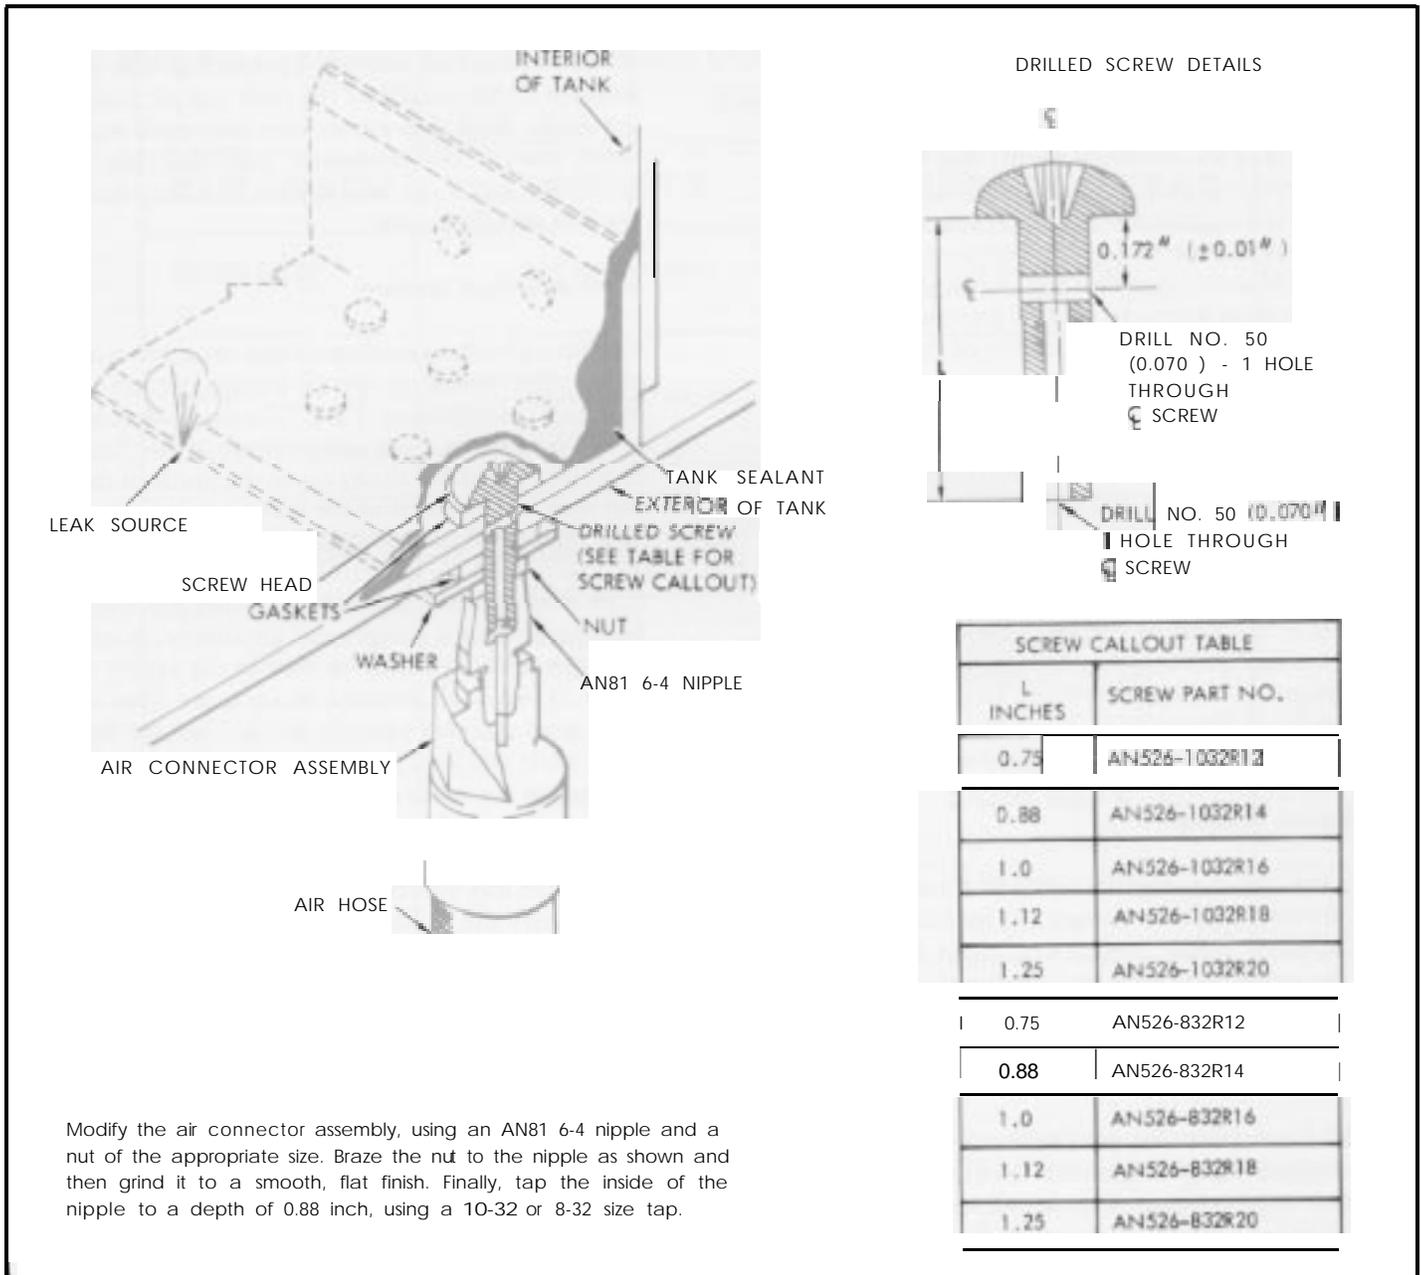
Figure 3. Drilled-screw leak detection method: fabrication details.

The drilled-screw method of leak detection uses a modified screw through which air or isopropyl alcohol can be injected. An AN526-series screw of the appropriate diameter and length is modified as shown in Figure 3. After the screw has been prepared, the rivet or bolt thought to be the leak exit point is removed. Then the drilled screw, gaskets, washer, and nut are installed as shown in Figure 3. Leak detector fluid is then applied to the suspected leak source area inside the tank. First try to determine the leak source, using air. Blow air through the drilled screw at a maximum pressure of 10 psi and watch for bubbles in the leak detector fluid inside the tank. If the use of air doesn't reveal the leak source, wash off the leak detector fluid and inject isopropyl alcohol through the drilled screw, utilizing the same equipment used for the fluid blowback method. Alcohol should appear at the leak source inside the tank. Remove all traces of alcohol after determining the leak source and before repairing the leak. If this method fails to find the leak source, the vacuum and dye method should be tried next.

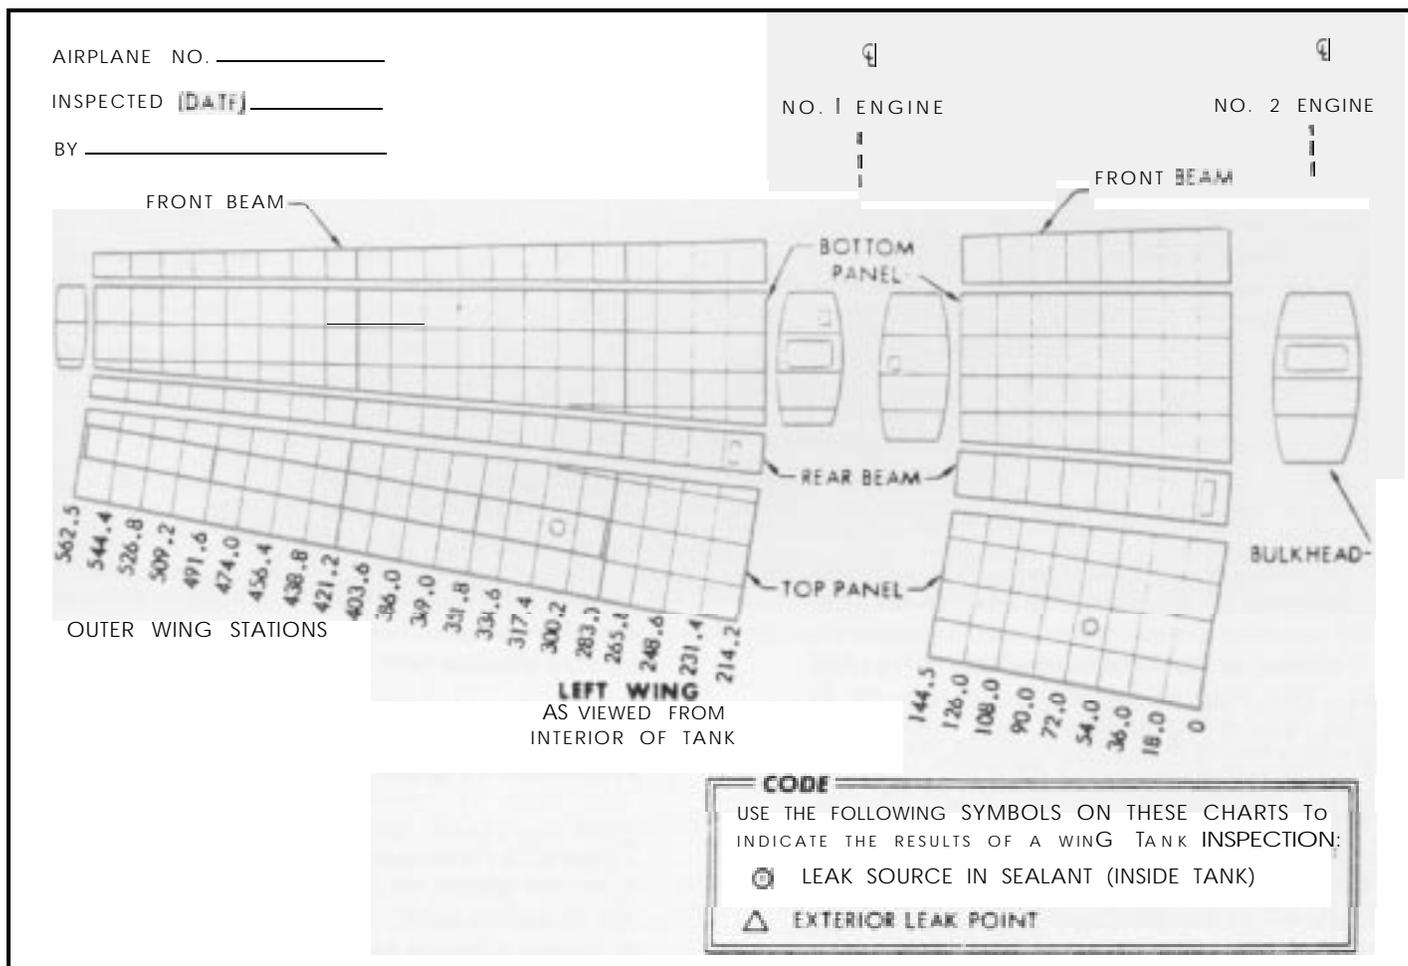
Figure 4a. Integral fuel tank inspection chart - left wing.

If one of the leak detection methods we discussed earlier has been used to determine the leak source inside the tank, a permanent repair should be made because the tank has already been drained and purged. If, on the other hand, time has not been taken to determine the leak source, a temporary repair can be made at the leak exit point. Temporary repairs can be justified when it is necessary to perform an urgent mission, or when the type of fuel leak, as described in the leak classification section of this article, is not bad enough to warrant grounding the airplane. Nevertheless, temporary repairs should always be replaced with a permanent repair when the airplane is grounded for other maintenance that requires entry into that tank, or during a scheduled maintenance period. Temporary repairs should be recorded on the airplane maintenance forms and referred to when performing fuel system repairs. Entries in the maintenance records should specify the location of the leak, the type of leak, and the repair method used. Charts such as the ones shown in Figures 4a and 4b can be very useful in keeping a history of fuel tank leaks and should be kept with the maintenance forms.

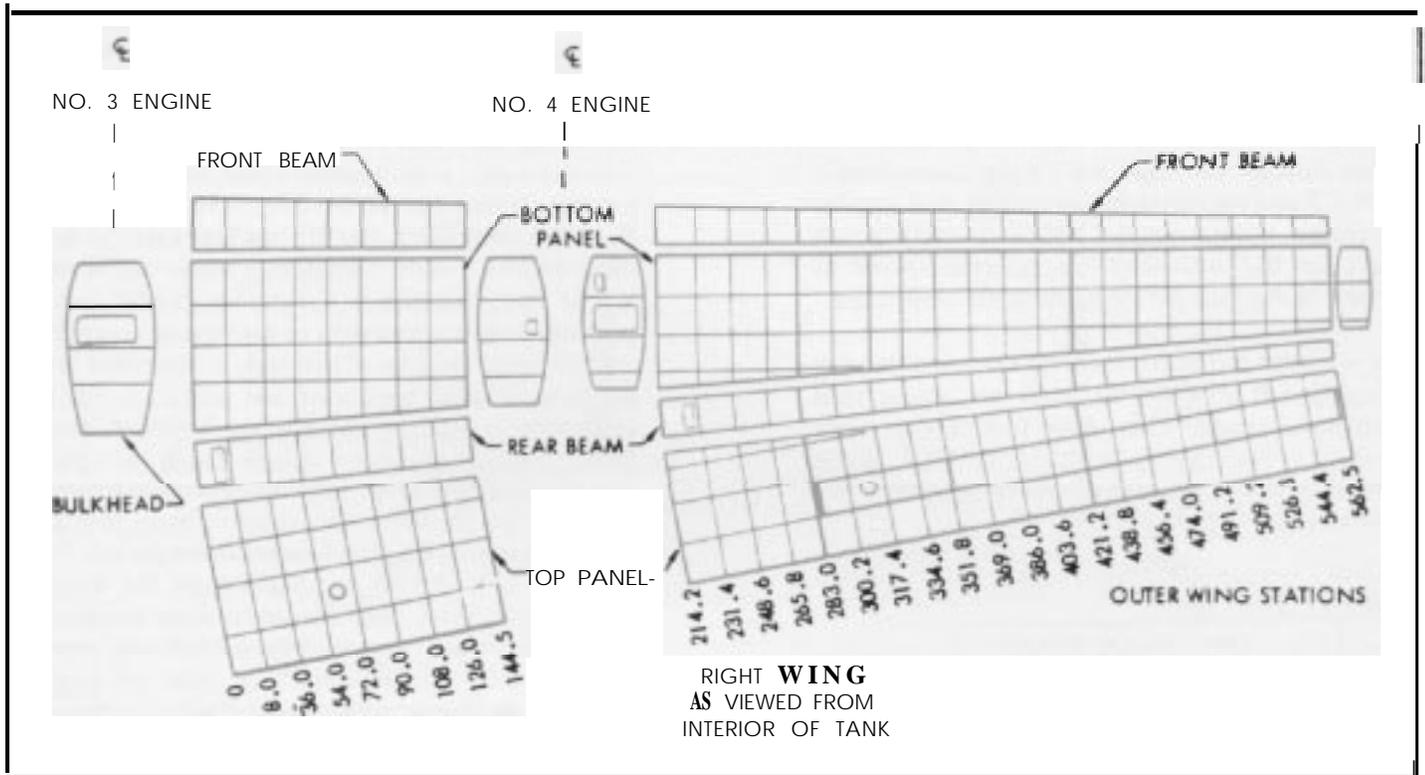
Figure 4b. Integral fuel tank inspection chart — right wing.

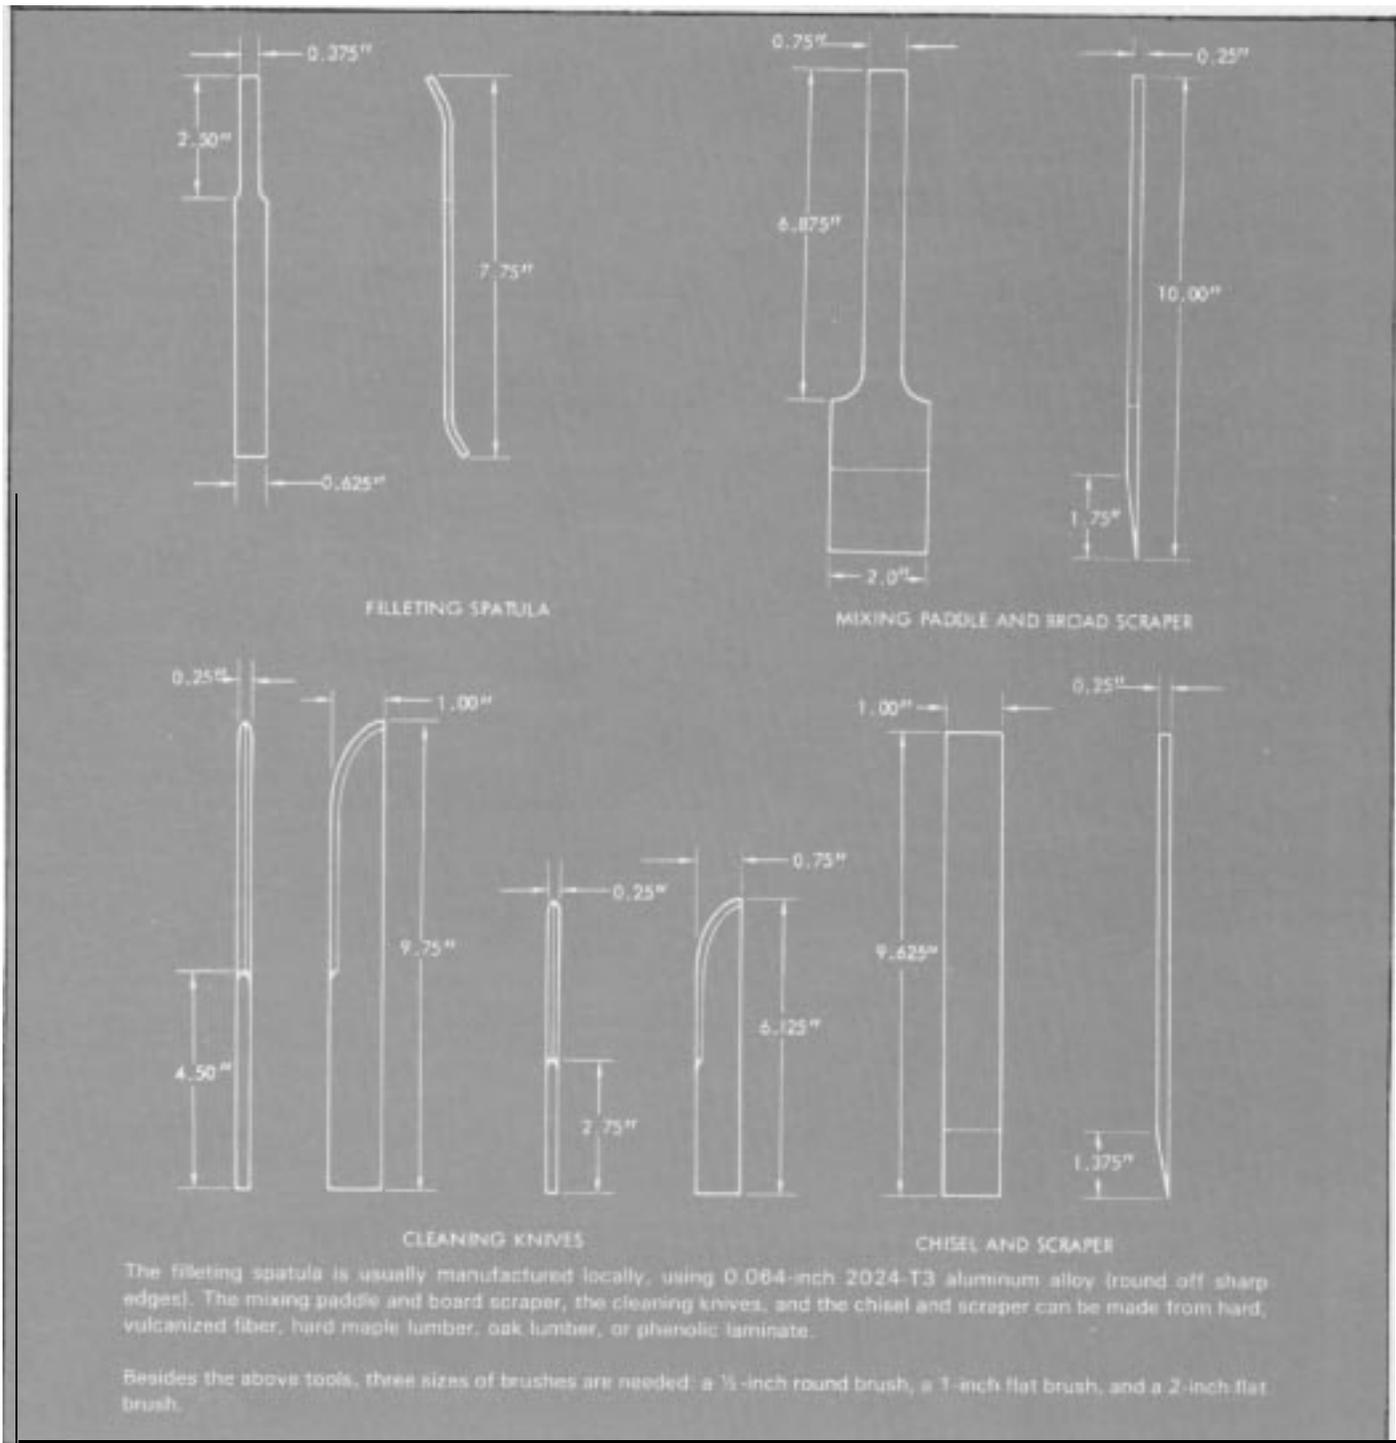
Figure 5. Hand tools for tank sealing.

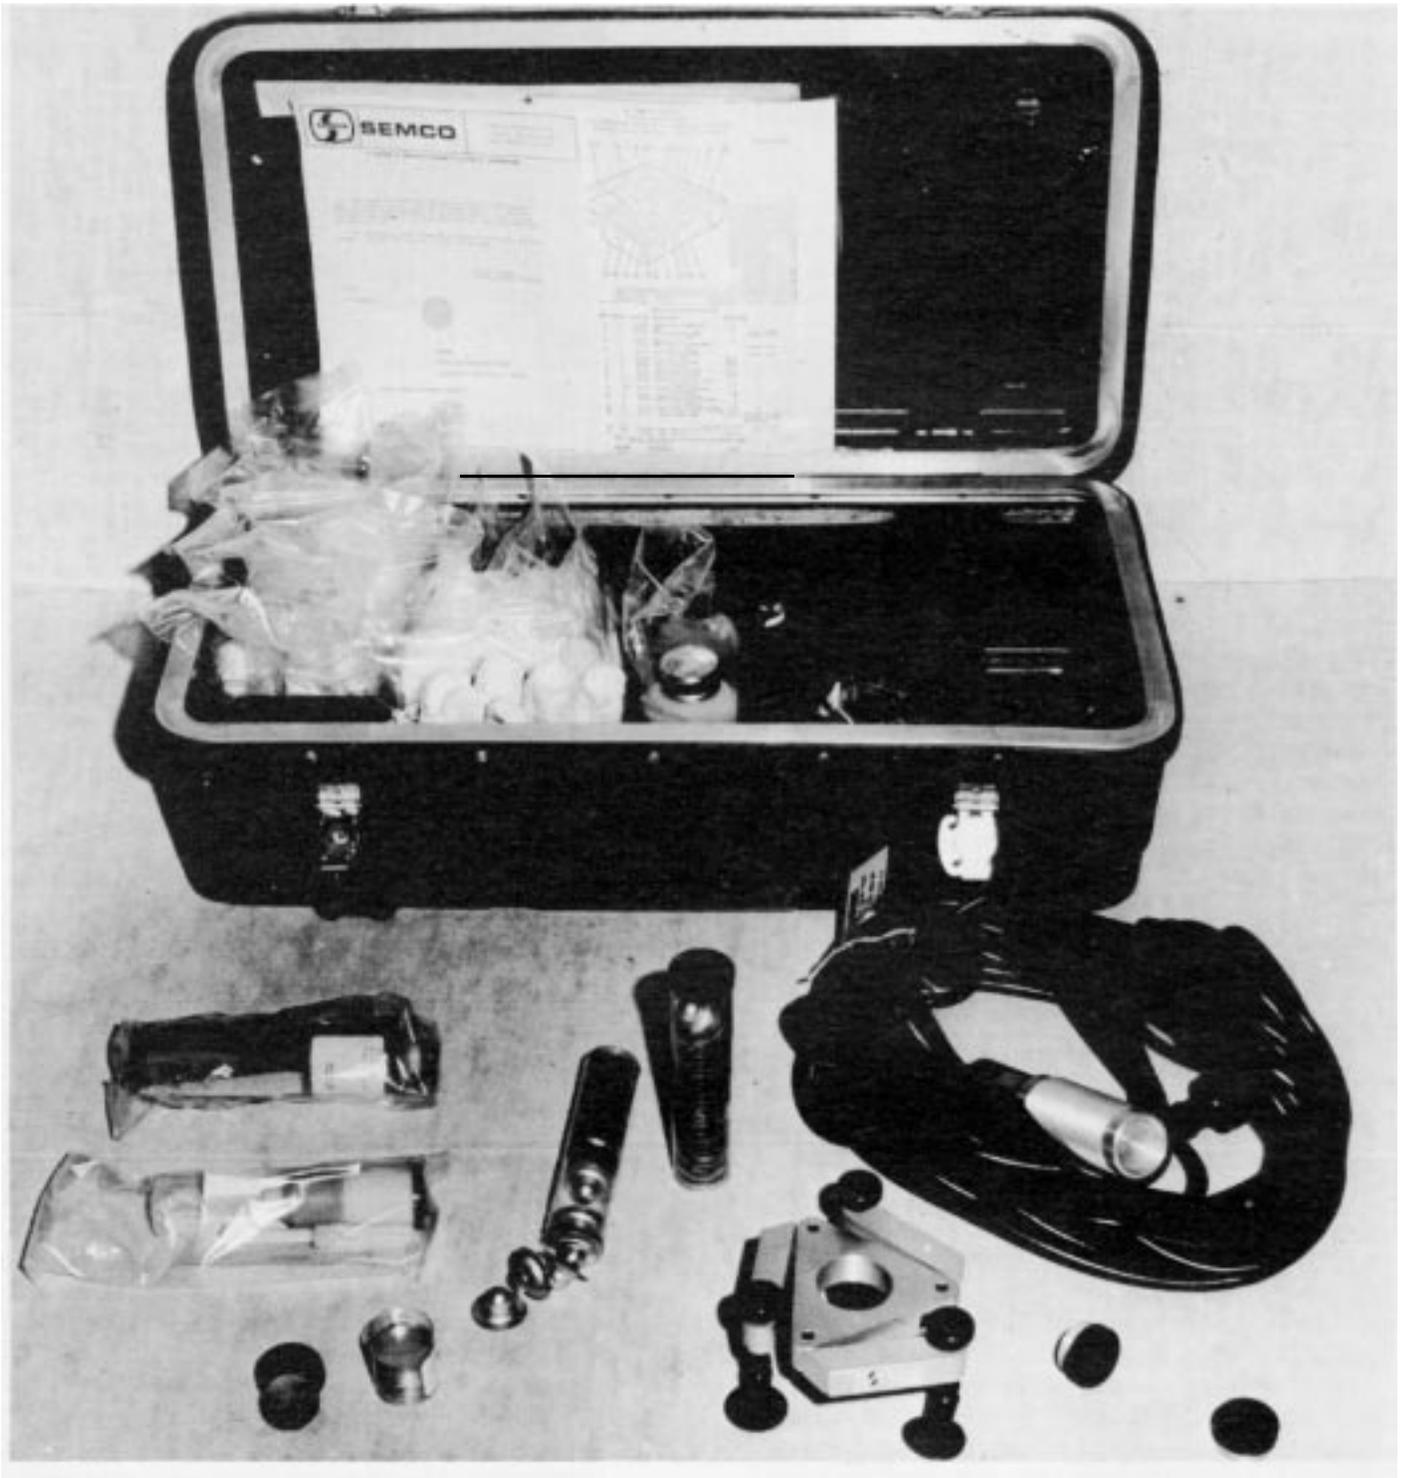
Figure 6. Semco Model 400A-1 Field Repair Kit.

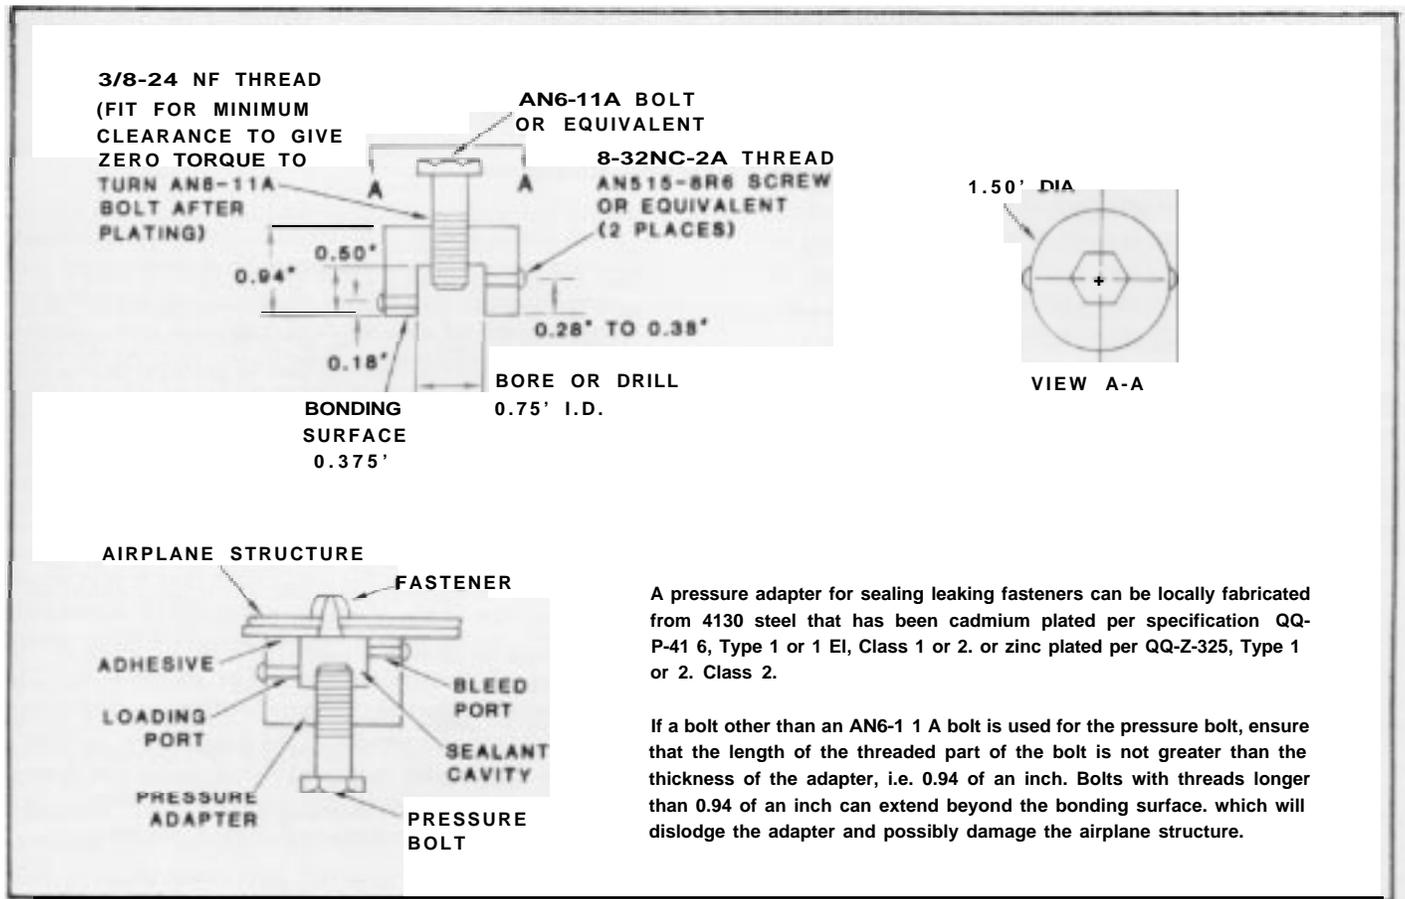
Figure 7. Pressure adapter: fabrication details.

adapter. The rigid adapter installation and controlled application of pressure (by use of a torque wrench) reduces the possibility of structural damage and increases the probability of a positive seal.

To use this procedure, start by cleaning the bonding surface of the adapter with MEK and, if necessary, emery cloth. Then strip the paint around the leak area and also clean it with MEK to ensure that the adhesive will bond properly. After determining where the

adapter is to be positioned on the wing, apply specification MIL-A-46050 adhesive (Eastman 910 or Loctite Super Bonder #430) to the bonding surfaces of the wing and adapter. Now press the adapter over the leaky fastener and hold for 10 seconds. Release the adapter and allow it to remain undisturbed for 15 minutes. After 15 minutes, remove the pressure adapter loading port screw and back out the bleed port screw until one further turn will remove it from the adapter. Remove the pressure bolt to drain any fuel and then reinstall it, turning it in about 12 turns. Inject MIL-S-8802 Class A sealant into the loading port until sealant appears at the bleed port. Now tighten both the loading screw and the bleed screw and apply 5 inch-pounds of torque to the pressure bolt for 5 minutes. After this time has elapsed, remove the adapter by tapping it with a hammer and clean any excess sealant from the wing surface. Apply aluminum tape to the repair area and force-cure the sealant by heating the area for 15 minutes at 150°F (65.6°C). After 15 minutes, remove the tape and inspect to ensure that the leak is sealed.

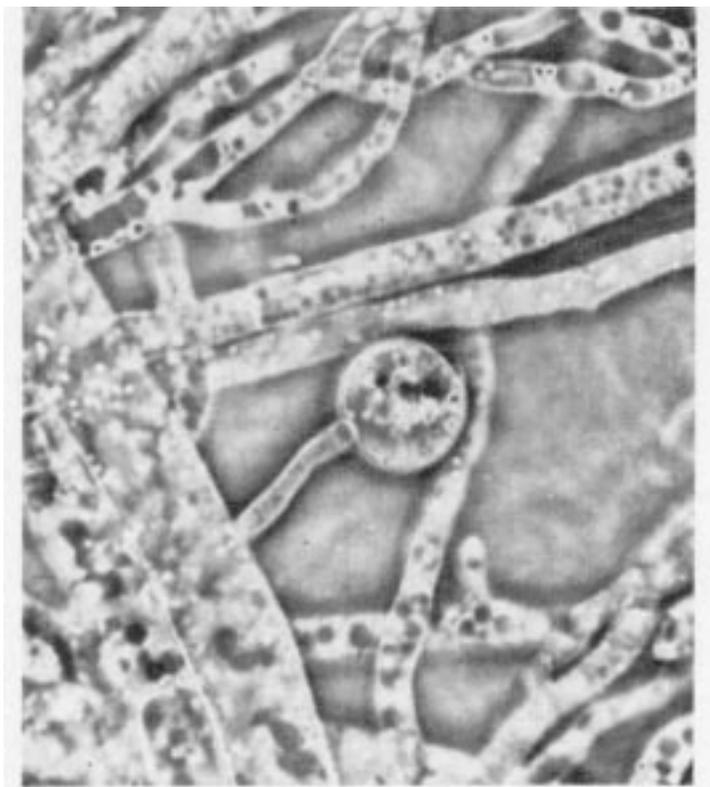
A photomicrograph of microbial growth taken from a contaminated fuel tank.

We indicated earlier that fuel tank corrosion caused by microbial contamination is not quite as much of a problem today as it has been in the past. This perhaps slightly optimistic statement reflects the combined effects of progress made in the area of quality control by fuel suppliers, the improved fuel storage and handling practices now employed by operators, the widespread use of biocidal anti-icing additives, and such improvements as fuel tank water removal systems and better protective coatings and finishes.
