# SERVICE NEWS

VOL. 11, NO. 1, JANUARY-MARCH 1984

# Checking and Adjusting B-1235 Hartman Contactors

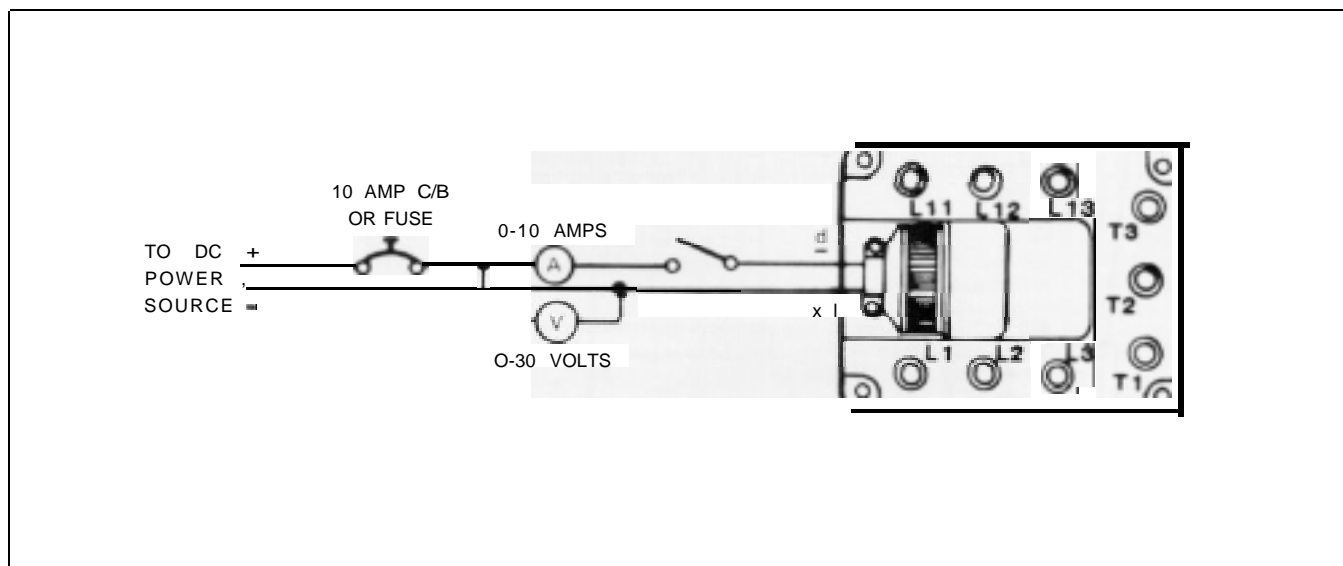
Figure 12. Test harness schematic (for local manufacture).

To check a contactor economizing switch, whether the contactor is installed on an airplane or in the shop on a workbench, simply connect the test harness to the contactor and a source of 28 VDC. Ensure that the test harness switch is open before making the connections. Once the test harness is connected to the contactor and the power source, close the test harness switch and read the ammeter. If it reads from 0.3 to 0.6 amp, the economizing switch is working normally. If the ammeter reads around 7 amps, the economizing switch should be adjusted in the shop, using the following procedure. If the ammeter reads 10 amps or greater, the contactor coils

To adjust an economizing switch, several things are needed: a suitable workbench with a 15 to 20 amp variable voltage 28 VDC maximum regulated power supply available, eight locally manufactured shims, and a test harness. The shims are to be manufactured in accordance with the specifications shown in Figure 13. Four of the shims are to be made from 0.008-inch stainless steel shim stock and four are to be made from 0.010-inch stainless steel shim stock. The test harness can be the same one that was used to test the economizing switch adjustment when the contactor was still installed on the airplane (Figure 12).

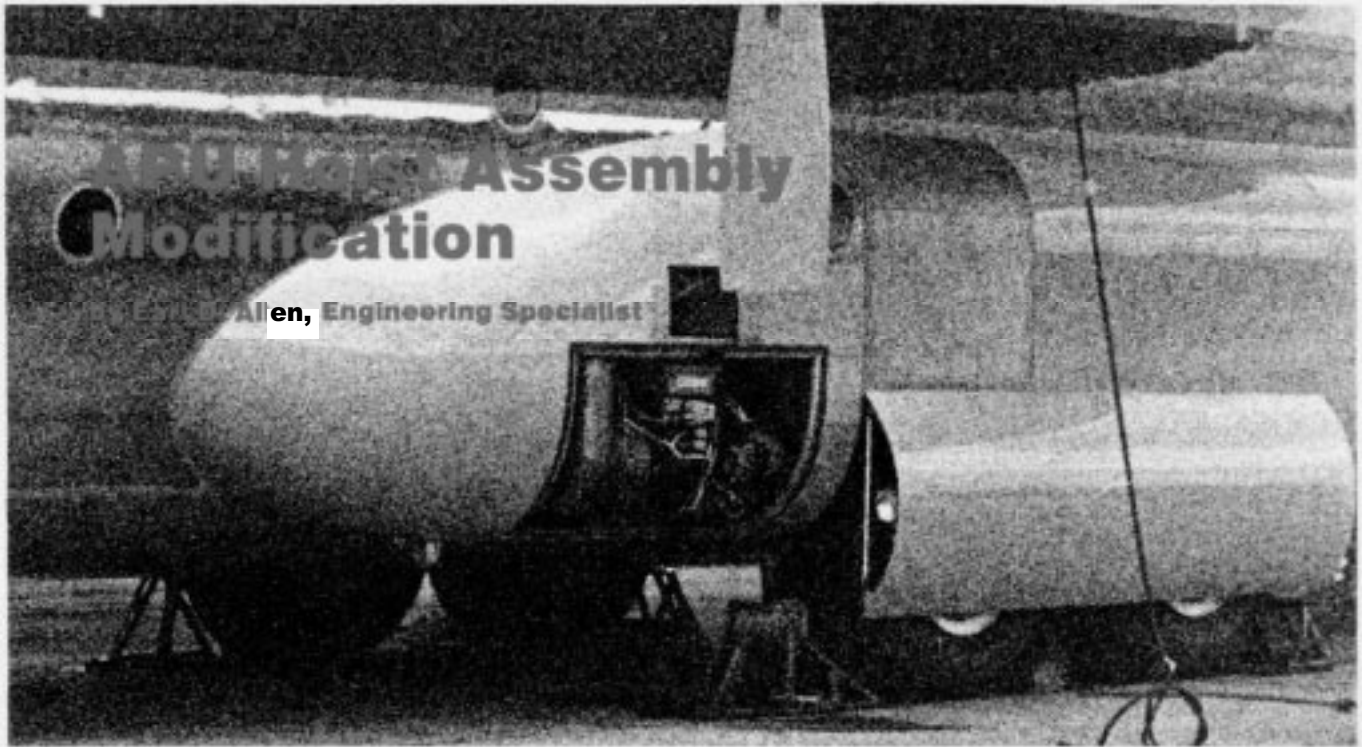
Figure 1. Unmodified P/N 3402246-1 hoist assembly.

The P/N 34022461 auxiliary power unit (APU) hoist assembly is used to remove and install the AiResearch Model GTCP 85-180L APU on Hercules aircraft LAC 4580 and up (Figure 1). It has come to our attention that occasionally the hoist assembly has been damaged during removal of an APU because an overzealous maintenance technician has attempted to raise the hoist with the APU still bolted to the aircraft. With the APU still attached to the aircraft, enough force can be applied to the pulley pin to bend it. With the pulley pin bent,

the hoist cable can slip off the pulley during a hoisting operation.

We would like to emphasize that if proper procedures are followed when using the APU hoist assembly, no problem should be experienced even without the brace assembly. However, Lockheed recommends adding the brace assembly; it is a worthwhile safety precaution.
