VOL. 16, NO. 3, JULY-SEPTEMBER 1989

SERVICE NEWS

TEFLON HOSES—AN APPLICATIONS GUIDE

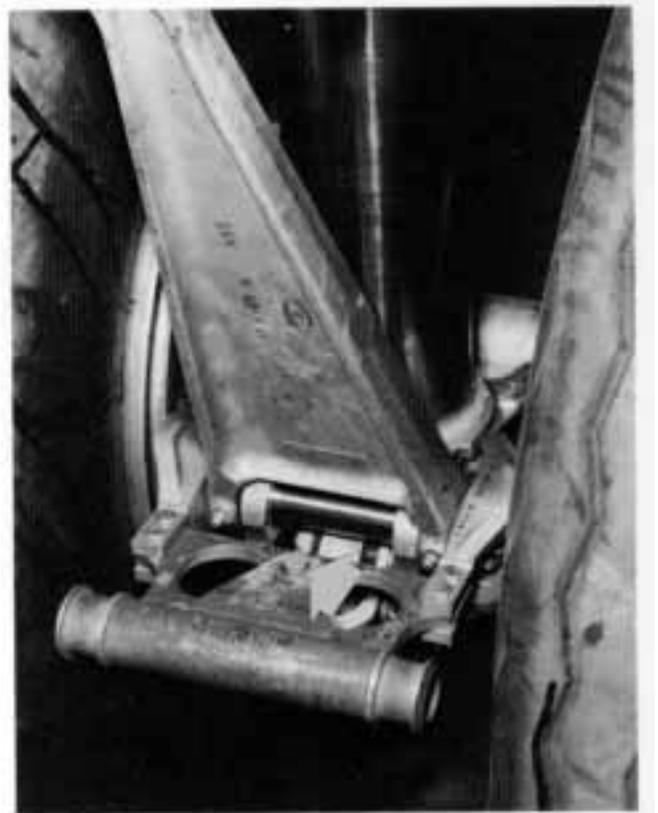
This safety shear bolt is designed to shear only when excessive pulling force is applied.

It should be remembered that the AN6 safety shear bolt installed in the aircraft nose landing gear crossbar and tow fitting (see illustration) is designed to shear only with a pulling force. If the Hercules aircraft is being pushed backward, the nose landing gear tow fitting will bottom out against the crossbar and the crossbar bolt will not shear, leaving only the AN6 bolts in the towbar to provide the safety shear function.

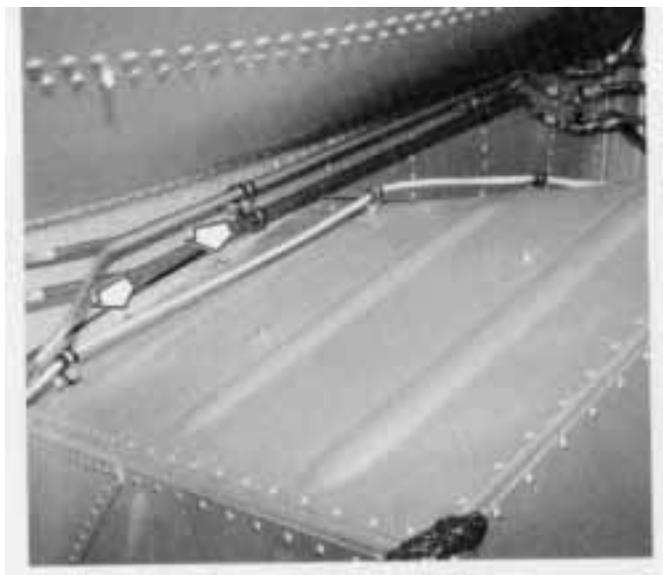
Two of the five rigid fasteners that can be replaced with NAS 1298 shoulders screws and spring washers are visible in this photograph.

Engineering analysis has determined that the problem does not present a safety of flight concern, but a change has been proposed that will eliminate the possibility of unwanted noises from this source in future production aircraft. The change replaces the rigid fasteners at the battery box attaching flange with spring washers and NAS 1298 shoulder screws. The new arrangement will allow a small amount of movement between the components during pressurization without the accompanying sound effects.

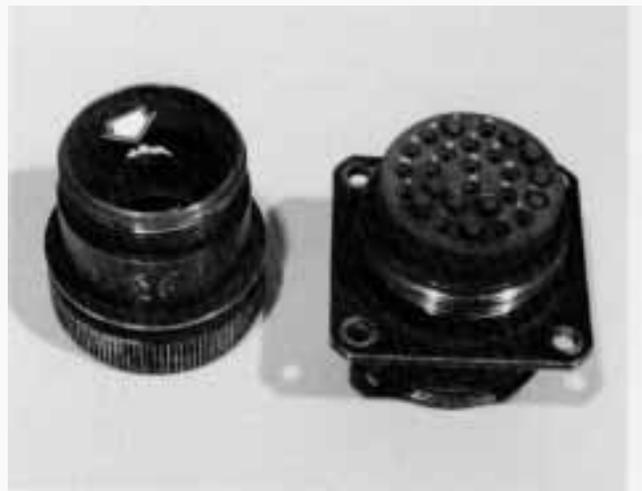
Corrosion has penetrated all the way through the metal structure of this connector body.
