Service News

SPECIAL CORROSION ISSUE

Volume 29, No. 1 2004

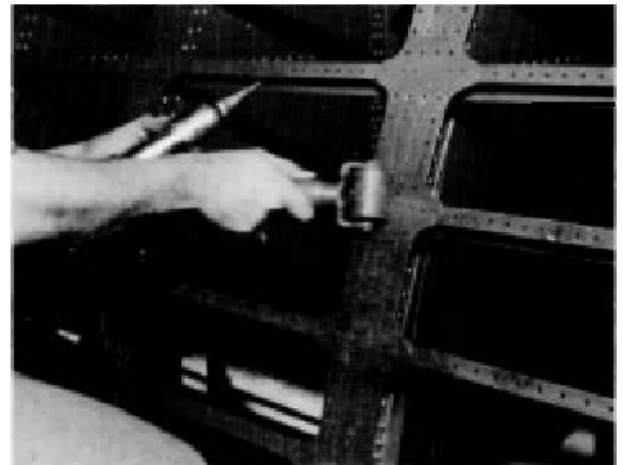
The use of sealants during aircraft manufacture has proved an effective and versatile weapon against corrosion.

Sealant may be the most versatile and effective weapon in preventing aircraft corrosion ever introduced. It is used to exclude moisture and water and to separate joined metals. Exterior joints and gaps are filled with sealants to prevent water and chemicals from entering. In addition to environmental sealing, sealant is also used for wet-installation of fasteners, pressure sealing, and aerodynamic smoothness.
