**RE: Annual Post-Construction Restoration Monitoring Summary Report  
Bloody Brook, Onondaga County, New York  
Voluntary Cleanup Agreement Index #D8-0001-01-09 (VCP Site No. V00501-7)**

Re: *Response to NYSDEC Comments on  
Annual Post-Construction Restoration Monitoring Summary Report  
Bloody Brook, Onondaga County, New York  
Voluntary Cleanup Agreement Index #D7-0001-01-09 (VCP Site No. V00501-7)*

Enclosed please find the *2017 Annual Post-Construction Restoration Monitoring Summary Report* for the Lockheed Martin Corporation Bloody Brook site for your review and approval. This summary report discusses results and recommendations from the May 2017 annual inspection to evaluate the success of the restoration at the Bloody Brook site in accordance with the March 2014 *Decision Document*.

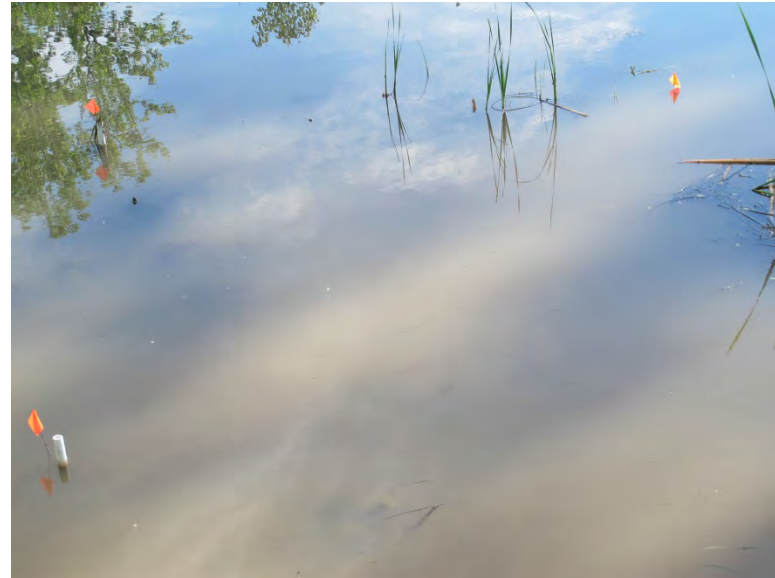
**PEM-2 Plot 3 (May 30, 2017)**

Plot 3 is located in the center of PEM-2 (Figure 3). Under current conditions, the plot is completely inundated with no emergent vegetation. The dominant vegetation that has developed in the area, but not yet within Plot 3, is the broad-leafed cattail.

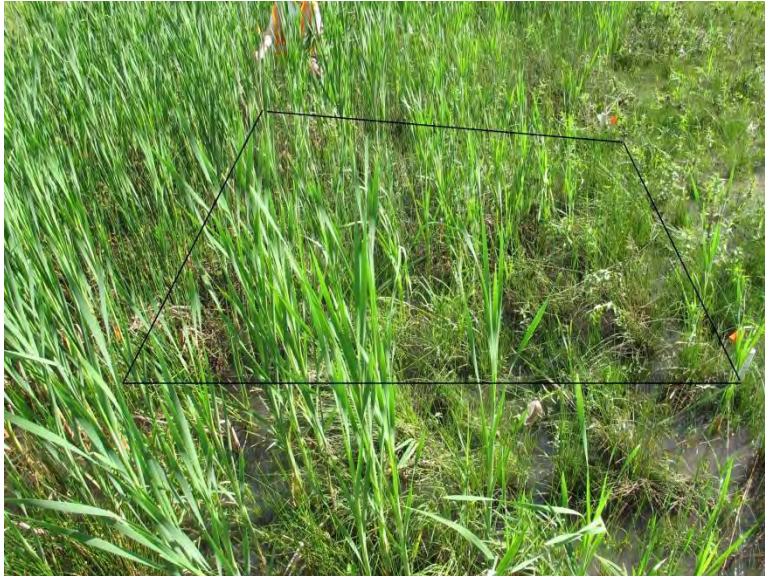
Outline of PEM-1 Plot 1 (May 30, 2017)

Within the saturated area of PEM-1, a healthy stand of cattails with bulrush and other desirable wetland species was evident. Invasive species were not observed within this saturated area. Groundwater seepage into the wetland was noted in the northwest corner of PEM-1.

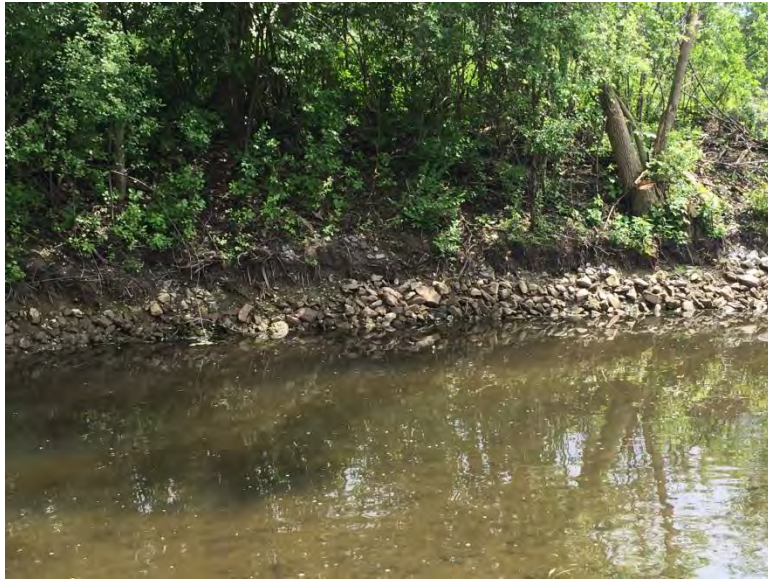
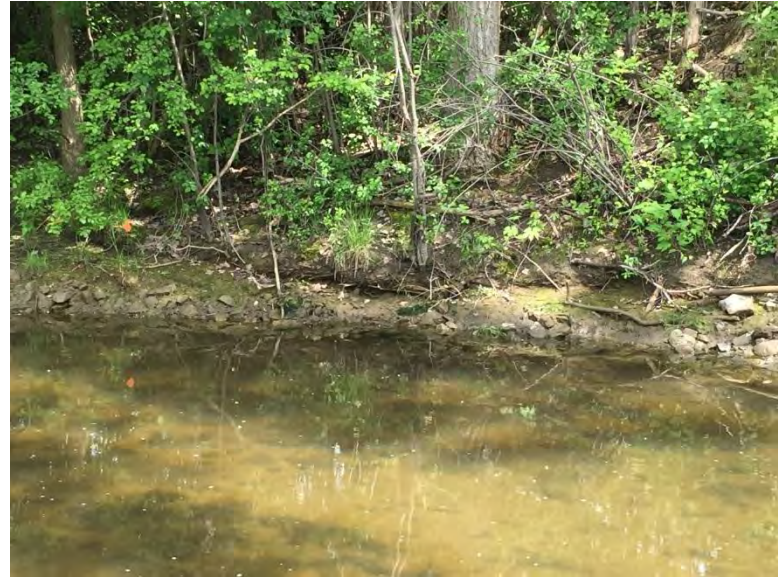
May 2017 Bloody Brook Erosion Inspection Photos  
Location 12\*

- Portion of side bank shows erosion of areas between rip rap and mature vegetation.
- Some areas will require installation of additional rip rap.
