Post-Restoration Vegetation Monitoring Plan

West Branch of Bloody Brook Bloody Brook Voluntary Cleanup Program Onondaga County, New York

February 2017, Revised May 2017

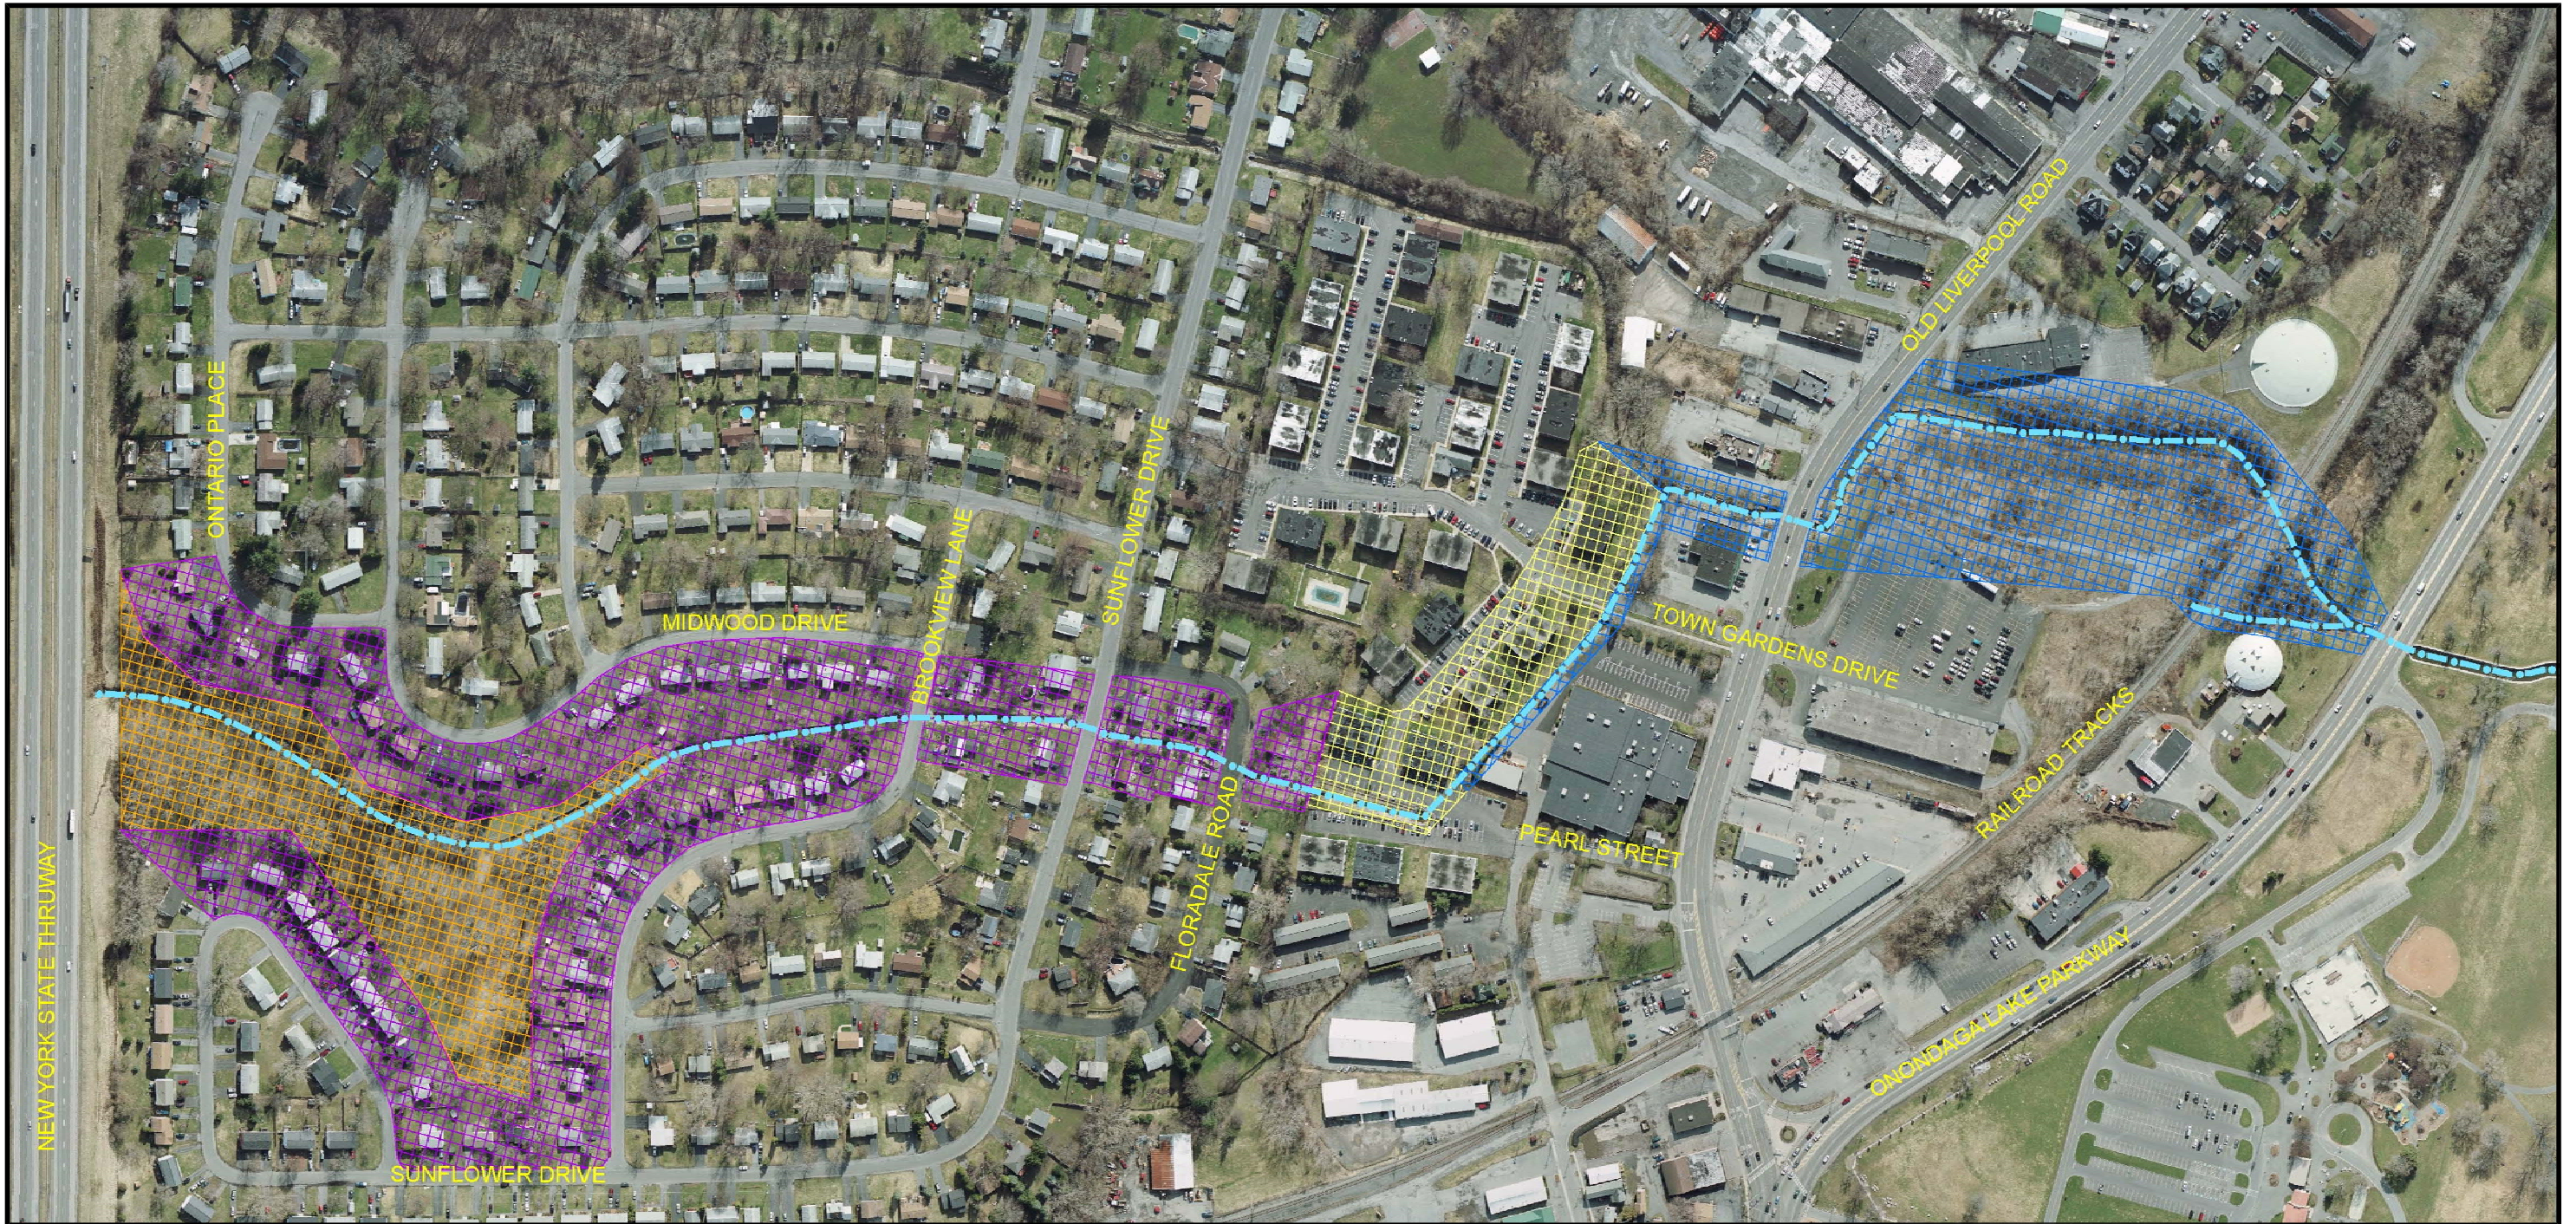
FILE NAME:	DRN	PROJECT NO.	DATE	FIGURE NO.
SiteAreaMap.dwg	--	60194430	03 / 2014	2

The WBBB site was broken into four distinct areas based on land use and characteristics as shown on Figure 2 and described below.

- **Wooded Area** – This portion of the site extends from the Thruway south (downstream) approximately 1,050 feet. This undeveloped area is irregularly shaped and relatively wide (i.e., greater than 150 feet) and includes three wetlands. The wooded area is entirely within the Onondaga County Bloody Brook Drainage District (Drainage District) easement and is owned by the Town of Salina. The Drainage District easement provides Onondaga County personnel permanent access to Bloody Brook for various projects to improve and maintain drainage. Storm water drainage from the surrounding development enters the WBBB from the west via a drainage channel at the southern end of the wooded area.

- **Residential Area** – The residential area surrounds the wooded area commencing at the Thruway and extending downstream of the wooded area with residential properties abutting the Drainage District easement along the WBBB to the downstream side of Floradale Road.

- Apartment Complex Area – The apartment complex area is located on Pearl Street and Town Gardens Drive between the residential properties along Floradale Road and the commercial properties along Old Liverpool Road.
- Commercial Area – The commercial area extends from commercial properties located along Old Liverpool Road to Onondaga Lake Parkway.
