Re: *Section 404 Nationwide Permit Application,  
Haley's Ditch Restoration Project  
North of East Archwood Avenue and south of Triplett Boulevard,  
Akron, Summit County, Ohio 44306*

12. PROJECT NAME OR TITLE (see instructions) Haley's Ditch Remediation	14. PROJECT STREET ADDRESS No associated street address; the project area is located in Akron, Ohio (Appendix A: Map 1) is bordered to the north by East Archwood Avenue and to the south by Triplett Boulevard; South Seiberling Street and Landon Street are located east of the project area (Appendix A: Maps 2 and 3).
13. NAME OF WATERBODY, IF KNOWN (if applicable) Haley's Ditch and adjacent wetland habitat	
15. LOCATION OF PROJECT Summit Ohio COUNTY STATE	
16. OTHER LOCATION DESCRIPTIONS, IF KNOWN (see instructions) Lat: 81° 28' 21.38" Long: 41° 02' 42.51"

Nationwide 404 Permit Application  
Haley's Ditch Restoration

***Haley's Ditch Remediation Area***

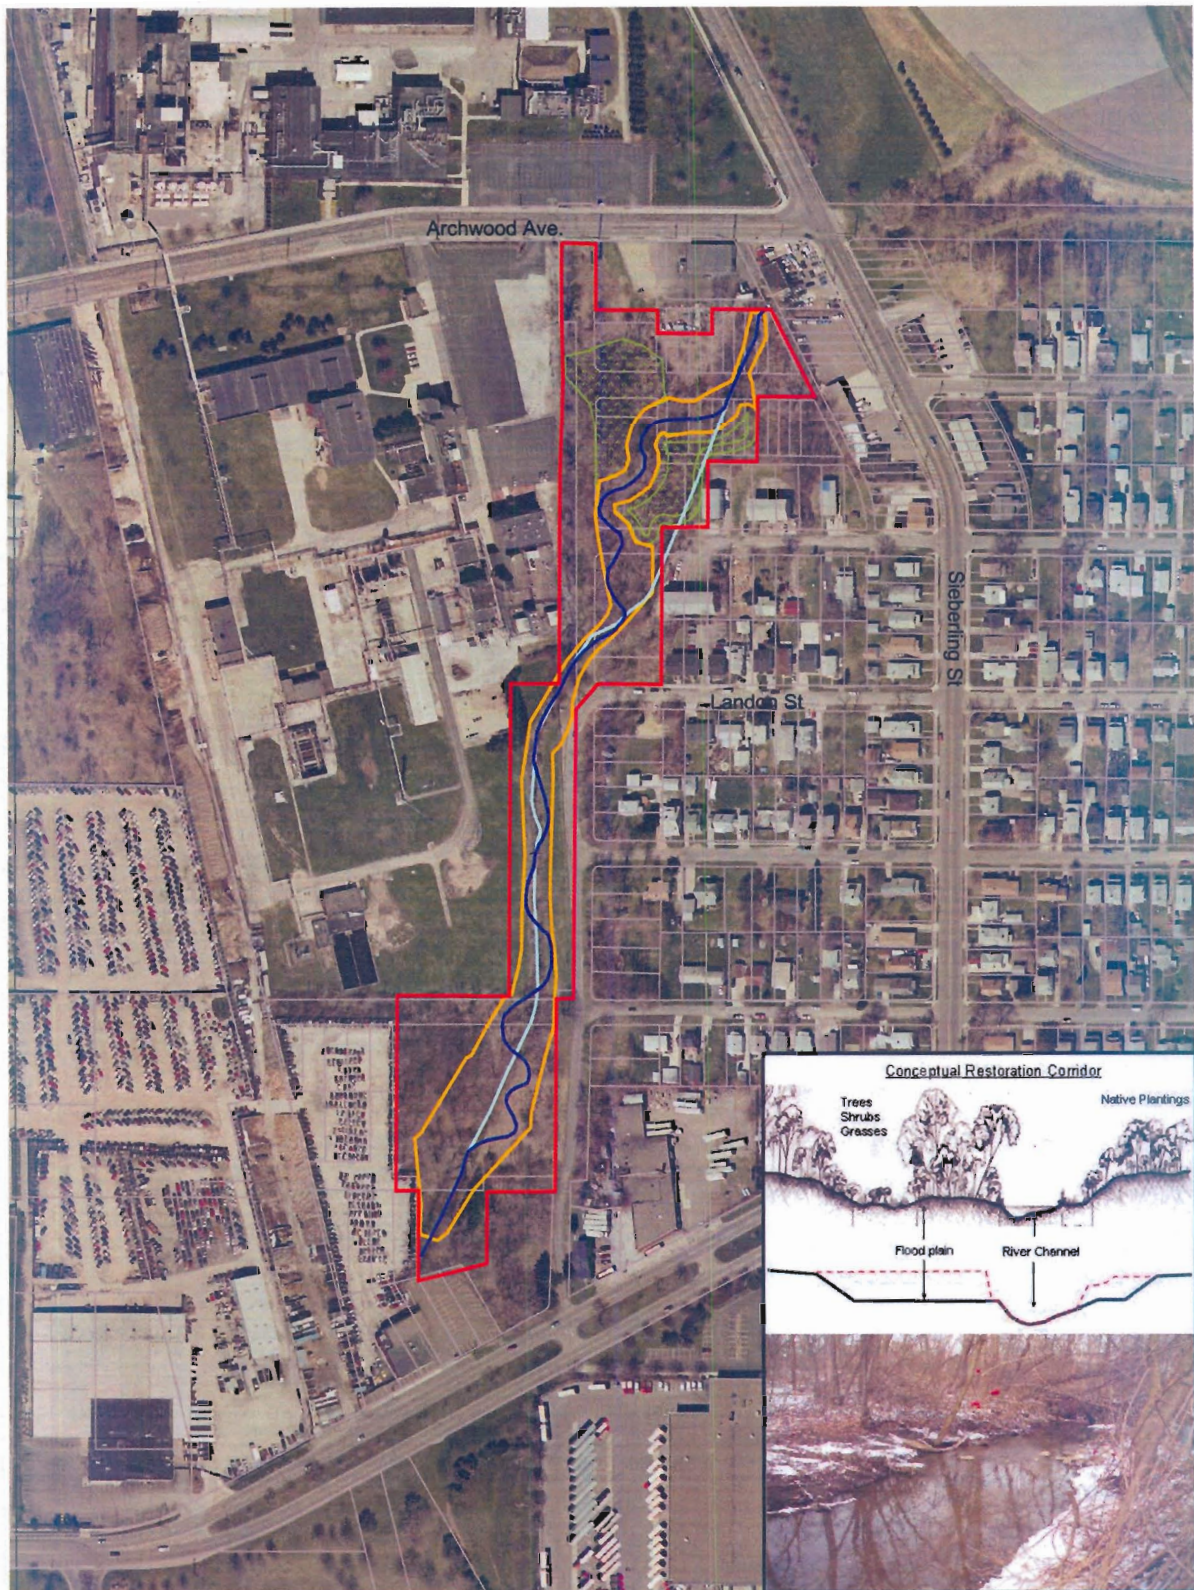
Map 4. Haley's Ditch  
Lockheed Martin Proposed Restoration

- Project Area
- Proposed Wetland or Floodplain expansion
- ~ Proposed alignment
- ~ Proposed floodway- approximate limits of remediation
- ~ Existing Haley's Ditch alignment

In conjunction with the remediation project, the applicant foresees an opportunity to enhance the long-term ecological function of the area instead of simply returning existing conditions and channel alignment. Therefore, a stream restoration project incorporating natural channel design strategies and native plantings is proposed for Haley's Ditch. The channelized ditch will be replaced with a meandering stream that is designed to improve hydraulics and habitat along the remediation corridor. Since the remediation effort is excavating materials beyond the stream channel, there is potential to expand the flood prone area for lower return interval storm events (ie. 1-2 yr storms) thereby improving hydraulics. The proposed restoration plan takes advantage of the remedial excavation to restore a new stream pattern and flood corridor within the work limits (Appendix A: Map 4). However, the exact limits of the flood plain expansion will be determined in final restoration design as this relates to additional cost of excavation, plantings and grading work.

A suitable mixture of natural sand and gravel material that will contain less than 0.5 mg/kg PCBs will be used to create the streambed. Riffle-pool characteristics will be replaced along the profile at appropriate slope and interval spacing determined in final design. The restored floodplain will be backfilled and graded to final elevation using suitable topsoil that will contain less than 0.5 mg/kg PCBs. The restoration plan will aim to establish an early successional community toward a trajectory of forest recovery. Native riparian grasses, sedges and forbs will be seeded through the corridor and floodplain. Woody vegetation will be concentrated near the restored stream banks such as willow and dogwood cuttings for long-term stability. Larger woody species such as sycamore, maple, ironwood etc. will be installed along the stream length as well.

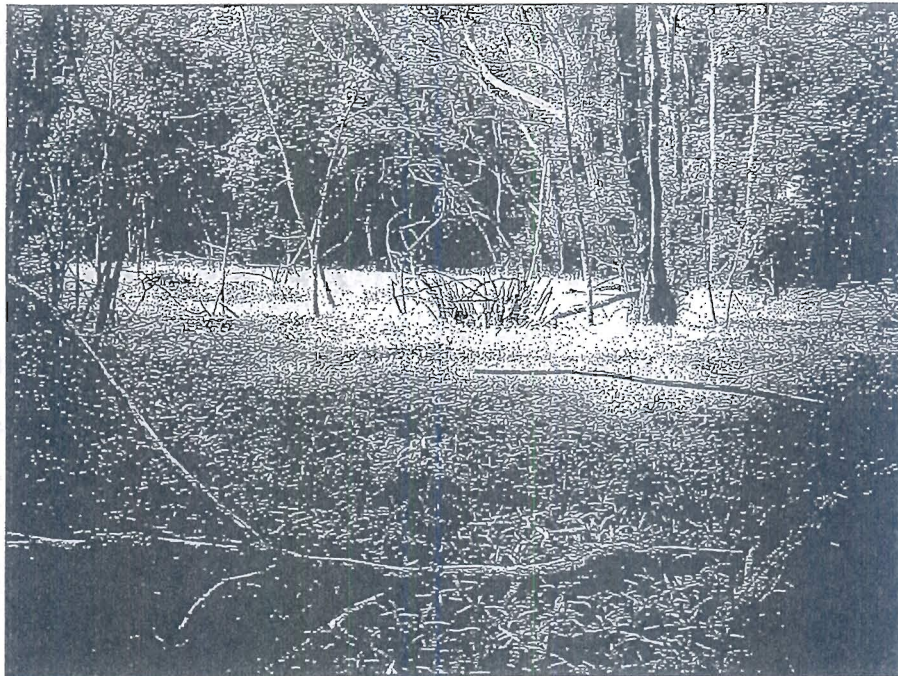
**Photograph 1 (6-25-08)** Wetland A is a lowland woods and wet meadow.

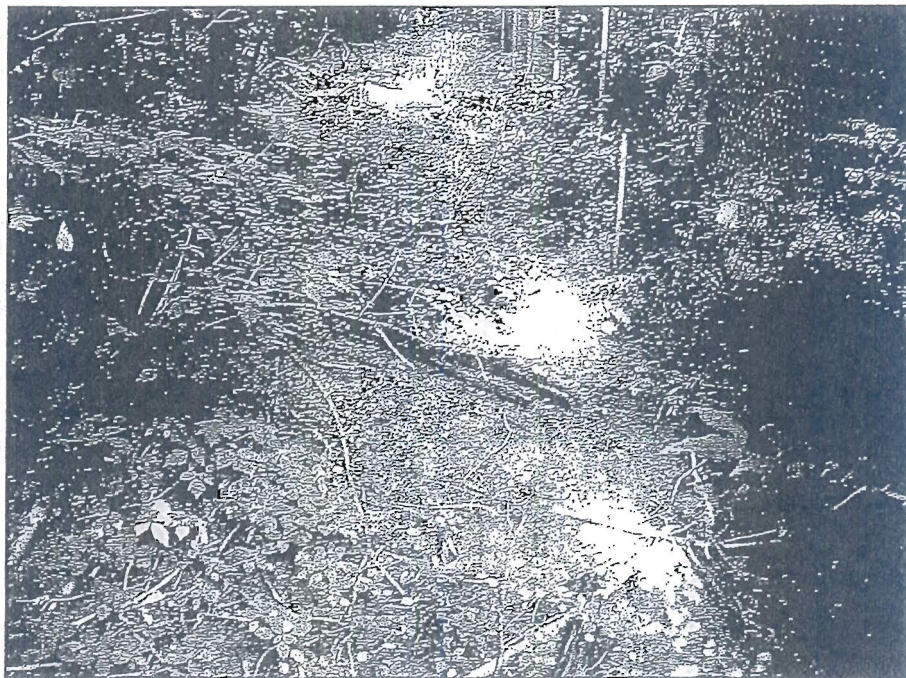
**Photograph 2 (6-25-08)** Wetland B is a lowland woods.

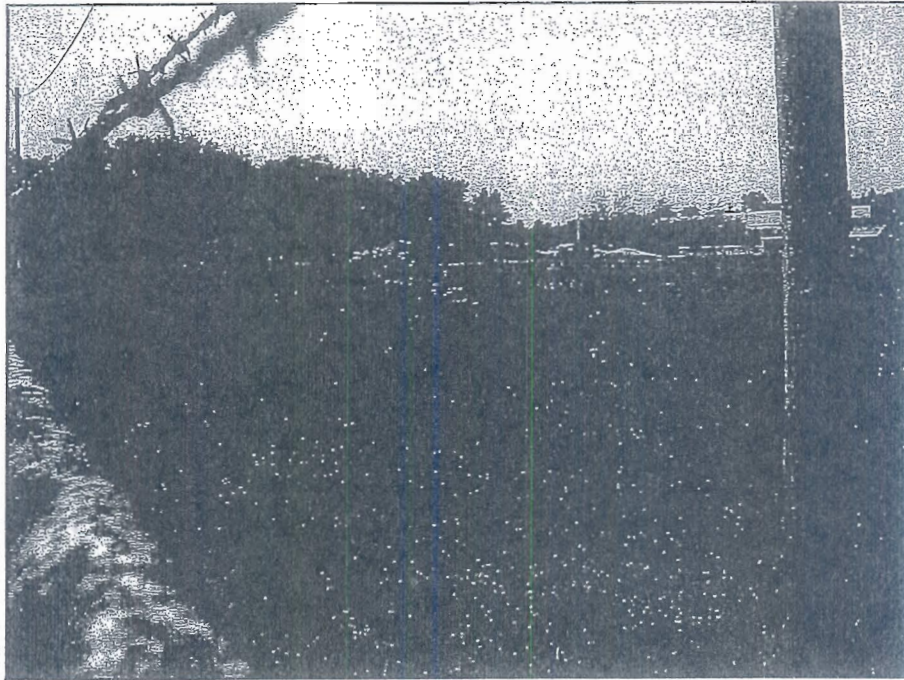
**Photograph 5 (6-25-08)** Haley's Ditch in the central portion of the site is surrounded by a narrow area of upland old field.

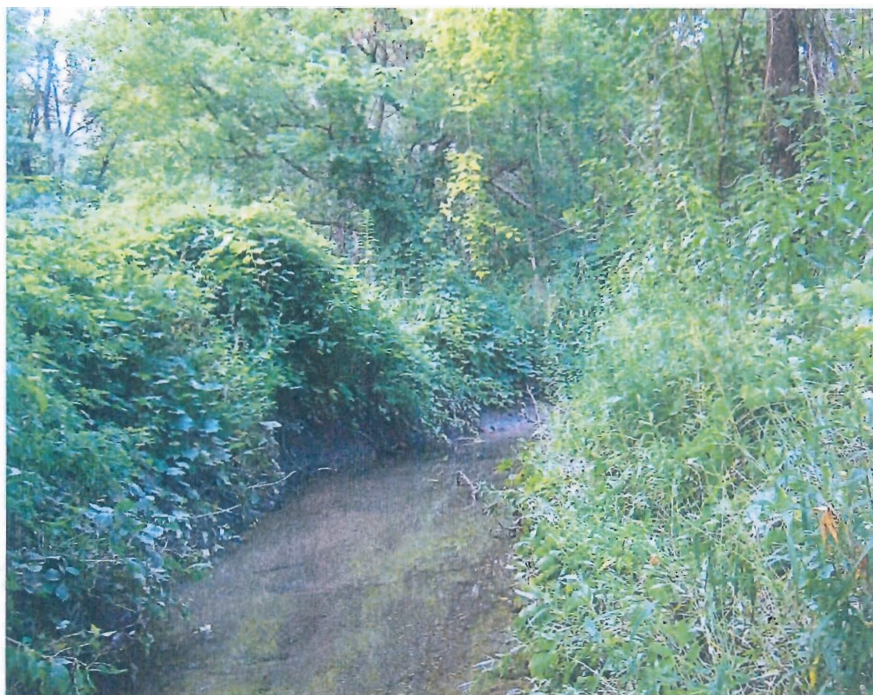
**Photo 3.** Haley's Ditch flowing northwards through the site.

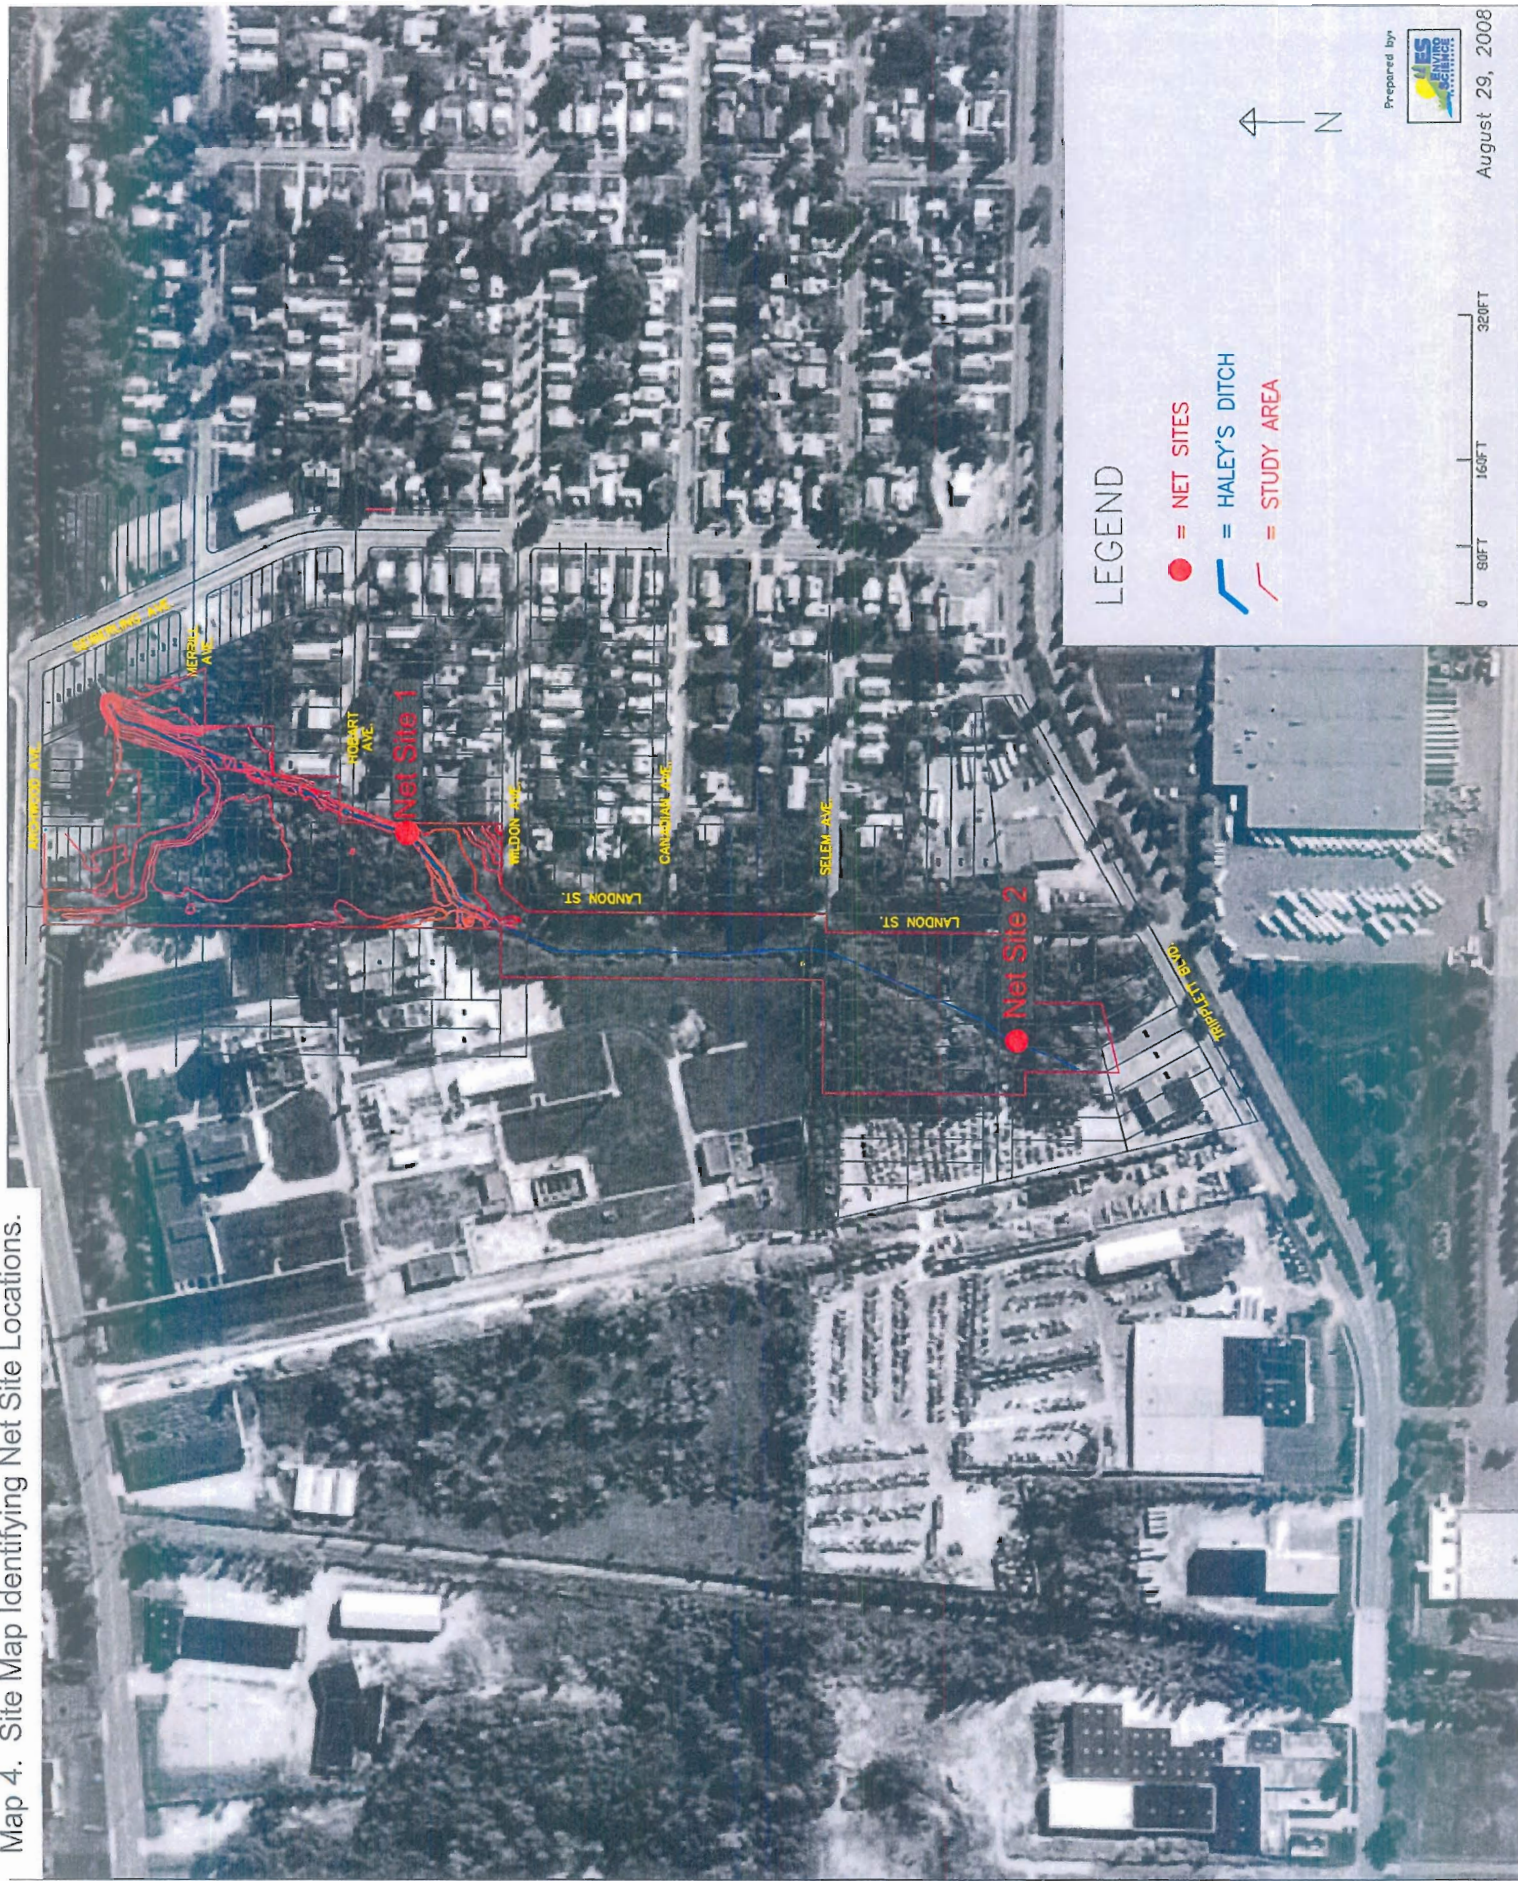
Map 4. Site Map Identifying Net Site Locations.

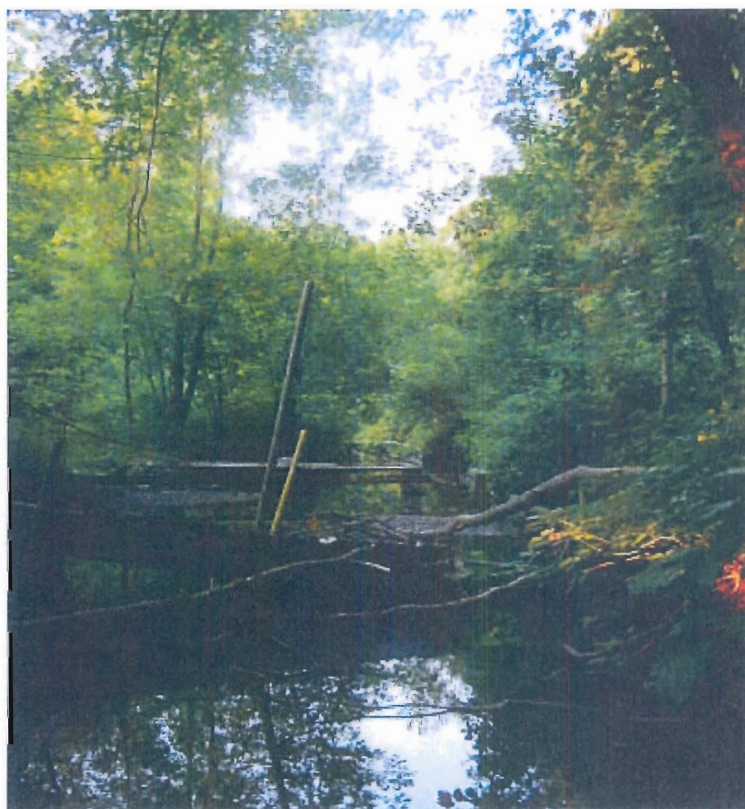
**Photo 6.** Net Site 2 looking down stream from walkway over ditch.
