# *Wetlands Delineation Report*

5.85 Acres

Haley's Ditch Remediation Area

Akron Airdock Facility, Lockheed Martin Corporation  
Akron, Ohio

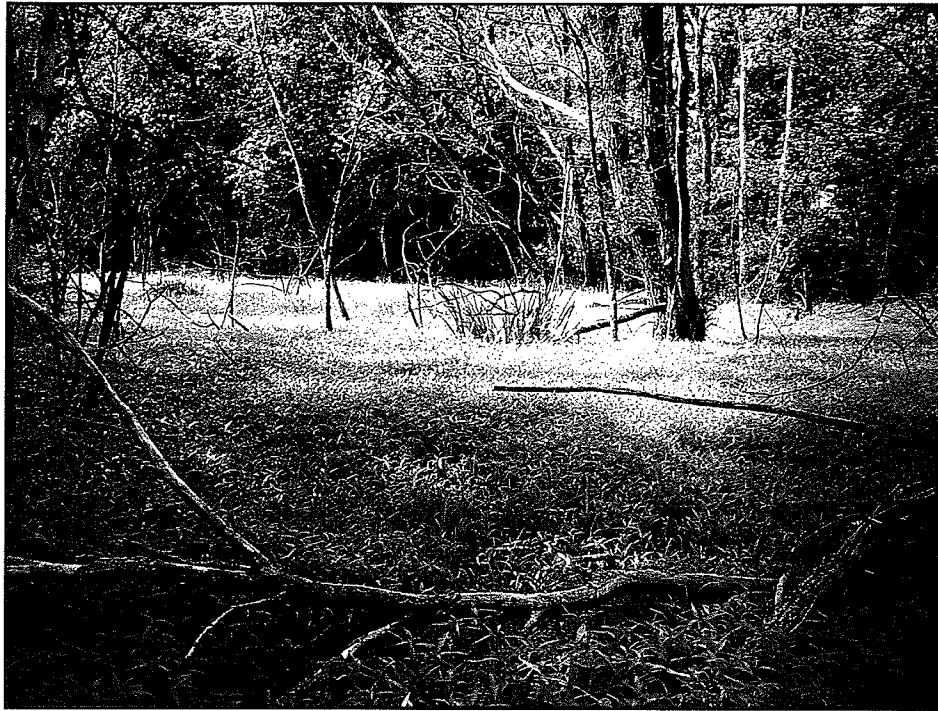
**Photograph 1 (6-25-08)** Wetland A is a lowland woods and wet meadow.

**Wet Meadows.** All of Wetland C and portions of Wetland A are wet meadows (Photographs 1 and 3, Appendix H). Common species include *Impatiens capensis* (spotted touch-me-not, FACW), *Leersia oryzoides* (rice cutgrass, OBL), and *Polygonum pennsylvanicum* (Pennsylvania smartweed, FACW).

**Lowland Woods.** All of Wetland B and portions of Wetland A are lowland woods (Photographs 1 and 2, Appendix H). These areas contain *Acer saccharinum* (silver maple, FACW), *Impatiens capensis* (spotted touch-me-not, FACW), *Lysimachia nummularia* (creeping Jennie, FACW-), *Populus deltoides* (eastern cotton-wood, FAC), and *Viburnum recognitum* (northern arrow-wood, FAC).

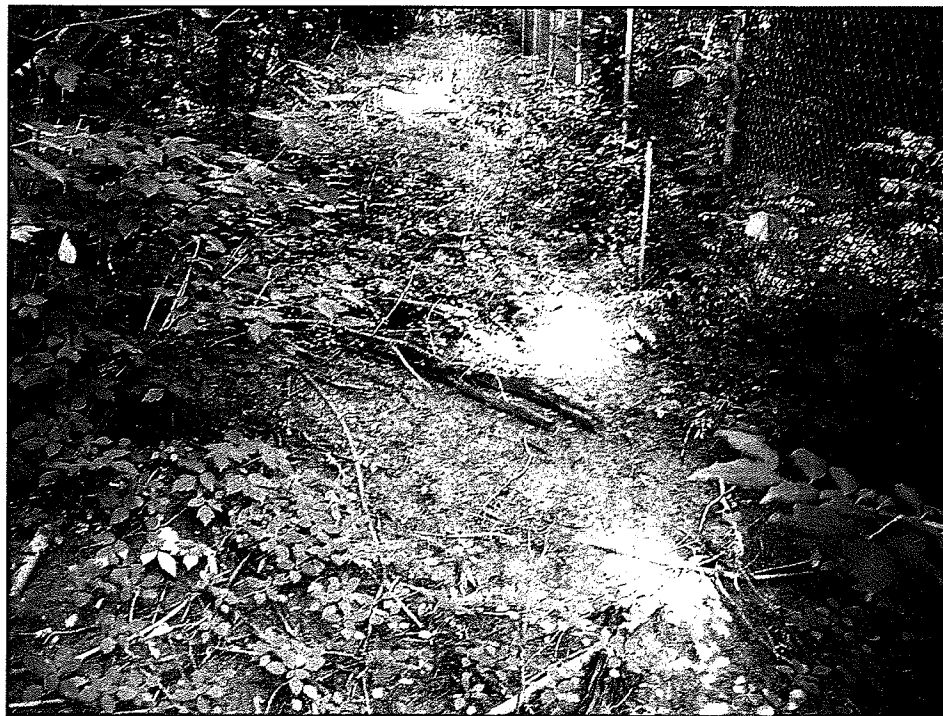
**Photograph 2 (6-25-08)** Wetland B is a lowland woods.

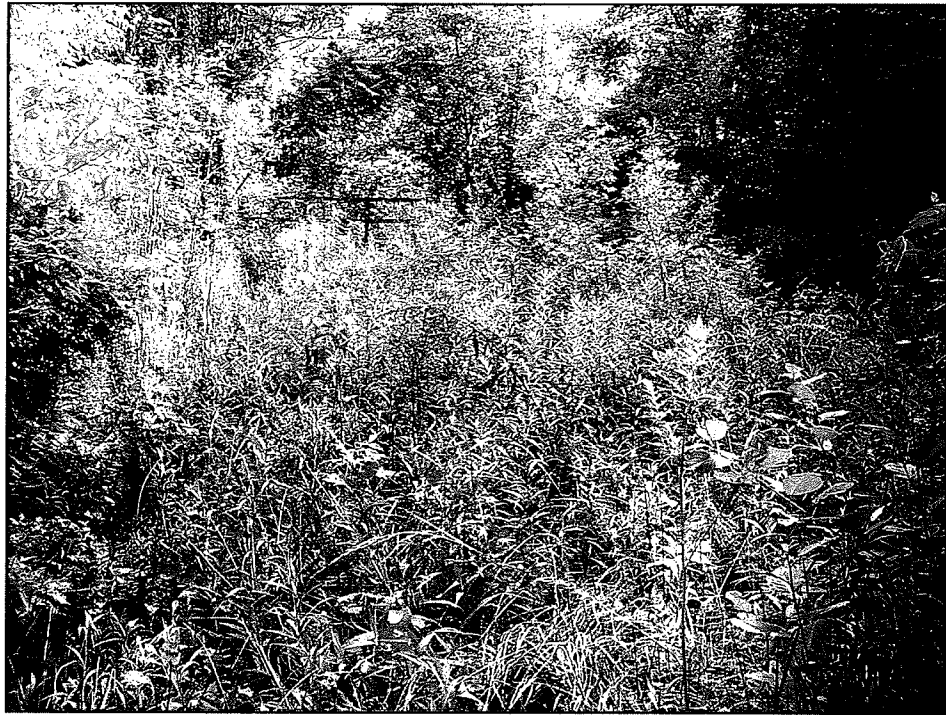
**Photograph 3 (6-25-08)** Wetland C is a wet meadow.

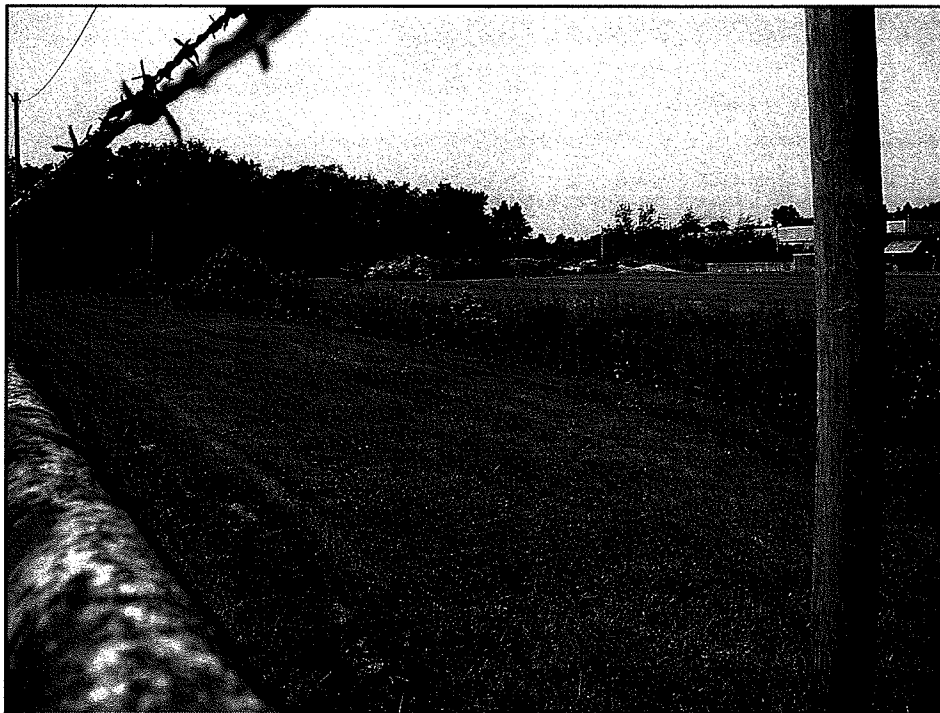
**Photograph 5 (6-25-08)** Haley's Ditch in the central portion of the site is surrounded by a narrow area of upland old field.

Haley's Ditch flows north through the study area, entering a culvert at the north end of the site (Photographs 4 and 5, Appendix H). Haley's Ditch continues flowing north through the Goodyear Tire and Rubber Company property, eventually entering Springfield Lake Outlet, which in turn enters the Little Cuyahoga River, a tributary to the Cuyahoga River. The Cuyahoga River has a watershed area of 809 square miles and debouches into Lake Erie in the City of Cleveland.
