REVISED **SUMMARY REPORT**

FOLLOW-ON MUNITIONS AND EXPLOSIVES OF CONCERN (MEC) EVALUATION

**Lockheed Martin Corporation
Former Beaumont Site No. 2
Beaumont, California**

July 2010

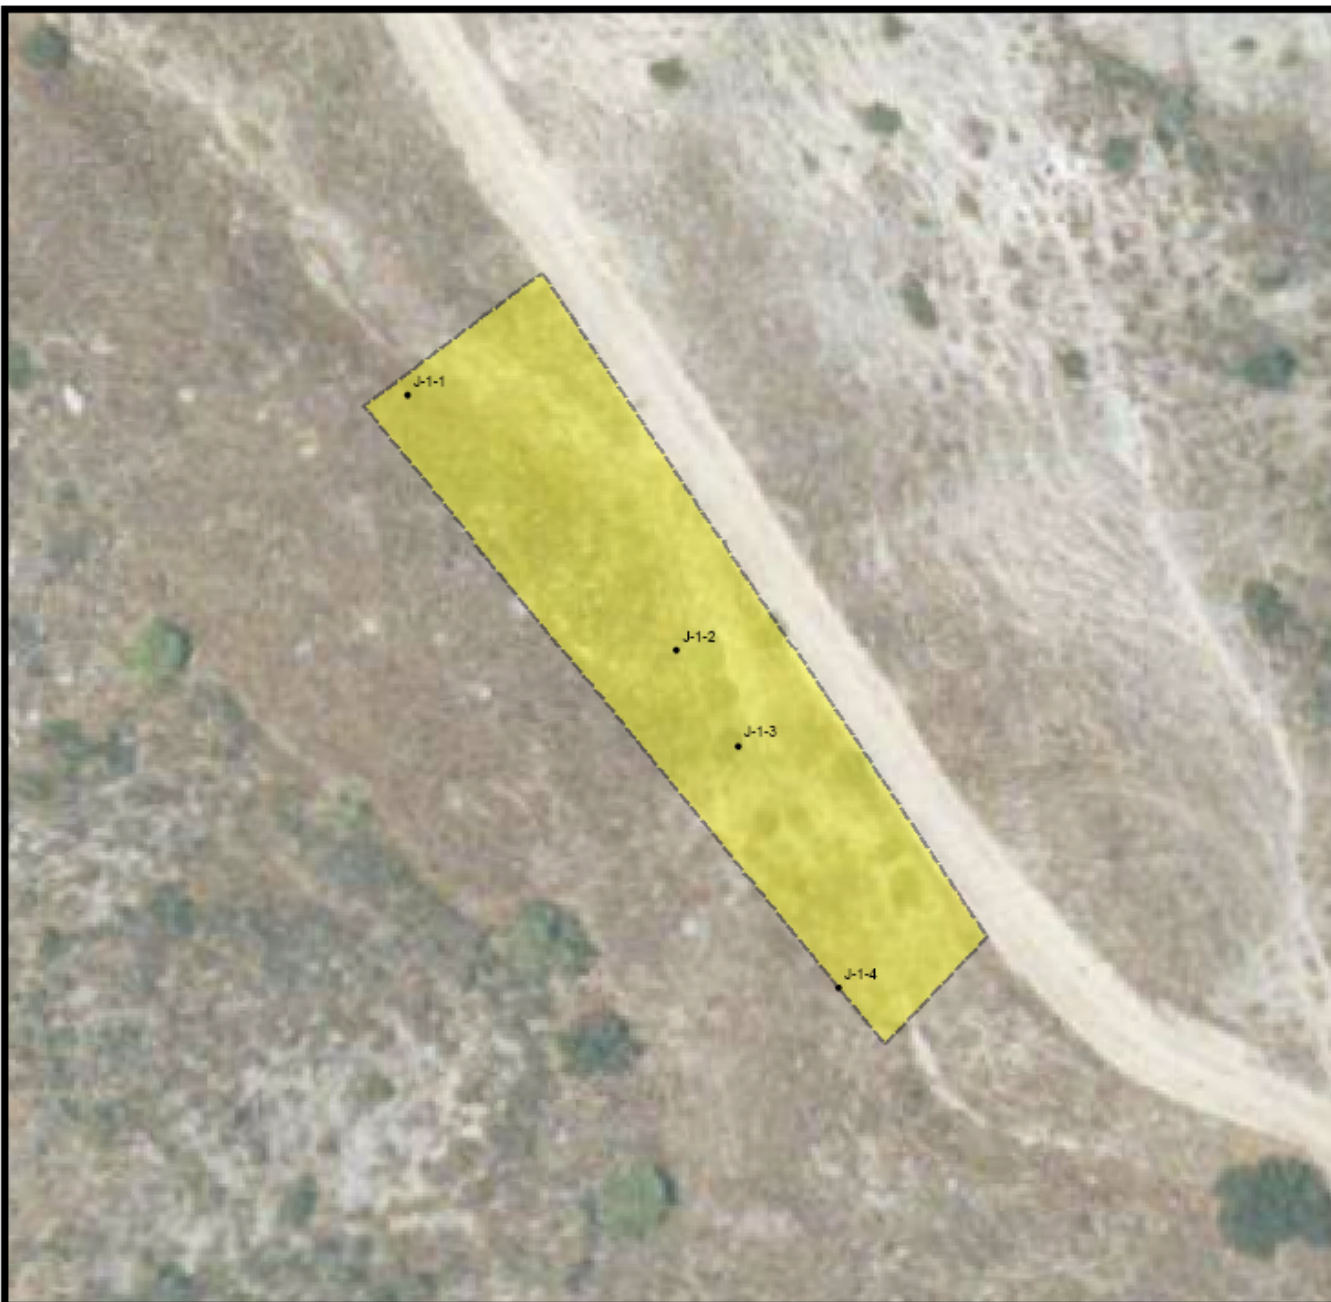
Figure 5-1
Evaluation Summary
Results for J-1

This site is located in a remote area near the western boundary of Area J along a dirt access road. It consists of a flat area beside the road that appeared consistent with conditions suitable

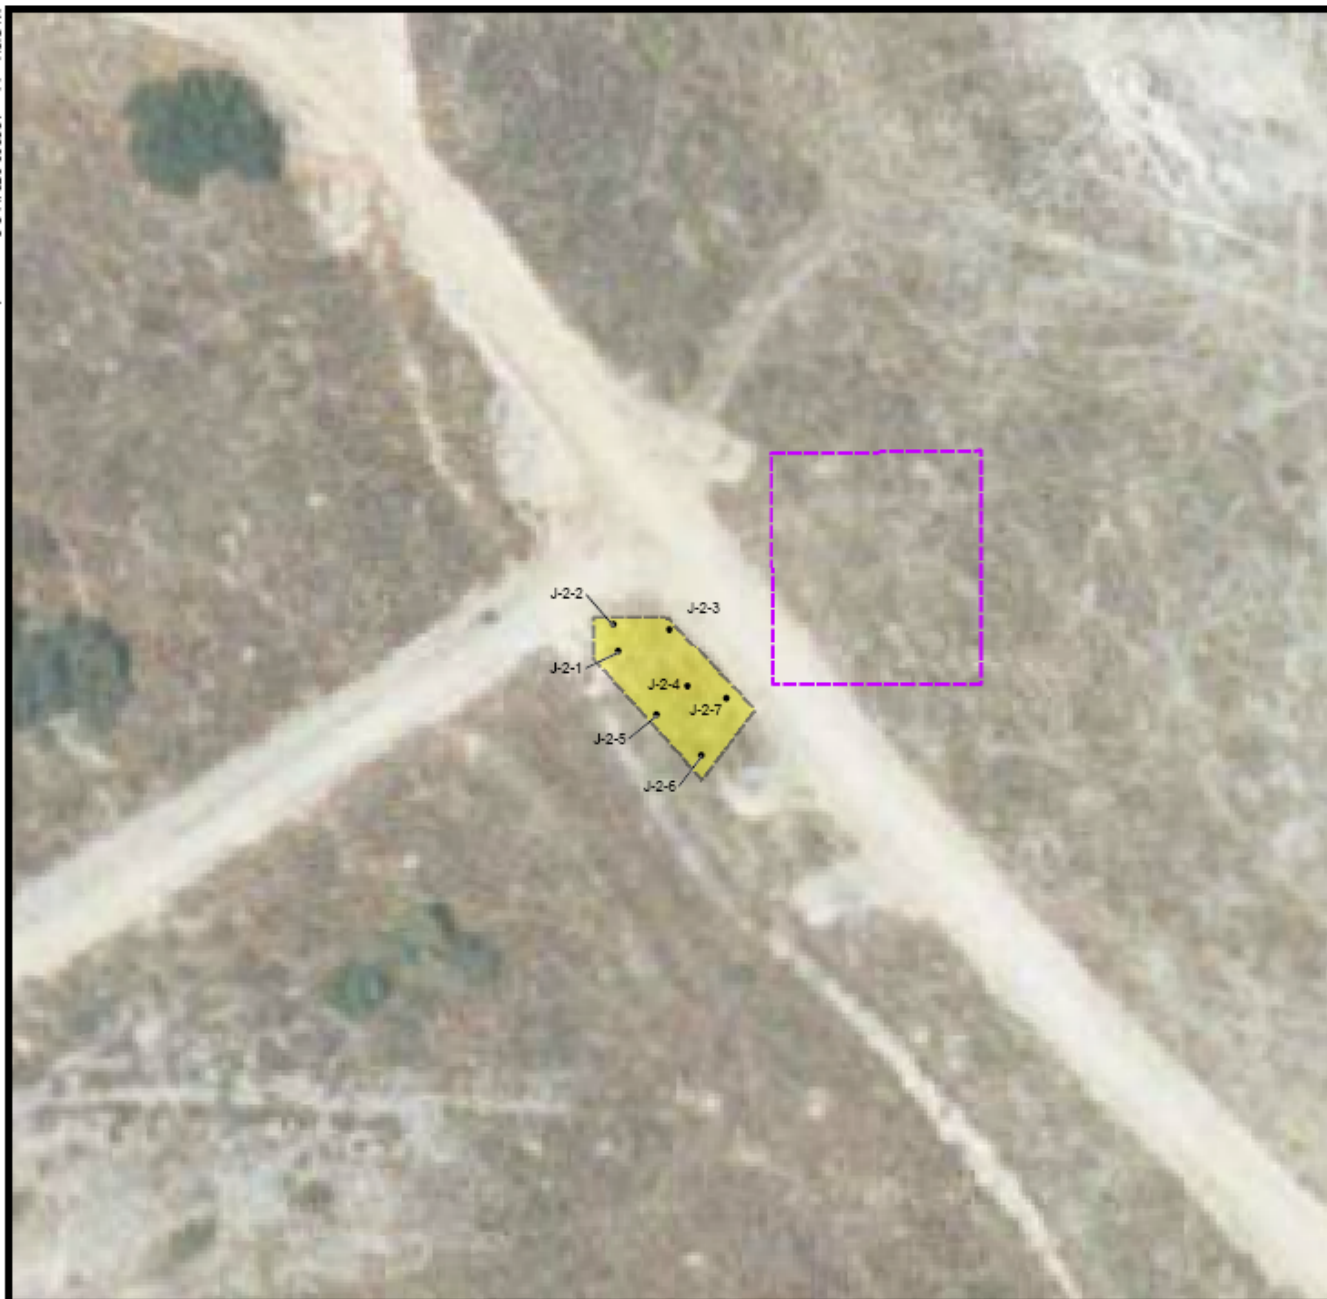
Figure 5-2
Evaluation Summary
Results for J-2

This site is located in a remote area west of the historical rocket motor assembly building along a dirt access road. It consists of a flat area beside the road that appeared consistent with conditions suitable for disposal. All seven (7) of the anomalies identified at this site were excavated for evaluation. Those anomalies evaluated consisted of a thin metal disk, two short metal rods, wire and a nail. Figure 5-2 shows the revised area and the locations of metal items discovered during the evaluation at Site J-2.

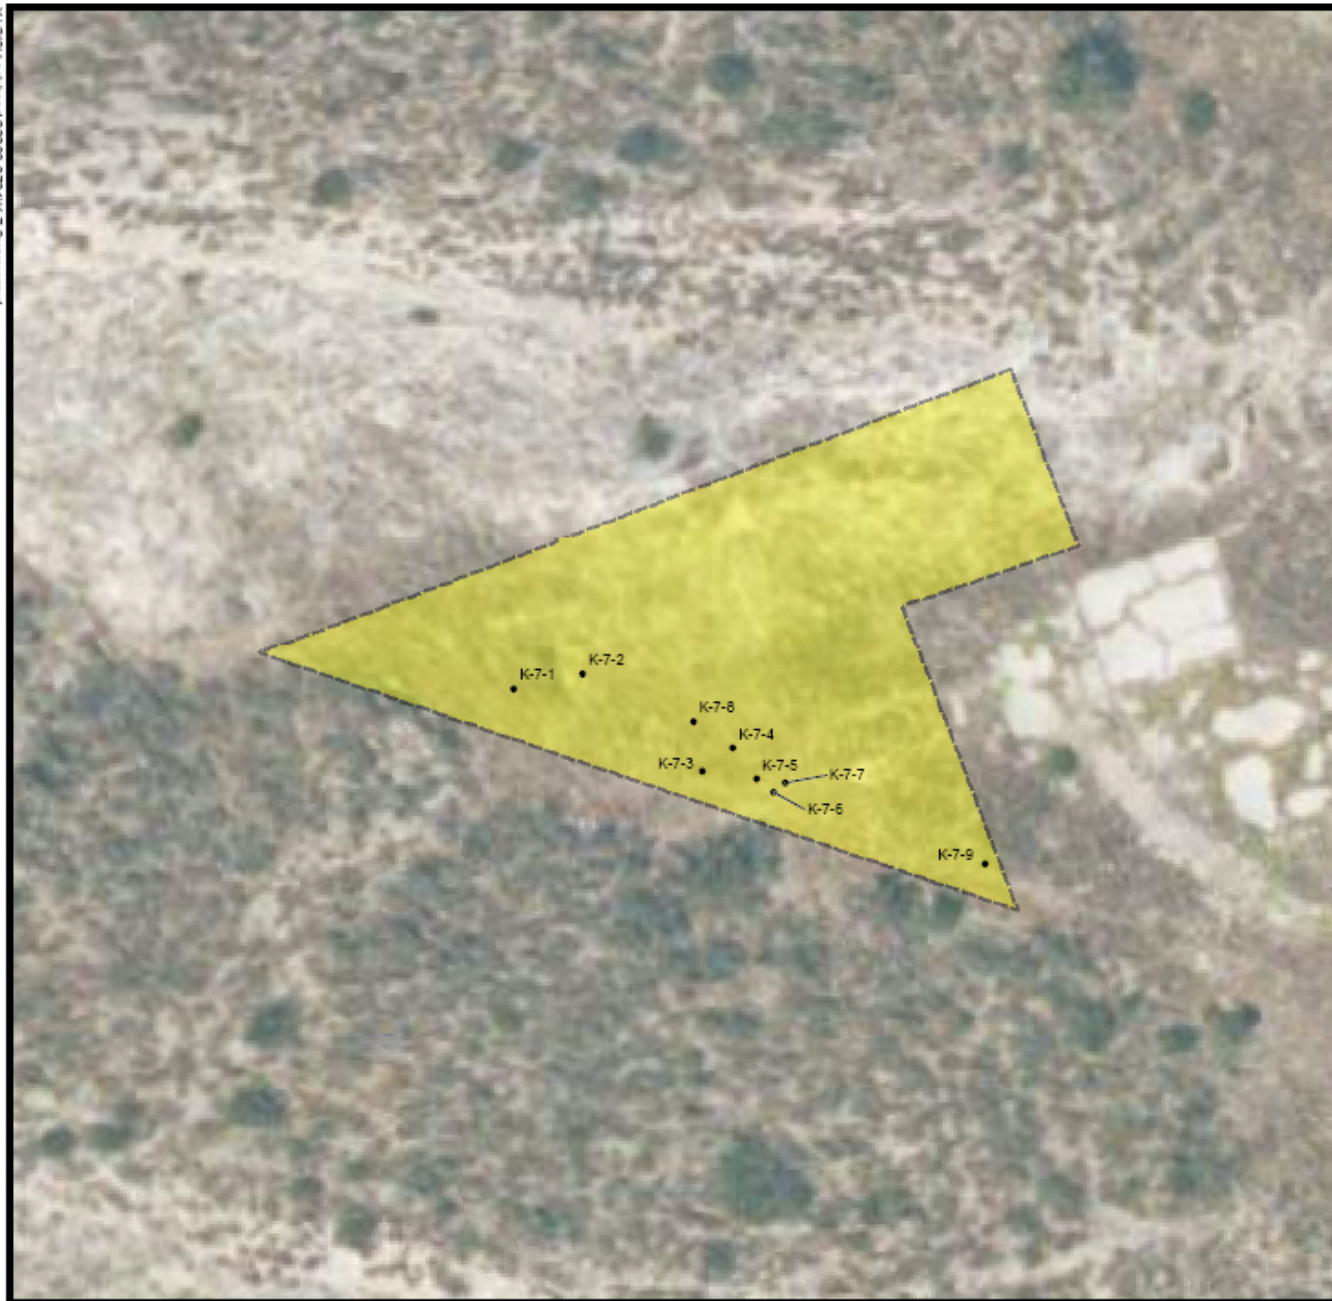
Figure 5-12
Evaluation Summary
Results for K-7

This site is located on the west side of Laborde Canyon, south of K-6. This irregularly-shaped site constitutes the area behind a former site structure reportedly containing indoor rocket motor conditioning chamber. All of the proposed area was accessible for evaluation. All nine (9) anomalies identified at this site were excavated for evaluation. Those anomalies evaluated consisted of a 4-foot piece of small diameter pipe, 24 expended .22 caliber casings, one expended .44 caliber casing, and other miscellaneous debris. Figure 5-12 shows the locations of metal items discovered during the evaluation at Site K-7.

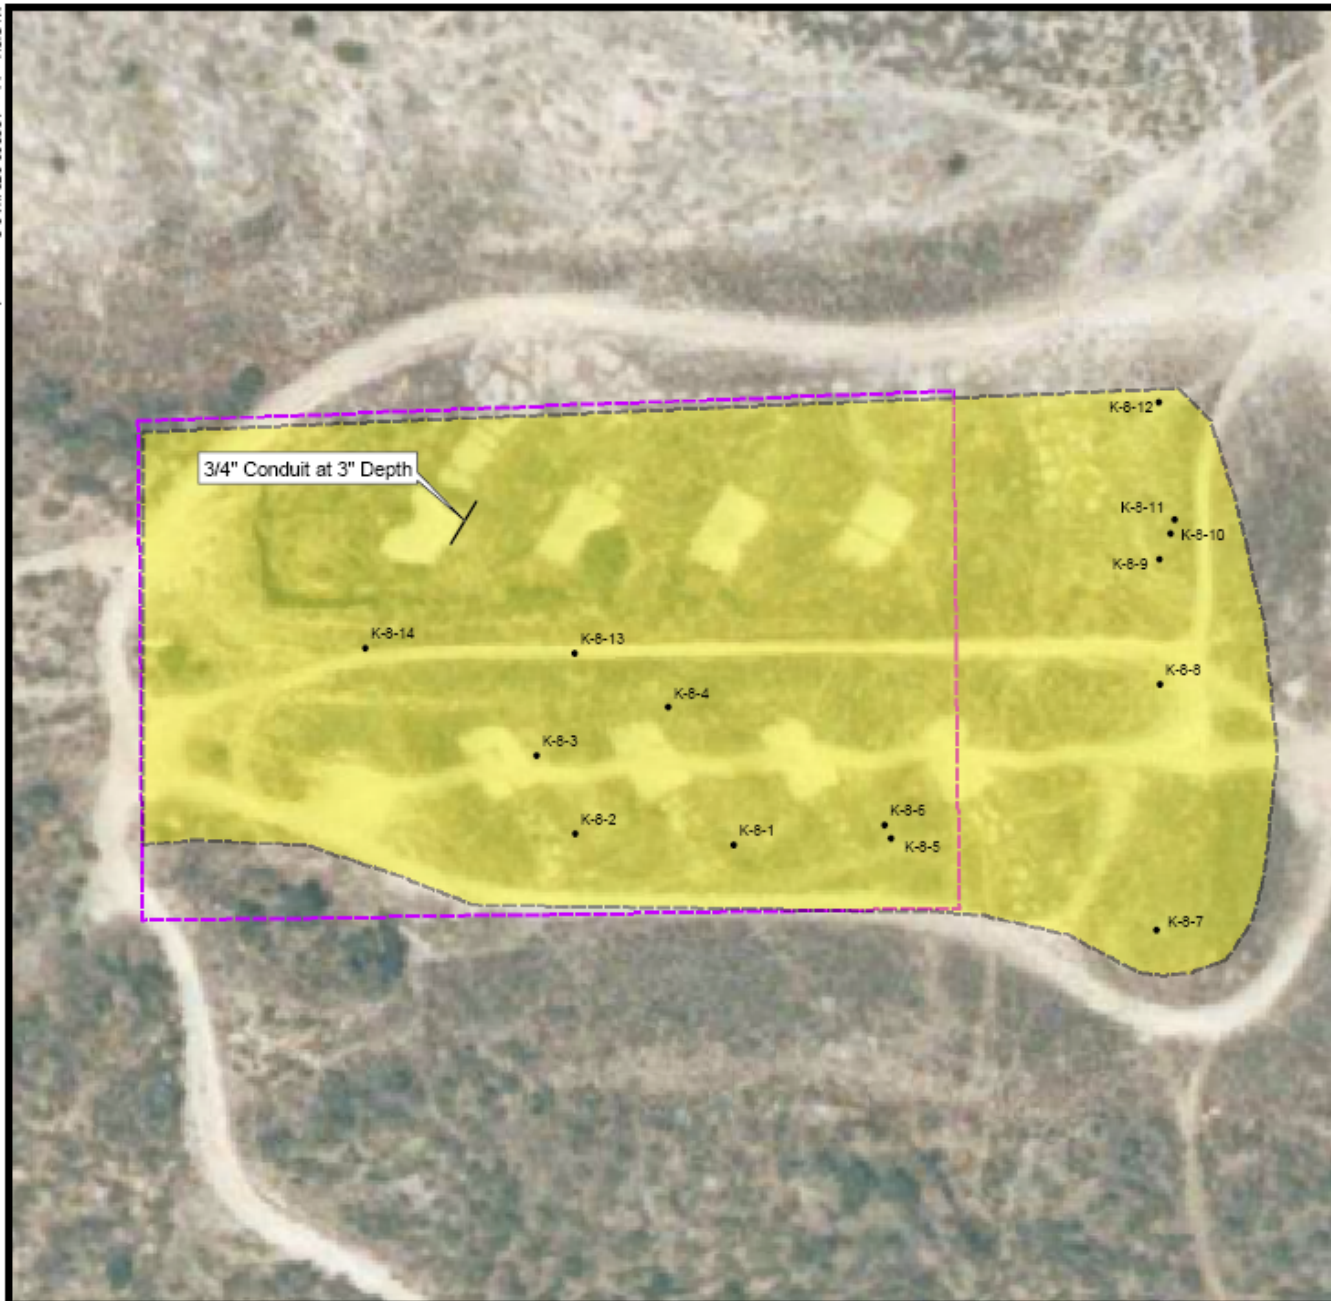
Figure 5-13
Evaluation Summary
Results for K-8

This site is located on the west side of Laborde Canyon, south of K-7. This roughly rectangular site was the location of 10 historical outdoor rocket motor conditioning chambers. Each chamber was set in a small bay surrounded on three sides by earthen berms. There was also a large berm shielding the front of the area. The initial evaluation area was expanded to include this berm. Evaluation was limited to the bays and some adjacent berm areas. All proposed area was accessible for evaluation. All fifteen (15) anomalies identified at this site were excavated for evaluation. Those anomalies consisted of a long piece of conduit, 2 9mm casings, one .44 caliber casing, one .357 caliber casing (all expended), a 4-foot square electrical box with wiring, 3 long pieces of angle iron (~3 ft.) and miscellaneous wiring, conduit

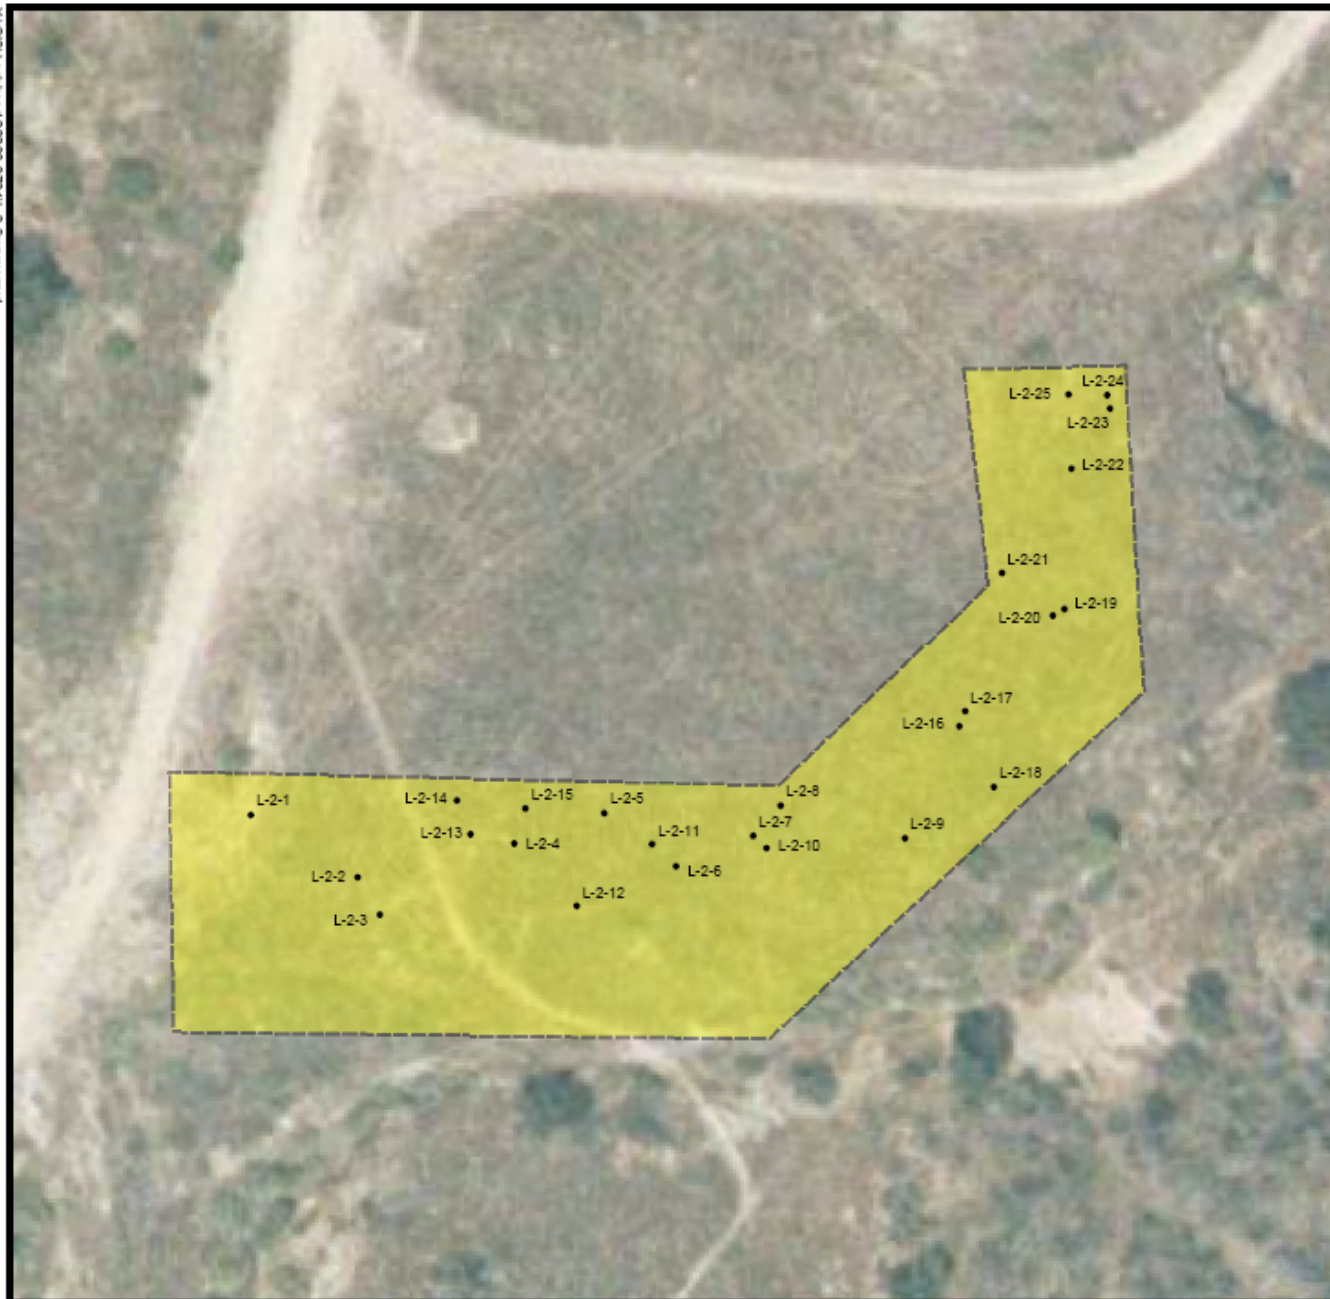
Figure 5-15
Evaluation Summary
Results for L-2

This site consisted of a large "L"-shaped area that was historically located behind structures in a staging area at the entrance to the canyon housing the former garbage disposal site. Twenty-five (25) of the fifty-nine (59) anomalies identified at this site were randomly selected and excavated for evaluation. Those anomalies evaluated consisted of assorted metal waste (wire, cans, nails, a metal bracket) along with two shotgun shells, a 9mm casing and two .45 caliber casing (all expended). A single piece of metal scrap was found in this area that resembled munitions frag. The item was twisted making it appear jagged like munitions frag. Based upon this potential, all anomalies near this item were excavated to obtain more data regarding the

nature of subsurface waste in this vicinity. No similar items were found. After careful examination of the item, and based upon the information available, knowledge and his past experience, the SUXOS directing field activities concluded the item was not munitions frag. Although it was twisted, one side was flat and the twisting was quite uniform as might be expected if the item were purposefully manufactured with a twist. In addition, if a munitions item had been detonated in this vicinity multiple pieces of frag would be normally be present. Figure 5-15 shows the locations of metal items discovered during the evaluation at Site L-2.
