2012 Annual Munitions and Explosives of Concern Inspection Report Potrero Canyon Unit (Lockheed Martin Beaumont Site 1) Beaumont, California

2012 Munitions and Explosives of Concern Inspection Report Potrero Canyon Unit (Lockheed Martin Beaumont Site 1) Beaumont, California

Tetra Tech, Inc.

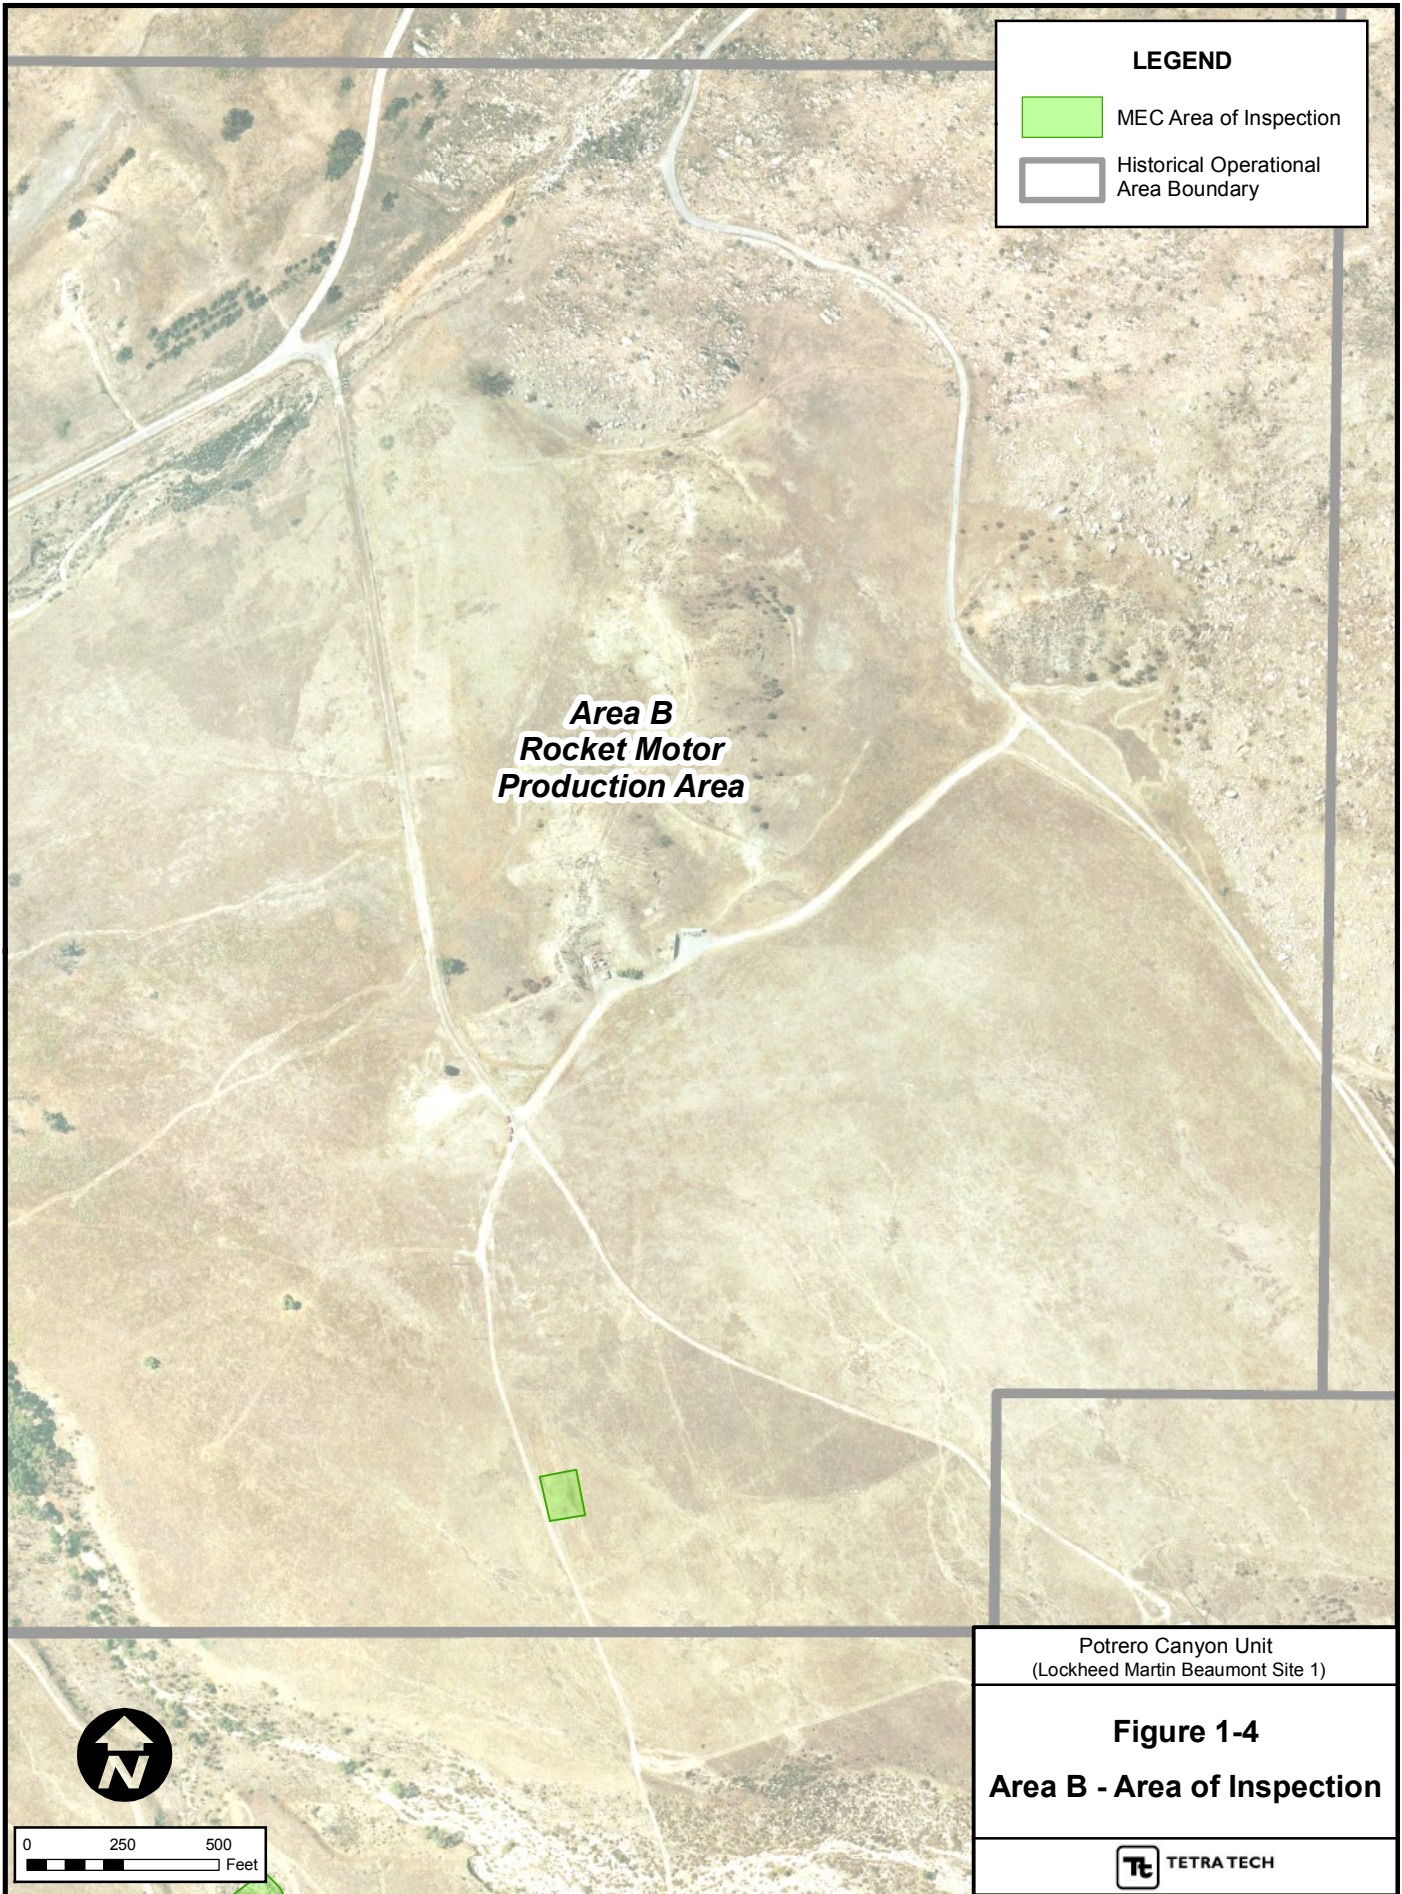
**Figure 1-5
Area D- Area of Inspection**

- Area D Berm at the Base of the TPLZ – While no explosive projectiles were reported to have been tested at this range, fragments found near a presumed target up range of the berm appeared to have been generated by explosive, not mechanical, means. The berm was investigated and detected items were removed. No MEC was found, but the detection equipment has depth limitations. The berm is steeply sloped and somewhat prone to erosion. With time, undetected objects deeper in the berm could be brought to the surface by erosion. As a result, the berm at the Base of the TPLZ has been included in the MEC inspection program.

- Area D Streambed – Bedsprings Creek bisects Area D. While no known MEC activities were conducted in the drainage it appears some munitions related items were discarded here. Several unfired burster tubes and 20 mm practice ammunition were found in the stream bed. These items are considered MEC. A 100% survey/removal was conducted in the accessible area of the streambed. With time, undetected objects buried in the area could be exposed by erosion. As a result, the Area D Streambed AOC has been included in the MEC inspection program.
