2021 RESTORATION MONITORING SUMMARY REPORT

Bloody Brook
Onondaga County, New York

Lockheed Martin Corporation
Syracuse, New York

AECOM Technical Services Northeast, Inc.
40 British American Boulevard
Latham, New York 12110

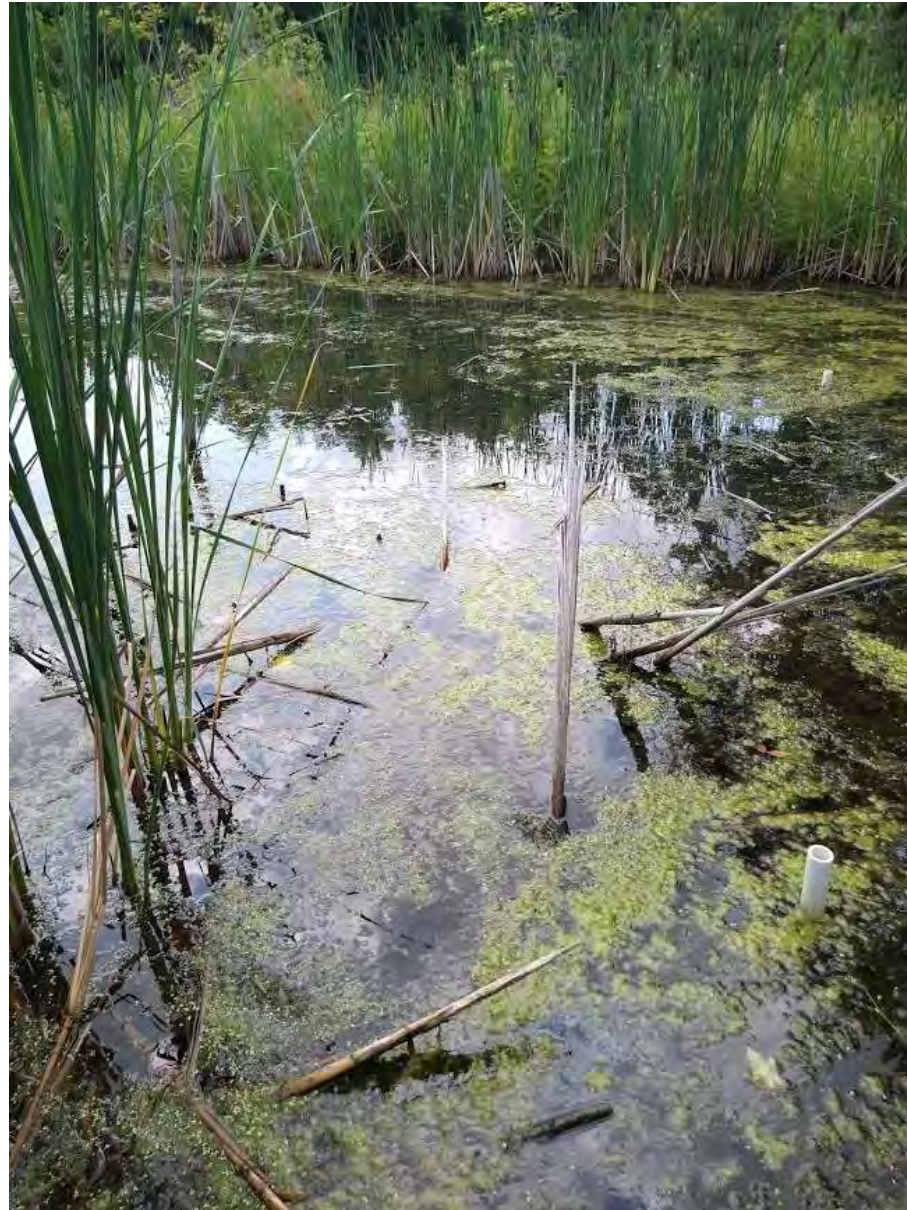
Wetland Plot Plant Identification and Count
July 2021 PEM-2

Under current conditions and consistent with past inspections, the plot is completely inundated with water. The plot was assessed as a single plot and had a total percent coverage by emergent vegetation of 5 percent, up from 3 percent in 2020 (Table 4). The coverage in 2019 was 100 percent, comprised of 60 percent broad-leafed cattail, 20 percent duckweed, and 20 percent bladderwort. Cattail, the dominant vegetation that has developed in other areas of PEM-2, had begun to spread into Plot 3 in 2019 but was reduced to 2 percent in 2020 due to muskrat activity. Results of monitoring completed in 2021 are consistent with 2020 with 5 percent coverage comprised of duckweed, narrowleaf cattail, and bladderwort. As observed in 2020, there continues to be muskrat activity in the area of Plot 3; and bladderwort may have again been observed at lower densities because the inspection was completed later in 2021, as it was in 2020. The plant would have already flowered and begun to die back. Other areas of PEM-2 are continuing to sustain dense stands of cattails, and the area in and around Plot 3 appears to be suitable habitat for wetland wildlife. Consistent results between 2020 and 2021 suggests the habitat area can sustain the muskrat activity.

It should be noted that, although duckweed (*Limna minor*) is not a rooted macrophyte but floats on the surface, it has been included in the percent coverage estimate for PEM-2 (Table 4). This plant is listed as a wetland plant in the NYSDEC Wetlands Delineation Manual (https://www.dec.ny.gov/docs/wildlife_pdf/wdelman.pdf).
