Subject: Transmittal of the Cow Pen Creek Wetland Restoration and Monitoring Report  
Lockheed Martin Corporation; Middle River Complex  
2323 Eastern Boulevard, Middle River, Baltimore County, Maryland

**COW PEN CREEK  
WETLAND RESTORATION MONITORING REPORT  
2323 EASTERN BOULEVARD  
LOCKHEED MARTIN MIDDLE RIVER COMPLEX  
MIDDLE RIVER, MARYLAND**

January 2019

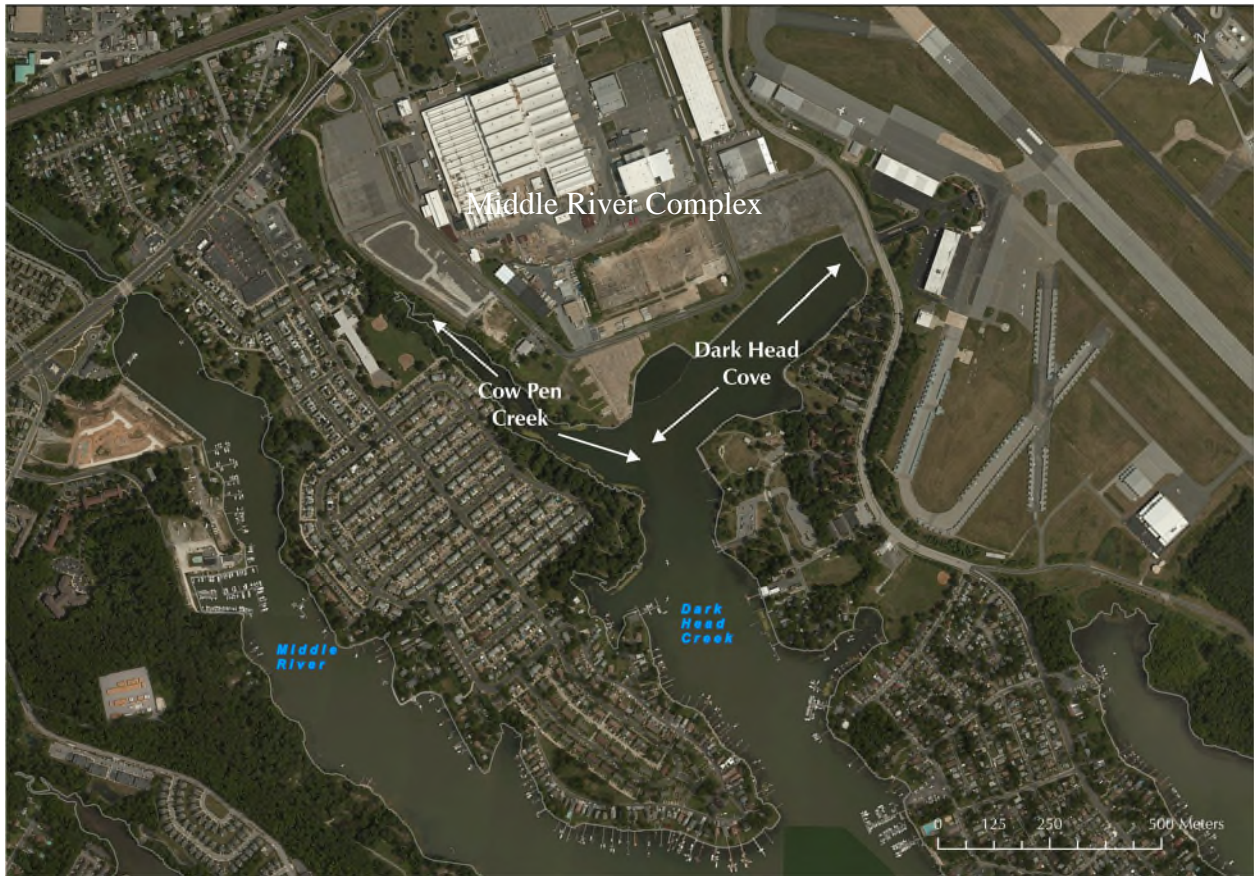
**Figure 2-1 Location of Cow Pen Creek and Dark Head Cove near the Middle River Complex.**

The Lockheed Martin Middle River Complex (MRC), which is part of the Chesapeake Industrial Park, is located at 2323 Eastern Boulevard in Middle River, Maryland, approximately 11.5 miles northeast of downtown Baltimore. The site is approximately 161 acres and includes twelve main buildings. The property also includes an active industrial area and yard, perimeter parking lots, an athletic field, a concrete-covered vacant lot, a trailer and parts storage lot, and numerous grass-covered green spaces along the facility's perimeter. Locked chain-link fences surround all exterior lots and the main industrial area. The site is bounded by Eastern Boulevard (Route 150) to the north, Dark Head Cove to the south, Cow Pen Creek to the west, and Martin State Airport to the east (Figure 2-1).

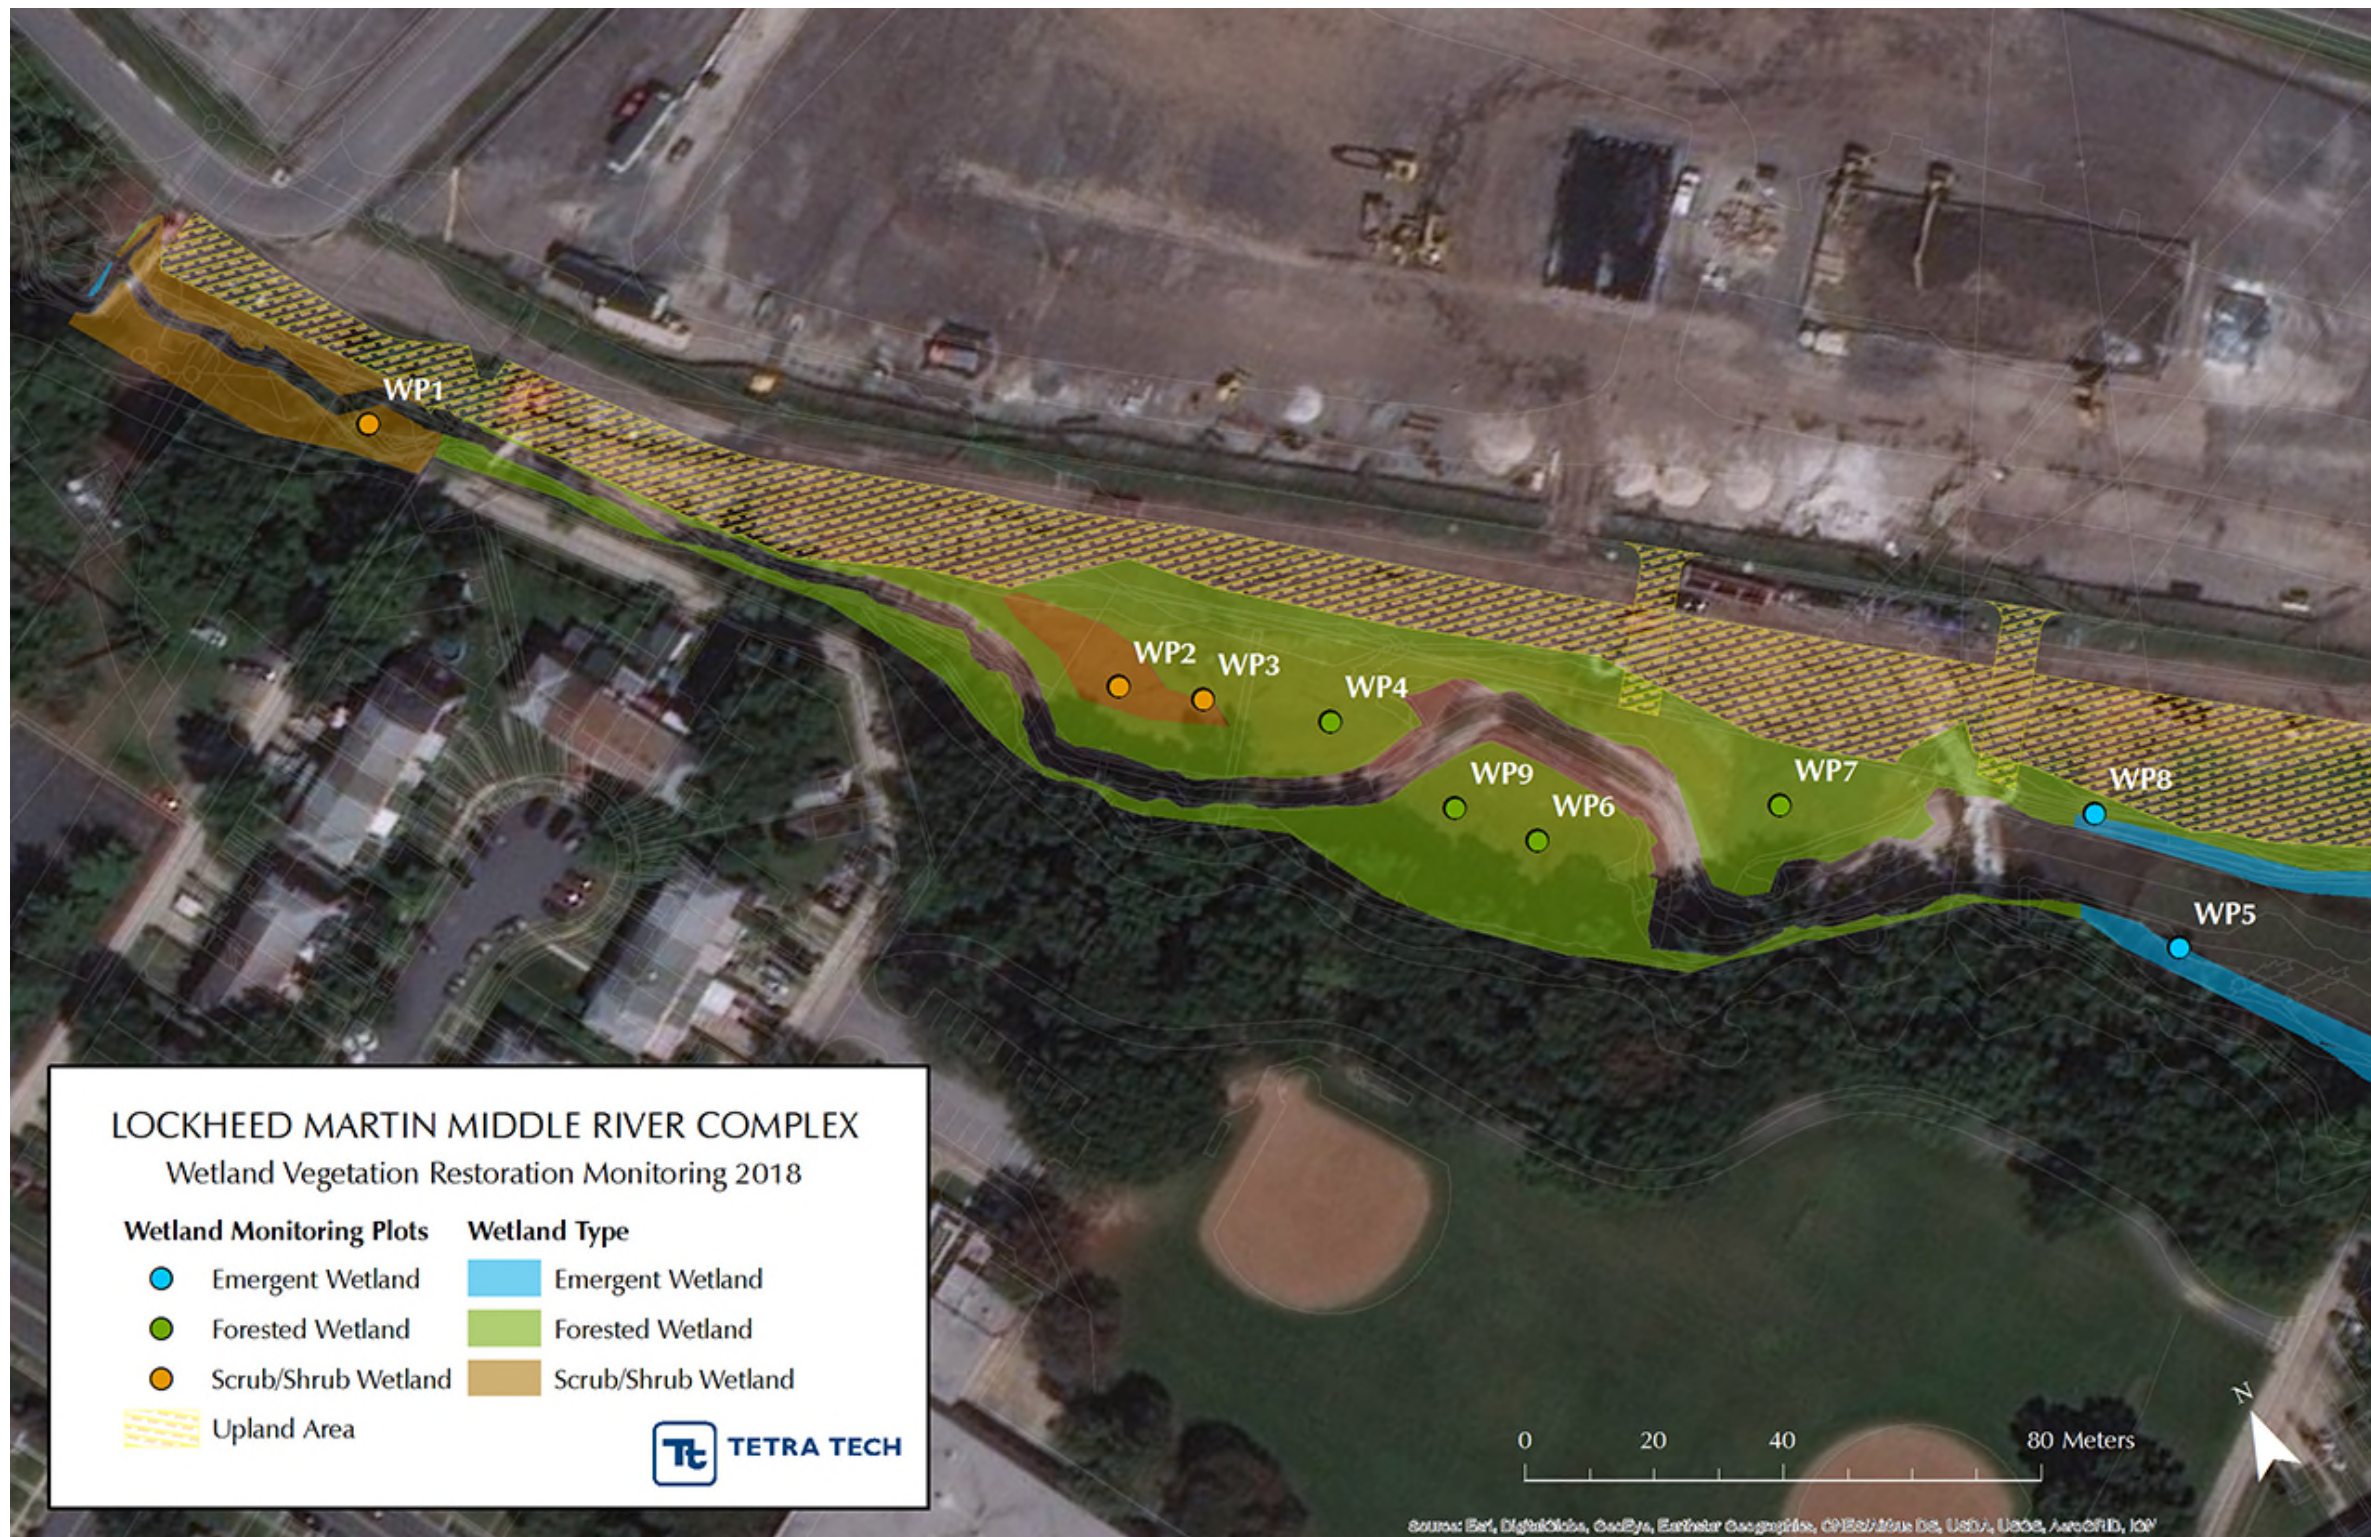
Figure 3-1 Map of wetland monitoring plot locations.

Developing vegetation and habitats were assessed using at least the minimum number of sampling plots recommended in the Interagency Review Team (IRT) protocol; therefore, three 400 square foot (ft<sup>2</sup>) randomly located sampling plots were monitored in the scrub-shrub habitat, while four 400 ft<sup>2</sup> plots in forest-dominated habitats, and two three-foot by three-foot sample plots, were randomly assessed in the herbaceous dominated community (Table 3-1). Figure 3-1 shows the location of the wetland sampling plots.

Sampling locations (numbered 1 through 9) are shown on Figure 3-1. Table 3-1 provides a summary of vegetation data observed and recorded at each site, corresponding to the monitoring and data collection objectives (see Section 3-1).

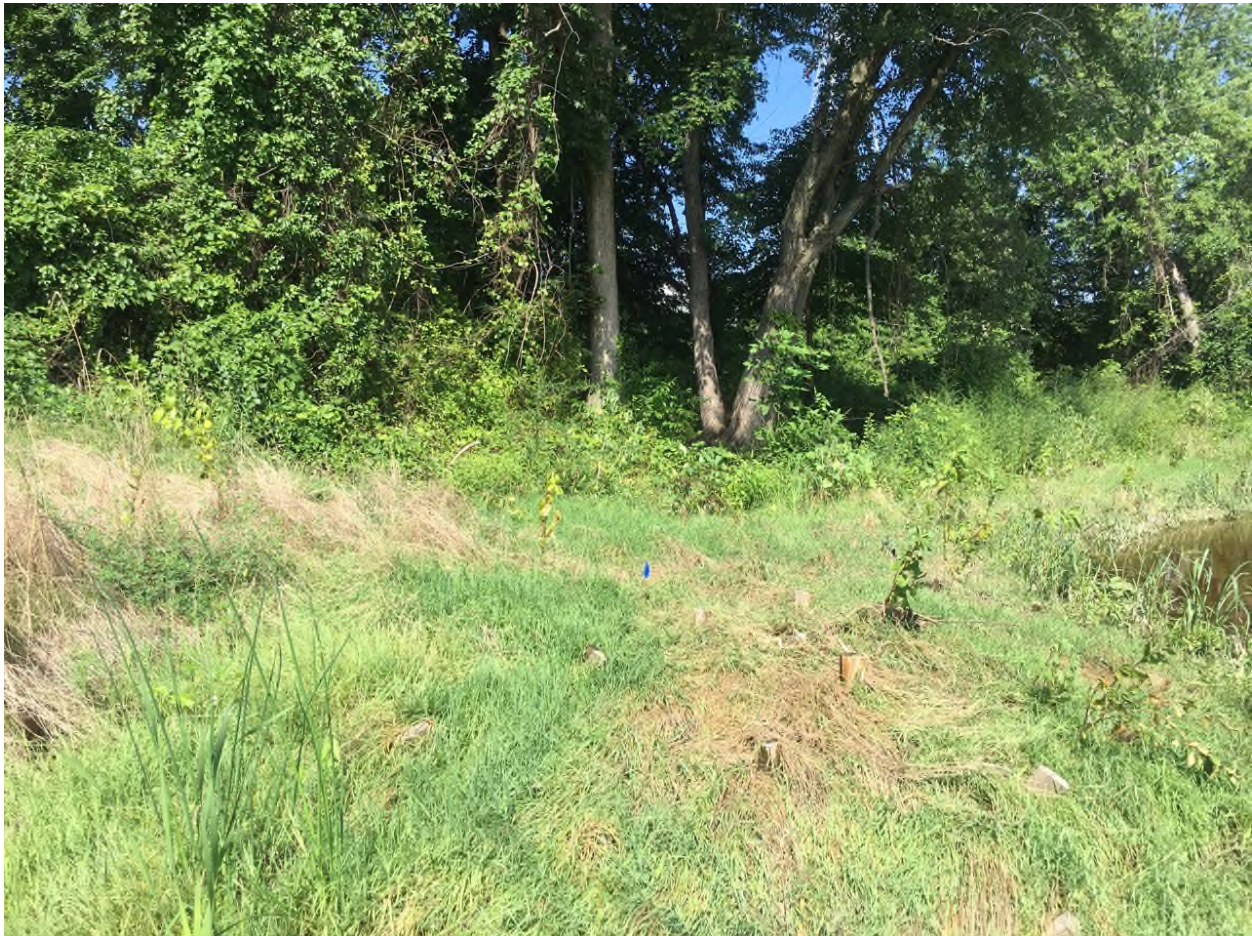
**WP1 (Appendix A: DWG L-103):** This scrub-shrub wetland monitoring location is between stormwater Outfalls 002 and 003 (Figure 3-2). Ground cover is 100% with no bare spots, and the dominant herbaceous vegetation (with 95% coverage) is creeping bentgrass (*Agrostis stolonifera*), that was seeded according to the approved seed mix for wetland areas. Woody stem count in this plot was 9 and there appears to be 100% survival of planted woody material since no dead shrubs were observed (Table 3-1). Soil in the monitoring location was wet or saturated at the surface. Although not within the boundary of this plot, common reed should be monitored because it is growing adjacent to the site under the power lines. Three or four stems of what appears to be narrowleaf cattail (*Typha angustifolia*) are growing adjacent to the plot and can become an aggressive colonizer forming a mono-culture. No invasive ground cover was observed in the plot.

**Figure 3-2 WP1 Photo looking southwest away from Martin Boulevard. Dominant herbaceous vegetation is creeping bentgrass. Planted small trees and shrubs are visible.**

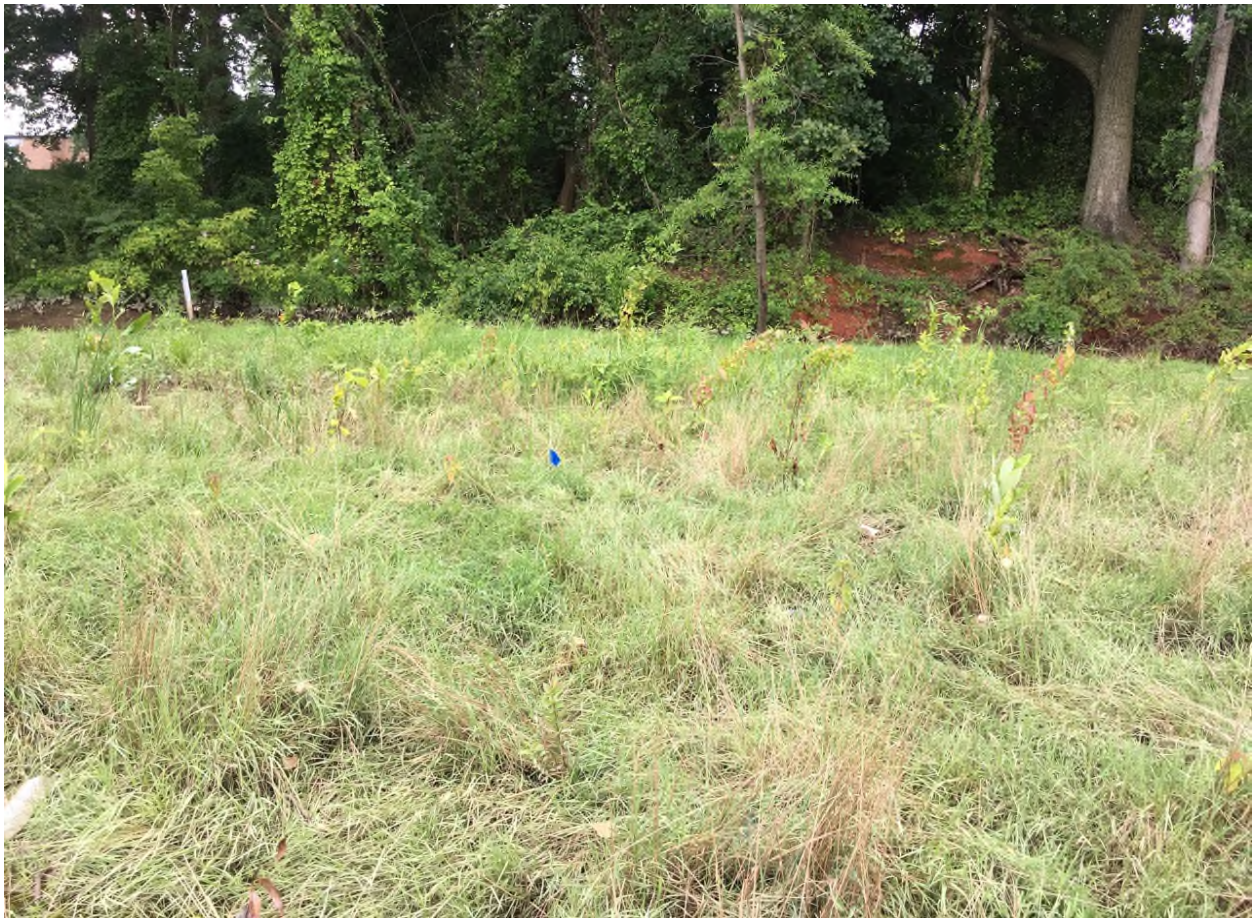
**WP2 (Appendix A: DWG L-104):** This scrub-shrub wetland monitoring location is near the center of the area designated on Figure 1-1 as scrub-shrub wetland vegetation (Figure 3-3). The vegetation at this plot is like the scrub-shrub of WP1. Ground cover was 90% with a few small bare spots, and the dominant herbaceous vegetation (with 85% coverage) is creeping bentgrass, which was seeded according to the approved seed mix for wetland areas. Woody stem count in this plot was 25 with survival greater than 90% (Table 3-1). Soil in this monitoring location was wet or saturated at the surface. No invasive plants were observed within this plot.

**Figure 3-3 WP2 Photo looking southwest away from Martin Boulevard. Stream is in the foreground before the mature tree line. Planted vegetation is doing well in this area.**

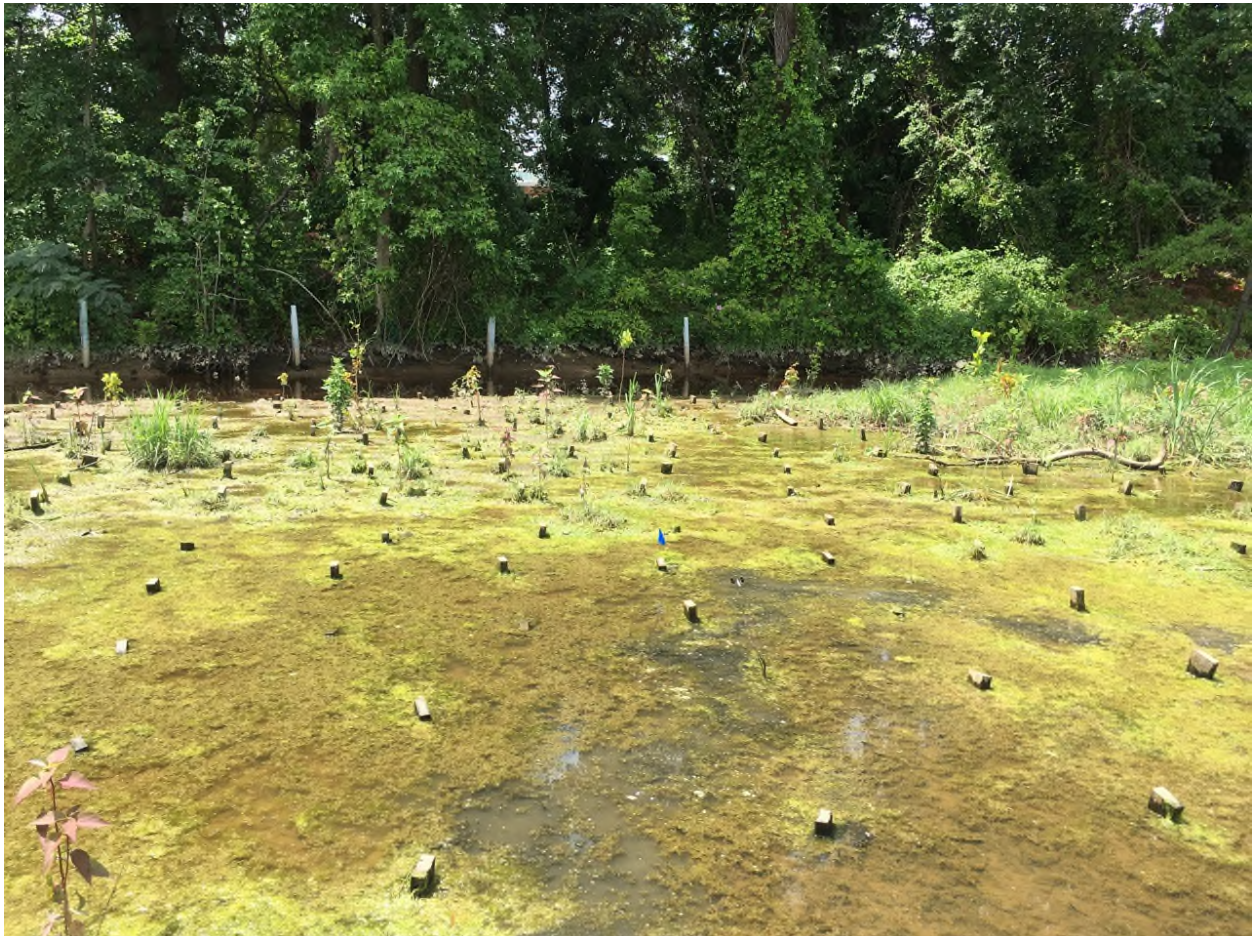
**WP3 (Appendix A: DWG L-104):** This scrub-shrub sampling plot is downstream or southeast of sampling plot WP2 (Figure 3-4). No woody stems (shrubs or trees) were observed within the sampling plot (0% woody plantings survival, Table 3-1). Signs of woody vegetation have disappeared at this monitoring location. The area inside this plot appeared to be continuously flooded due to the presence of algae and submerged aquatic vegetation (SAV). Shrubs and or trees that are typically grown in nursery potting mixes may not survive in not preconditioned for areas that are continually saturated or have inundated soils, Hibiscus or Button Bush would likely survive with the best chance of survival when grown in (or pre-conditioned) to saturated soils. The areas adjacent to WP3 contained both live and dead woody plants. No invasive ground cover or woody plants were observed within the plot.

**Figure 3-4 WP3 Photo looking southwest away from Martin Boulevard. This area appears to be semi-permanent or permanently flooded. Shrubs such as Hibiscus or Button Bush would likely survive here but they probably need to be conditioned before planting to the flooded anaerobic soil.**

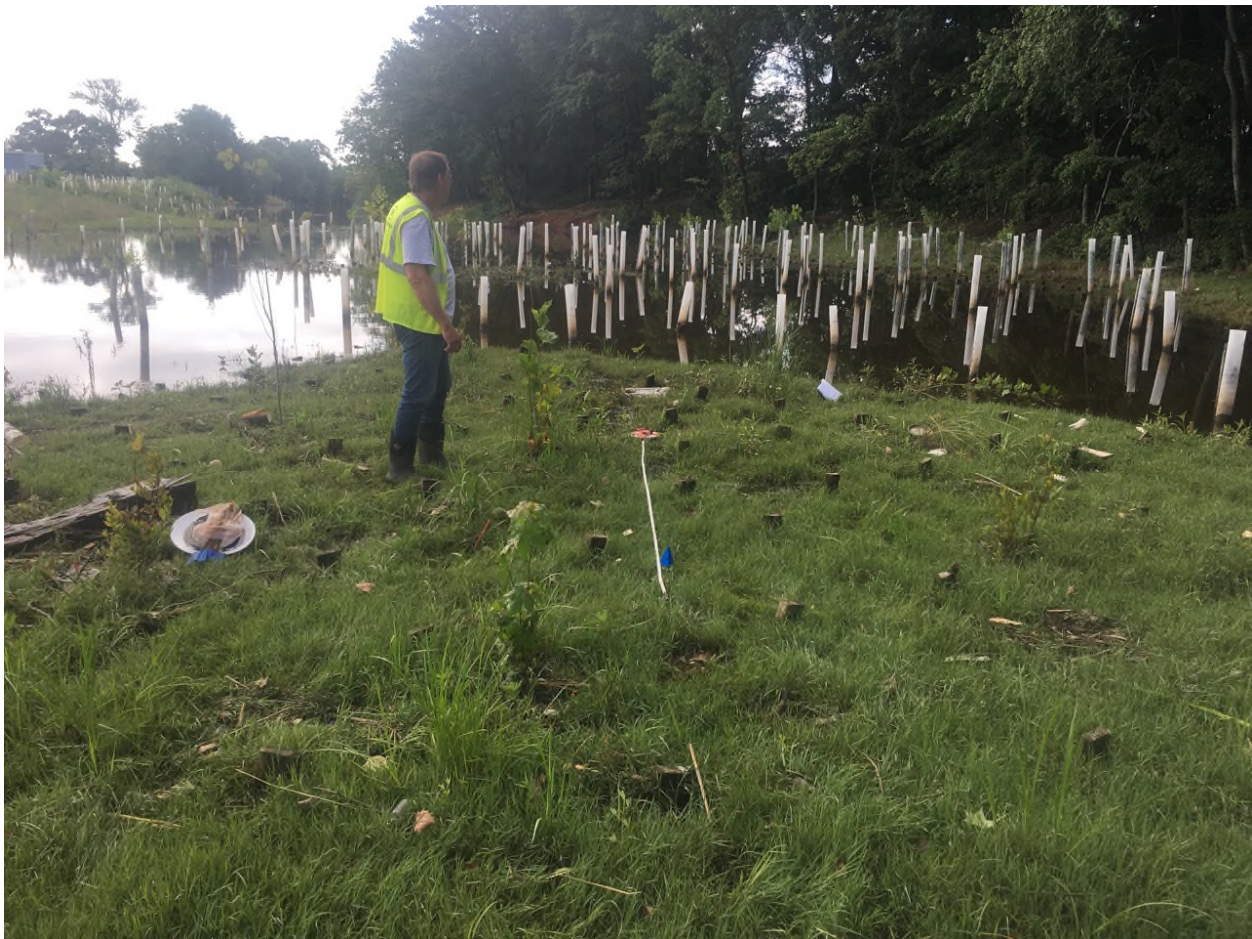
**WP4 (Appendix A: DWG L-104):** This forested wetland sampling location is downstream and southeast of the WP3 plot and is bordered on the south and east by flooded areas (Figure 3-5). Ground cover is 95% with a few small bare spots, and the dominant herbaceous vegetation (with 90% coverage) is the creeping bentgrass that was seeded according to the approved seed mix for wetland areas. Adjacent to the plot, flooded areas lacked ground cover and contained SAV and algae due to prolonged flooded conditions. Woody stem count in this plot was 11, and survival appears to be 100% since no dead shrubs or trees were observed (Table 3-1). Soil in the monitoring location was wet or saturated at the surface. No invasive ground cover was observed within the plot.

**Figure 3-5 WP4 Photo looking down Cow Pen Creek. Soils are saturated to the surface, herbaceous vegetation, shrubs, and trees are doing well.**

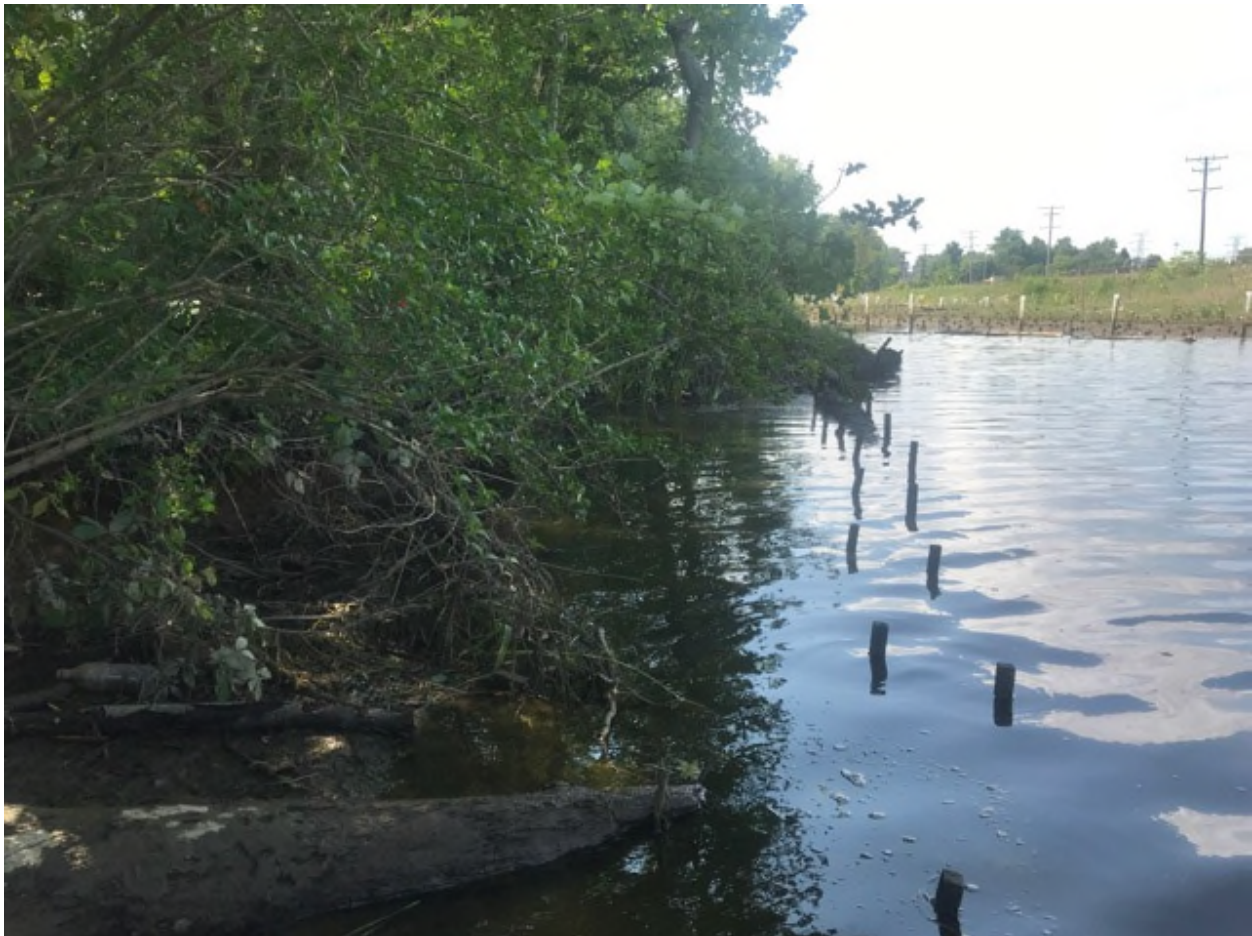
**WP5 (Appendix A: DWG L-105):** This emergent wetland plot is on the southeast shoreline of Cow Pen Creek, downstream of the farthest downstream forested wetland area (Figure 3-6). The shoreline is relatively steep and rapidly transitions to upland forest. This area was flooded at the time of sampling, and no emergent vegetation was found during sampling within the sampling plot. There was a small stand of emergent vegetation consisting of pickerelweed (*Pontederia cordata*) downstream but outside of the plot area. Overall none of the planted emergent vegetation survived in this emergent wetland plot (Table 3-1).

**Figure 3-6 WP5 Photo of near-shore emergent zone. No emergent vegetation was observed.**

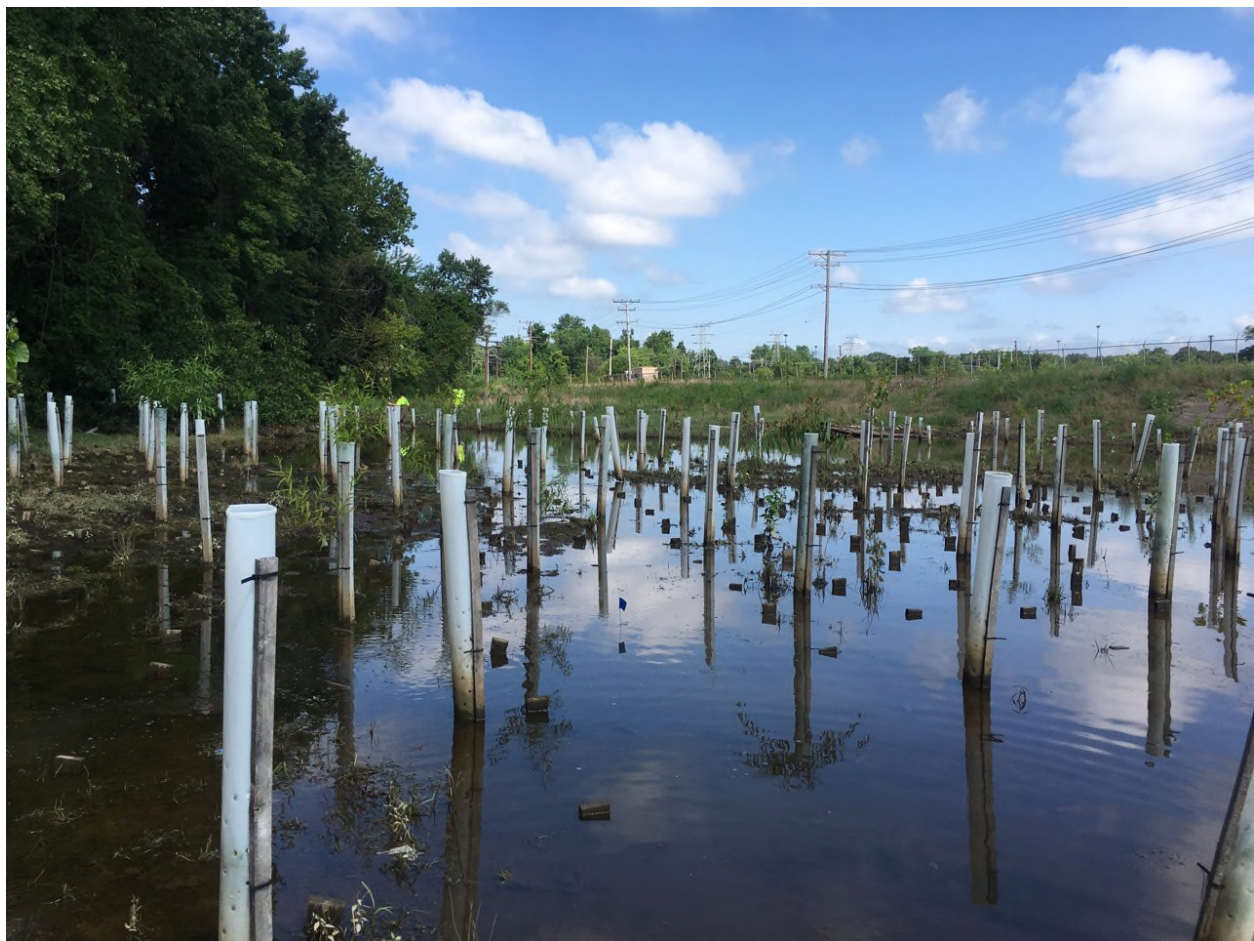
**WP6 (Appendix A: DWG L-105):** This forested wetland plot is on the southeastern shore where the creek bends with the resulting forested wetland along the shore (Figure 3-7). The sampling plot and adjacent areas appear to have been flooded with at least a few inches of water for long periods of time. The flooded soils are 70% covered with algae and SAV. Approximately 10% of the area is at water level and is vegetated with creeping bentgrass, the dominant herbaceous vegetation. Woody plants are mostly trees with protective tree tubes in place. Only 40% of the woody vegetation in this plot is alive, most likely due to the flooded conditions (Table 3-1). As noted previously, shrubs and or trees planted in continually saturated or inundated soils have the best chance of survival when grown in or pre-conditioned to saturated soils, as compared to those grown in typical nursery potting mixes then planted in anaerobic soils. The forested wetland areas adjacent to this plot contained both live and dead woody plants. No invasive herbaceous plants or woody plants were observed within the plot.

**Figure 3-7 WP6 Photo of southern shore looking northeast. This area is shown on the design plan as forested wetland, but the area appears to be continually flooded; that may be the reason for limited survival.**

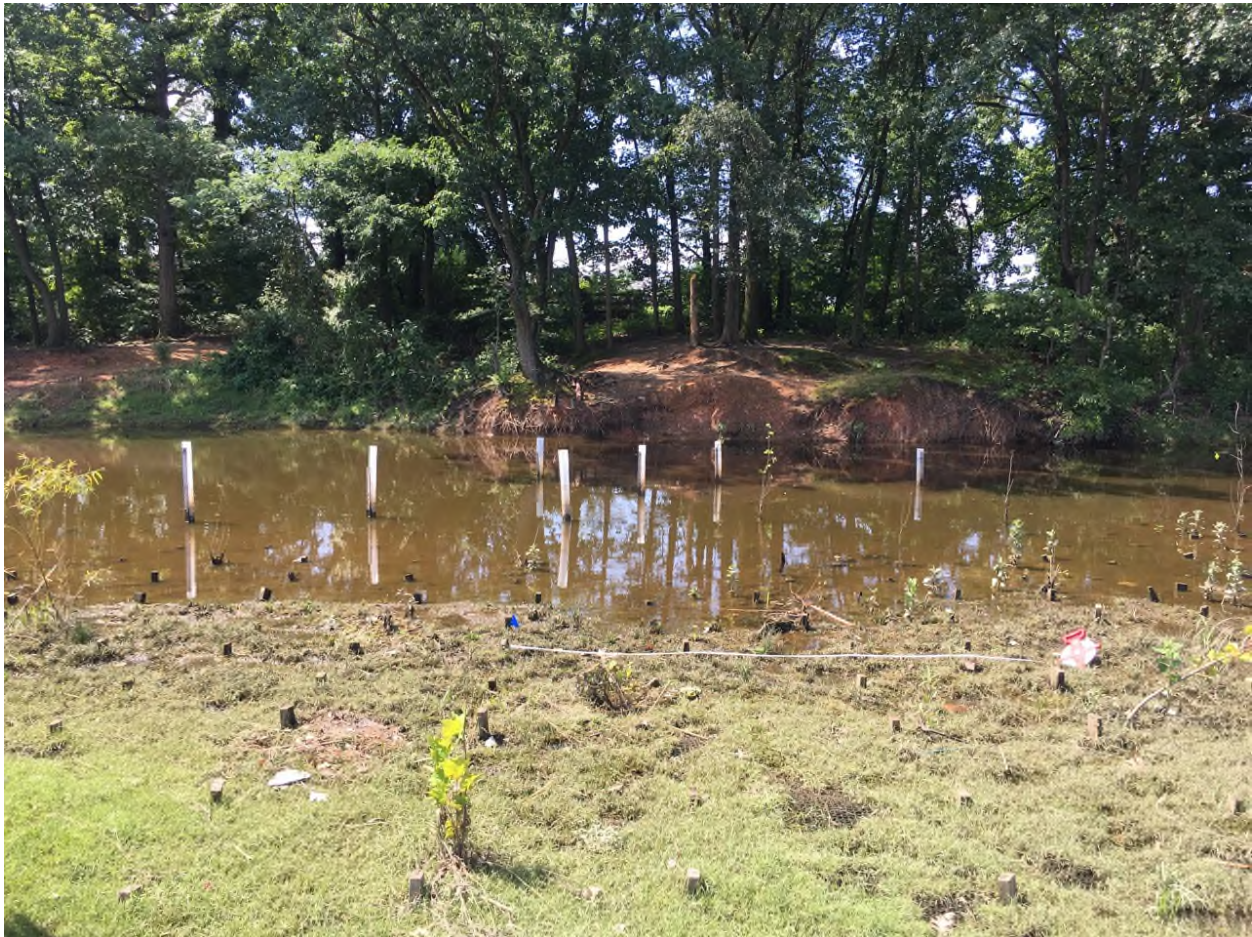
**WP7 (Appendix A: DWG L-105):** This forested wetland plot is on the northwestern shore, downstream from WP6 and is the farthest downstream area of forested wetland (Figure 3-8). The soils transition from saturated at the surface to inundated or flooded. The trees and shrubs that are in areas prone to flooding have a low survival rate, while woody plants that have not been subject to flooding and are in wetland areas have a higher survival rate. Ground cover was 50% with a few small bare spots, the dominant herbaceous vegetation (with 50% coverage) is creeping bentgrass. No ground cover or SAV were observed within the flooded area of the plot. Woody stem count was 10 with no dead woody plants observed (Table 3-1). Dead woody plants were observed in the flooded area beyond the plot. Groundsel bush (*Baccharis halimifolia*) appeared as six to ten stems adjacent to the plot and appeared to have established by natural recruitment.

**Figure 3-8 WP7 Photo looking southwest away from Martin Boulevard. Vegetation on soils that are not inundated is surviving. Dominant herbaceous vegetation is creeping bentgrass. Note groundsel bush (*Baccharis halimifolia*) on the right in the water appears to have established from natural recruitment.**

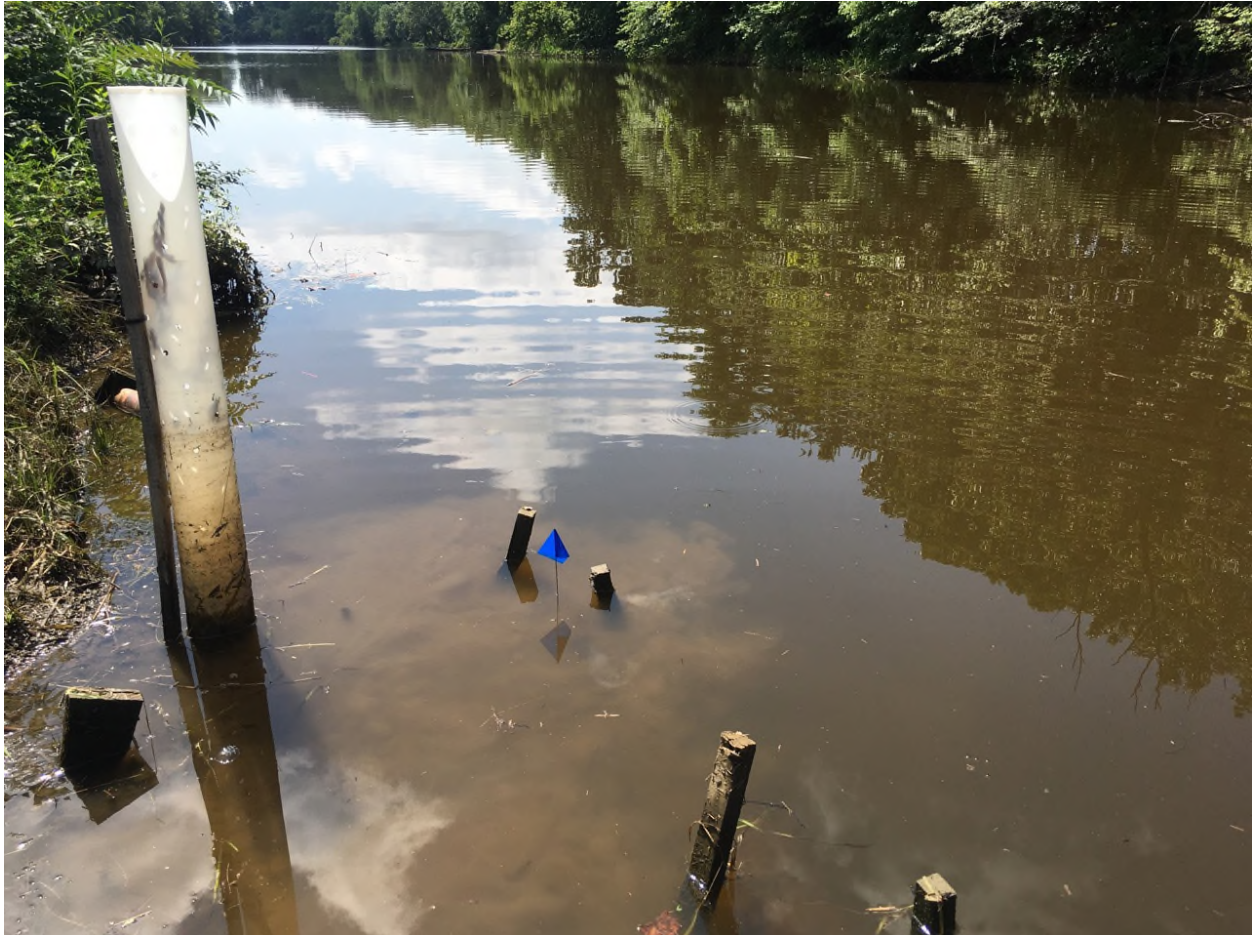
**WP8 (Appendix A: DWG L-106):** This emergent wetland sampling plot is on the northwestern shore, downstream from the forested wetland areas (Figure 3-9). The plot was flooded at the time of sampling, no emergent vegetation or any vegetation was observed at the sampling point (Table 3-1). It is possible no vegetation was observed due to limited visibility.

**Figure 3-9 WP8 Photo of emergent wetland zone near shore. North shore looking down Cow Pen Creek.**

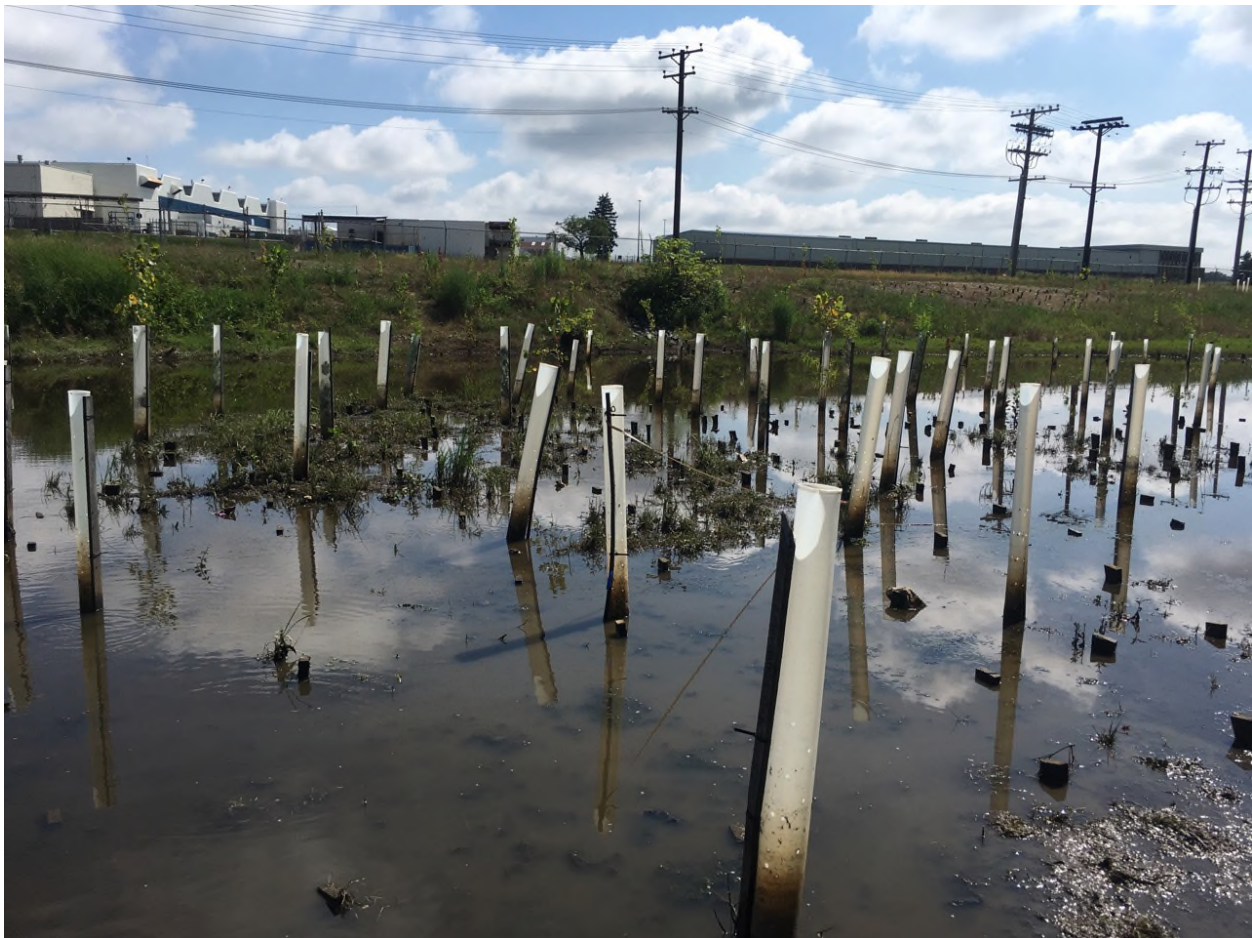
**WP9 (Appendix A: DWG L-105):** This forested wetland plot is on the southeastern shore where the creek bends from running towards the east to a southeast direction (Figure 3-10). Like the adjacent sampling plot, WP6, this area appears to be in an area prone to flooding and at the time of observation were covered with at least a few inches of water. The flooded soils are 20% covered with algae and SAV. About 10% of the area is at water level and is vegetated with creeping bentgrass, the dominant herbaceous vegetation. Woody plants are mostly trees with protective tree tubes in place. Only 10% of the woody vegetation in this plot are alive, most likely due to the continuous flooding (Table 3-1). The forested wetland areas adjacent to this plot contained both live and dead woody plants. No invasive herbaceous or woody plants were observed within the plot. The area is matted.

**Figure 3-10 WP9 Photo of forested wetland. West shore of forested wetland looking towards Lockheed Martin Complex.**

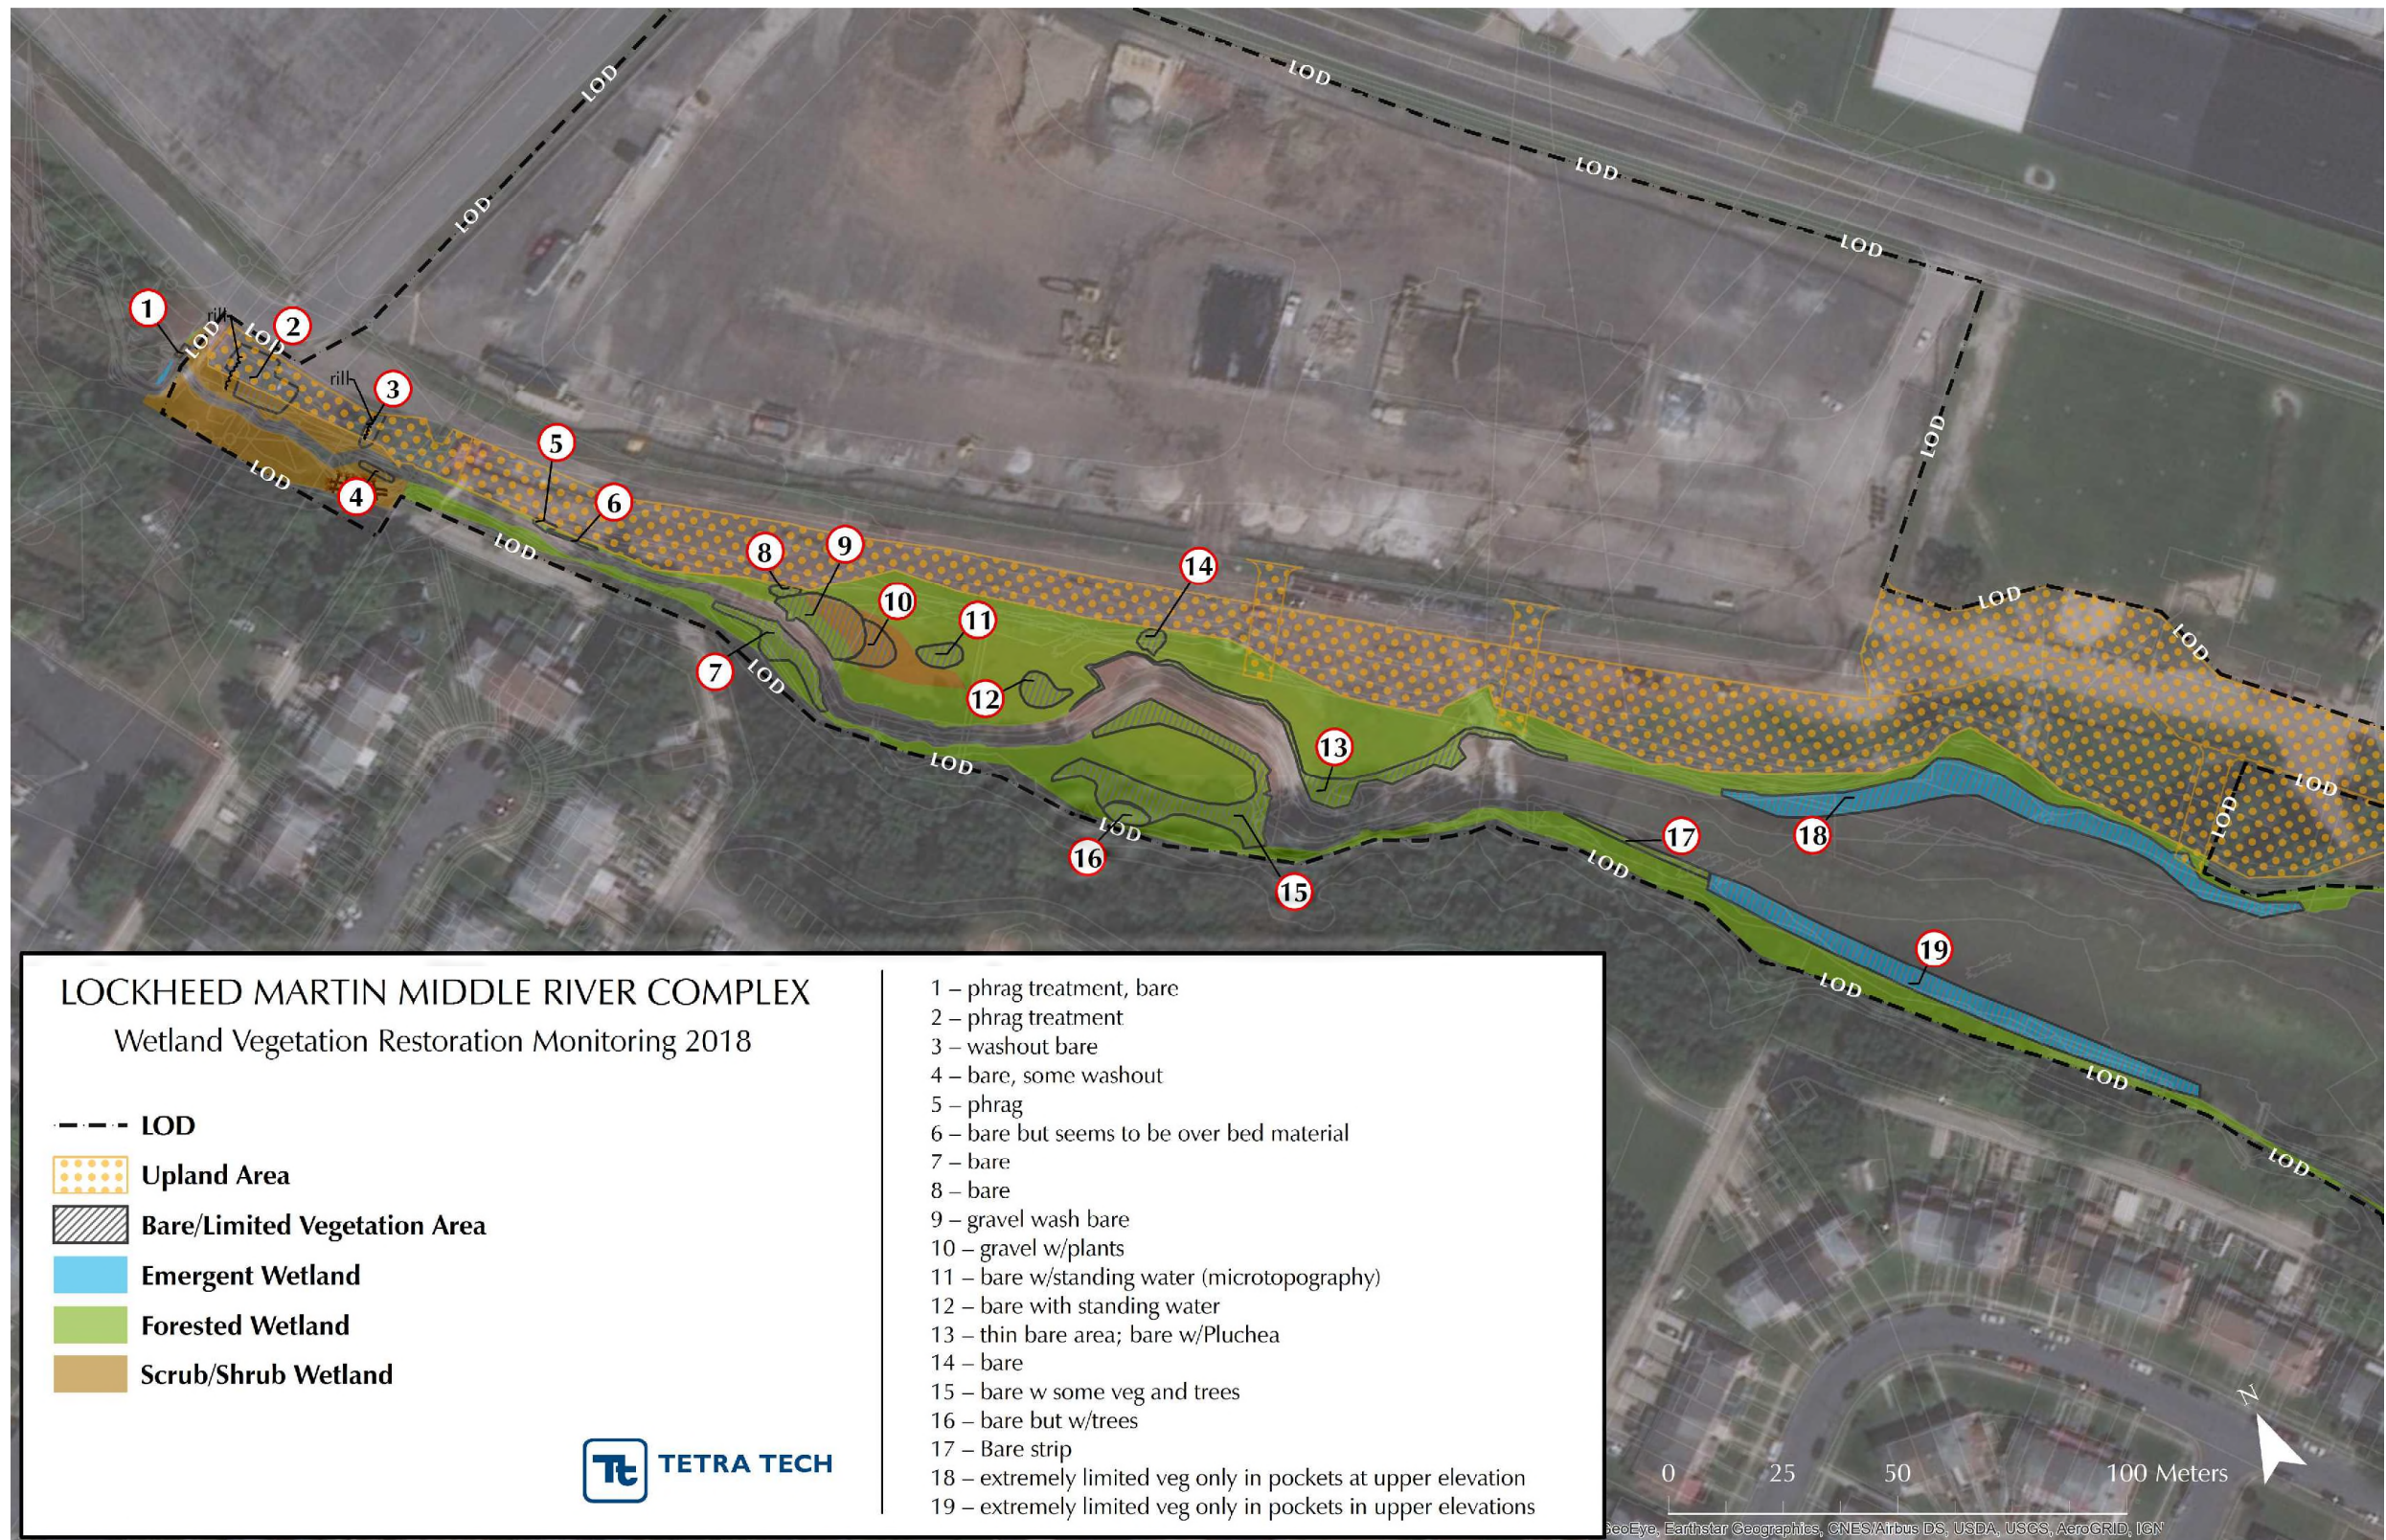
Two areas of scrub-shrub wetland were restored, one in the BGE easement near the upstream portion of the site and one about half way downstream. Areas of scrub-shrub wetlands that are not flooded are dominated by bentgrass and contain planted shrubs and trees. Part of the downstream scrub-shrub wetland closest to the stream channel was flooded with two to three inches of water and appeared to be consistently inundated with water over extended periods of time (Figure 4-1). Most of the flooded area does not contain planted shrubs. The revegetation plan calls for shrubs in this area.

Figure 4-1 Site-wide observation map of bare areas in restored wetlands along Cow Pen Creek.

The site plan shows emergent wetlands along the downstream banks of the site. We observed one small patch of pickerelweed (*Pontederia cordata*) on the southern shore at or near the boundary of the site. The water along the shore was turbid but visibility was approximately 6 to 12 inches, yet no emergent vegetation or SAV was observed above or below the water. More than 90% of the area designated as emergent wetland lacked vegetation (Figure 4-1).
