Subject: Transmittal of the Cow Pen Creek Wetland Restoration and Monitoring Report  
Lockheed Martin Corporation; Middle River Complex  
2323 Eastern Boulevard, Middle River, Baltimore County, Maryland

**COW PEN CREEK  
WETLAND RESTORATION MONITORING REPORT  
2323 EASTERN BOULEVARD  
LOCKHEED MARTIN MIDDLE RIVER COMPLEX  
MIDDLE RIVER, MARYLAND**

January 2019

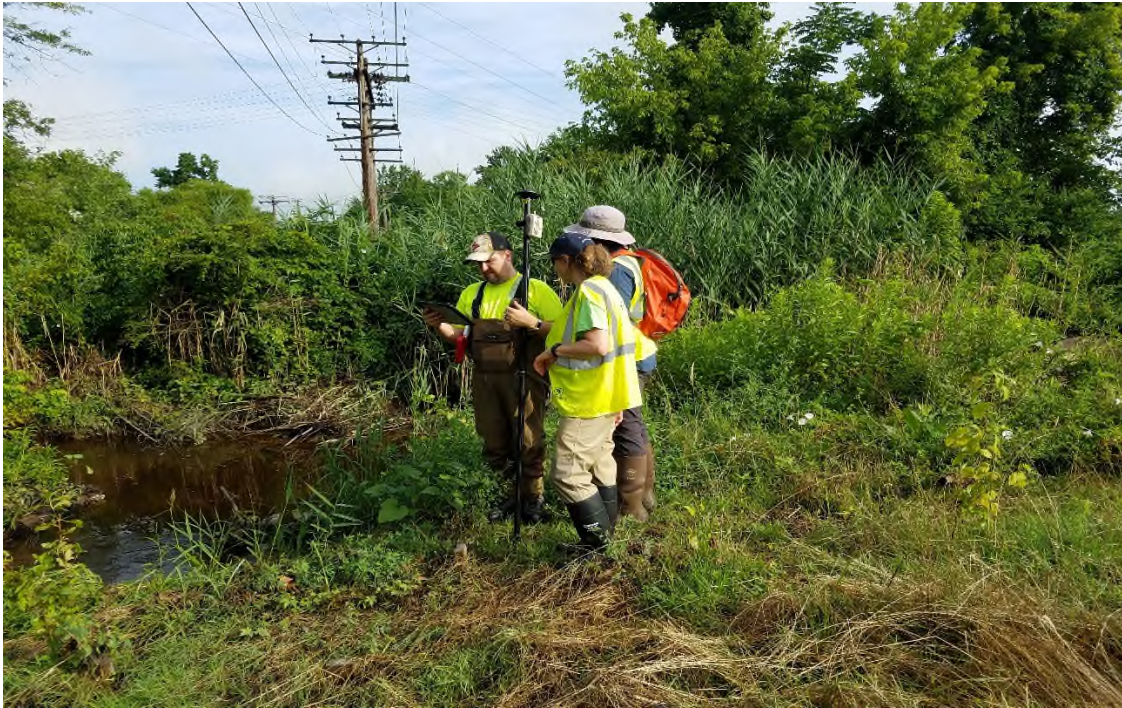
*Figure 1– Upstream boundary of project area. Invasive common reed in background.*

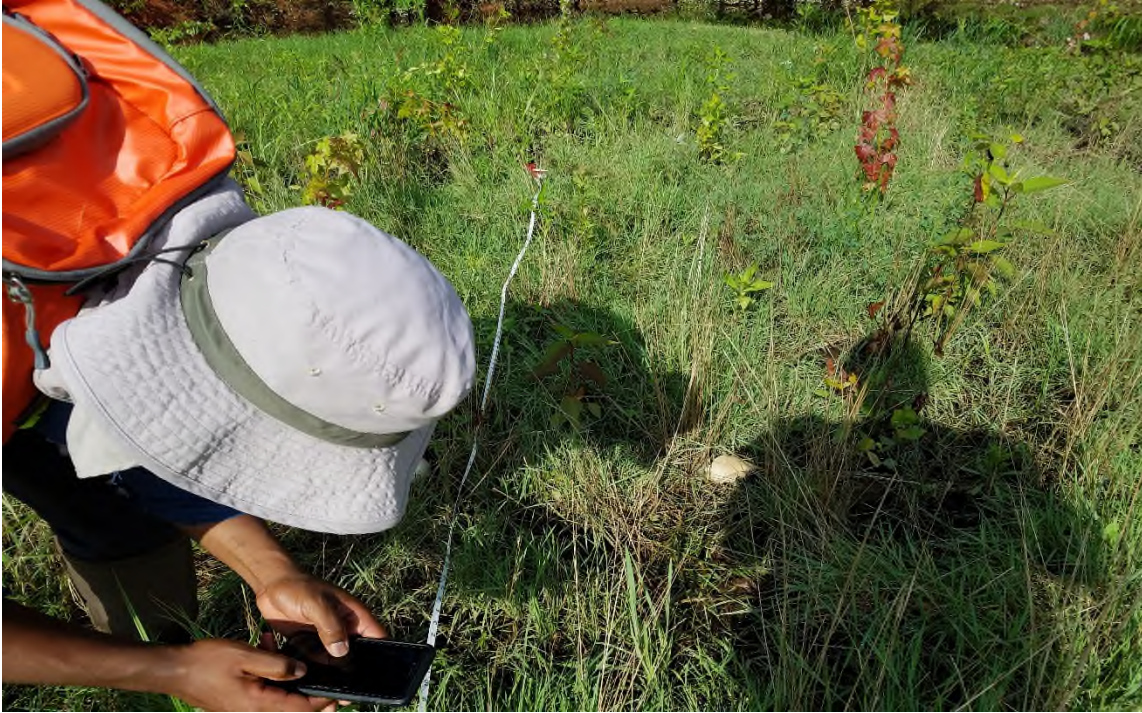
*Figure 2 – Good vegetation coverage in wetland areas that were not flooded.*

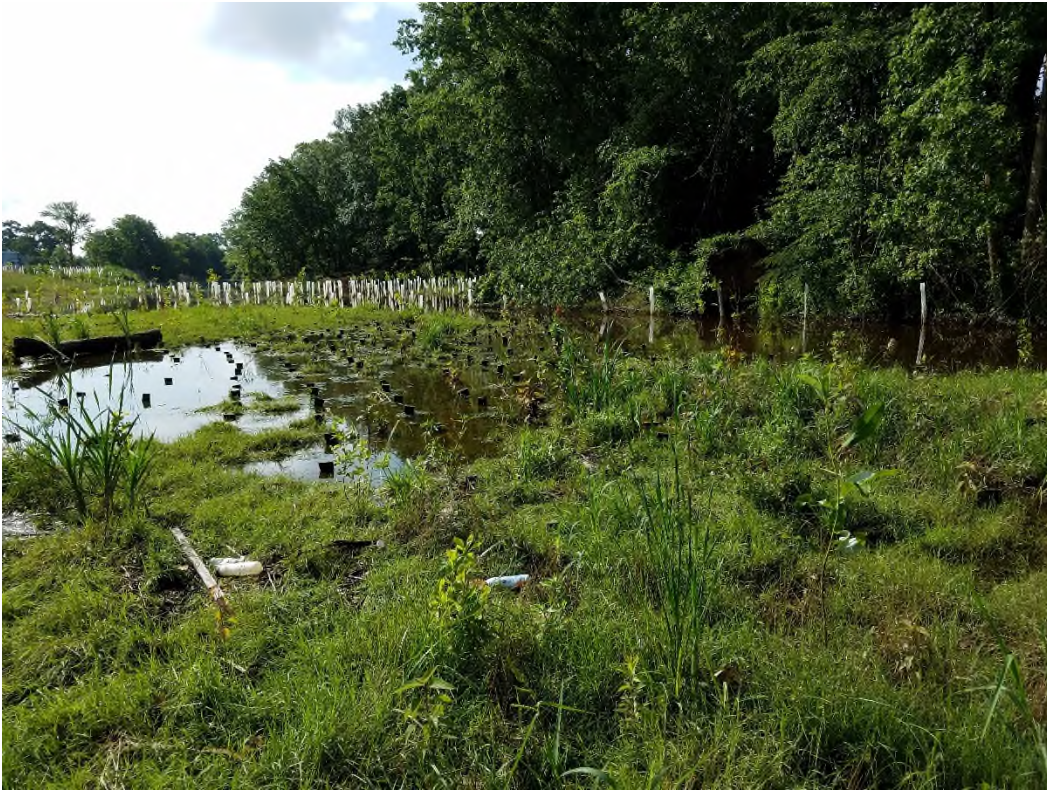
*Figure 3 – Scrub Shrub wetland; note that cattails are starting to grow.*

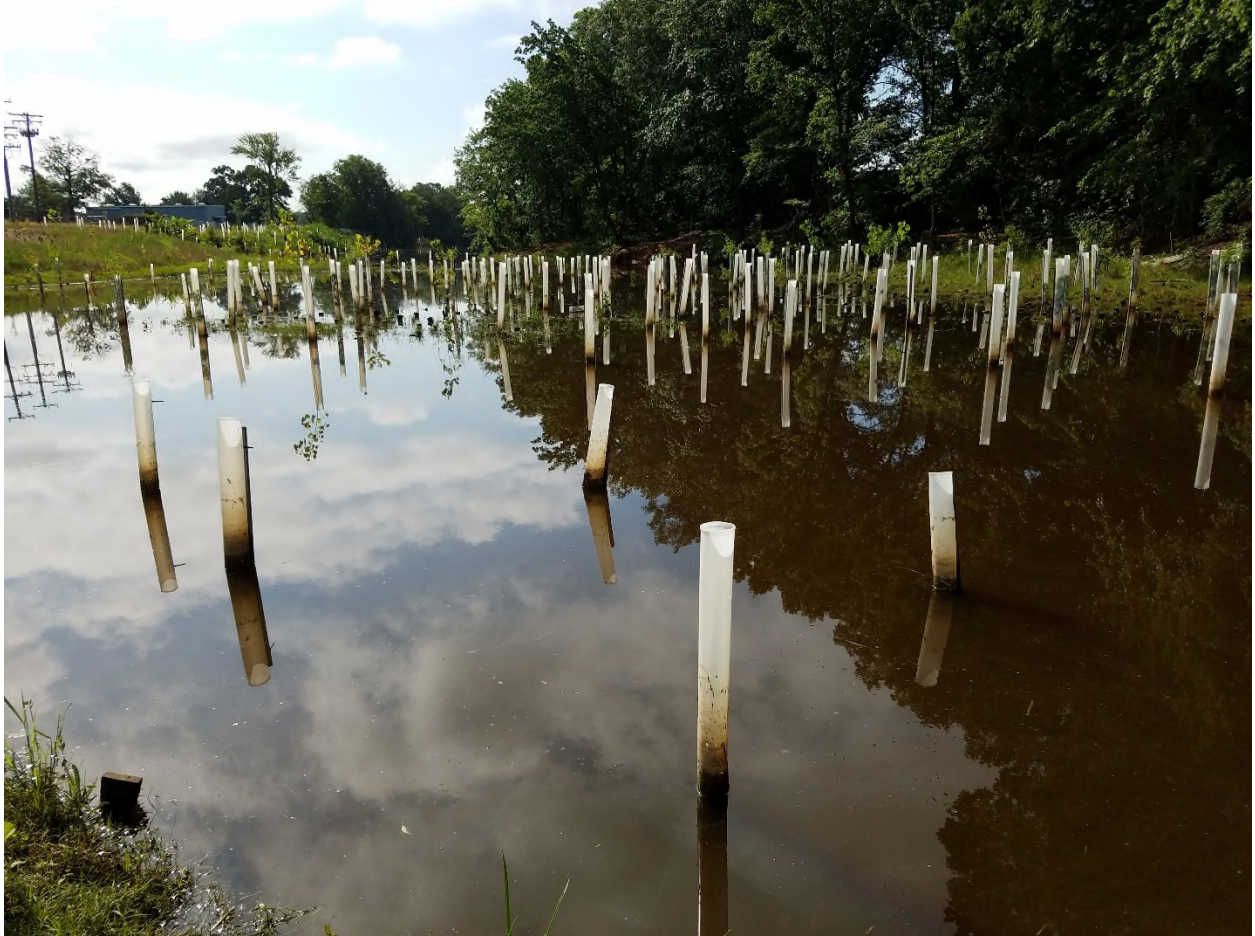
*Figure 4 – Downstream area designated on site plan as forested wetland. Area is flooded and most of the woody plants are dead.*

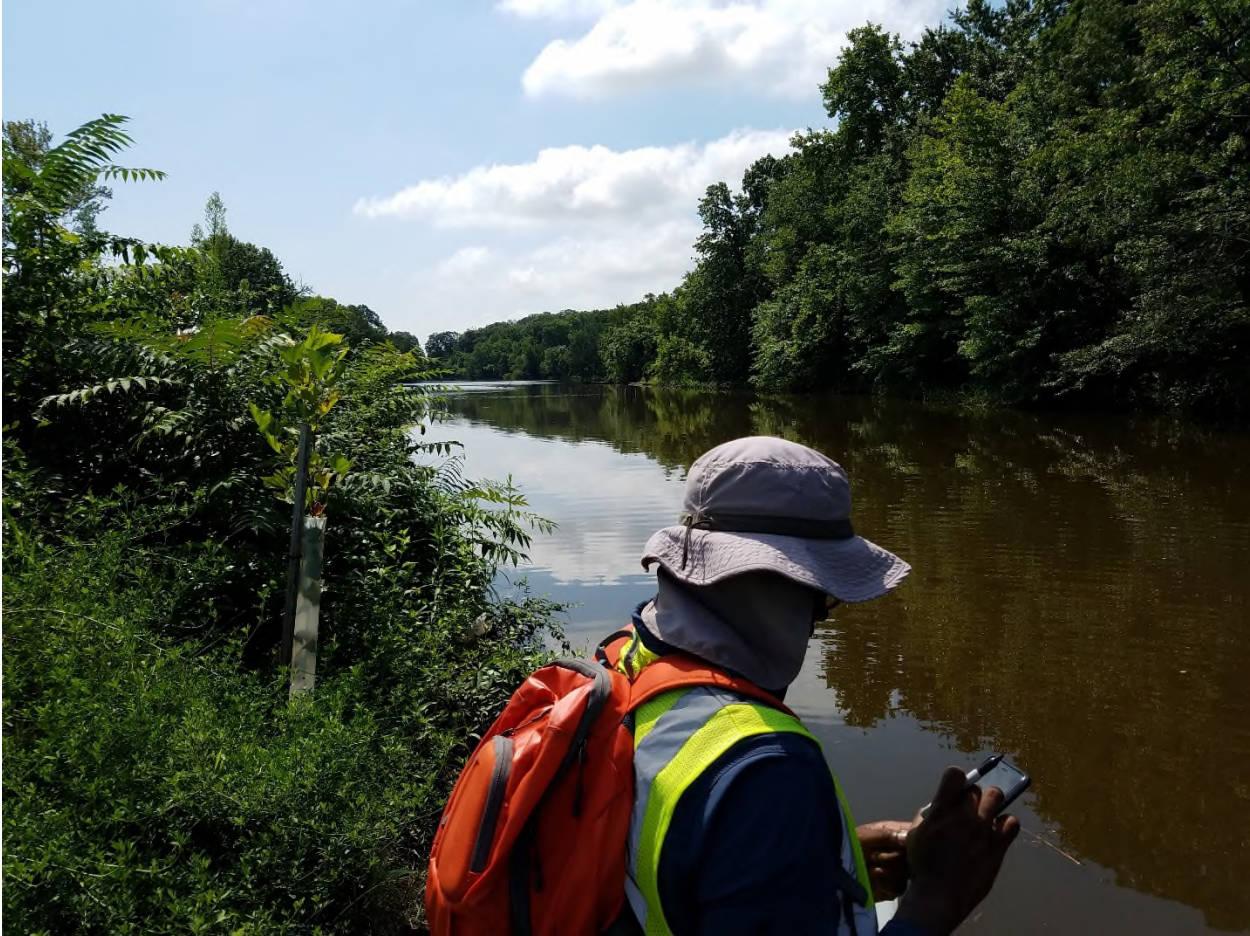
*Figure 5 – Area designated as emergent wetlands along creek. No emergent plants at this location.*
