Subject: Transmittal of the Cow Pen Creek Wetland Restoration Monitoring Report
Lockheed Martin Corporation – Middle River Complex
2323 Eastern Boulevard, Middle River, Baltimore County, Maryland

**COW PEN CREEK
WETLAND RESTORATION MONITORING REPORT
2323 EASTERN BOULEVARD
LOCKHEED MARTIN MIDDLE RIVER COMPLEX
MIDDLE RIVER, MARYLAND**

March 2020

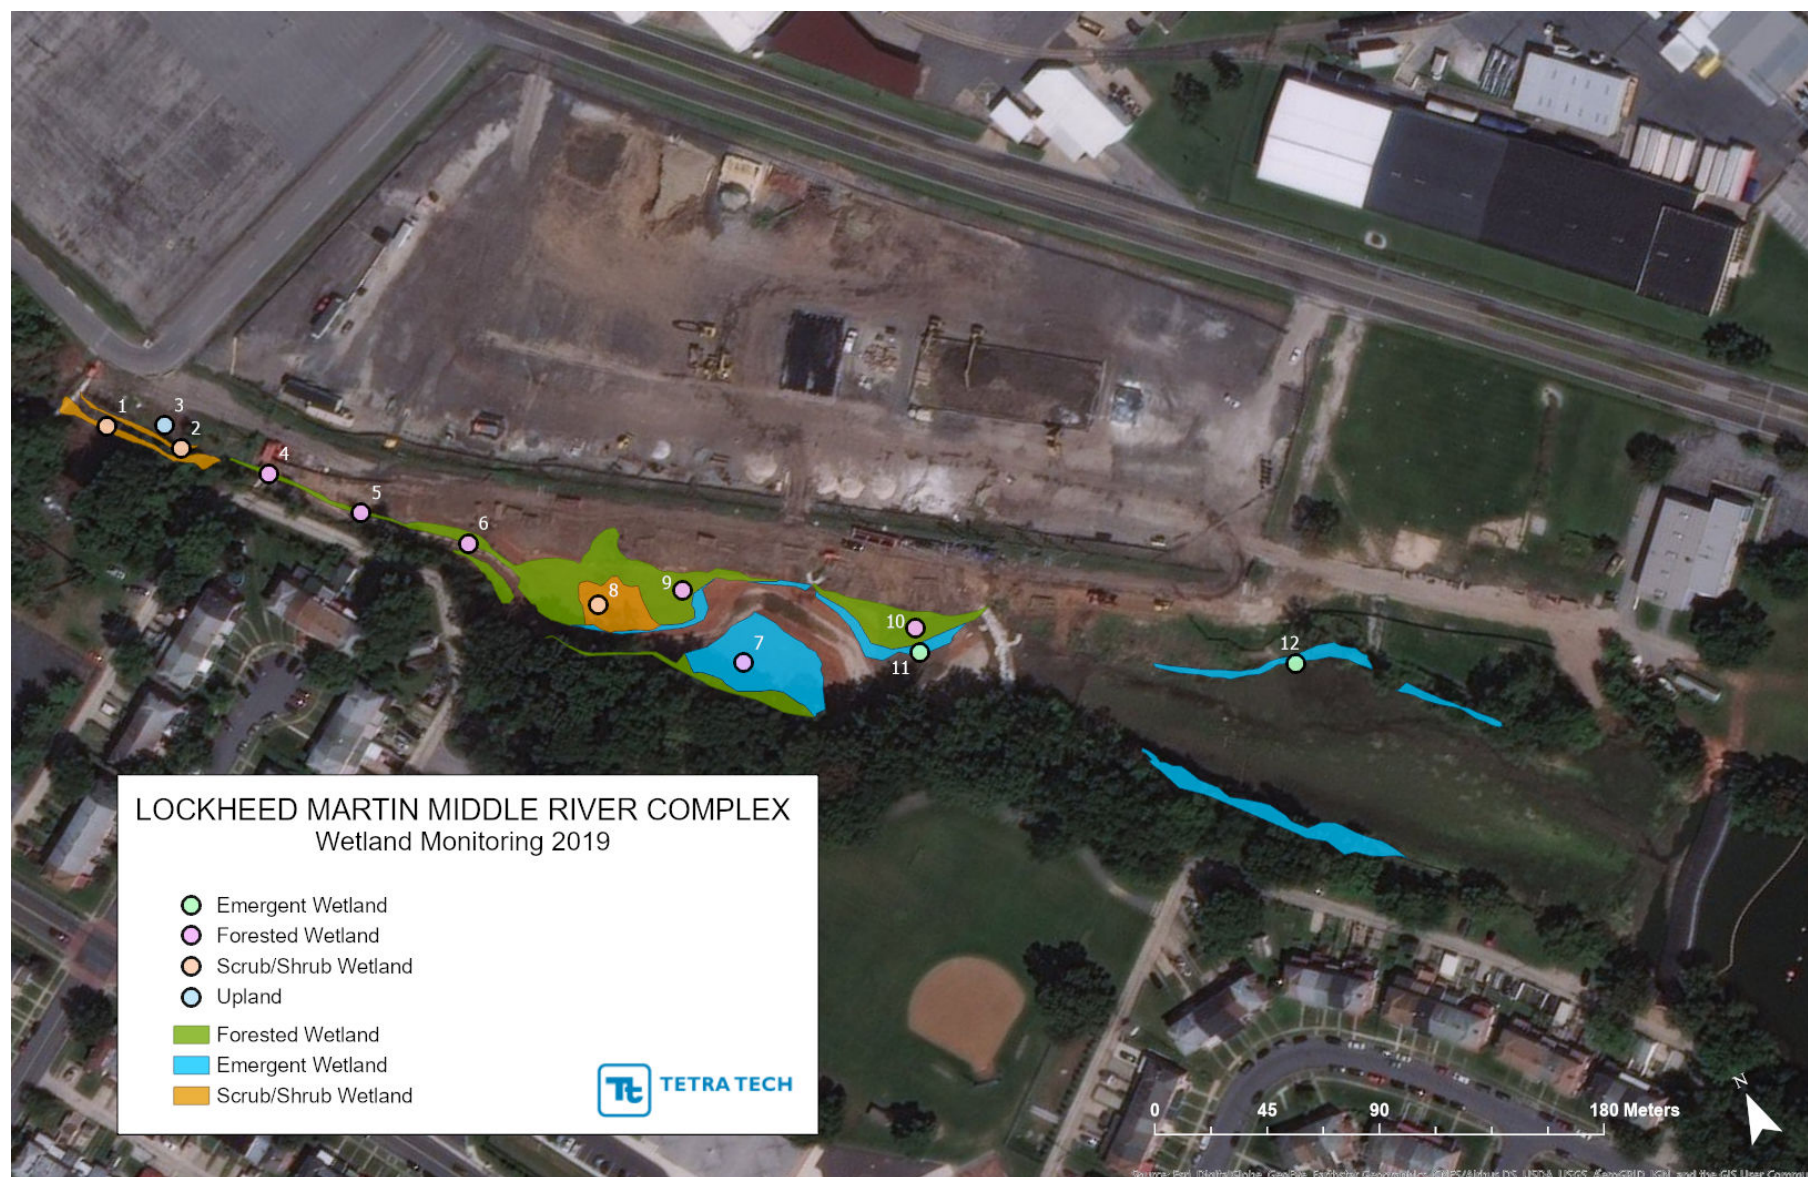
Figure 3-1. Map of 2019 wetland monitoring plot locations.

Sampling locations for 2019 (numbered 1–12) are shown on Figure 3-1. Table 3-1 provides a summary of the vegetation observed and recorded at each site, per the monitoring and data collection objectives outlined in Section 3-1. Note that no dead shrubs or trees were observed,

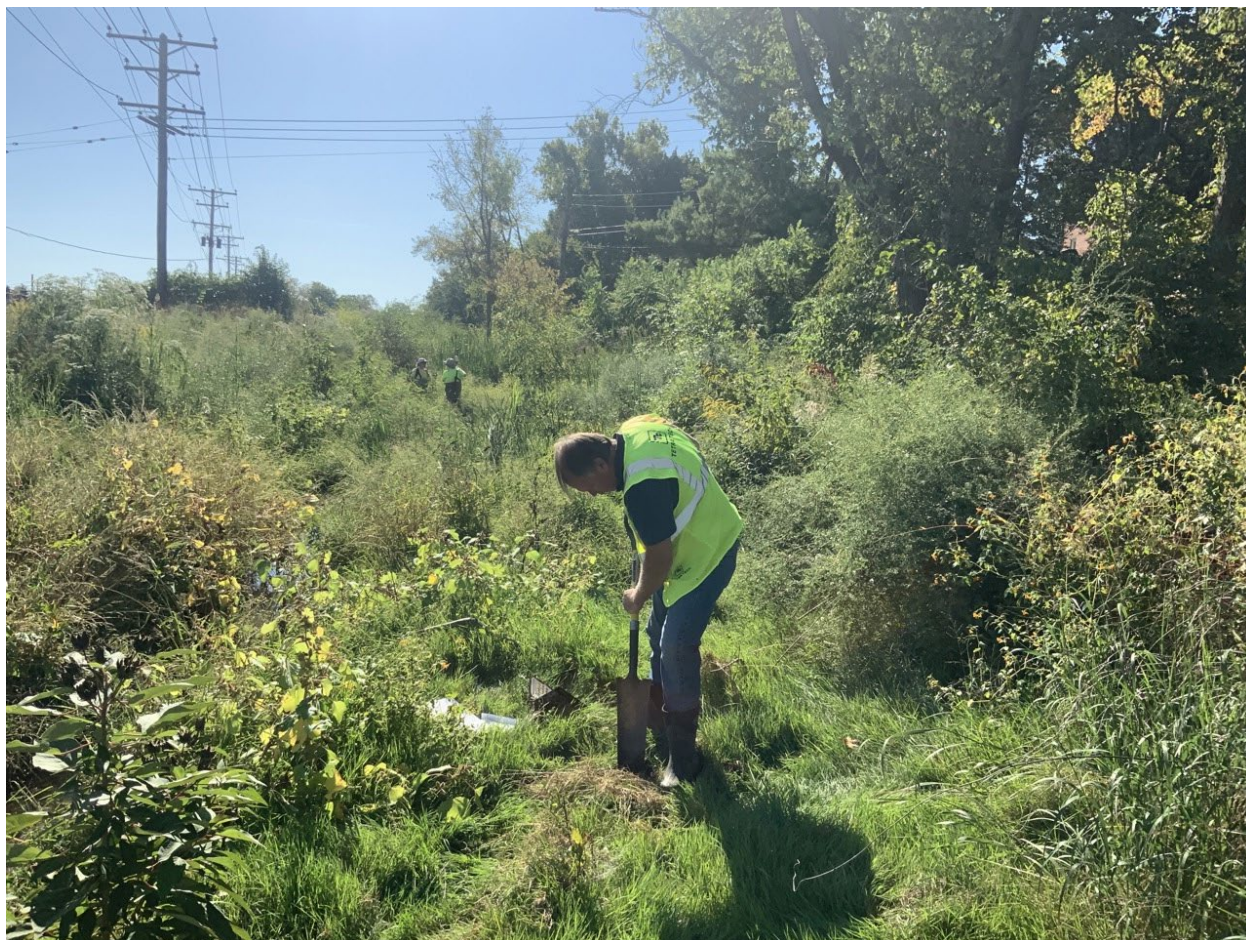
Plot 1: This scrub-shrub wetland monitoring location is between stormwater Outfalls 002 and 003 (Figures 3-1 and 3-2). Ground cover is 100% with no bare spots, and the dominant herbaceous vegetation (with 95% coverage) is creeping bentgrass (*Agrostis stolonifera*), that was seeded according to the approved seed mix for wetland areas. Woody stem count in this plot was 4 and there appears to be 100% survival of planted woody material since no dead shrubs were observed (Table 3-1). Soil in the monitoring location was wet or saturated at the surface and is hydric based on colors and features (Table 3-2). Some small patches of common reed were observed near this location, but none were within the sampling plot.

Plot 2: This scrub-shrub wetland monitoring location is downstream of plot 1. Ground cover is 100% with no bare spots, and the dominant herbaceous vegetation (with 95% coverage) is creeping bentgrass that was seeded per the approved seed mix for wetland areas. Three plants with woody stems were observed in this plot, with an apparent 100% survival of planted woody material, as no dead shrubs were observed. Several common burdocks (*Arctium minus*) were observed in the area. Soil in the monitoring location was wet or saturated at the surface and is hydric based on colors and features.

Figure 3-2. Scrub-shrub wetland near power line (Plots 1 and 2), facing southeast.

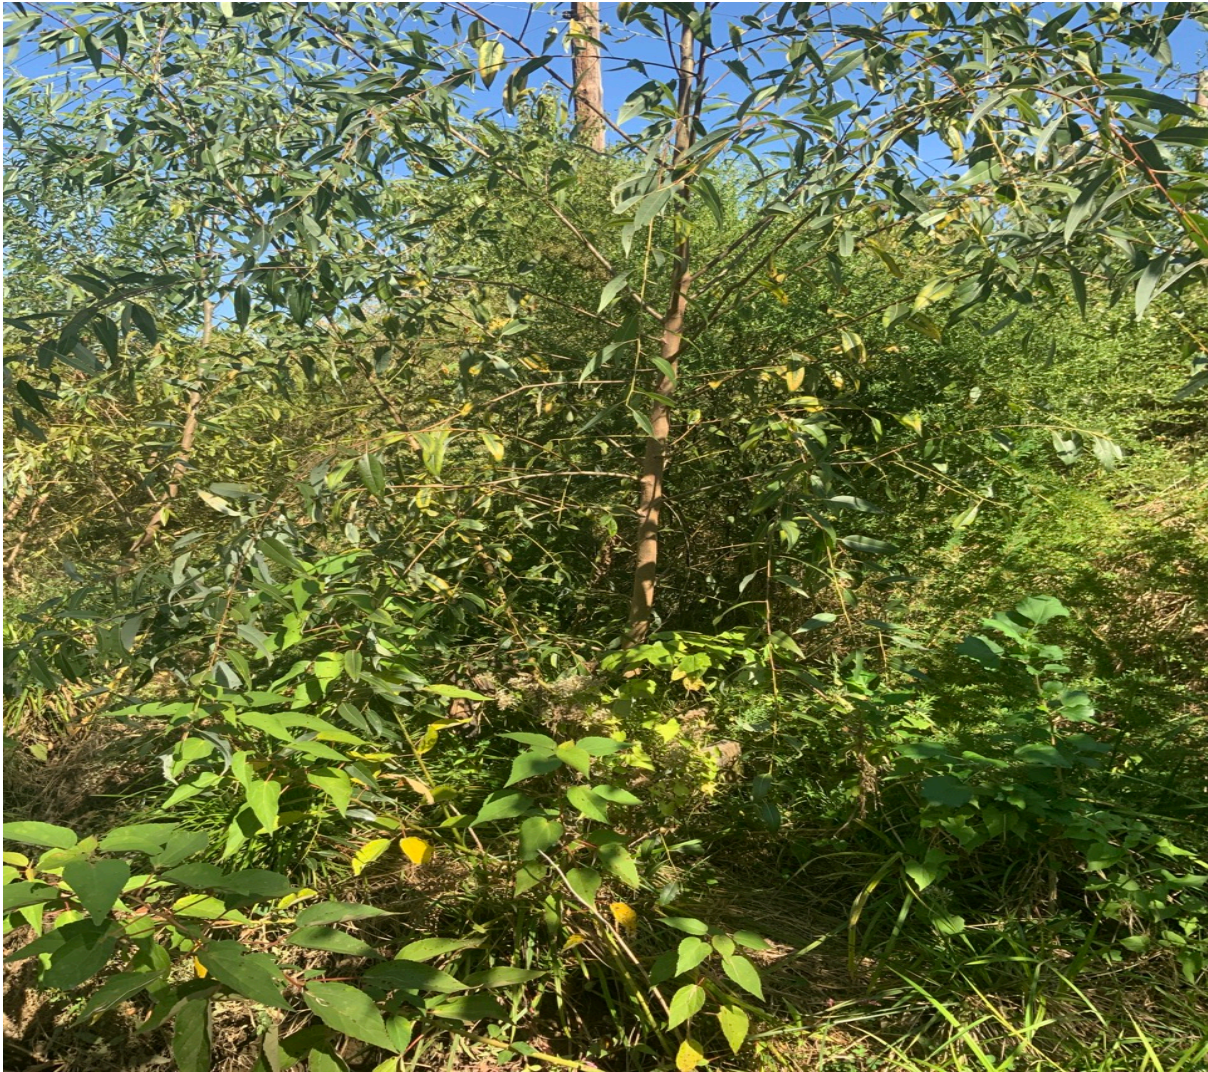
Plot 3: This monitoring location (Figure 3-3) is upslope between plots 1 and 2 in an upland area that was selected to be representative of upland conditions across the entire study area. Soil at this location is not hydric and can be used to compare upland conditions to wetland conditions in the restoration area. The dominant vegetation in this plot is turf-type fescue. No woody stem plantings are within the plot, although tree seedlings from natural recruitment are present in the area.

Figure 3–3. Forest wetland on upslope (Plot 3), facing east.

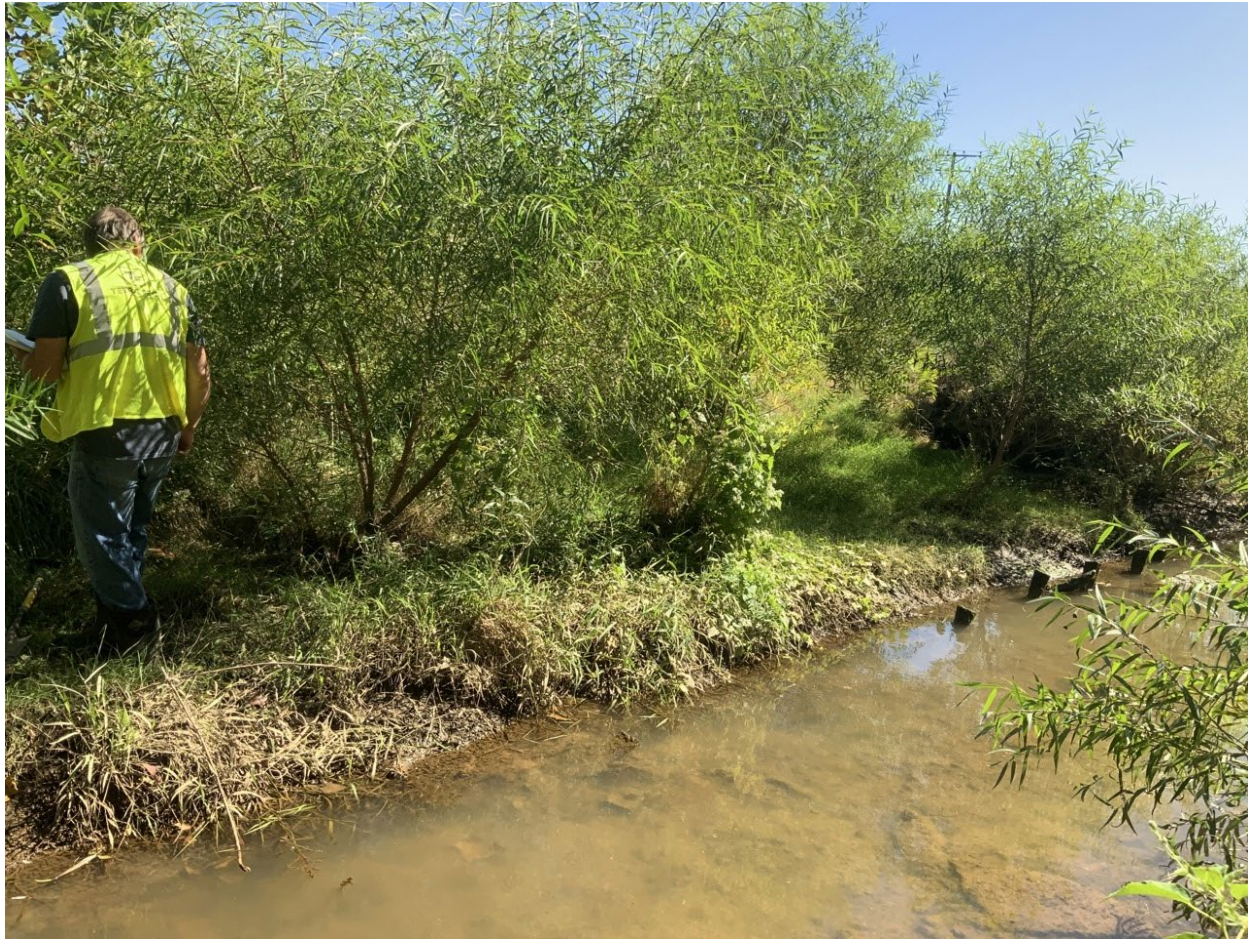
Plot 5: This forested wetland sampling location is downstream and southeast of plot 4 and in a narrow band of forested wetland along the stream (Figure 3-4). Ground cover is 100%, and the dominant herbaceous vegetation is creeping bentgrass, seeded per the approved seed mix for wetland areas. Like plot 4, sedges have become more numerous since the 2018 monitoring. Common beggar's tick (*Bidens frondosa*) is becoming common. Five plants with woody stems were observed at this site, and survival appears to be 100% as no dead shrubs or trees were observed. Planted tree species observed include sweet gum, red maple, and sycamore. Black willow is the dominant tree species and is numerous along the edge of the site, and more numerous as compared to that observed during the 2018 monitoring. Soil in the monitoring location was wet or saturated at the surface and is hydric based on colors and features. No invasive ground cover was observed within the plot.

Figure 3-4 Forested wetland including willows near Cow Pen Creek (Plot 5), facing southeast.

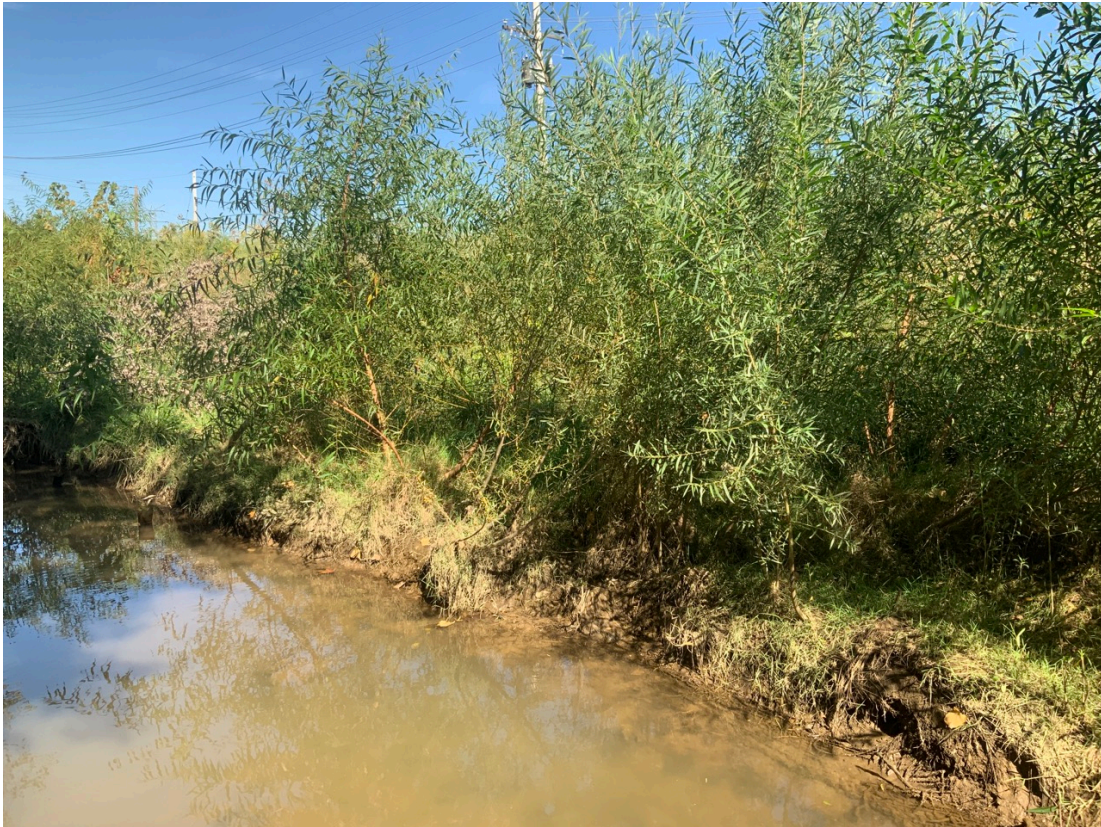
Plot 6: This forested wetland sampling location is downstream of plot 5 where the stream starts to widen (Figure 3-5). Ground cover is 100%, the dominant herbaceous vegetation is the creeping bentgrass that was seeded according to the approved seed mix for wetland areas. A few soft rush (*Juncus effuses*) were present. Nine plants with woody stems were counted at this site, and survival appears to be 100% as no dead shrubs or trees were observed. Planted tree species observed include sweet gum, red maple, and sycamore, with some natural recruitment of seedlings of the same species. Black willow is the dominant tree species. Soil in the monitoring location was wet or saturated at the surface and is hydric based on colors and features. No invasive ground cover was observed within the plot.

Figure 3-5. Forested wetland with willows bordering Cow Pen Creek (Plot 6), facing northwest.

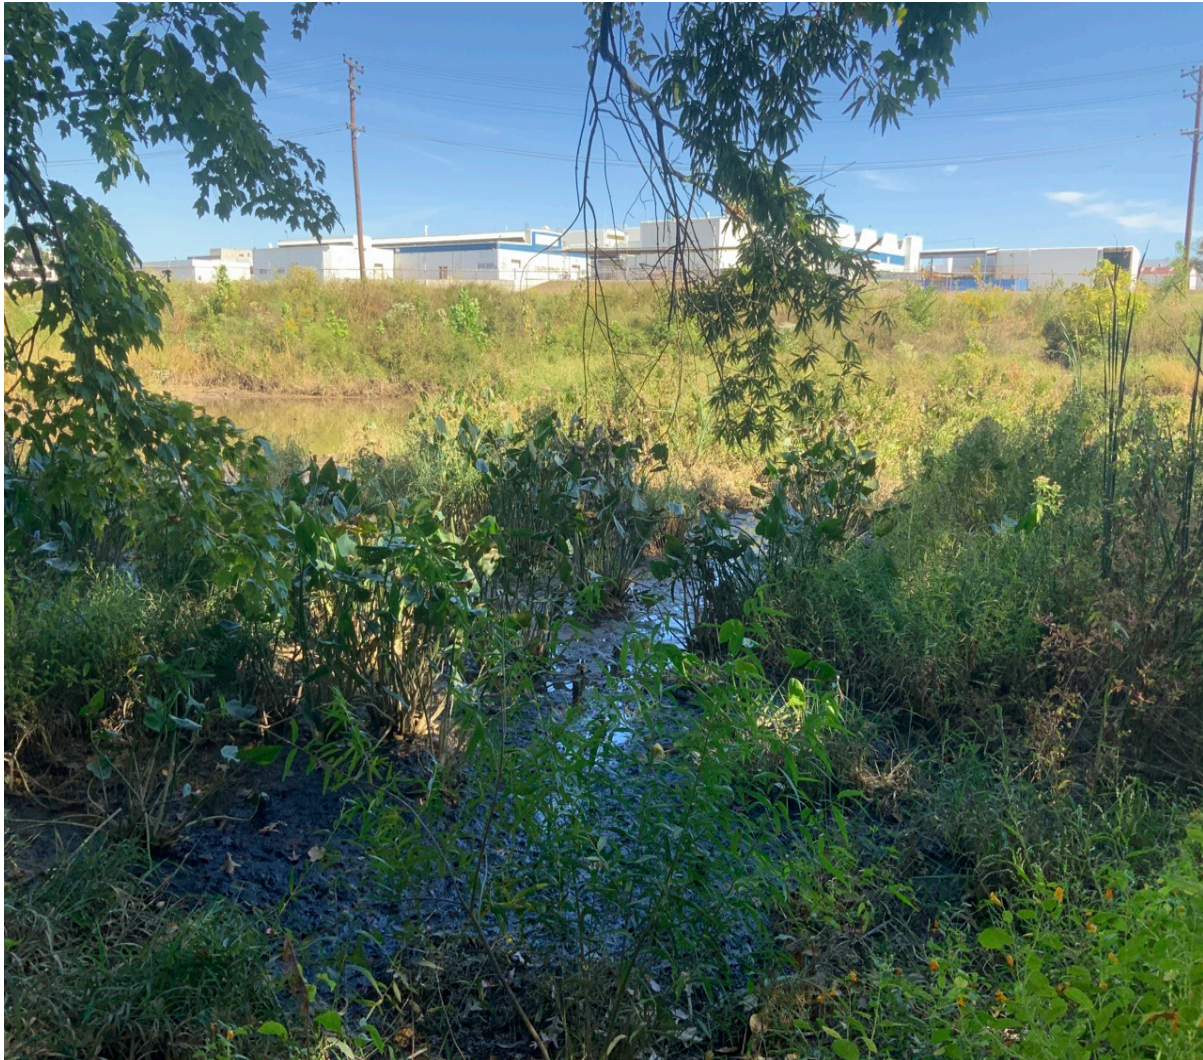
Plot 7: This forested wetland plot is on the southeastern shore on the school side where the creek bends from running towards the east to a southeast direction (Figure 3-6). This area is frequently inundated at high tide. Only 10% of this area was covered with vegetation when observed in

September 2018, but as of September 2019, 90% of the area is covered by herbaceous vegetation, with hibiscus or rose mallow (*Hibiscus moschuetos*) and orange jewelweed (*Impatiens campensis*) being dominant. There is some natural recruitment of tree seedlings (including sycamore, red maple, and sweet gum) closer to the upland bank and existing upland tree line. Six woody stem plants were counted, including four hibiscus and two sycamore seedlings. About 90% of planted trees and shrubs did not survive, likely due to inundation. No invasive herbaceous or woody plants were observed within the plot. This area is proposed for replanting with more inundation tolerant trees. Bald cypress (*Taxodium distichum*) is one of the best candidates for this site and is on the Maryland Aviation Administration (MAA) list of approved species. Although we are slightly north of its natural range in Calvert County, bald cypress will likely thrive and reproduce at this site as conditions in plot 7 are similar to the hydrologic conditions in its native stands farther south in Maryland. This site will provide the constantly saturated seed bed that is needed for a successful high percentage germination of bald cypress.

Figure 3-6. Forested and emergent wetland on Hawthorne side of Cow Pen Creek (Plot 7), facing northeast.

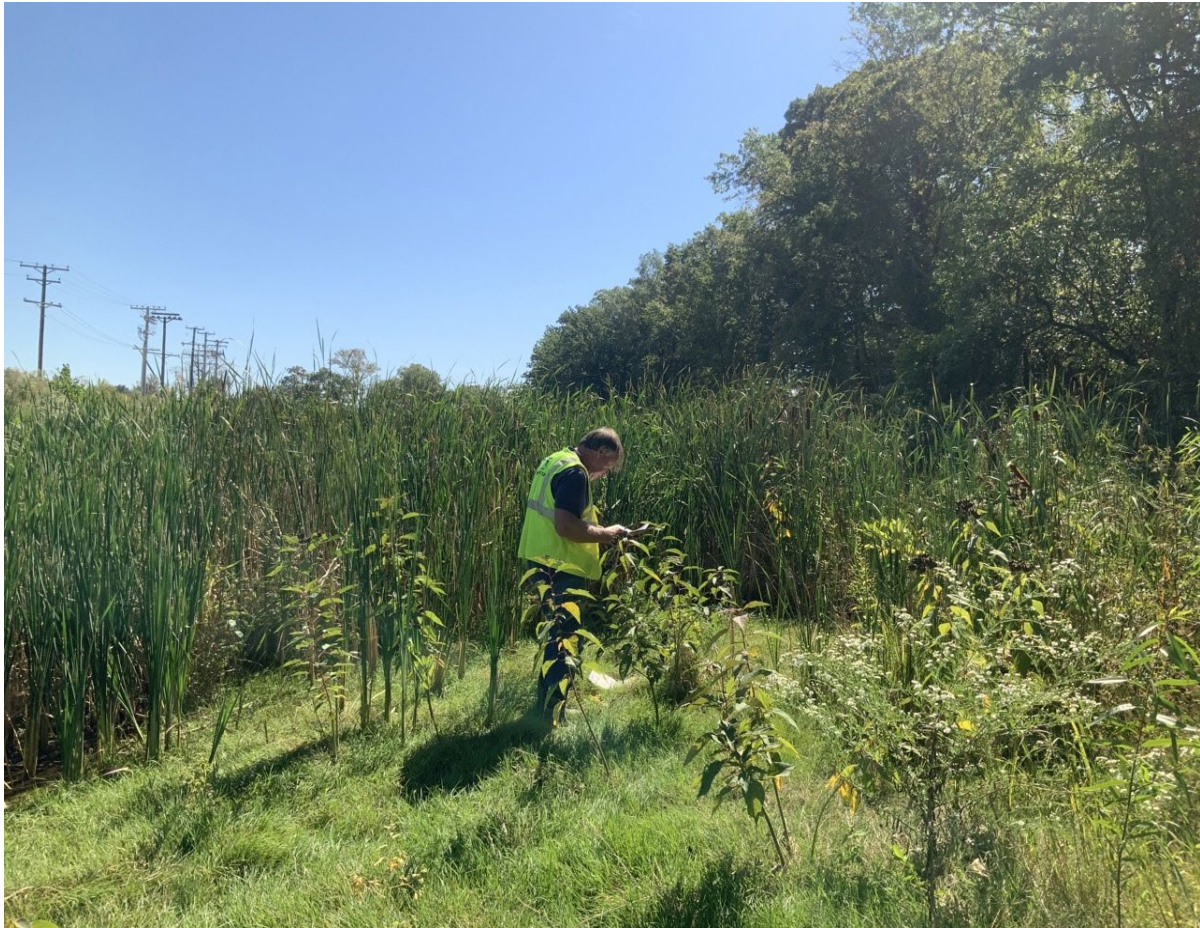
Figure 3-7. Farthest downstream scrub shrub wetland (Plot 8), facing southeast.

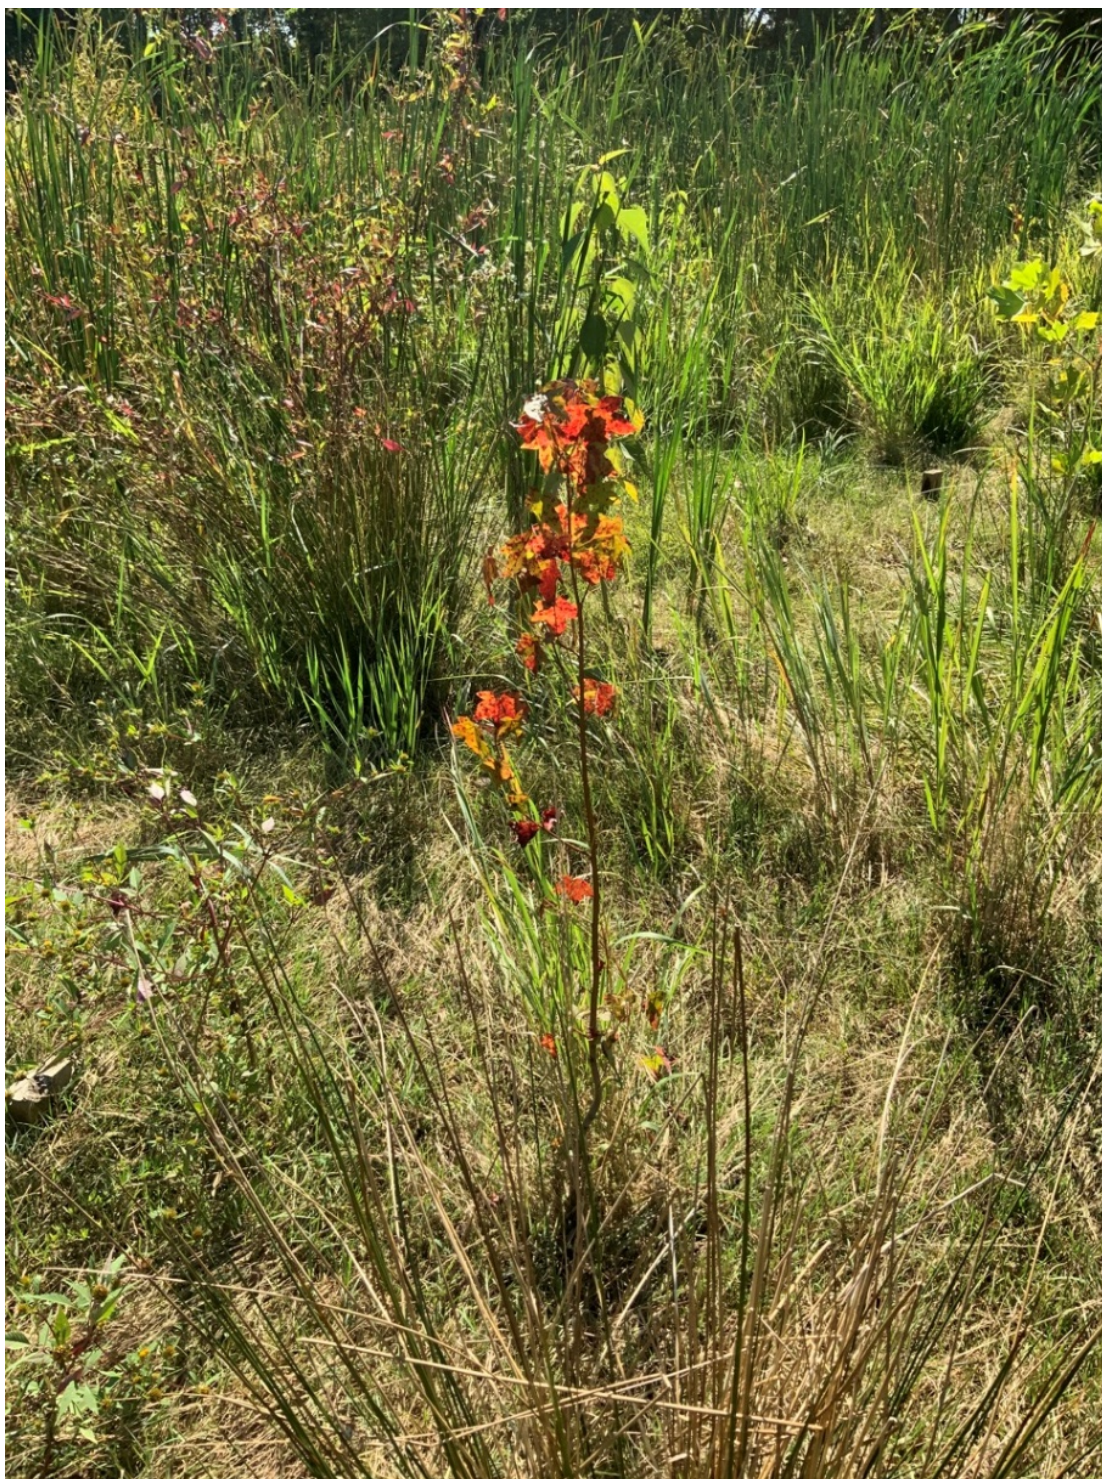
Plot 9: This forested wetland is halfway down the creek and within the project area on the Lockheed Martin side (Figure 3-8). Like most non-inundated sites, creeping bentgrass is the dominant herbaceous vegetation, with rush and sedge species becoming more numerous (100% ground cover). Five woody stem plants were counted at this site, and survival appears to be 100% as no dead shrubs or trees were observed. Planted trees including sweet gum, red maple, and sycamore. Black willow is the dominant tree species. Soil in the monitoring location was

saturated at the surface and is hydric based on colors and features. No invasive ground cover was observed within the plot.

Figure 3-8. Forested wetland on Lockheed Martin side of Cow Pen Creek (Plot 9), facing southeast.

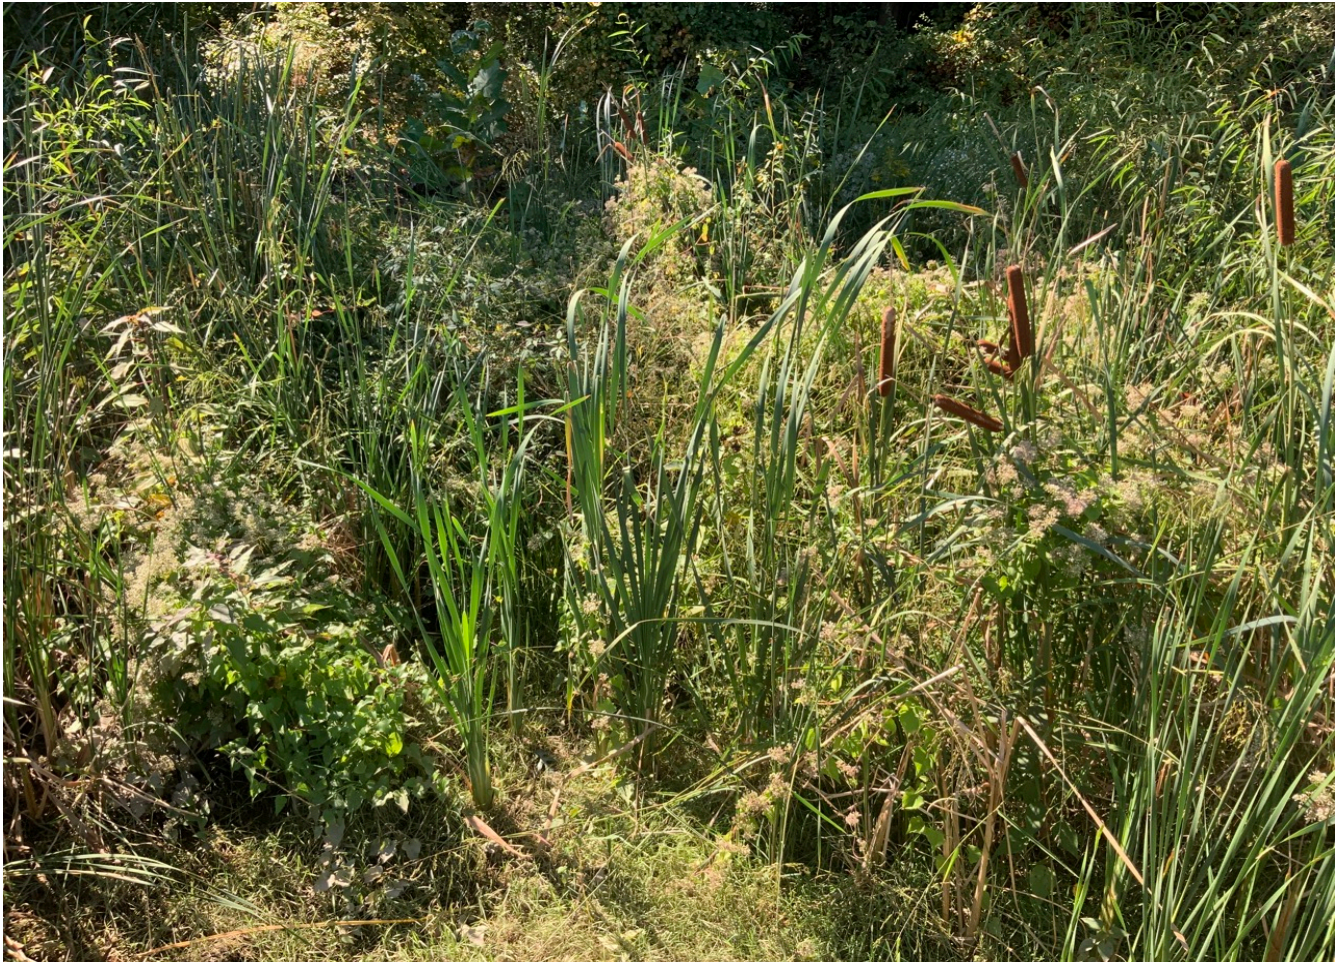
Plot 10: This forested wetland is within the project area more than halfway downstream and on the Lockheed Martin side (Figure 3-9). Like plot 9, this area is low and on the inside bend of the creek. Ground cover here is 100%, with creeping bentgrass being the dominant herbaceous vegetation, and rush and sedge species becoming more numerous. Six woody stem plants were counted in this plot, and survival appears to be 100%, as no dead shrubs or trees were observed. Planted trees include sweet gum, red maple, and sycamore, with sweet gum and sycamore established as dominant species. Soil in the monitoring location was saturated at the surface and is hydric based on colors and features. No invasive ground cover was observed within the plot.

Plot 11: This plot is in the emergent wetland between forested wetland and open water (Figure 3-9). Marsh fleabane and cattail are the dominant herbaceous vegetation, with pickerel weed, rushes, and sedges also observed. No woody vegetation was observed in this plot, and vegetative coverage is 100%. This area is shallow so emergent vegetation may expand waterward over time.

Figure 3-9. Boundary between forested (Plot 10) and emergent wetland (Plot 11), facing southeast.

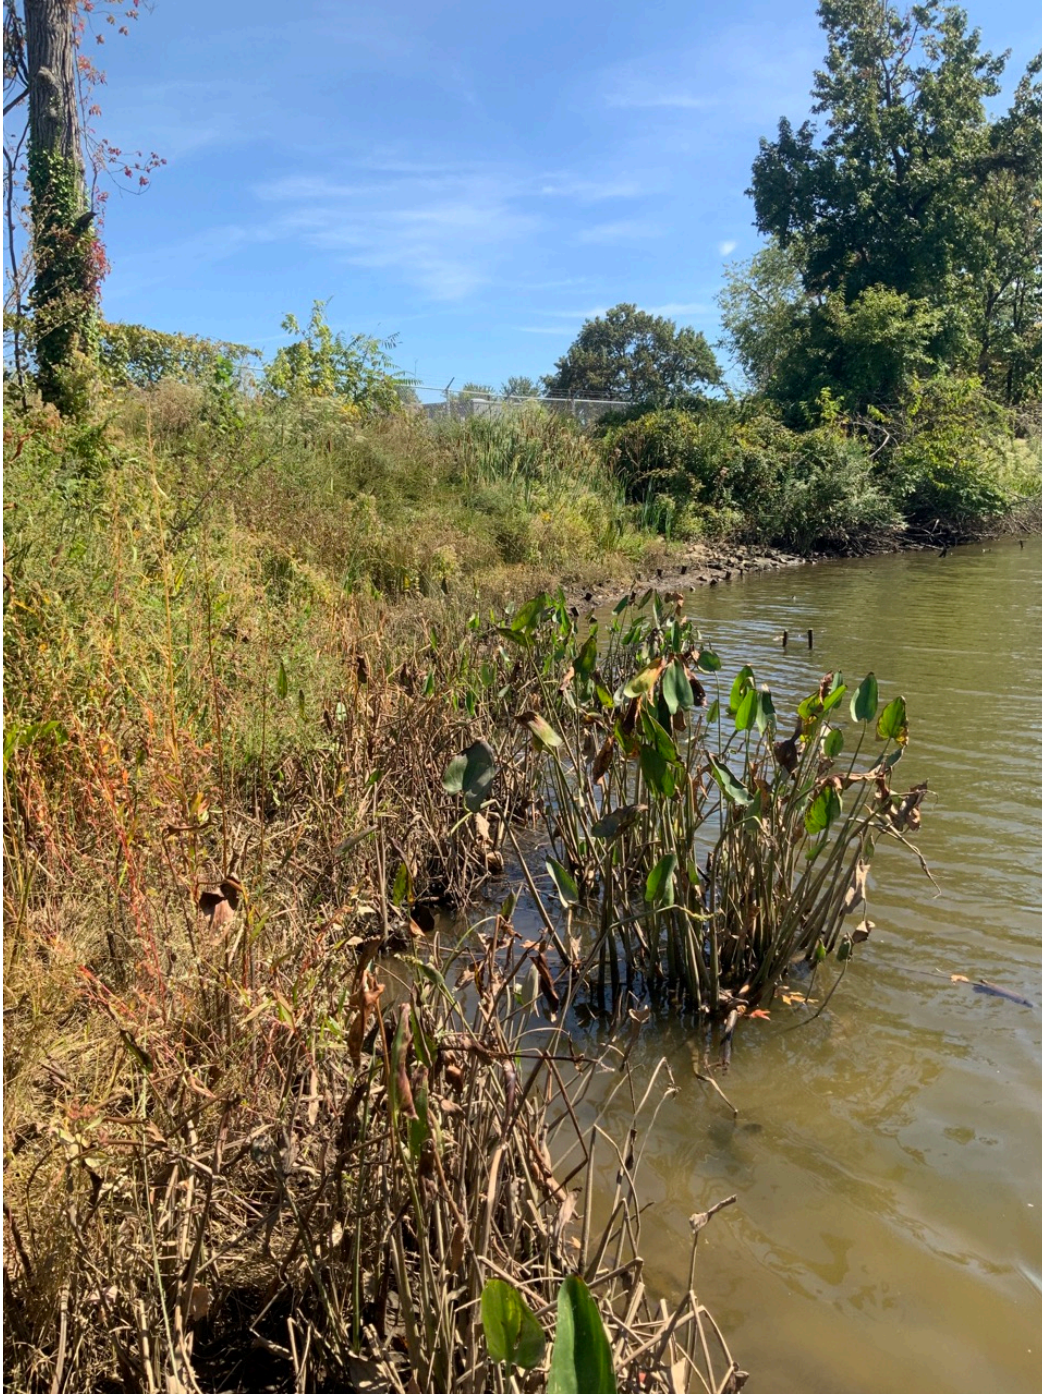
Plot 12: This site is the farthest downstream and on one of the constructed benches designed to function as an emergent wetland (Figure 3-10). Vegetation is still sparse, with less than 25% coverage. Herbaceous plants are mostly pickerel weed with a smaller amount of green arrow-*arum* (*Peltandra virginica*). No invasive plants were observed within the plot.

Figure 3-10. Emergent wetland on downstream bench (Plot 12), facing southeast.

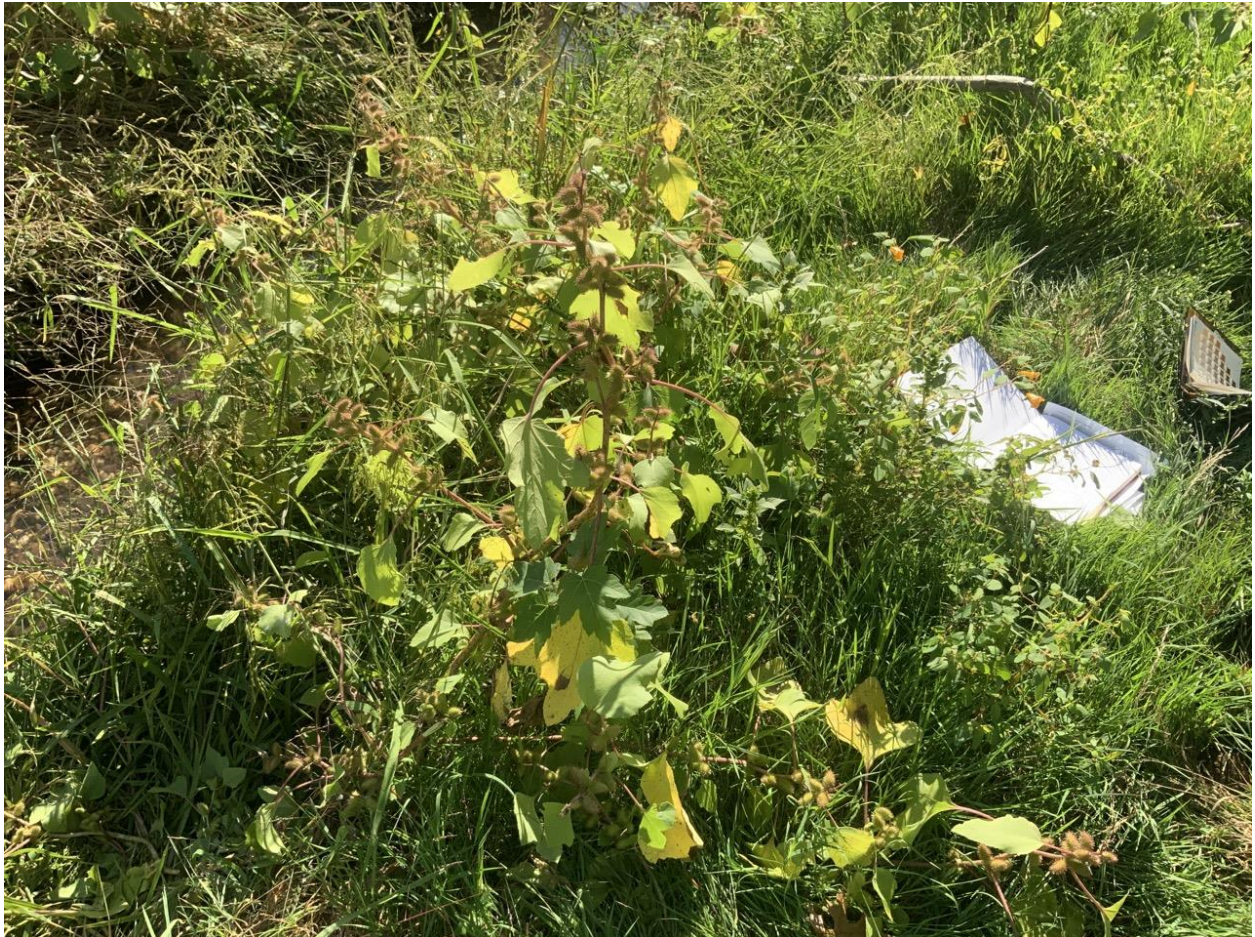
Figure 1 – Upstream boundary of project area. Area is well vegetated although there are some non-native invasive plants such as this burdock.

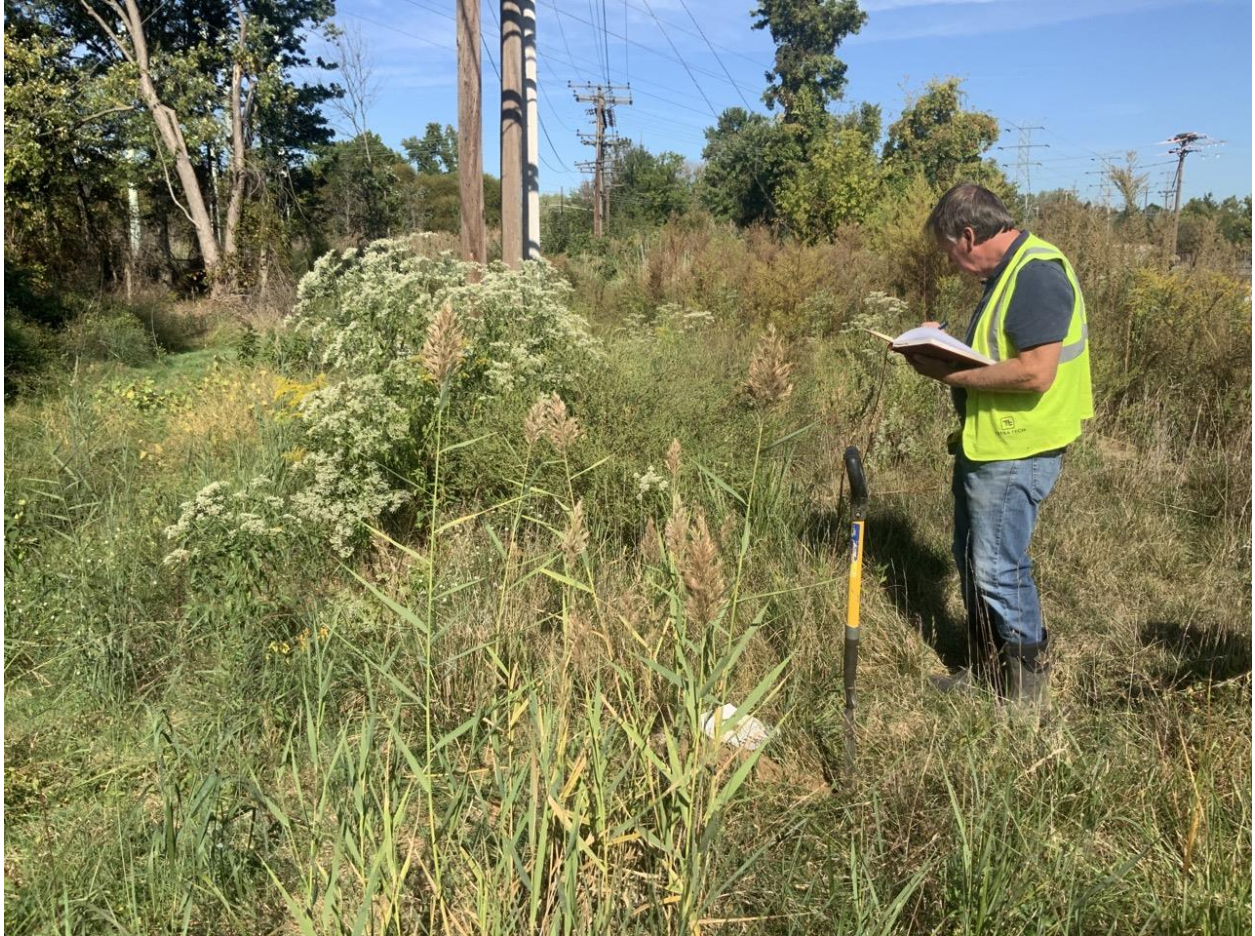
Figure 9 – Some patches of invasive common reed or phragmites are present but are being controlled with herbicide and a wipe applicator.

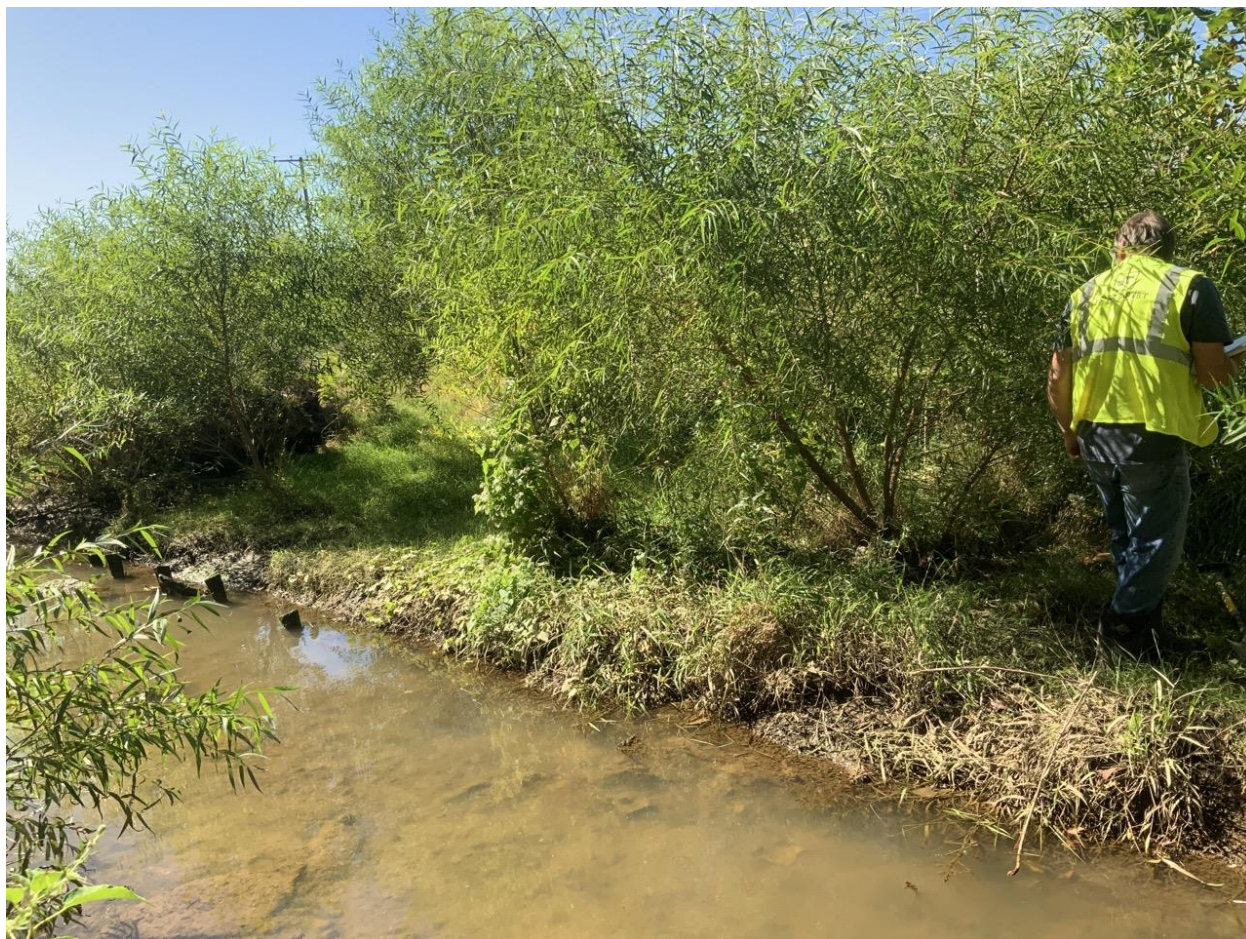
Figure 14 – Area designated as emergent wetlands along Cow Pen Creek. No emergent plants at this location.

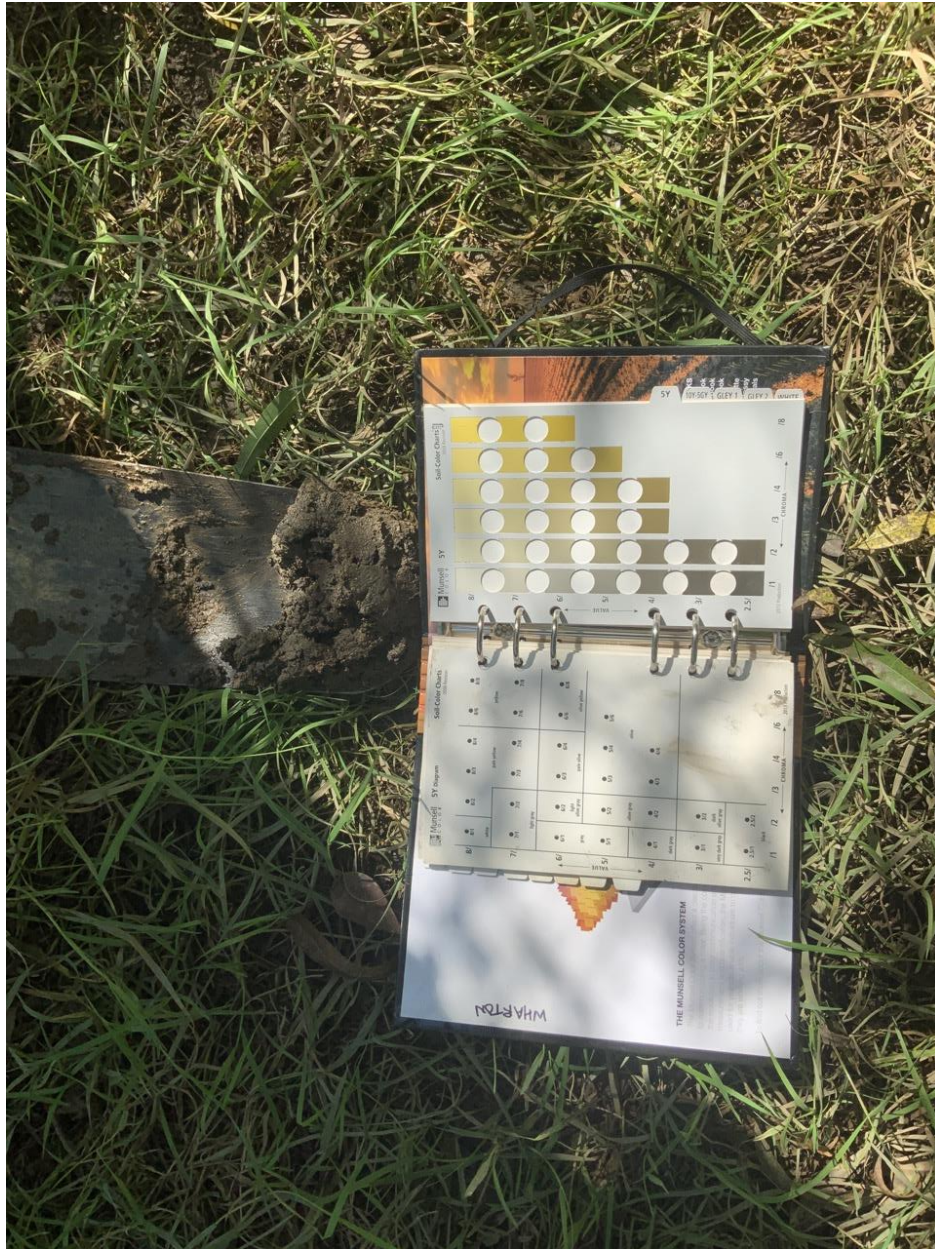
Figure 16 – Hydric soil have a grey color and chroma value of 2 or less.

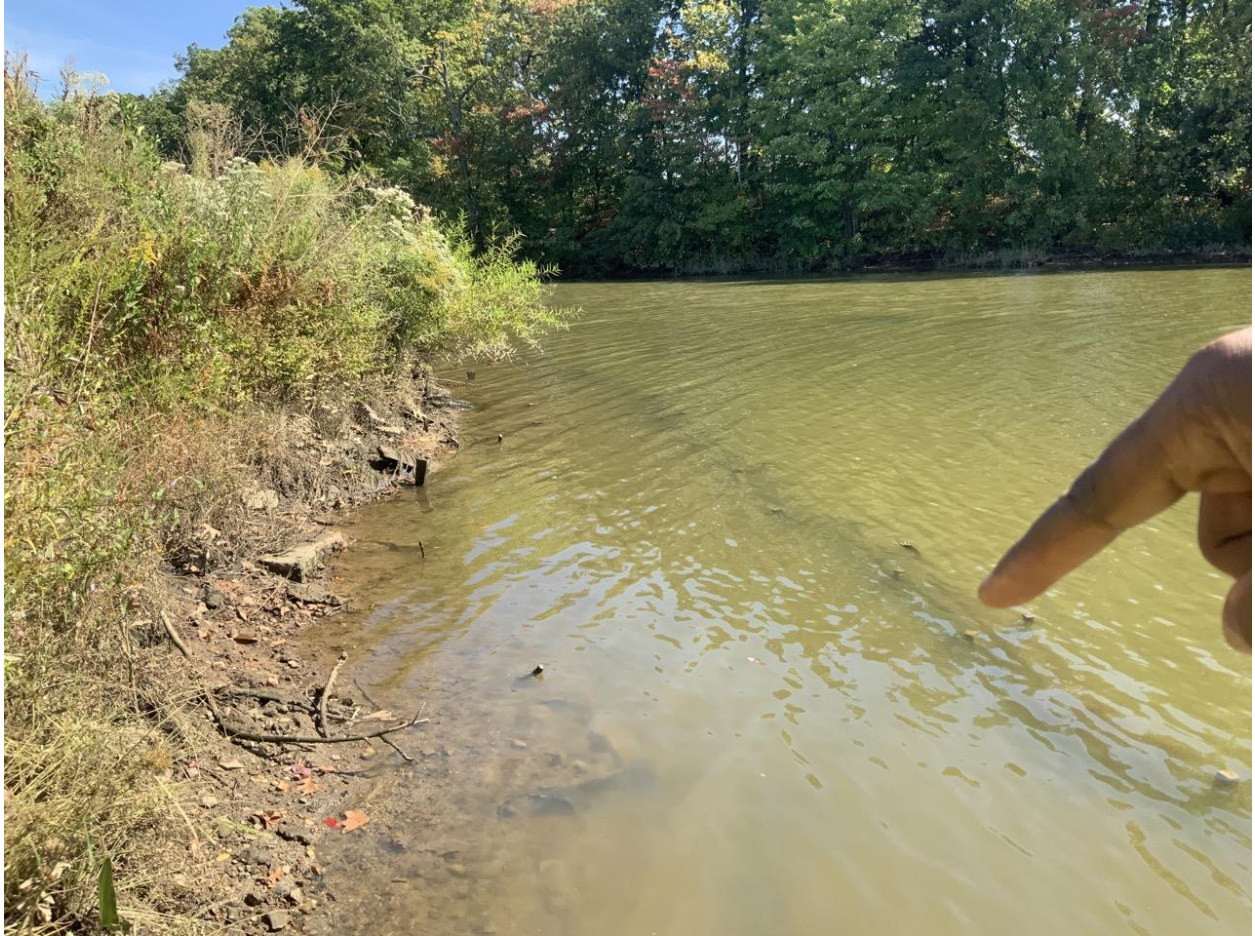
Figure 6 – Submerged soil benches created near the downstream boundary. This area was designed to support emergent vegetation and are about 25% vegetated with additional planting planned.
